Inspection Report

Facility: Towers, The
Address: 2366 East Mall Dr,
Fort Myers, 33901

Work Order #: 5326

Re.: **Inspection Report (4 of 6) for The Towers**

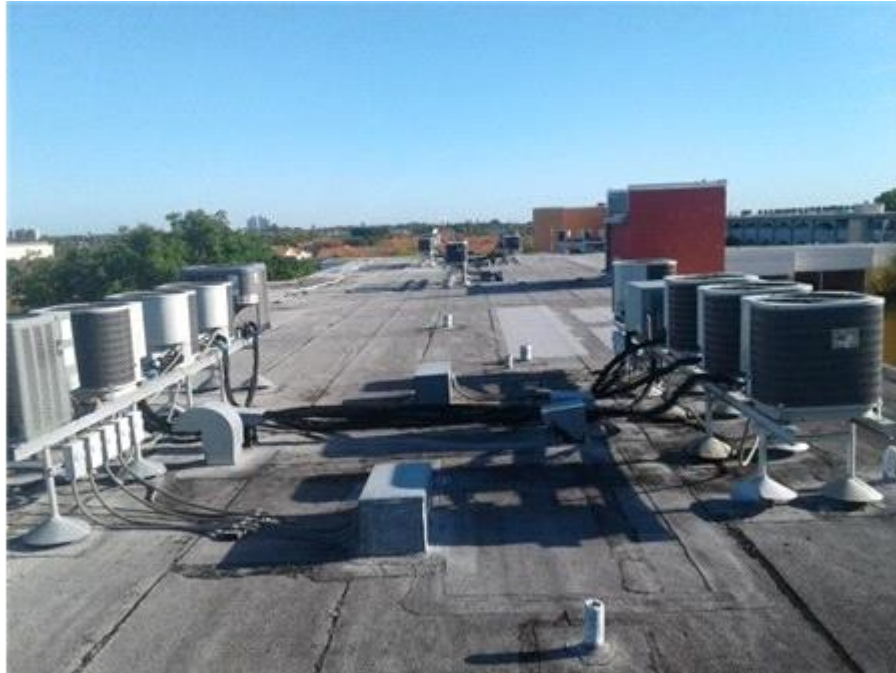
002F - The Towers - BUR Appearance Overview

The appearance of the roof is in fair condition at this time.

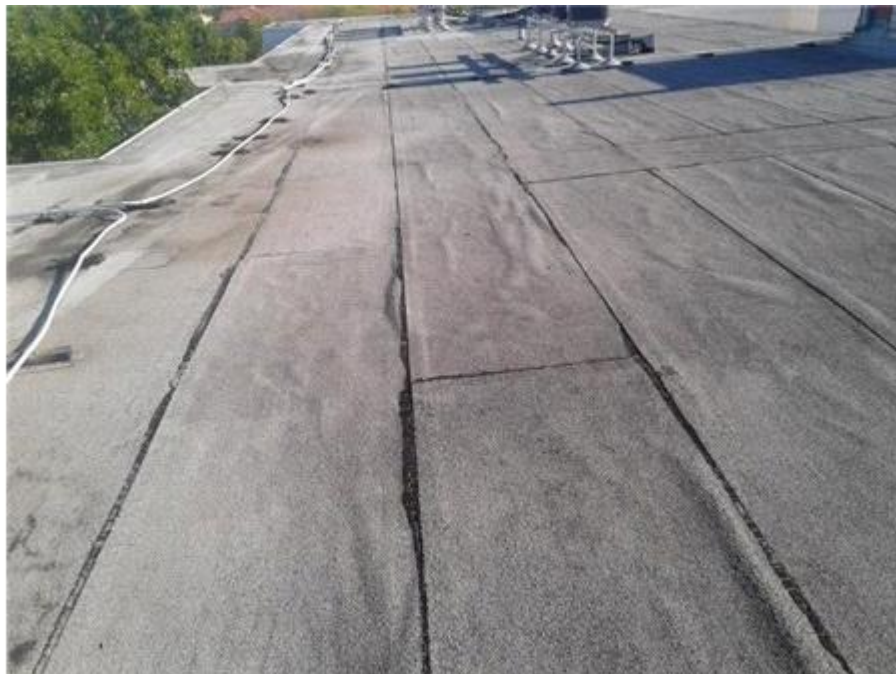
003F - The Towers - BUR Membrane Overview

The roof membrane appears to be in fair condition at this time.

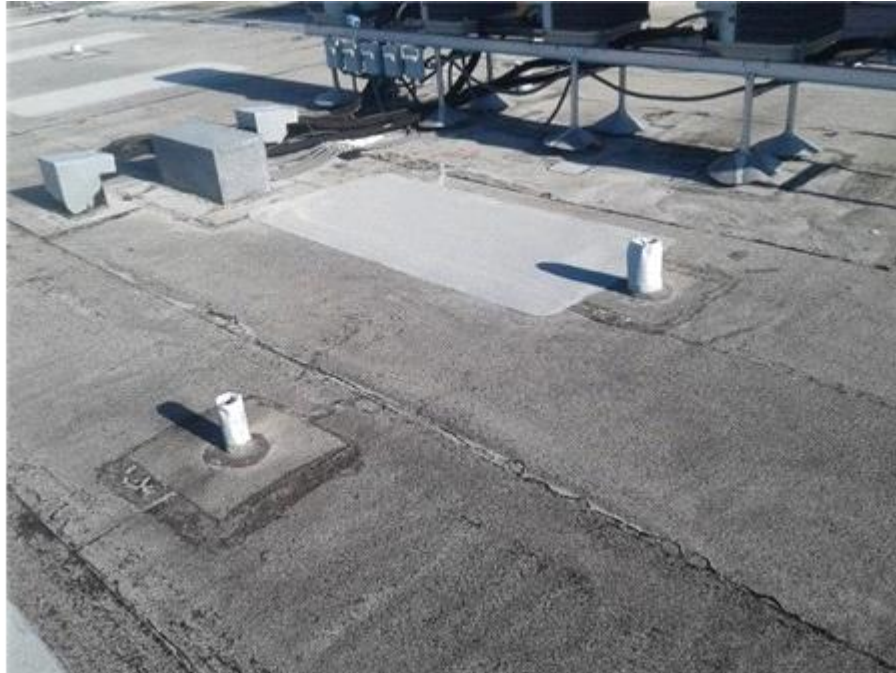
019F- The Towers - BUR Lead Boots

Lead boots appear to be in fair condition.

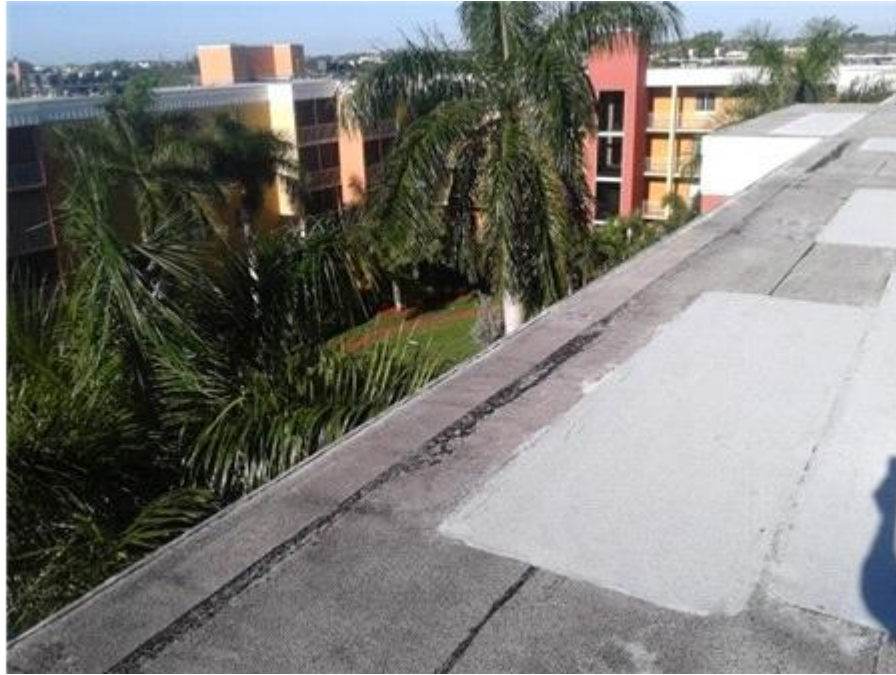
016F- The Towers - BUR Roof Edge

Roof edge appears to be in fair condition.

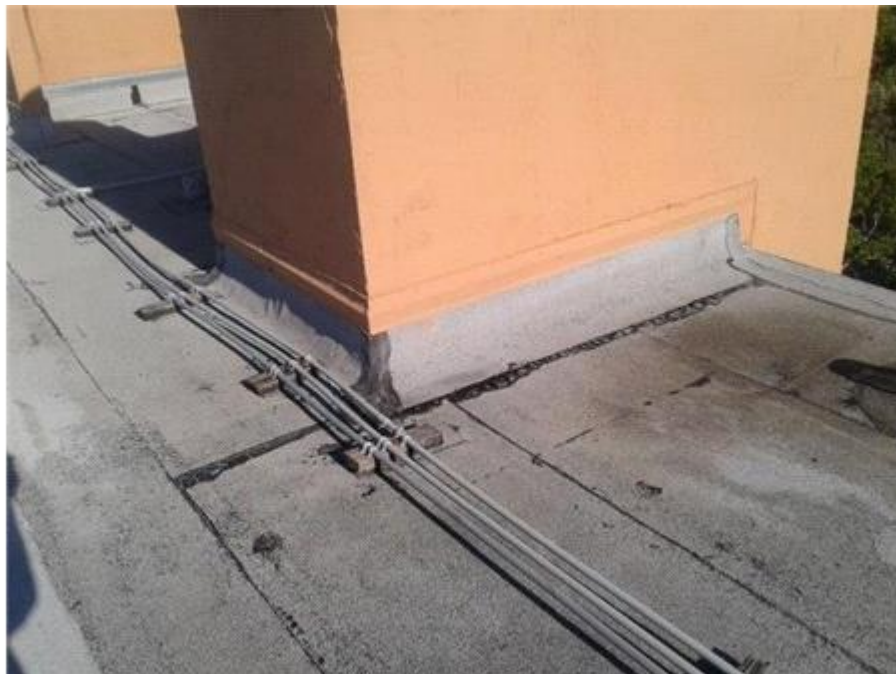
004F - The Towers - BUR Base Flashings

The base flashings appear to be in fair condition.

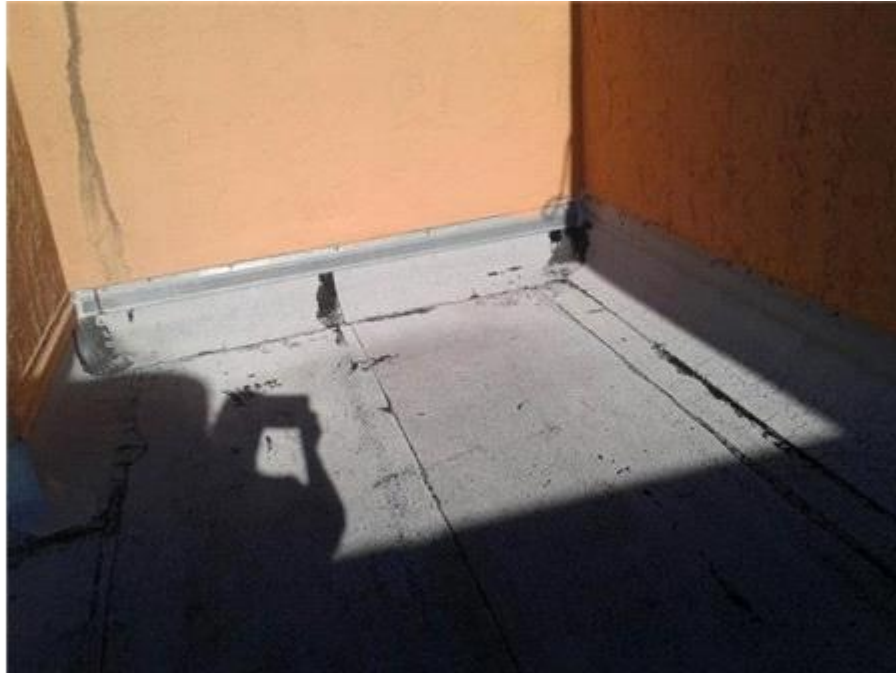
004F - The Towers - BUR Base Flashings

The base flashings appear to be in fair condition.

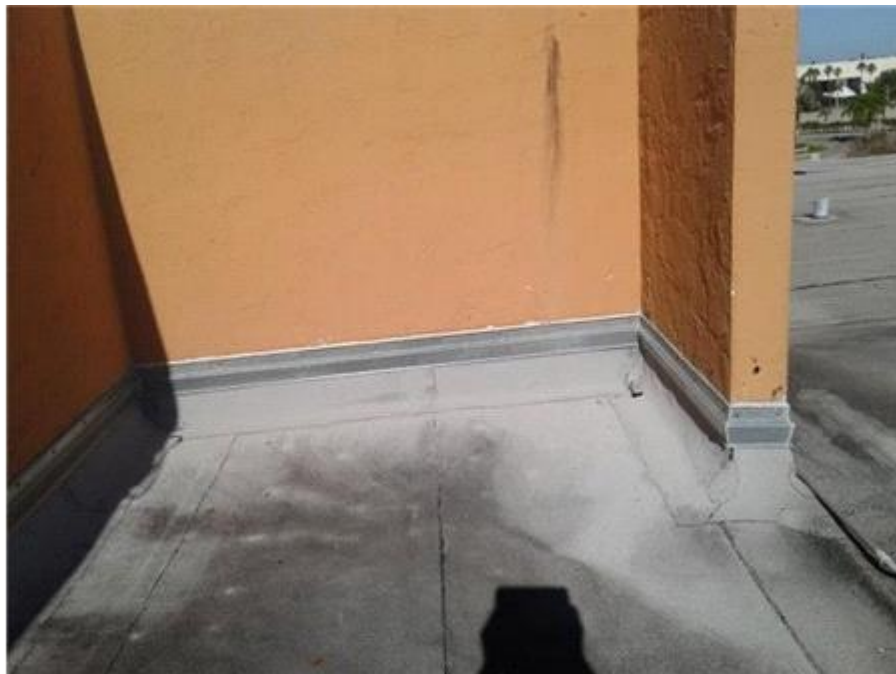
005F- The Towers - BUR Counter Flashing

The counter flashing appears to be in fair condition.

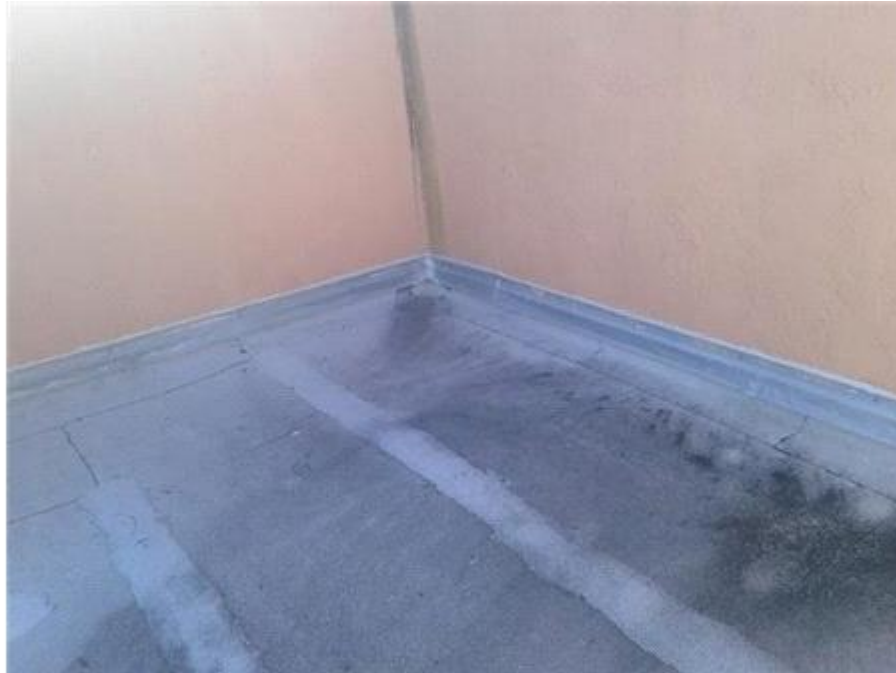
005F- The Towers - BUR Counter Flashing

The counter flashing appears to be in fair condition.

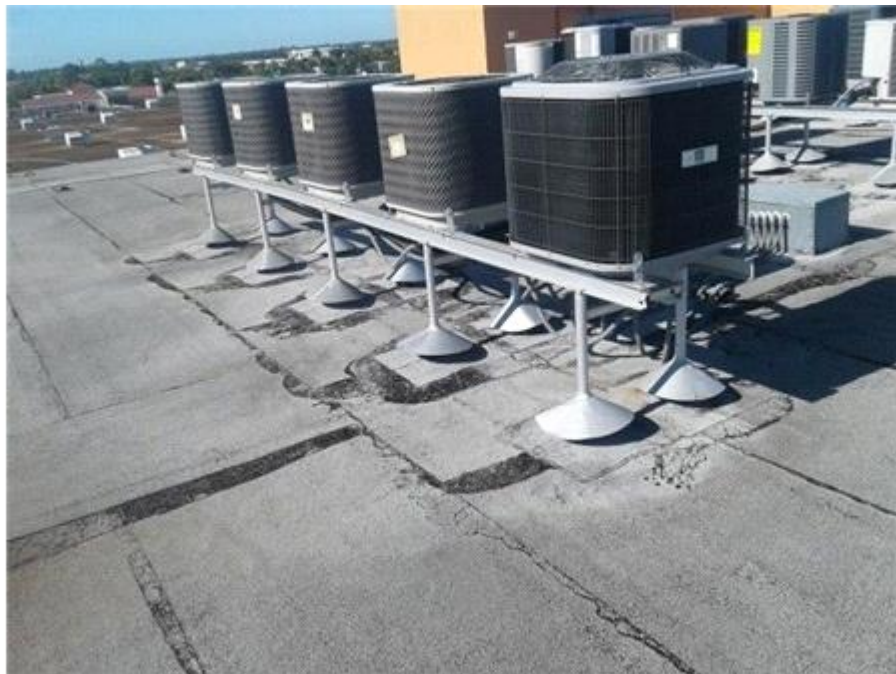
002F - The Towers - BUR Appearance Overview

The appearance of the roof is in fair condition at this time.

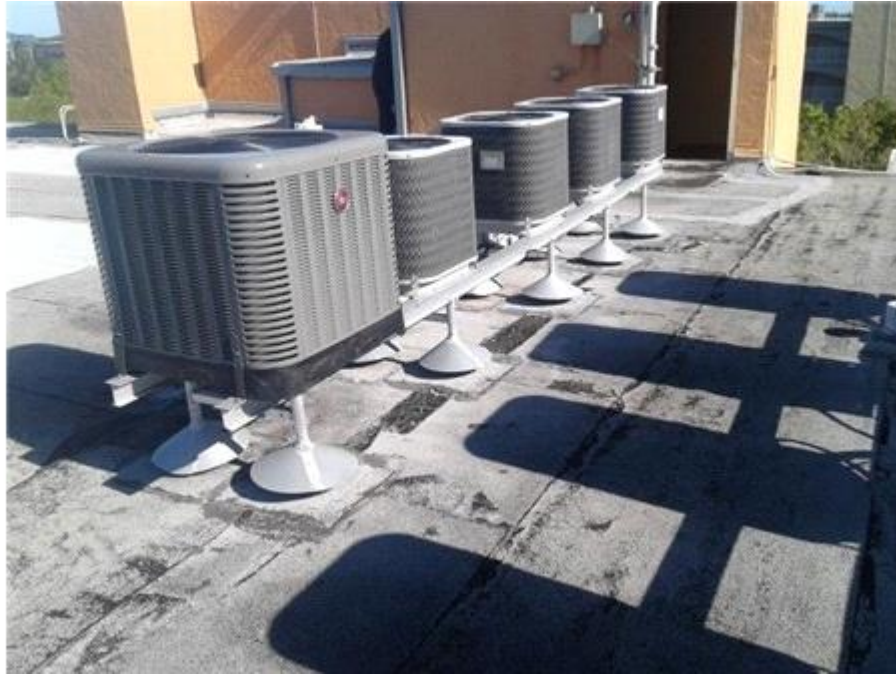
002F - The Towers - BUR Appearance Overview

The appearance of the roof is in fair condition at this time.

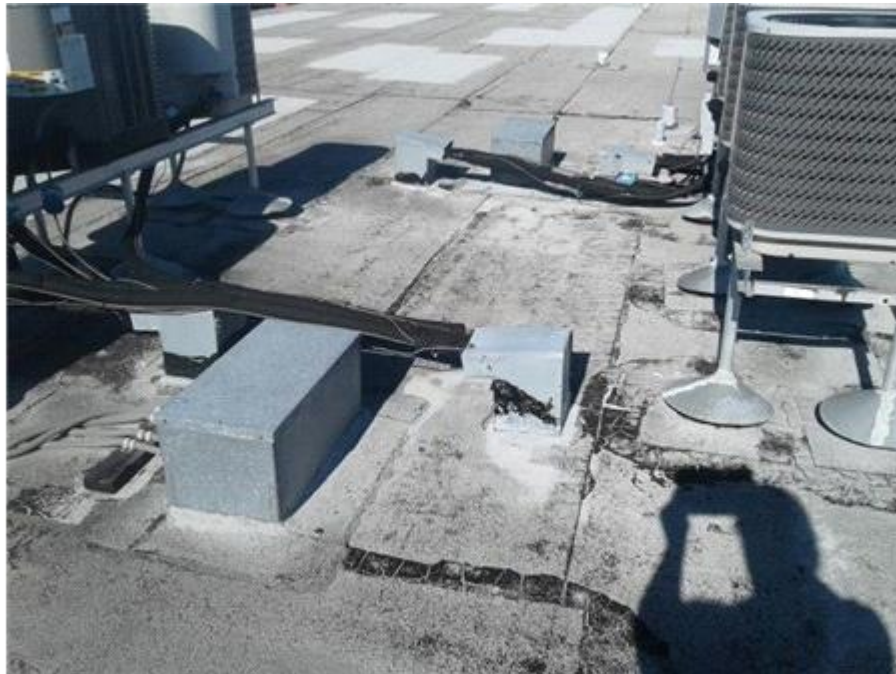
002F - The Towers - BUR Appearance Overview

The appearance of the roof is in fair condition at this time.

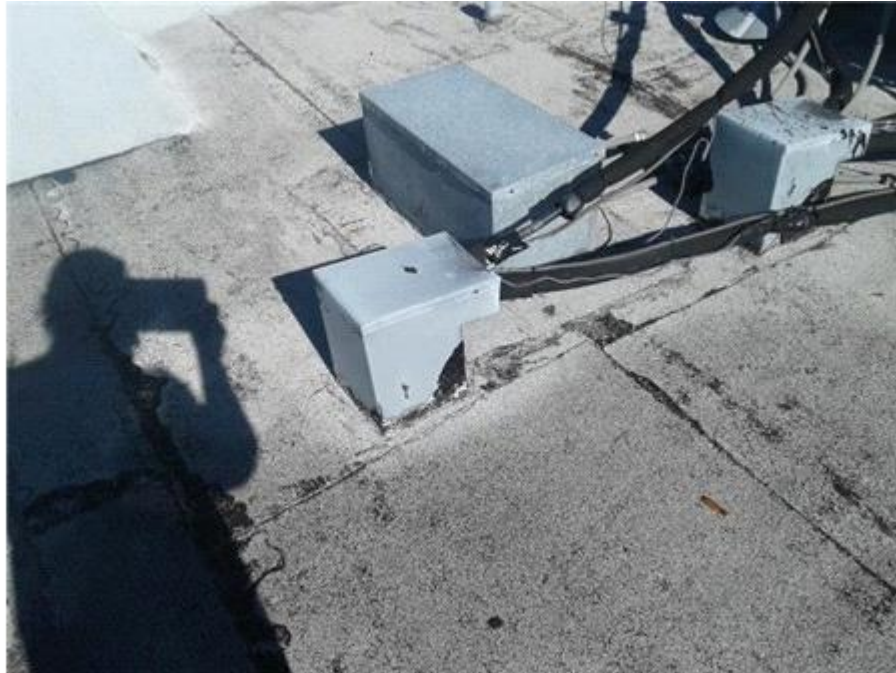
010F- The Towers - BUR Equipment Housing

The equipment housing appears to be in fair condition.

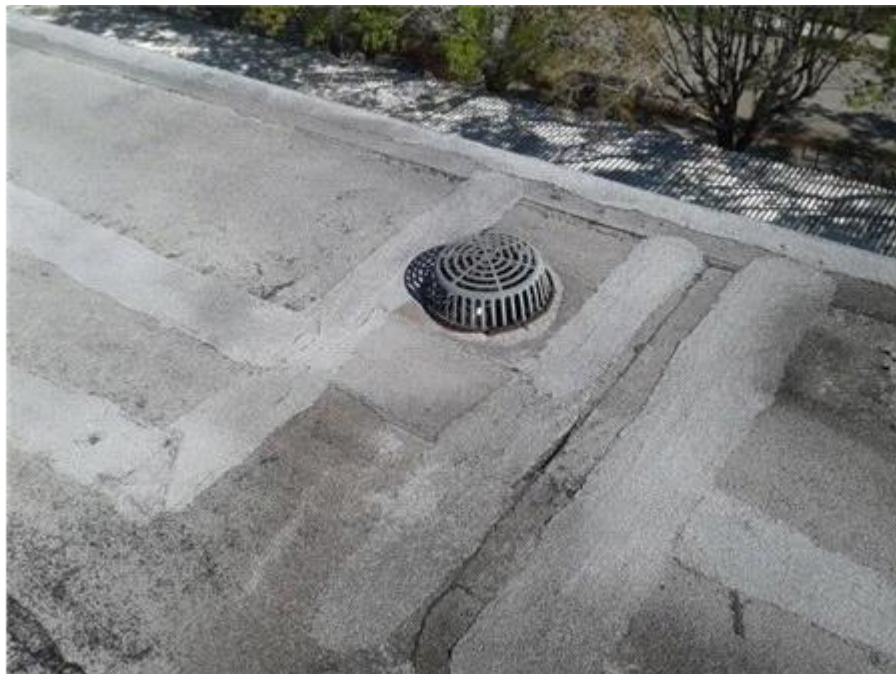
020F- The Towers - BUR Roof Drains

Roof drains appear to be in fair condition.

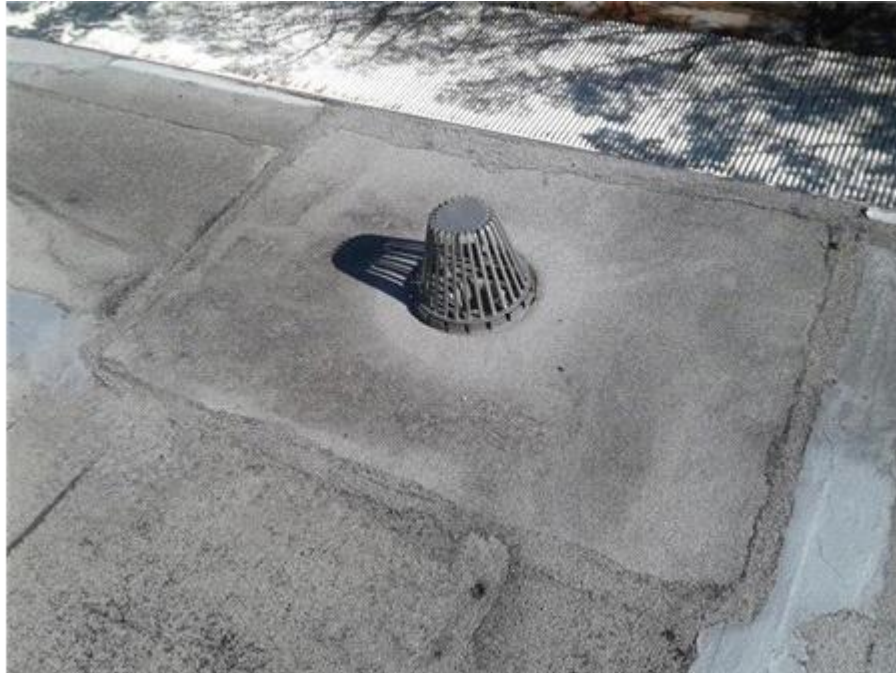
020G- The Towers - BUR Roof Drains

Roof drains appear to be in good condition.

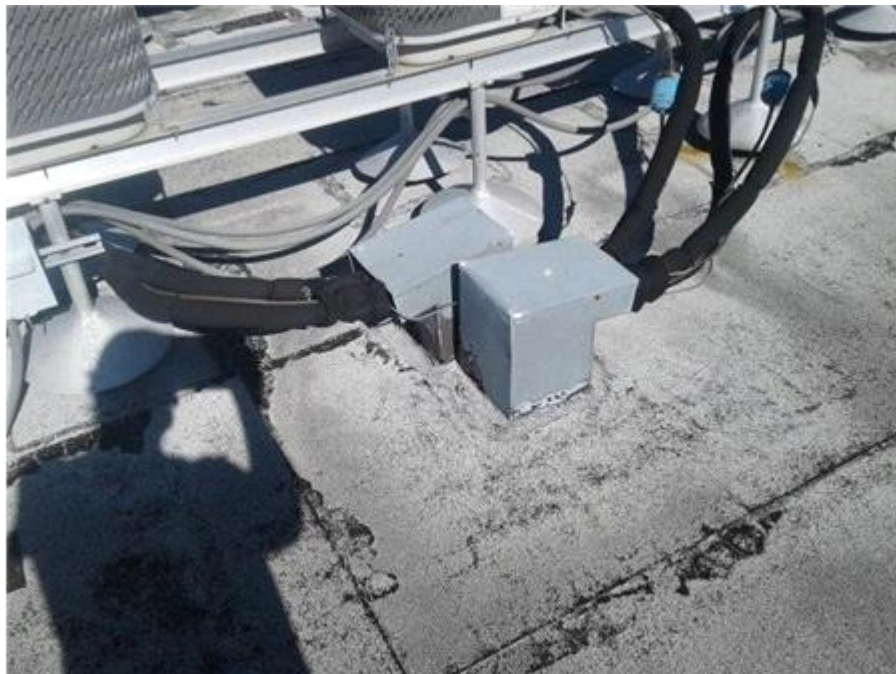
010F- The Towers - BUR Equipment Housing

The equipment housing appears to be in fair condition.

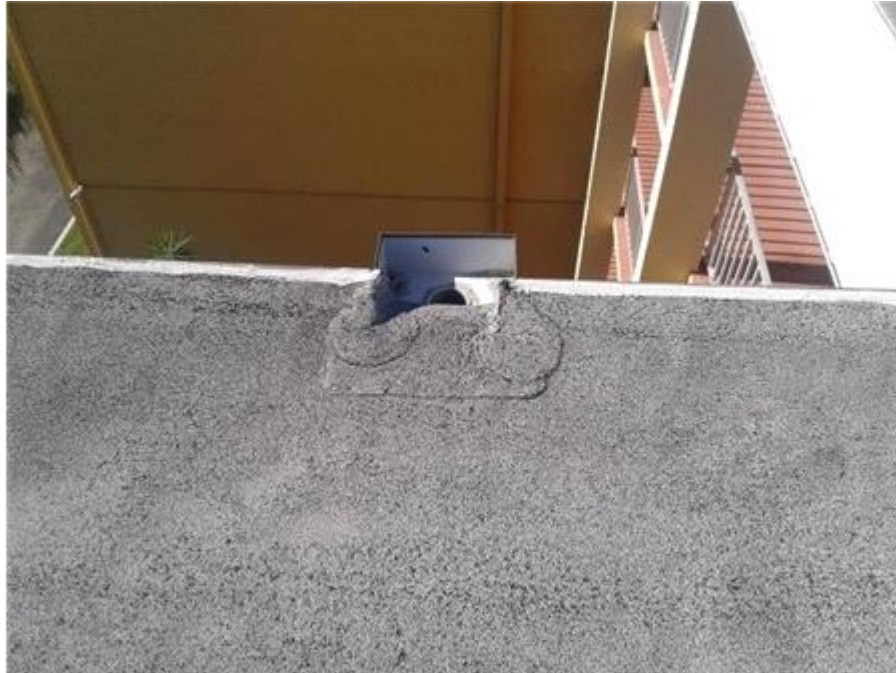
The Towers - BUR Scuppers

Scuppers appear to be in fair condition at this time.

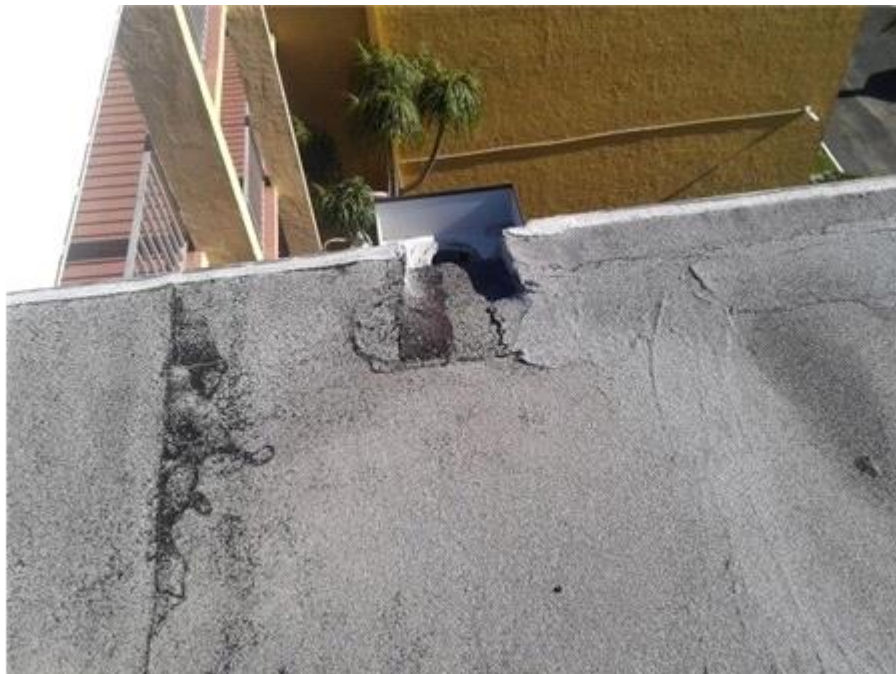
The Towers - BUR Scuppers

Scuppers appear to be in fair condition at this time.

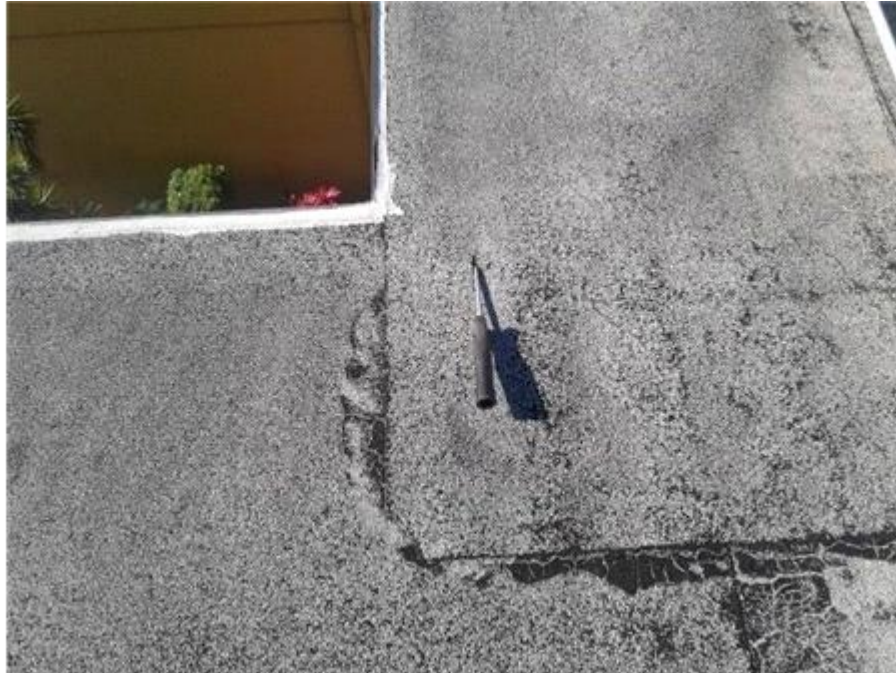
F-102 The Towers - BUR Field Membrane - Puncture

Holes in the membrane are considered high severity due to their high leak potential.

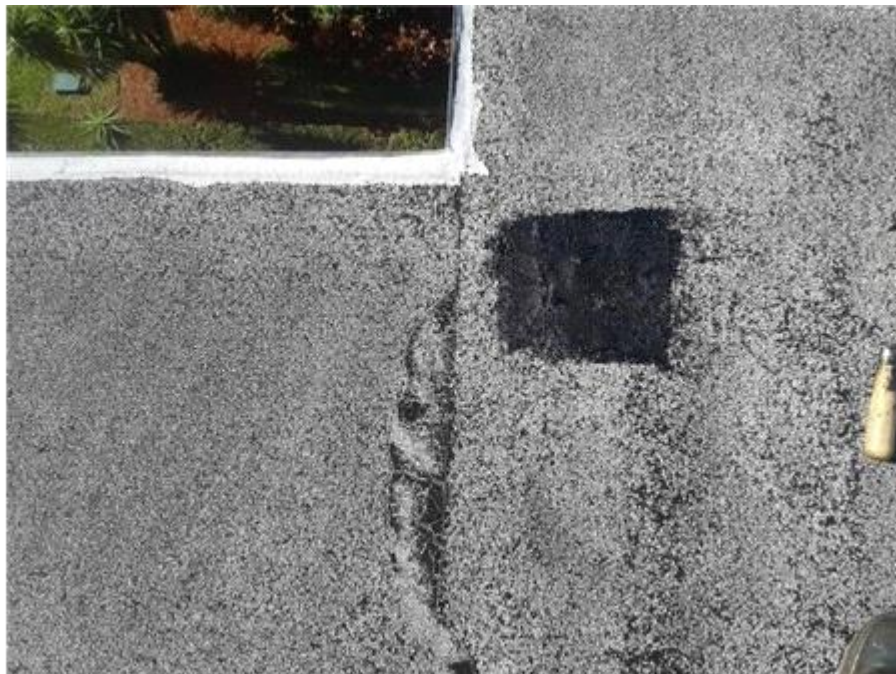
The Towers - BUR Field Membrane - Puncture

Three coursed puncture.

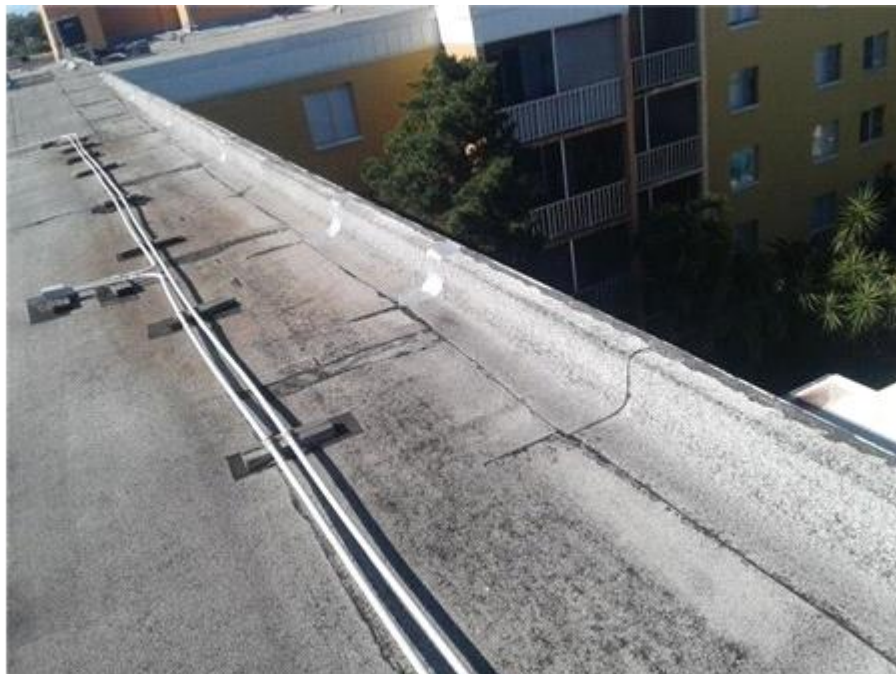
004F - The Towers - BUR Base Flashings

The base flashings appear to be in fair condition.

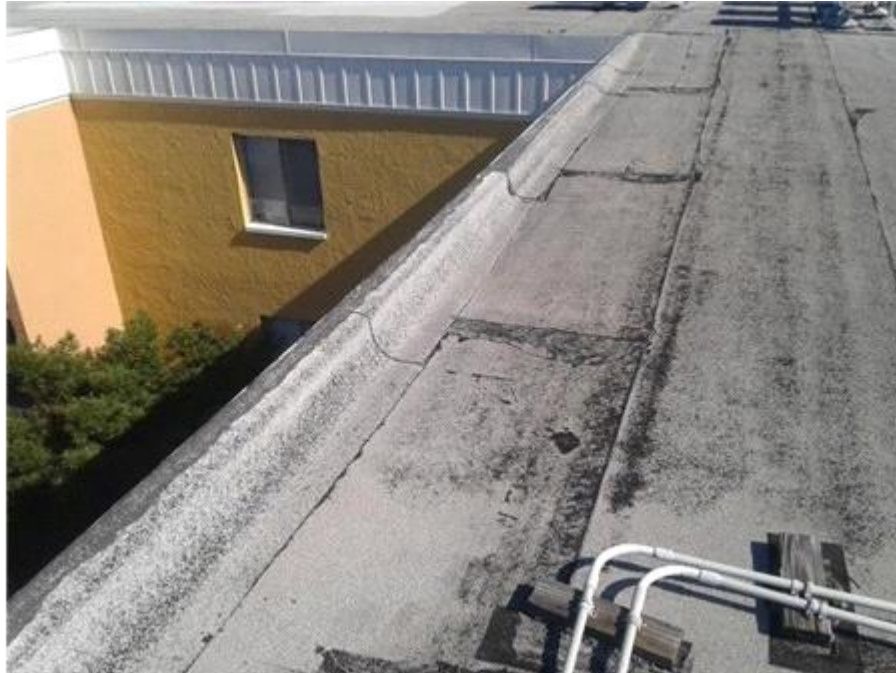
004F - The Towers - BUR Base Flashings

The base flashings appear to be in fair condition.

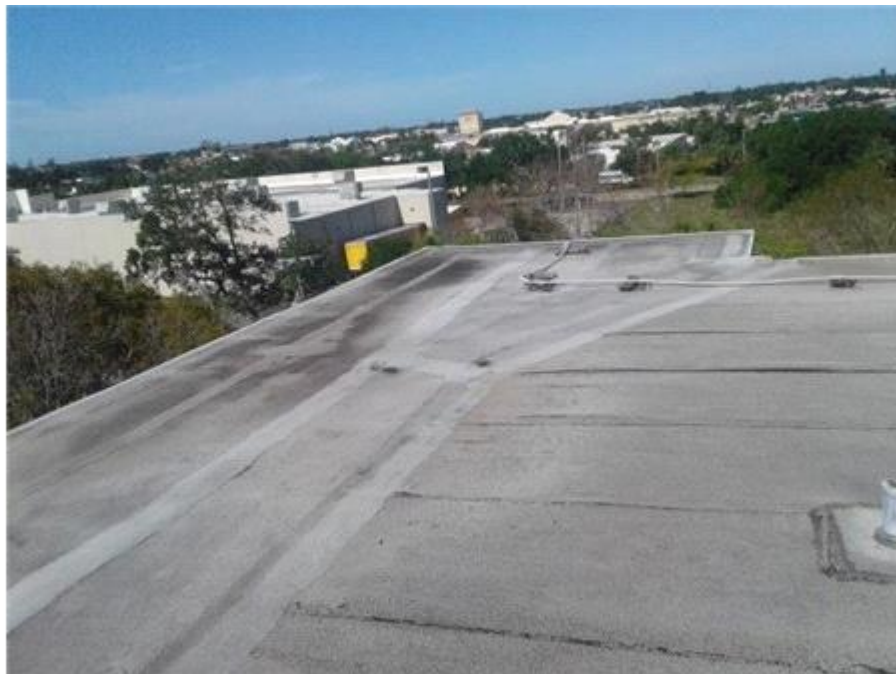
002F - The Towers - BUR Appearance Overview

The appearance of the roof is in fair condition at this time.

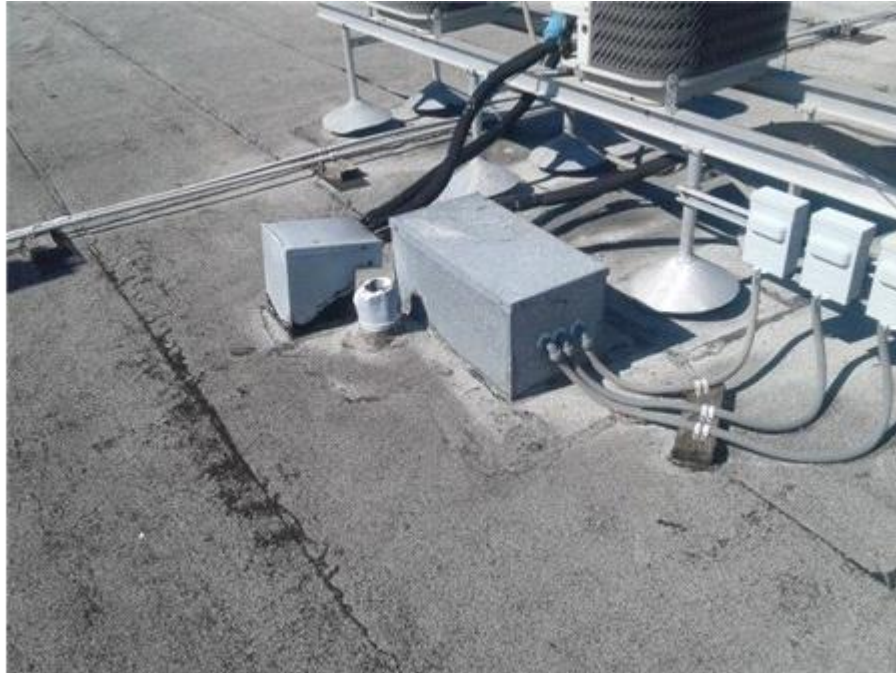
002F - The Towers - BUR Appearance Overview

The appearance of the roof is in fair condition at this time.

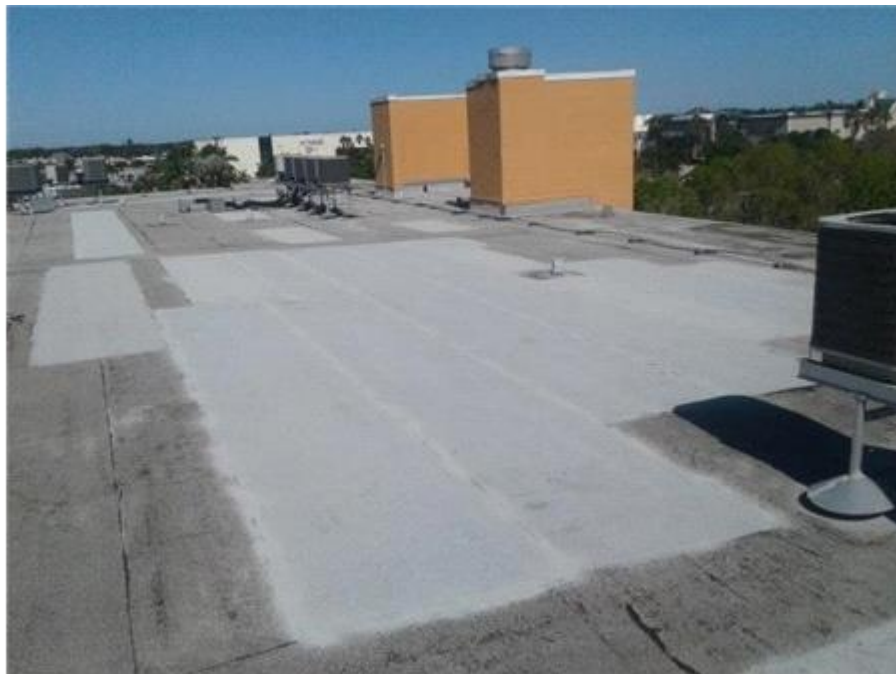
The Towers - BUR Field Membrane

Blister repairs.

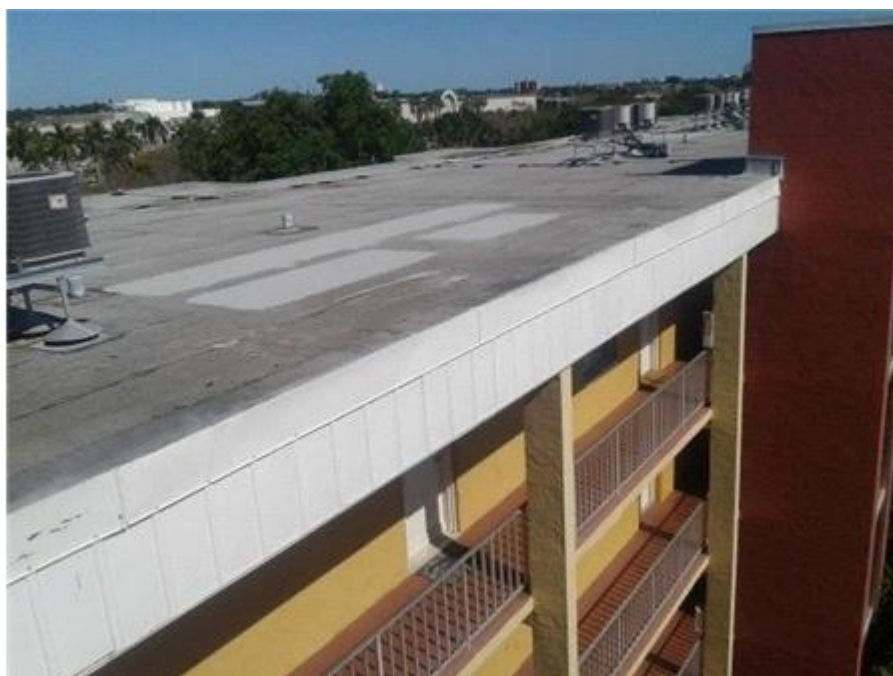
The Towers - BUR Edge Metal/Fascia

Edge metal/fascia appears to be in good condition at this time.

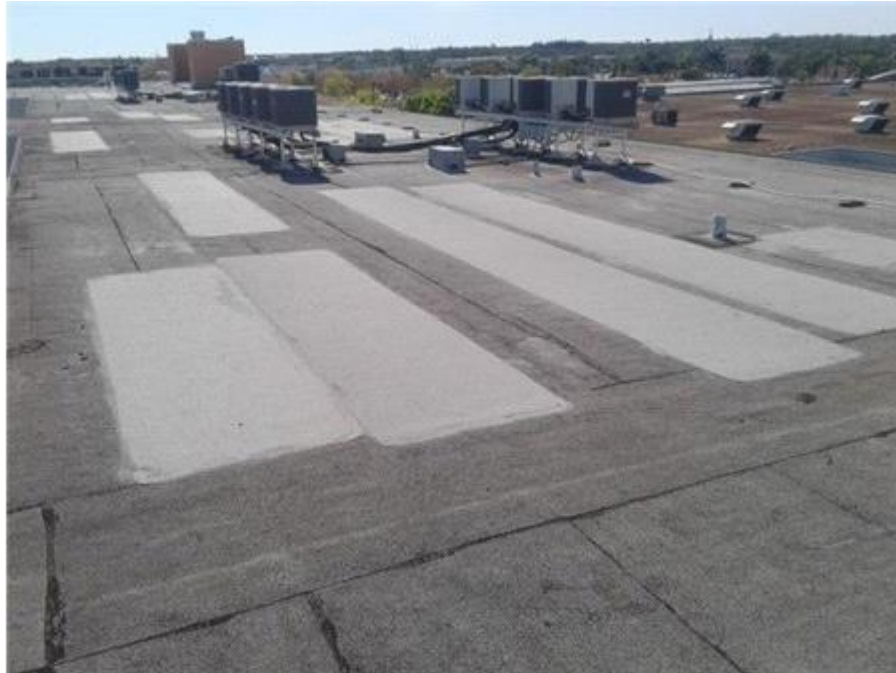
The Towers - BUR Field Membrane
Blister repairs.

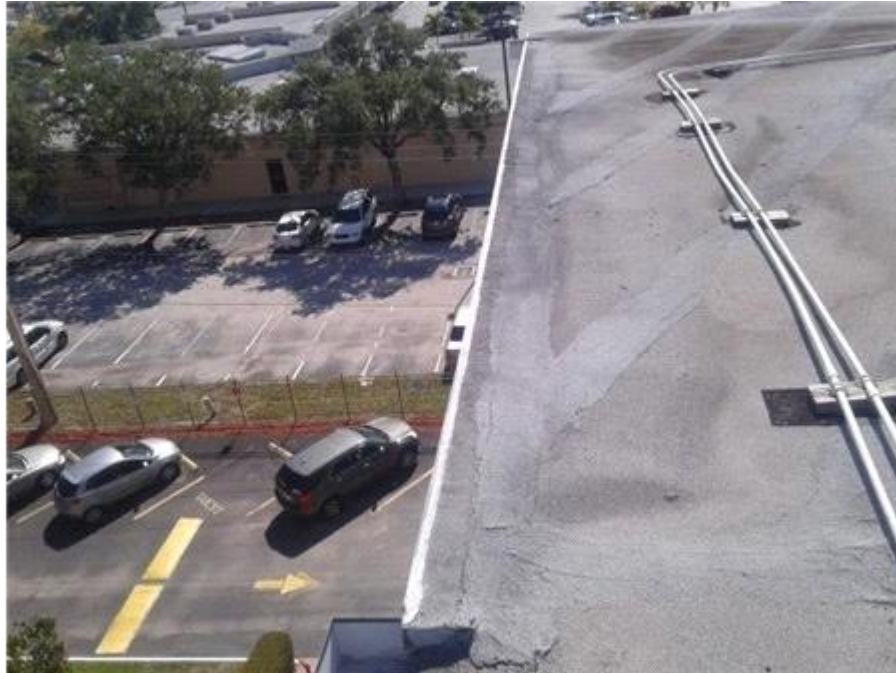
016F- The Towers - BUR Roof Edge

Roof edge appears to be in fair condition.

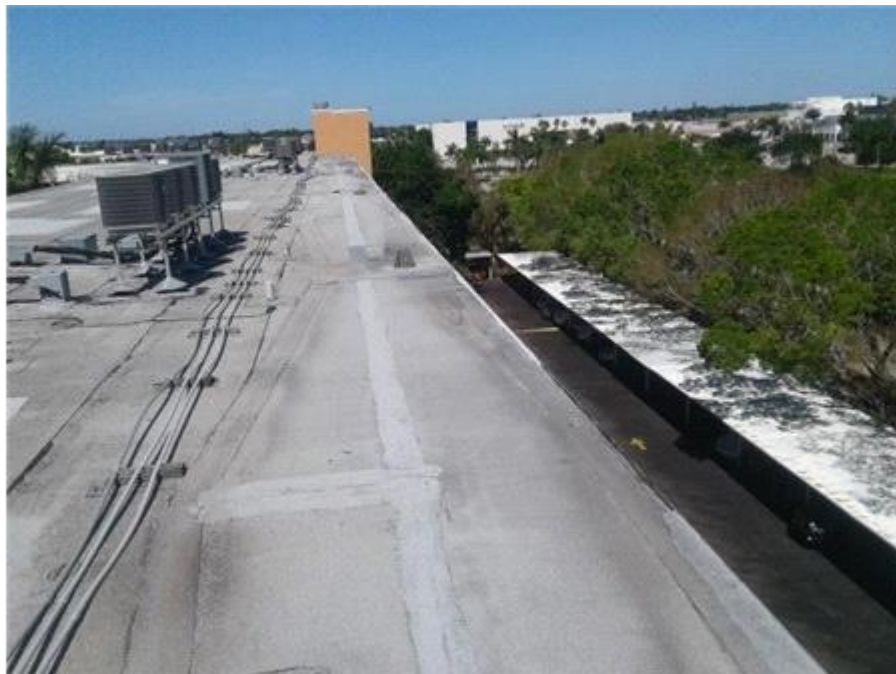
016F- The Towers - BUR Roof Edge

Roof edge appears to be in fair condition.

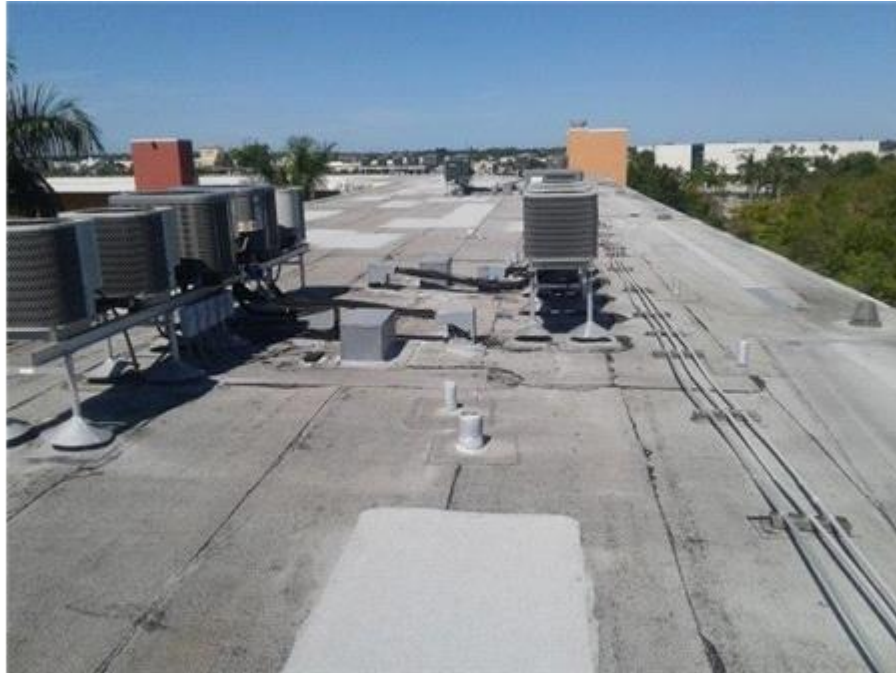
002F - The Towers - BUR Appearance Overview

The appearance of the roof is in fair condition at this time.

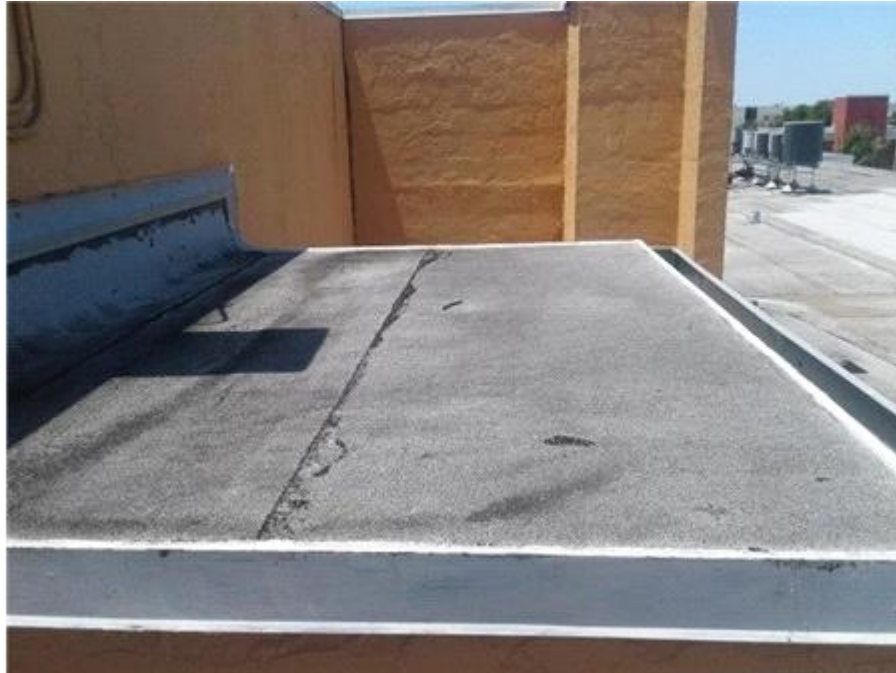
003F - The Towers - BUR Membrane Overview

The roof membrane appears to be in fair condition at this time.

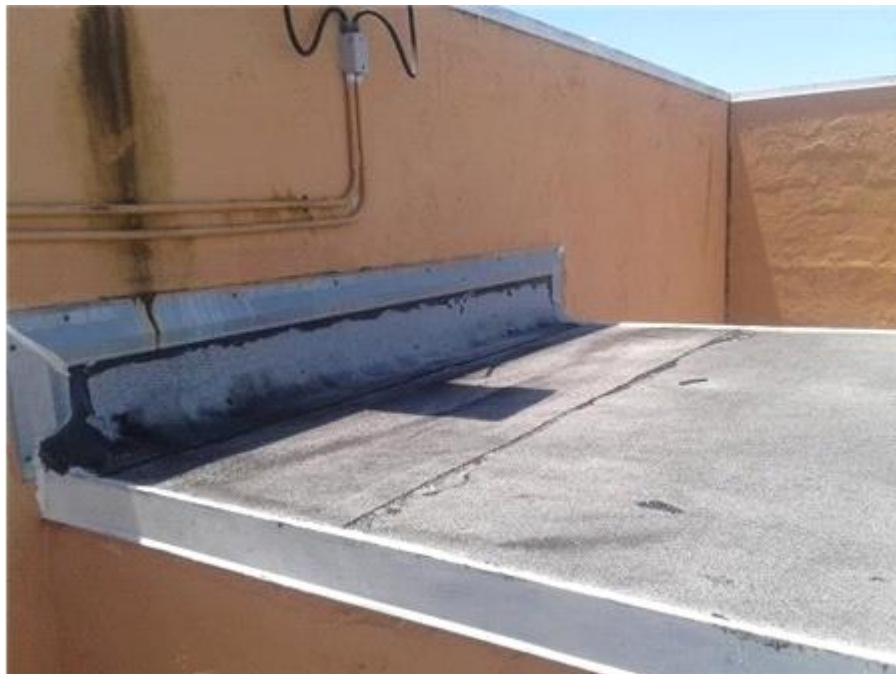
004F - The Towers - BUR Base Flashings

The base flashings appear to be in fair condition.

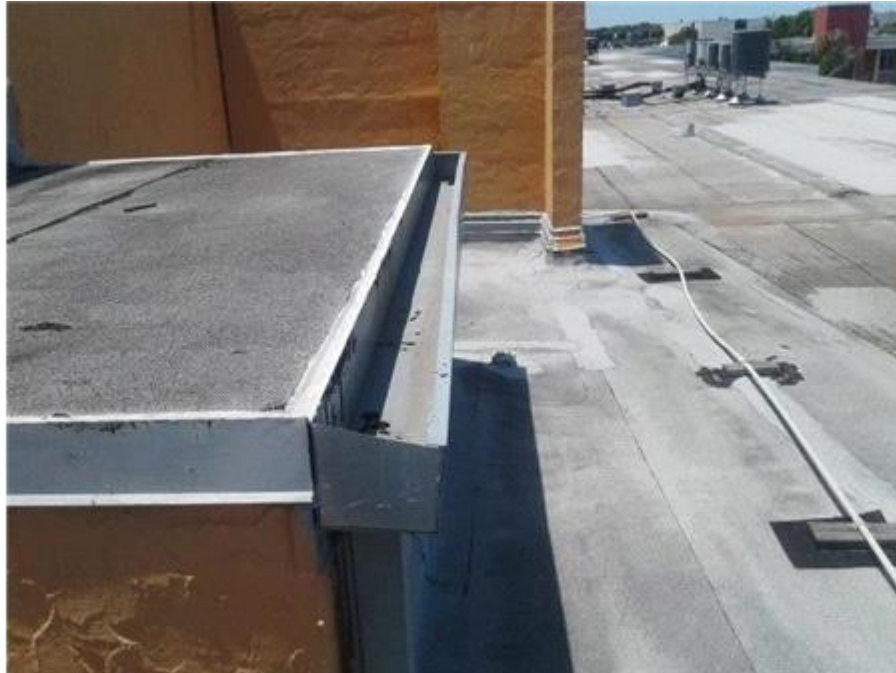
008G- The Towers - BUR Gutters
The gutters appear to be in good condition.

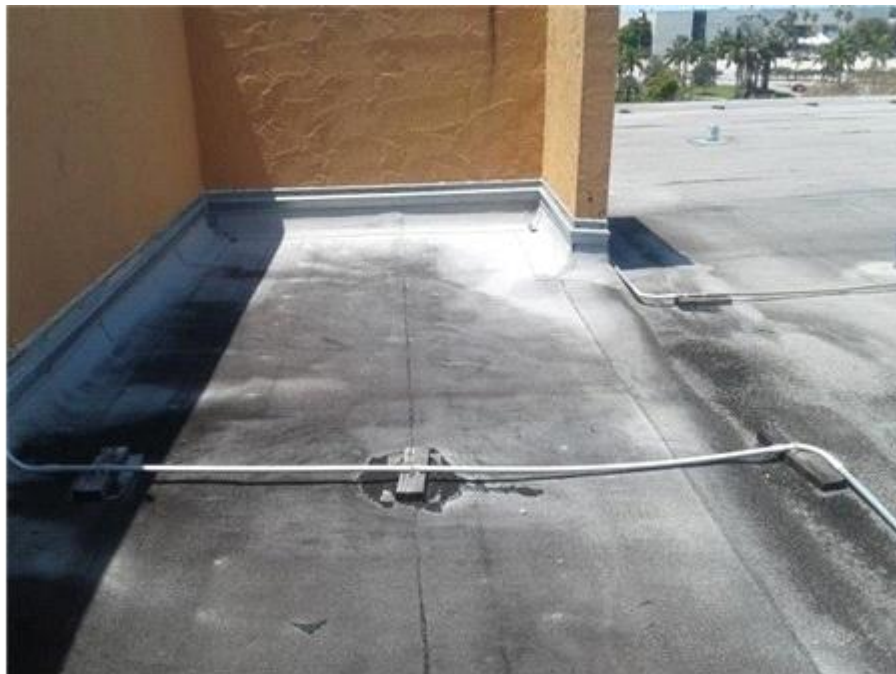
002F - The Towers - BUR Appearance Overview
The appearance of the roof is in fair condition at this time.

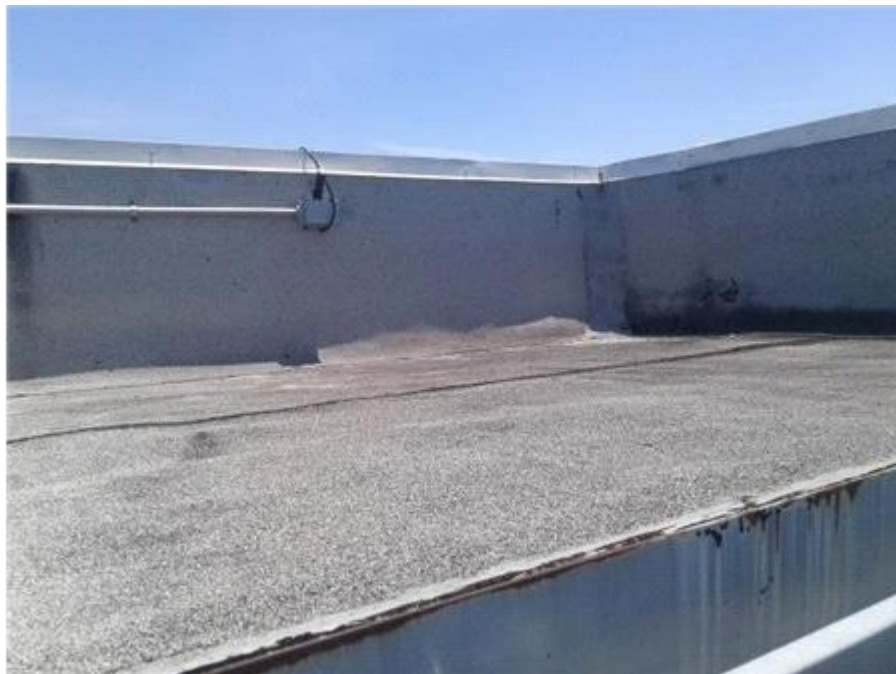
003F - The Towers - BUR Membrane Overview
The roof membrane appears to be in fair condition at this time.

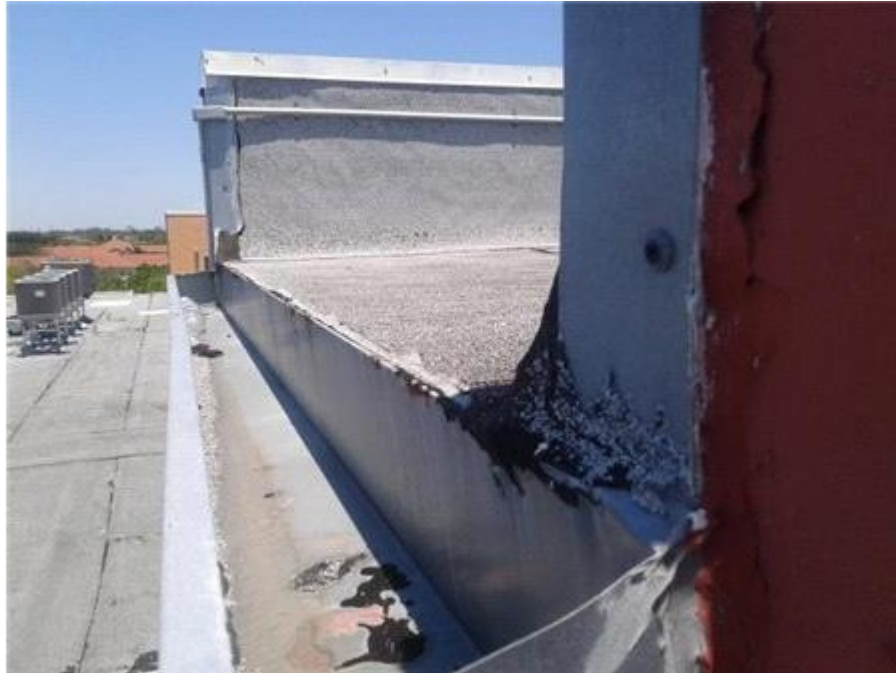
008G- The Towers - BUR Gutters

The gutters appear to be in good condition.

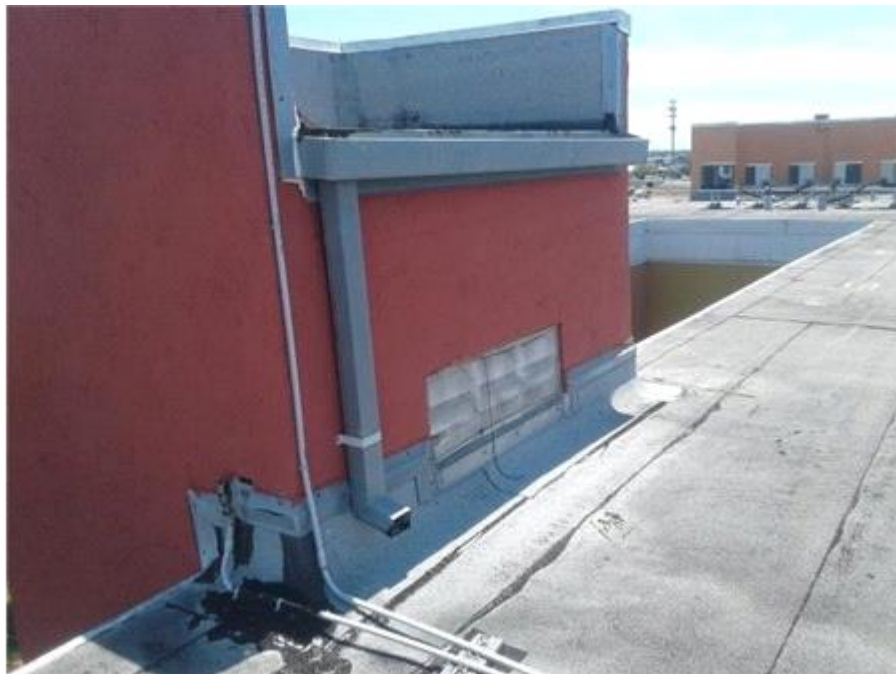
009G- The Towers - BUR Downspouts

The downspouts appear to be in good condition.

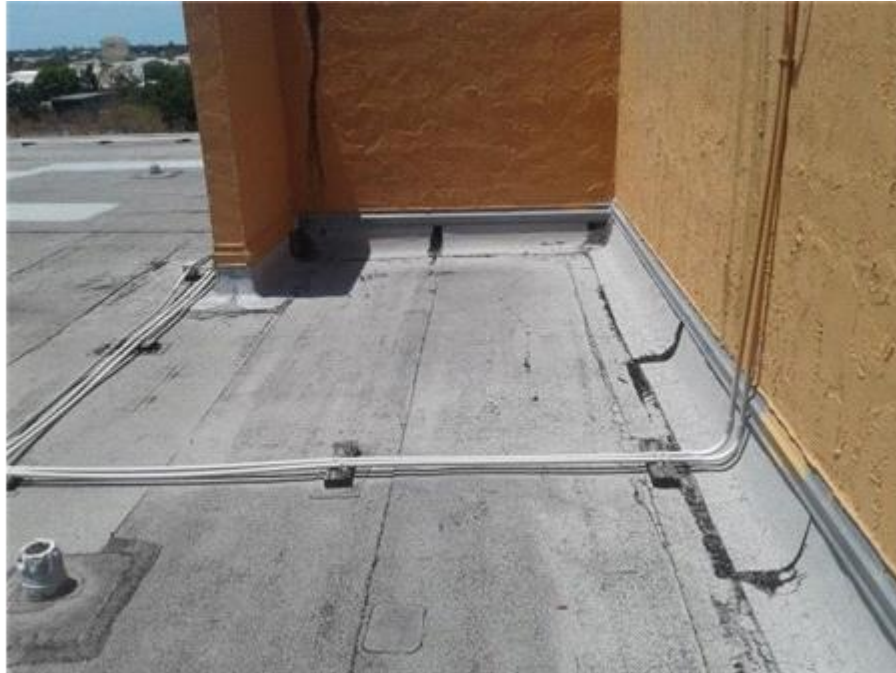
002F - The Towers - BUR Appearance Overview

The appearance of the roof is in fair condition at this time.
