Inspection Report

Facility: Towers, The
Address: 2366 East Mall Dr,
Fort Myers, 33901

Work Order #: 5326

Re.: **Inspection Report (4 of 6) for The Towers**

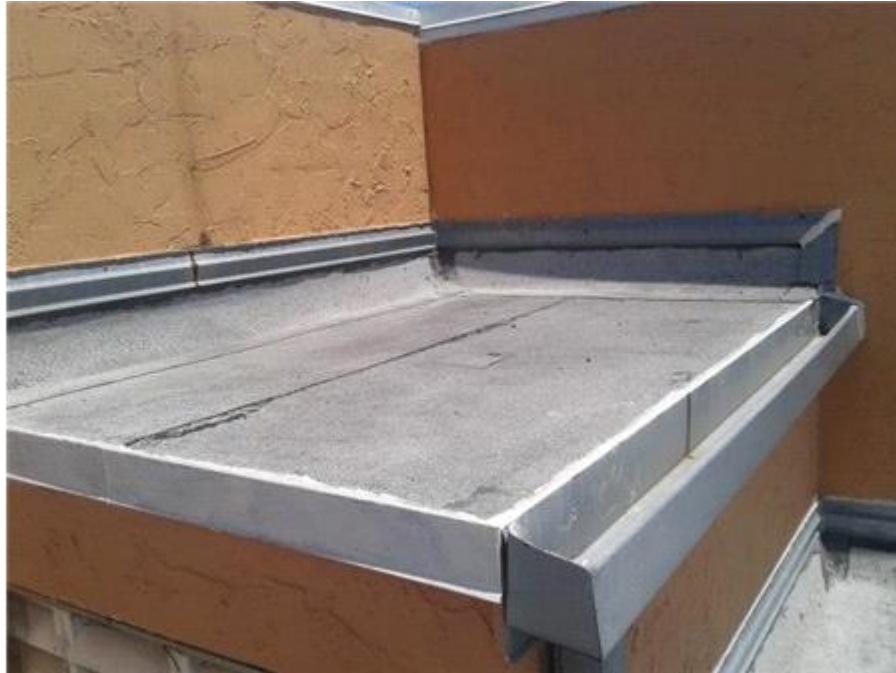
003F - The Towers - BUR Membrane Overview

The roof membrane appears to be in fair condition at this time.

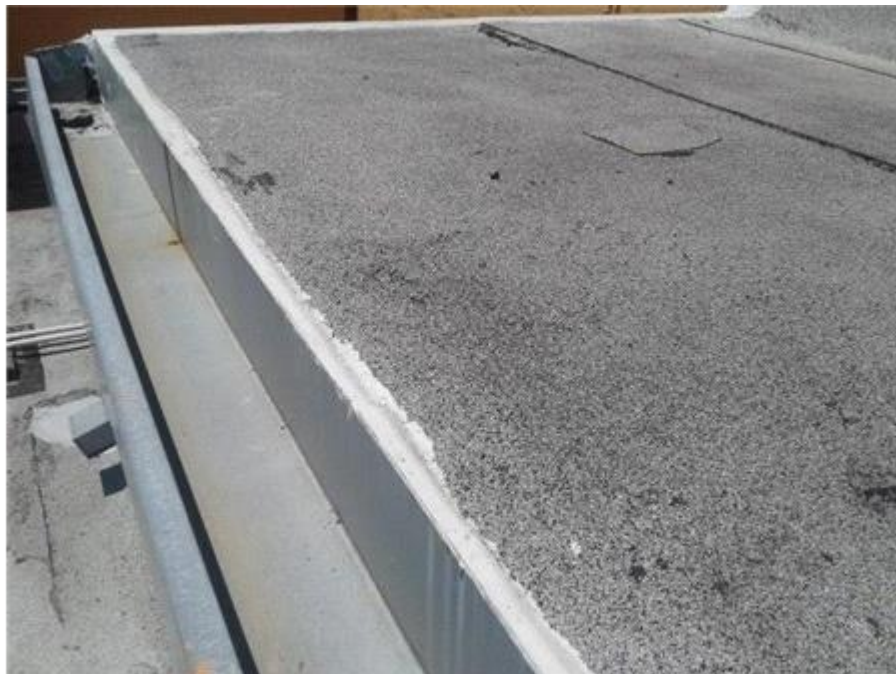
008G- The Towers - BUR Gutters

The gutters appear to be in good condition.

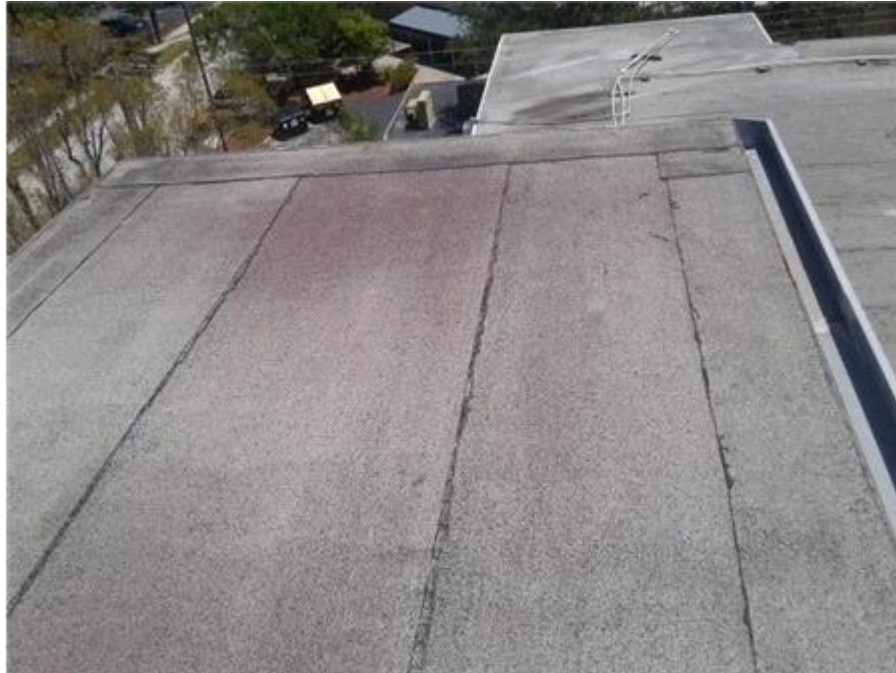
003F - The Towers - BUR Membrane Overview - Stairwell Roof

The roof membrane on the stairwell roof appears to be in fair condition at this time.

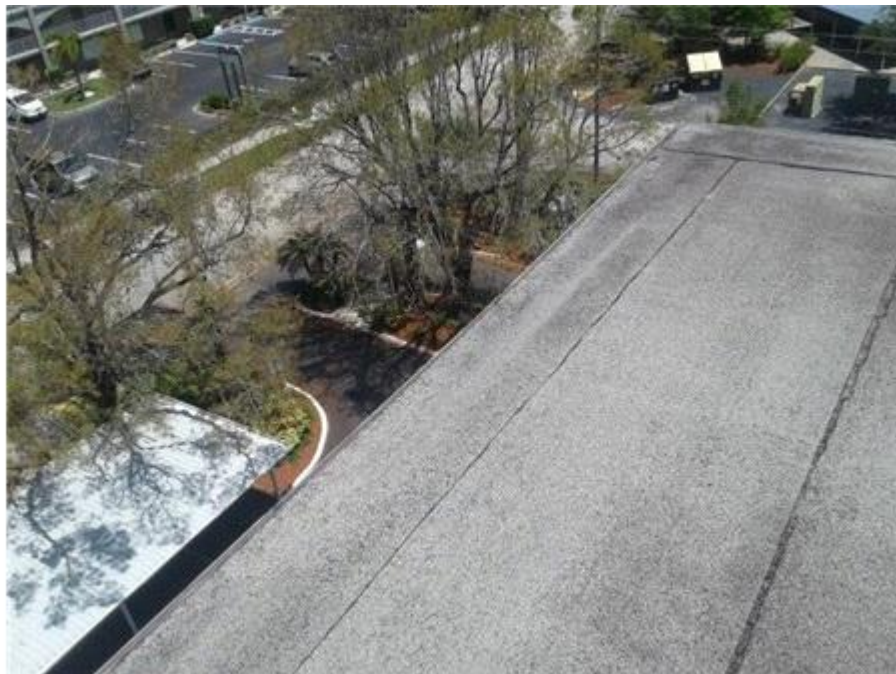
016F- The Towers - BUR Roof Edge

Roof edge appears to be in fair condition.

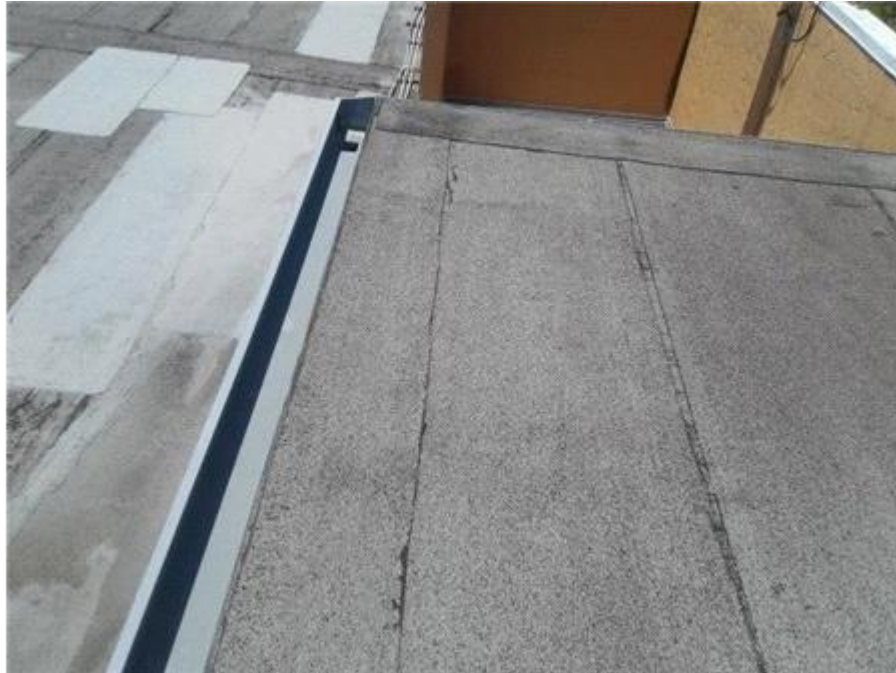
008G- The Towers - BUR Gutters

The gutters appear to be in good condition.

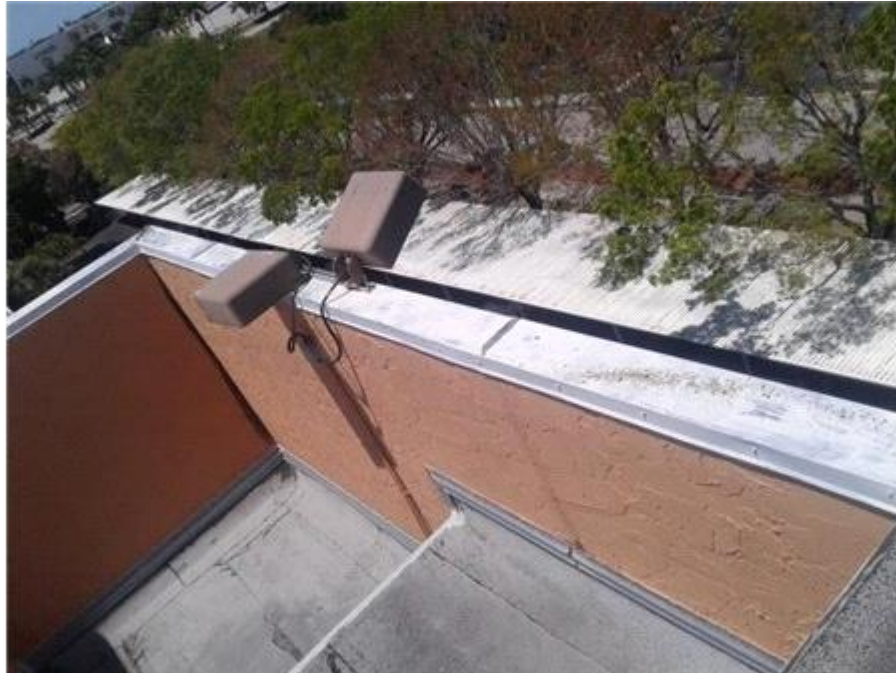
006F- The Towers - BUR Coping

The coping appears to be in fair condition.

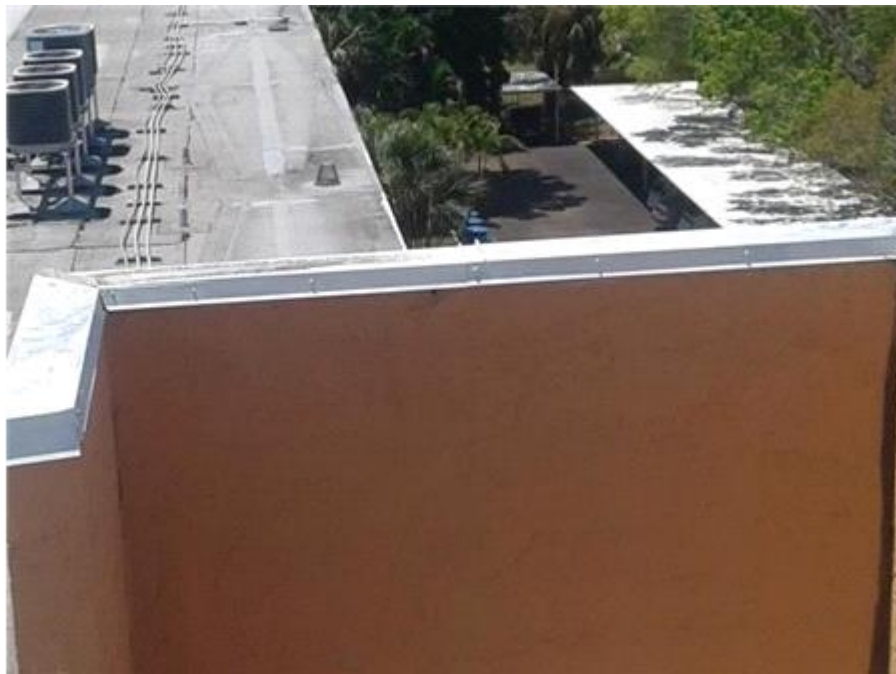
006F- The Towers - BUR Coping

The coping appears to be in fair condition.

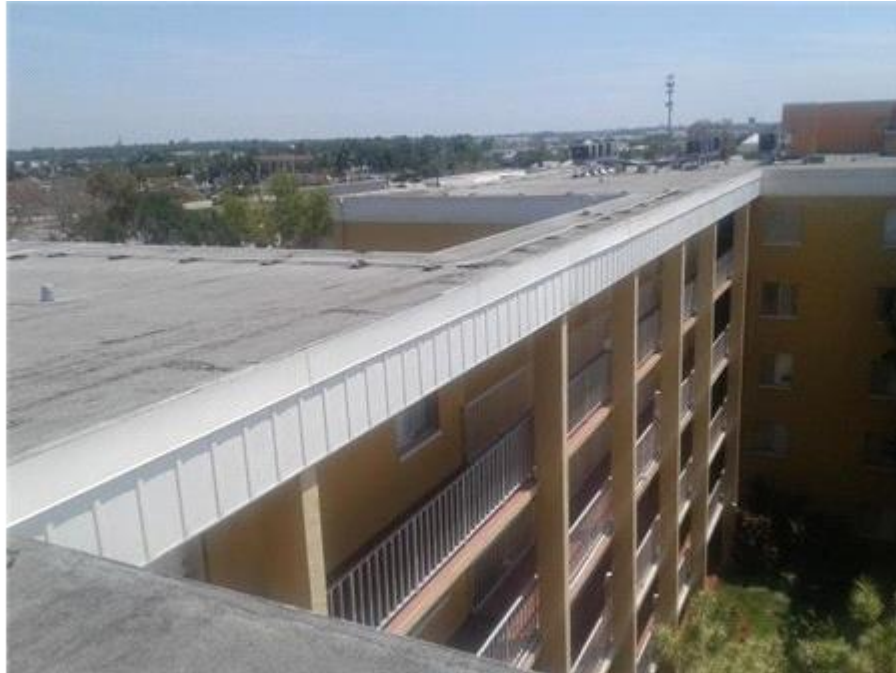
The Towers - BUR Edge Metal/Fascia

Edge metal/fascia appears to be in good condition at this time.

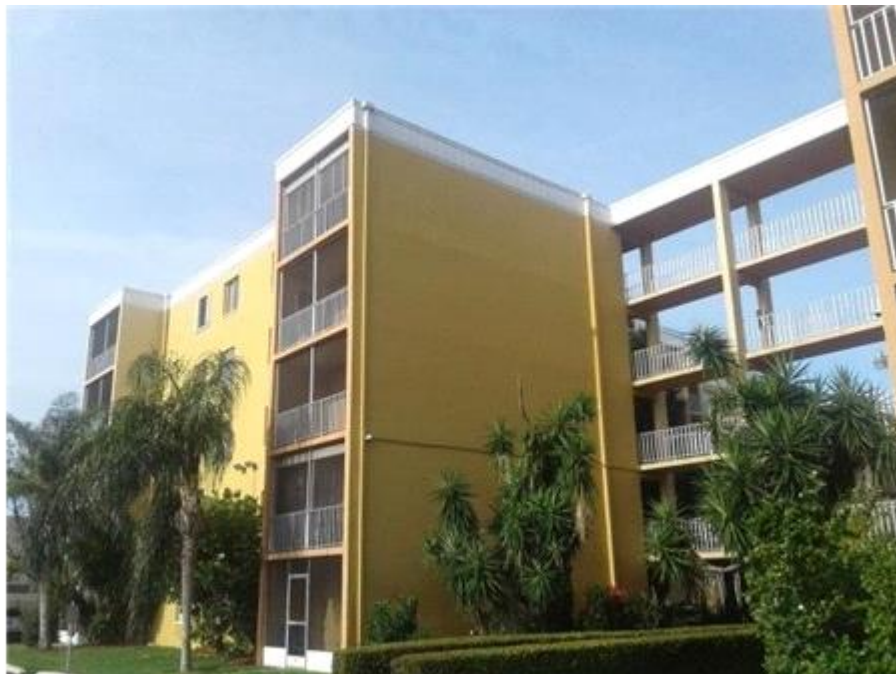
009G- The Towers - BUR Downspouts

The downspouts appear to be in good condition.

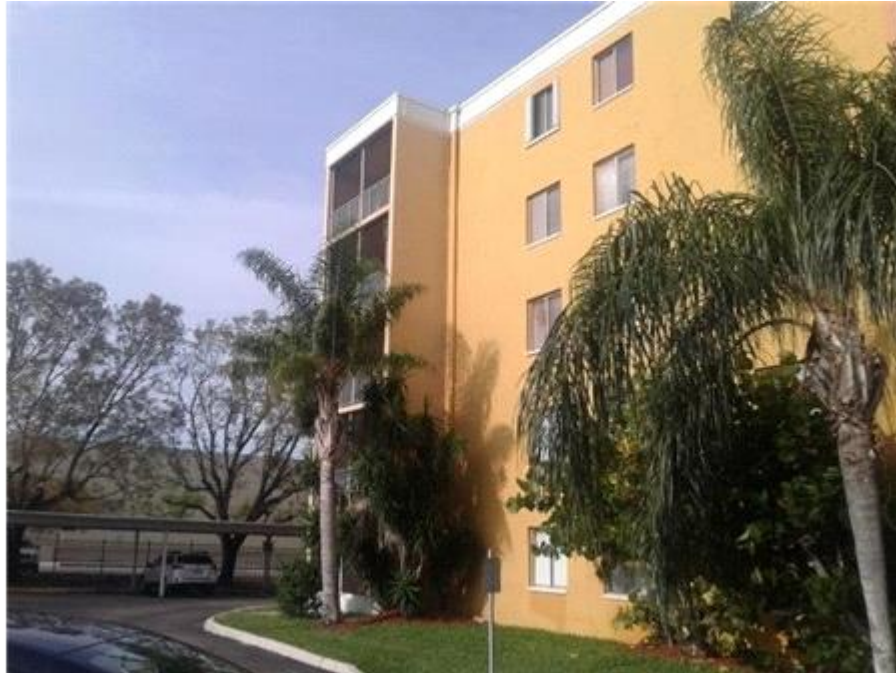
009G- The Towers - BUR Downspouts

The downspouts appear to be in good condition.

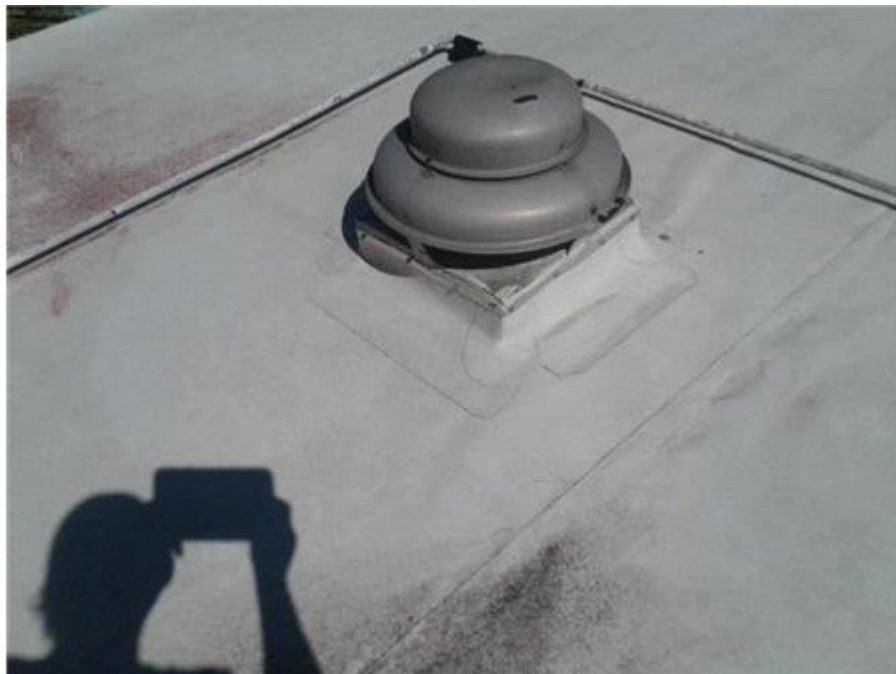
004G - The Towers - TPO Roof Base Flashings

The base flashings appear to be in good condition.

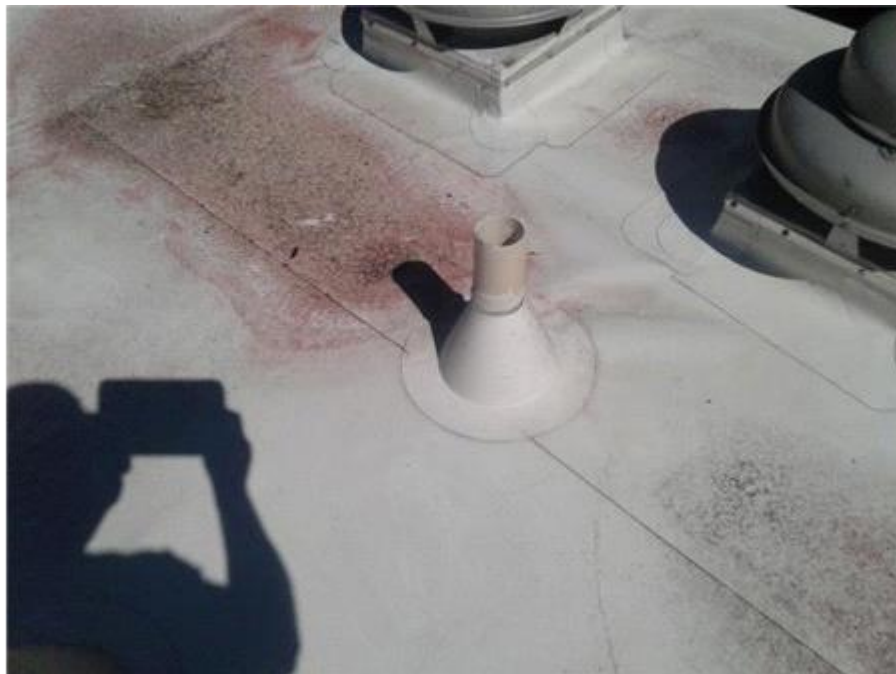
The Towers - TPO Roof Soil Stacks

Soil stack boots appear to be in good condition at this time.

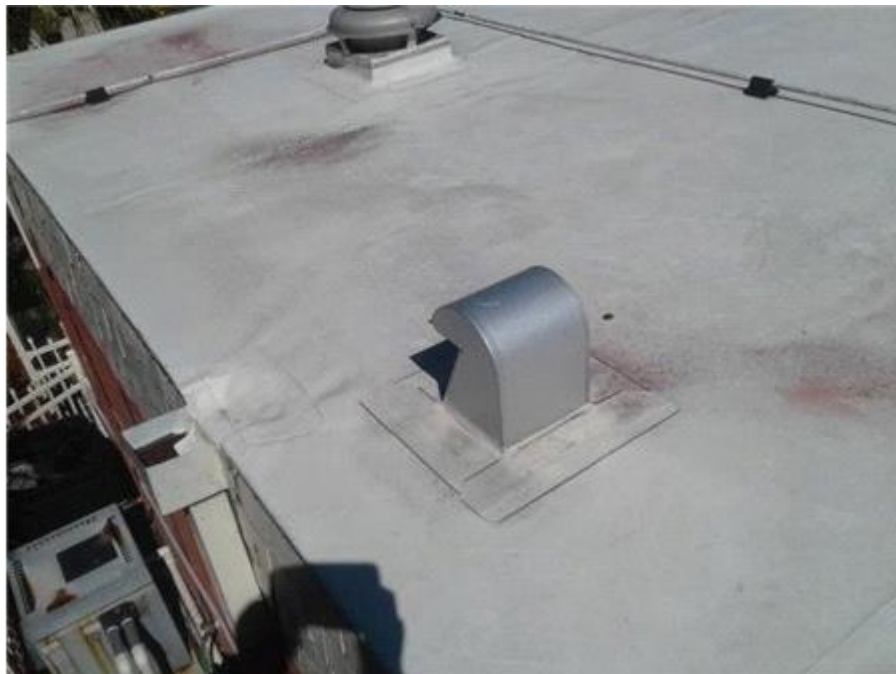
002G The Towers - TPO Roof Roof Vents

Roof vents appear to be in good condition at this time.

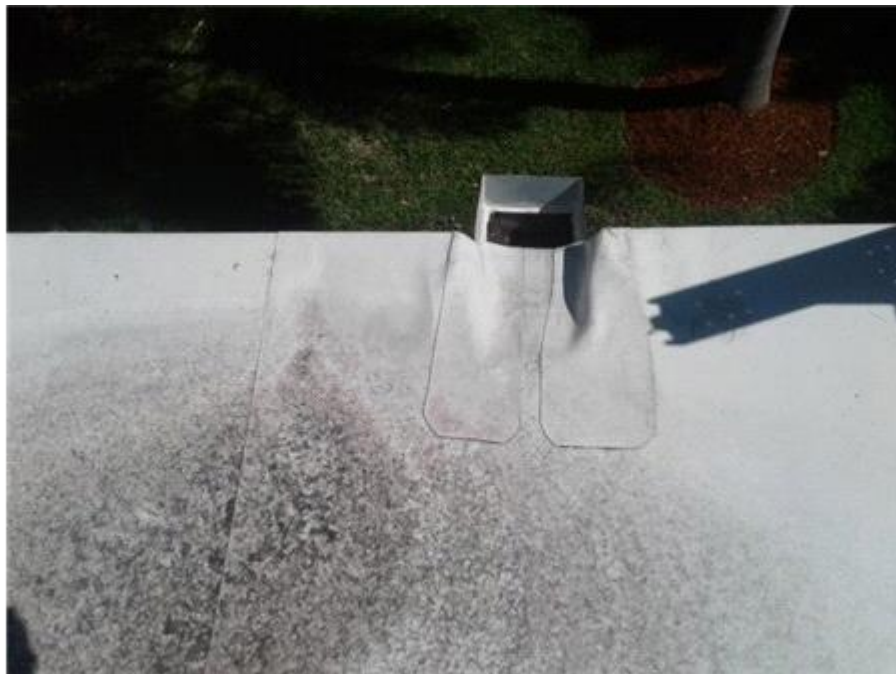
The Towers - TPO Roof Scuppers

Scuppers appear to be in good condition at this time.

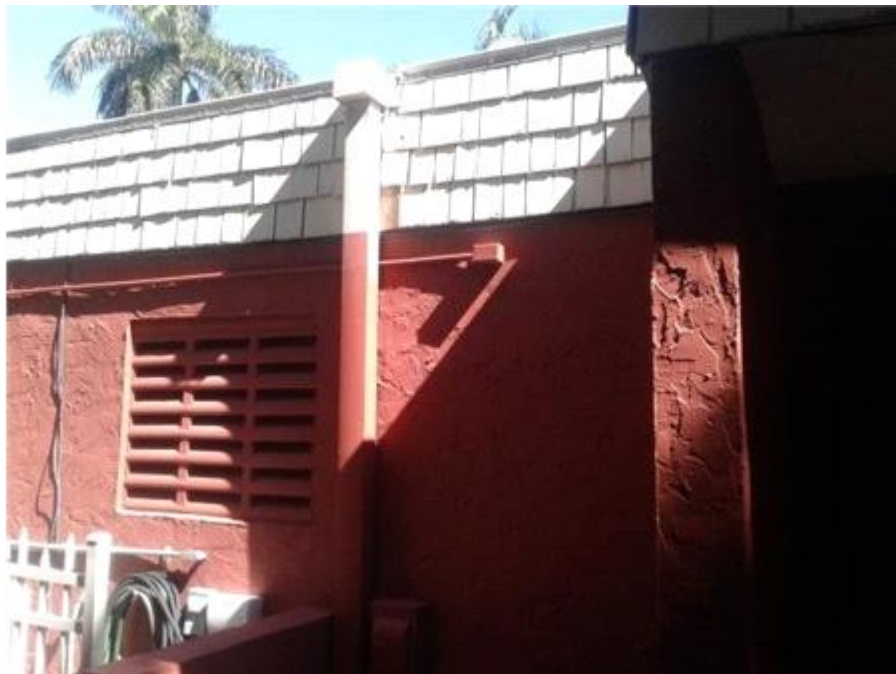
009G- The Towers - TPO Roof Downspouts
The downspouts appear to be in good condition.

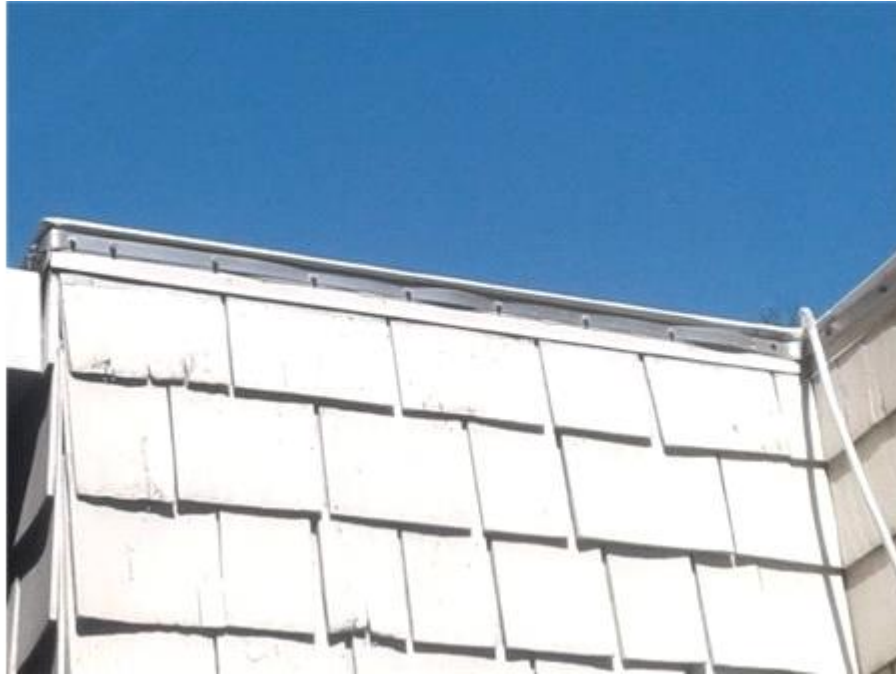
The Towers - TPO Roof Termination Bar

T-Bar appears to be in good condition at this time.

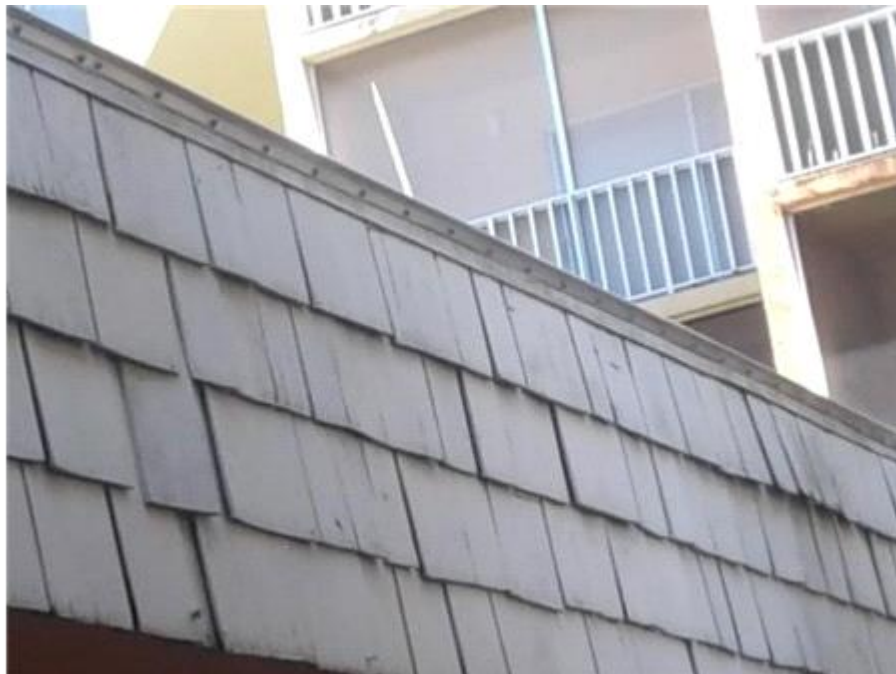
The Towers - TPO Roof Termination Bar

T-Bar appears to be in good condition at this time.
