Inspection Report

Facility: Towers, The
Address: 2366 East Mall Dr,
Fort Myers, 33901

Work Order #: 4780

Re.: **Inspection Report (3 of 6) for The Towers**

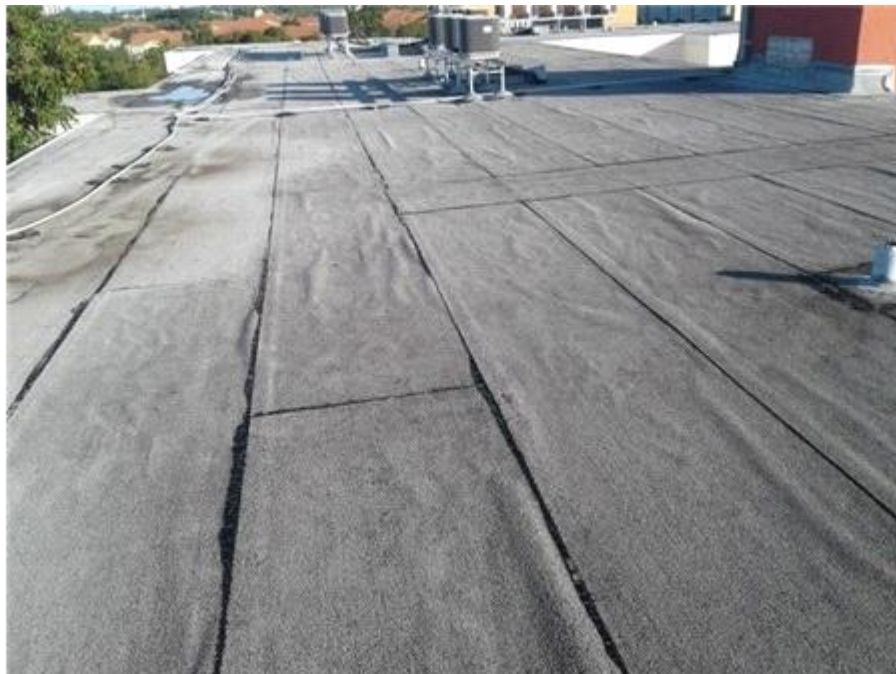
Main Roof: Membrane Overview

The roof membrane appears to be in fair condition at this time.

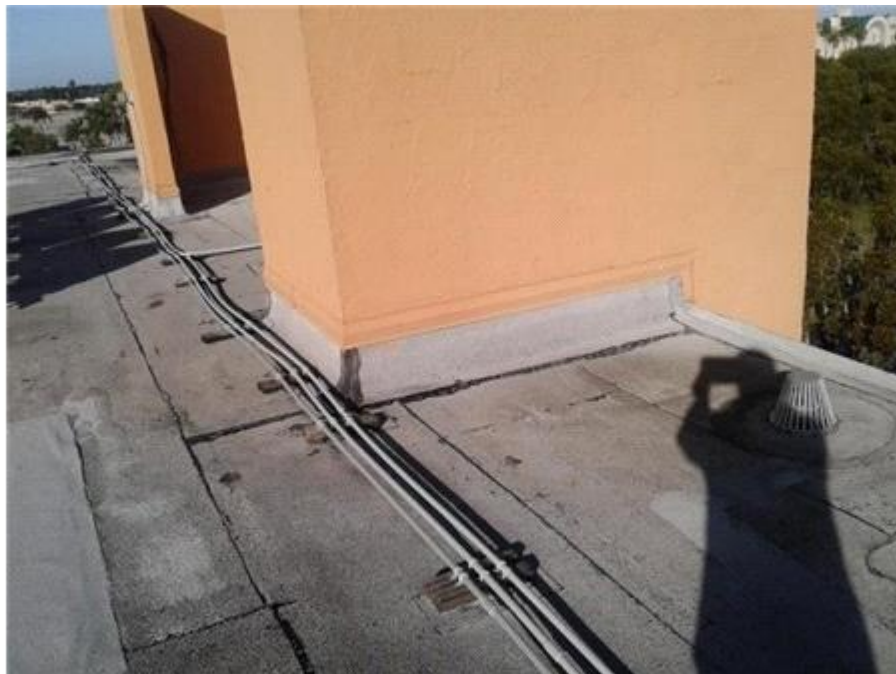
Main Roof: Base Flashings

The base flashings appear to be in fair condition at this time.

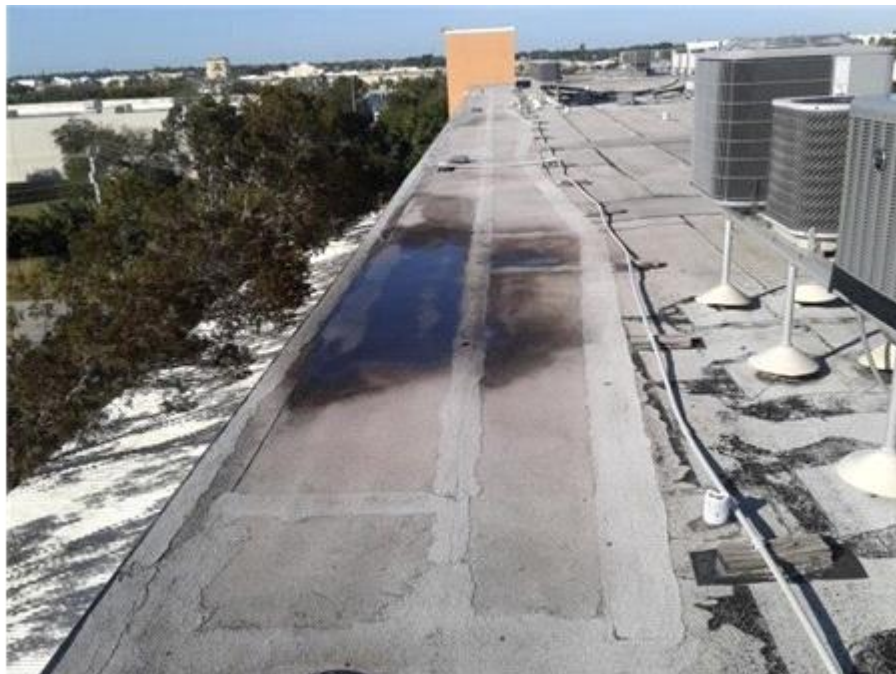
Main Roof: Ponding

Ponding adds weight to the roof, and can cause many undesirable problems. If the roof membrane is damaged in a ponded area, the water may drain into the roof system and building.

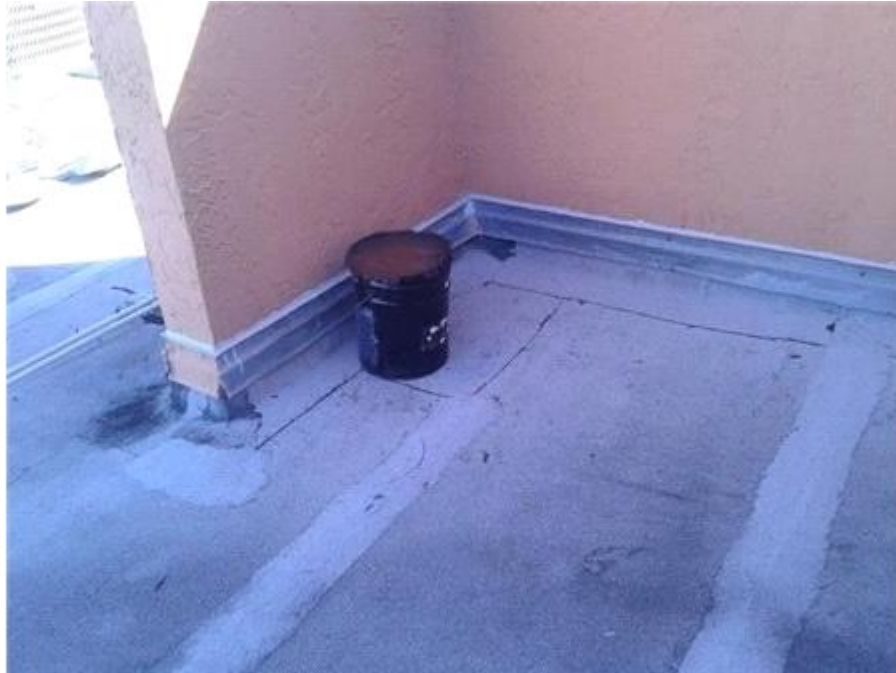
Stairwell Roof: Debris on Roof

Identified debris on the surface of the roof that could damage or puncture the membrane.

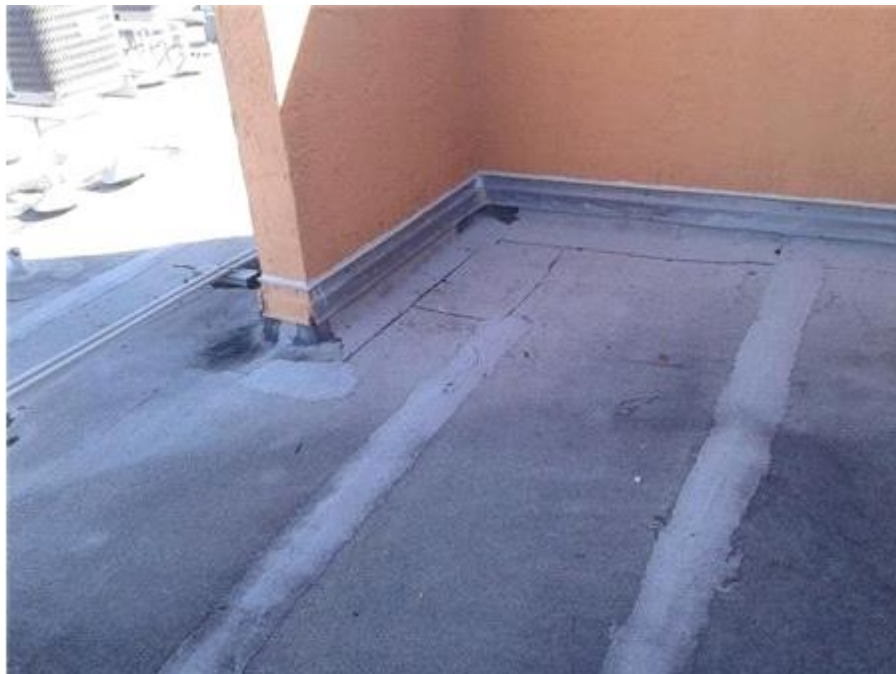
Stairwell Roof: Removed Debris on Roof

The debris was removed from the surface of the roof and disposed of properly.

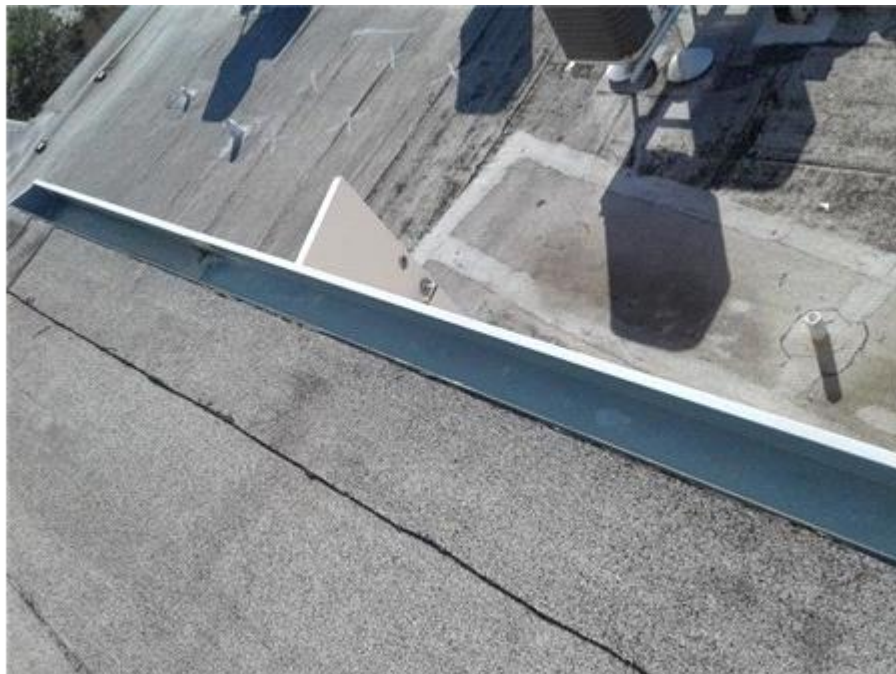
Stairwell Roof: Gutter Metal

The gutter has loose/missing fasteners. Crowther Roofing suggests installing new fasteners as required to secure the flashing.

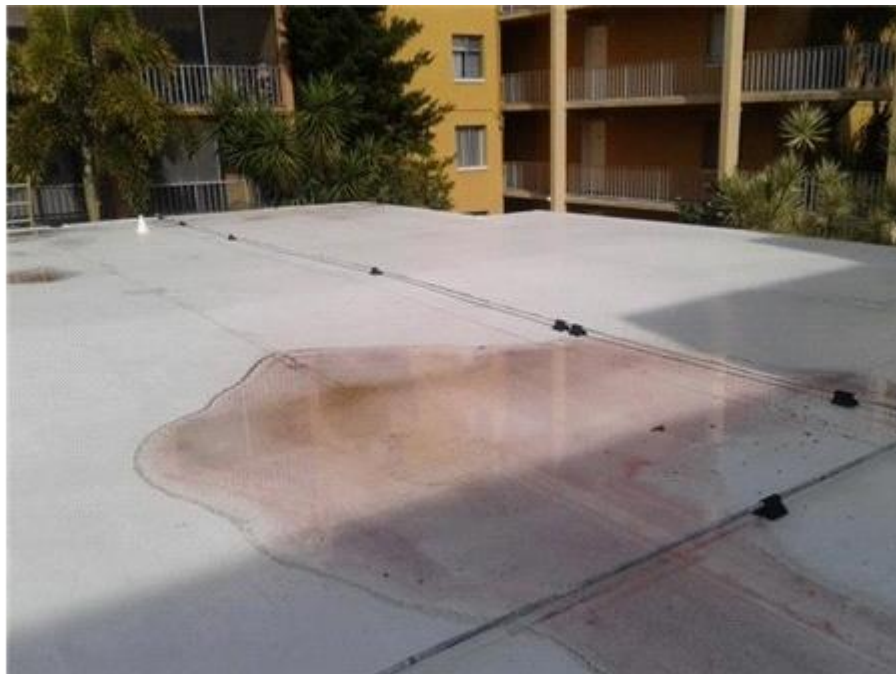
Clubhouse: Ponding

Ponding adds weight to the roof, and can cause many undesirable problems. If the roof membrane is damaged in a ponded area, the water may drain into the roof system and building.

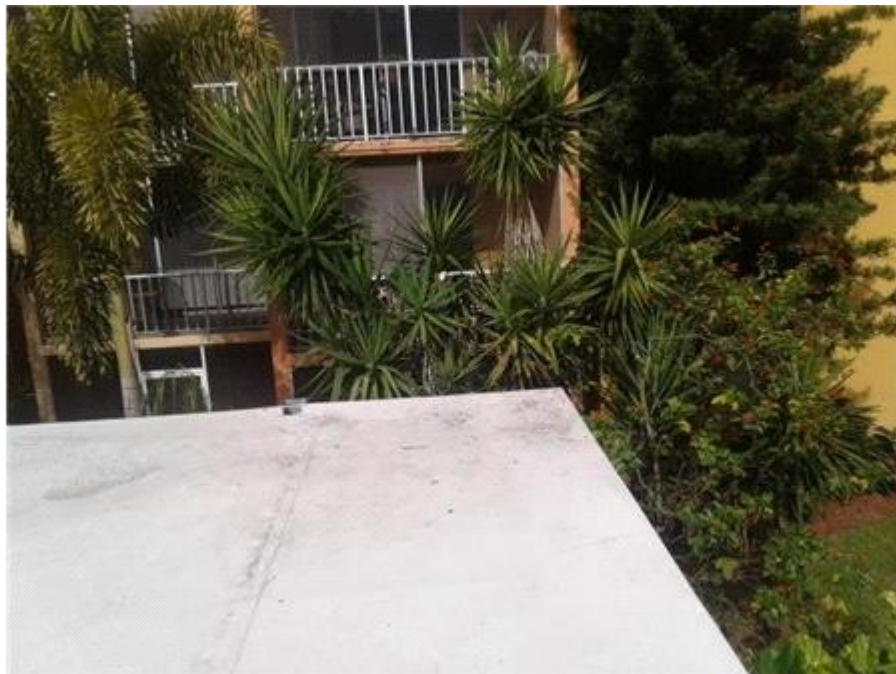
Clubhouse: Tree Branches

Identified tree branches hanging over the roof surface. Branches on the roof surface can cause deterioration of membrane, and act as an access for rodents and unwanted bugs/pests.

The tree branches were cut back from the surface of the roof and disposed of properly.
