Inspection Report

Facility: Towers, The
Address: 2366 East Mall Dr,
Fort Myers, 33901

Work Order #: 7558

Re.: **Inspection Report (2 of 6) for The Towers**

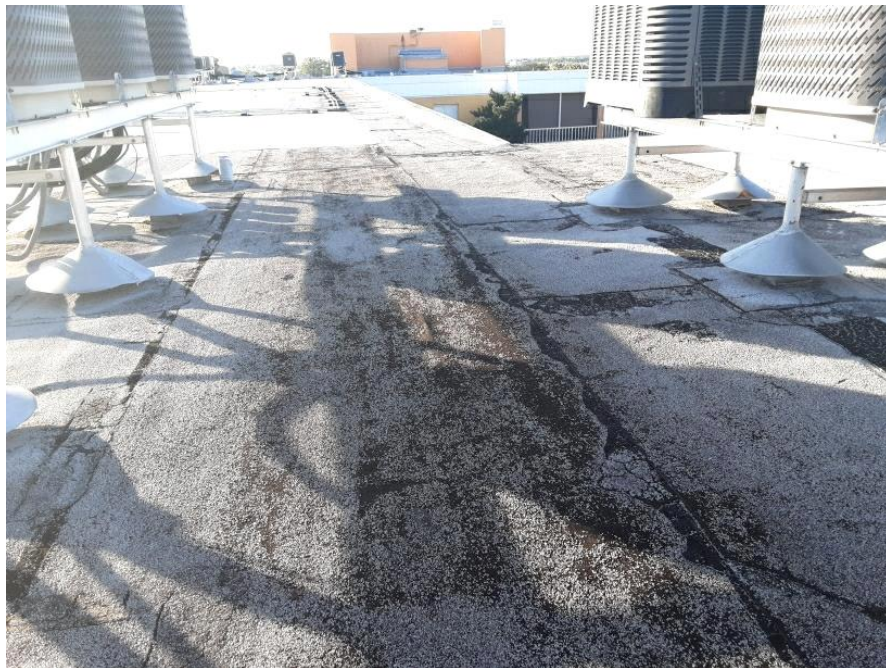
Membrane Overview

The roof membrane appears to be in fair condition.

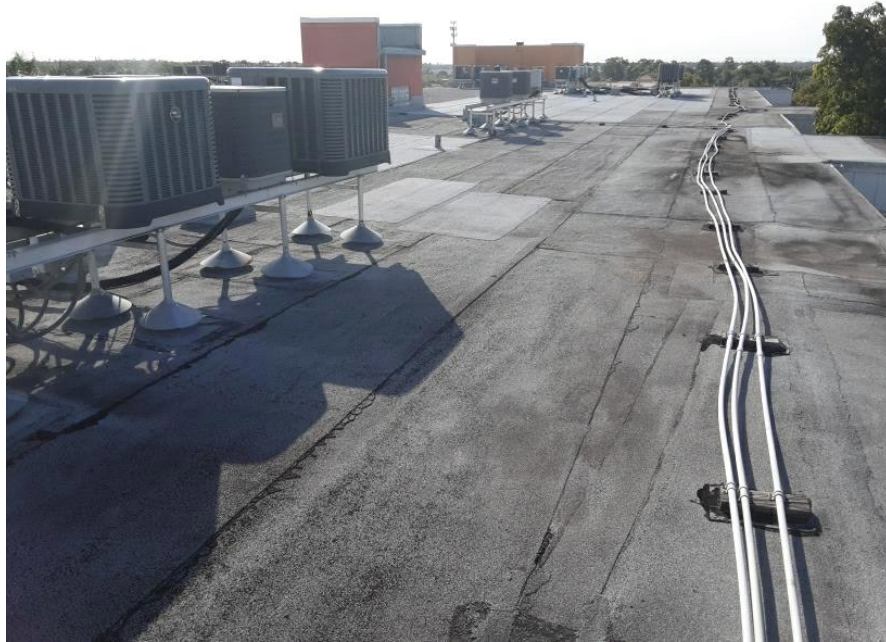
Membrane Overview

The roof membrane appears to be in fair condition.

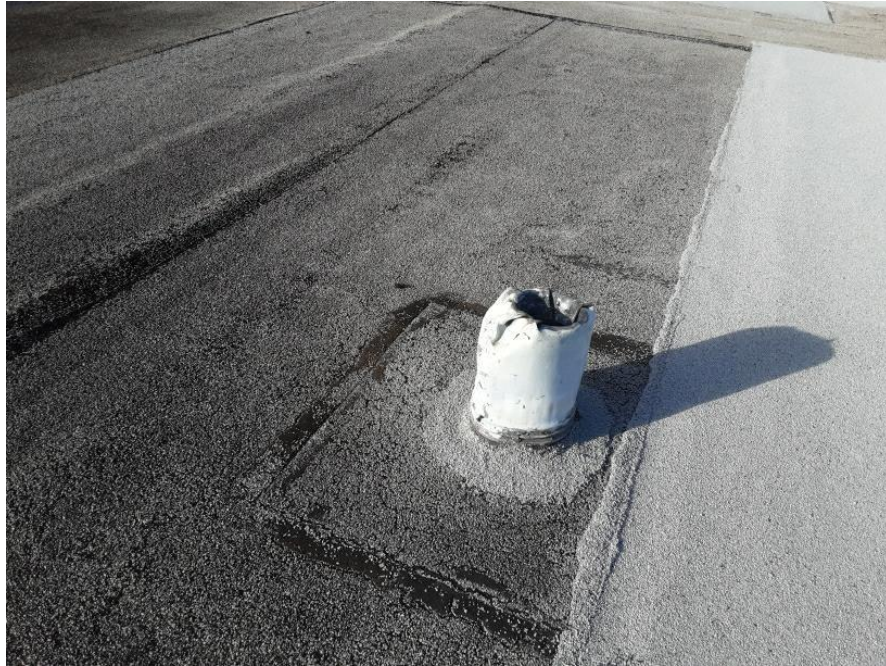
Lead Boot-Damaged

The lead boot appears to be in poor condition.

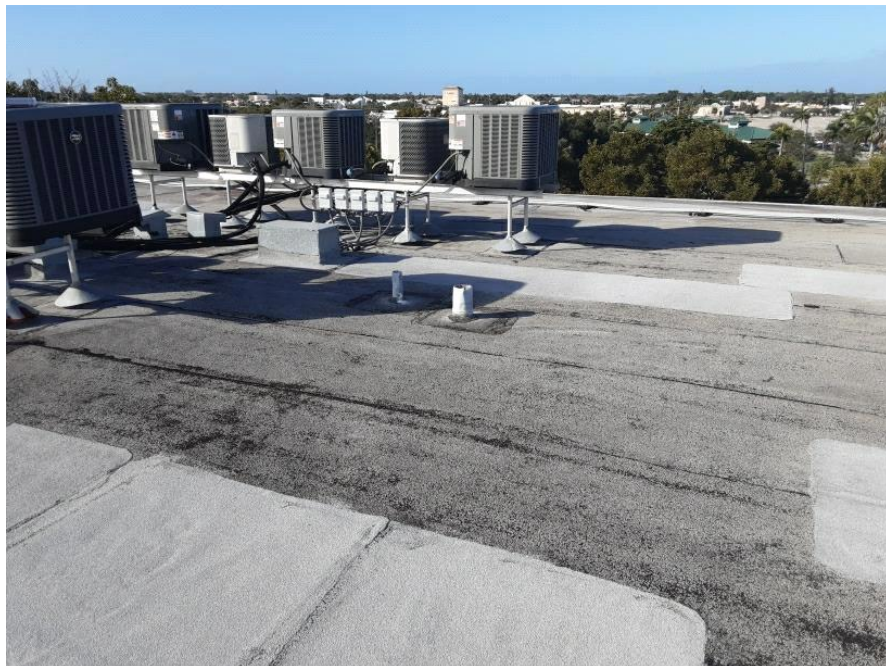
Lead Boot-Damaged

Identified a puncture at the base of the lead boot.

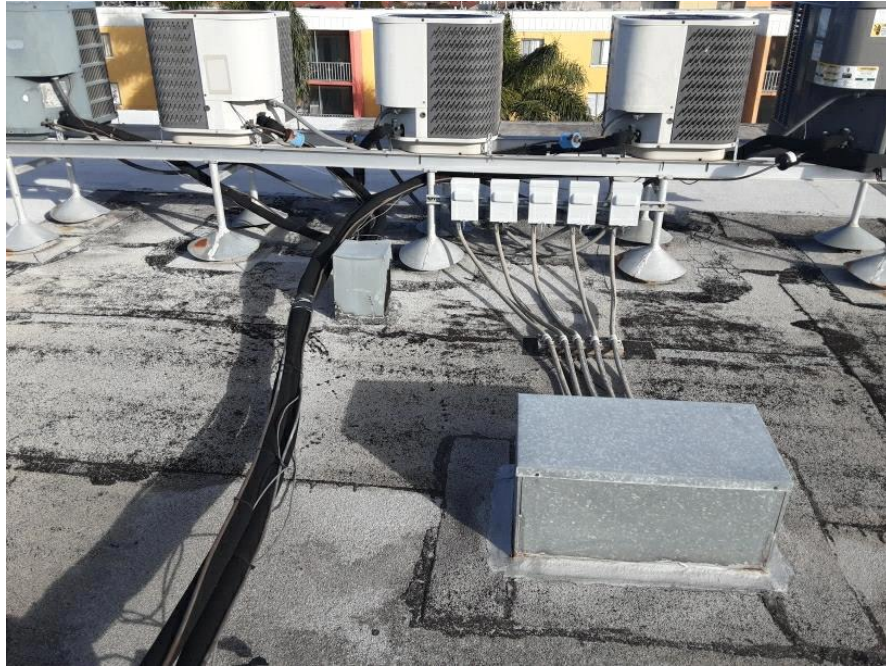
Electric Cover

The electric cover appears to be in poor condition at this time.

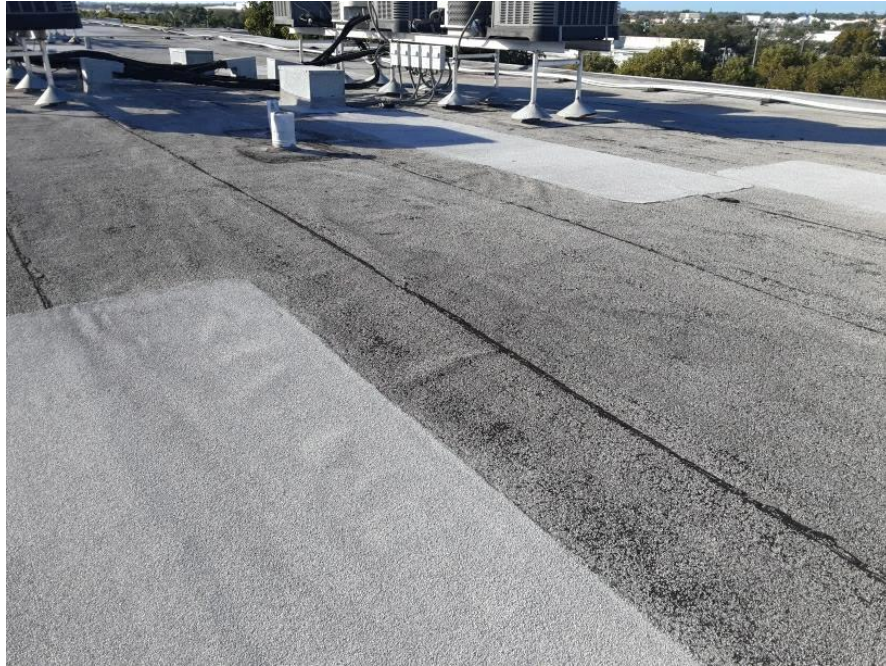
Field Membrane Blister

Blisters have been identified and are caused by gas trapped in the system and may be ruptured with foot traffic. Felts are exposed and premature deterioration will occur.

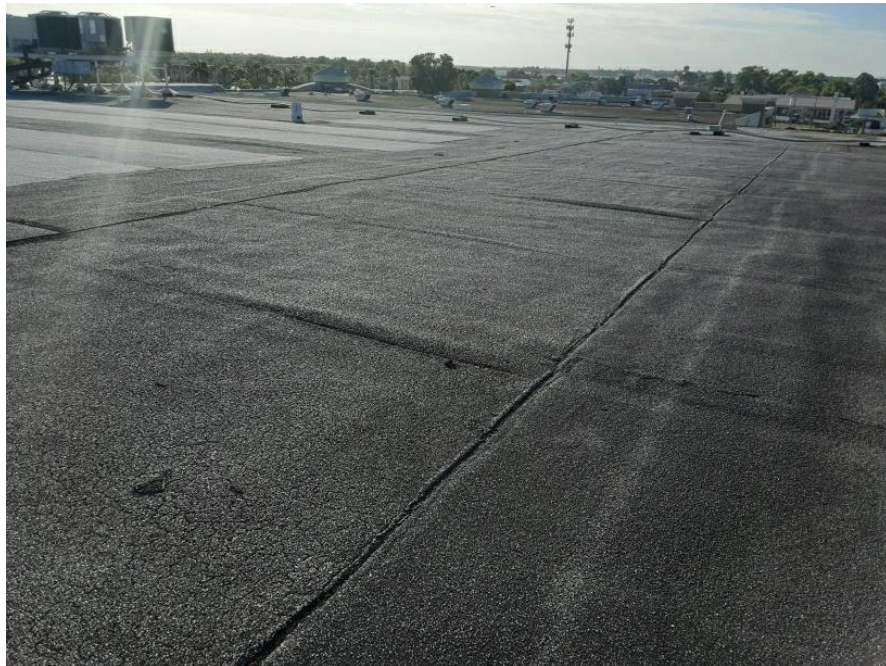
Field Membrane Blister

Blisters have been identified and are caused by gas trapped in the system and may be ruptured with foot traffic. Felts are exposed and premature deterioration will occur.

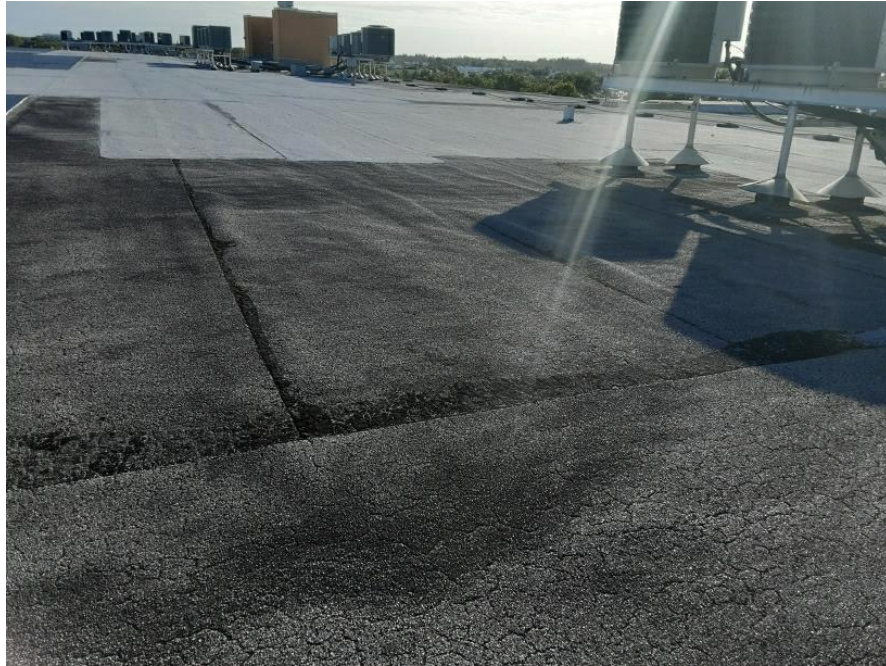
Field Membrane Blister

Blisters have been identified and are caused by gas trapped in the system and may be ruptured with foot traffic. Felts are exposed and premature deterioration will occur.

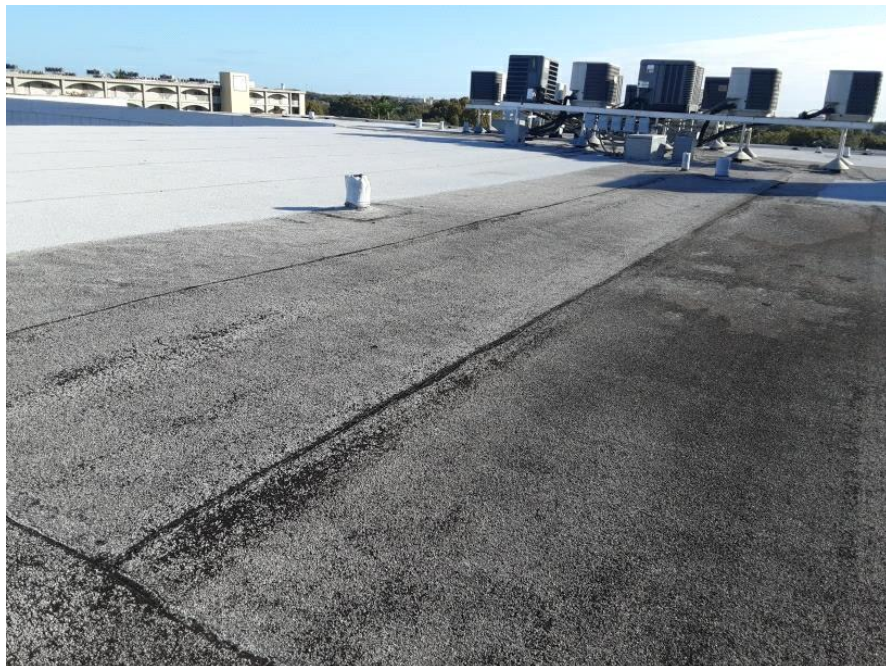
Sealant Failure

Identified a void in the sealant.

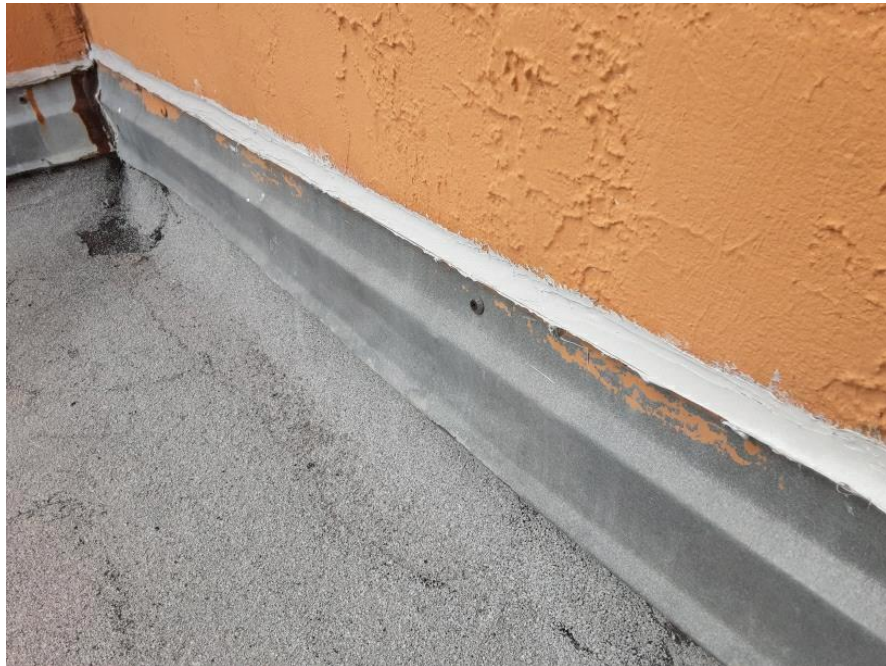
Sealant Failure

Identified a void in the sealant.

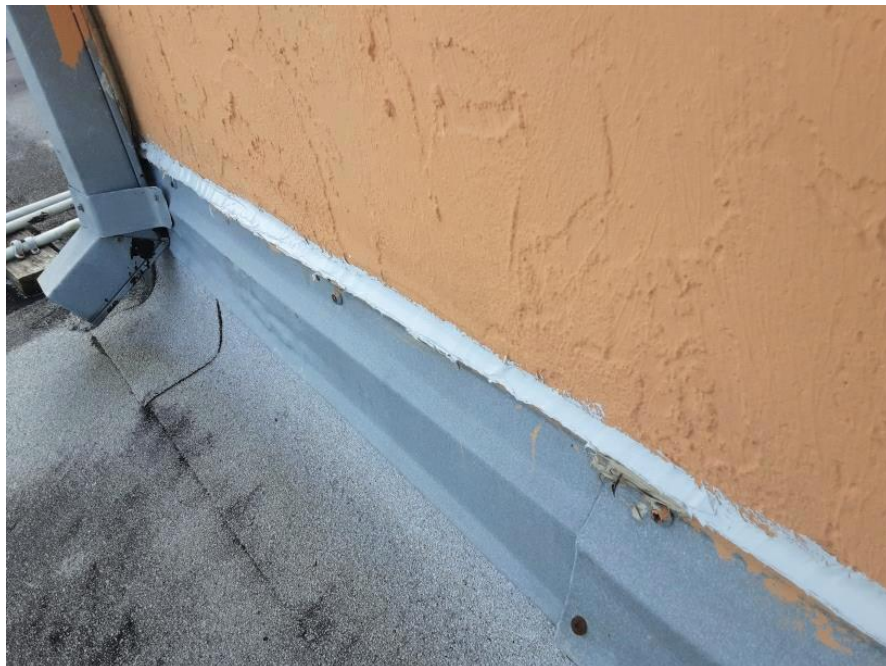
Loose Granules

Identified loose granules on the roof surface.

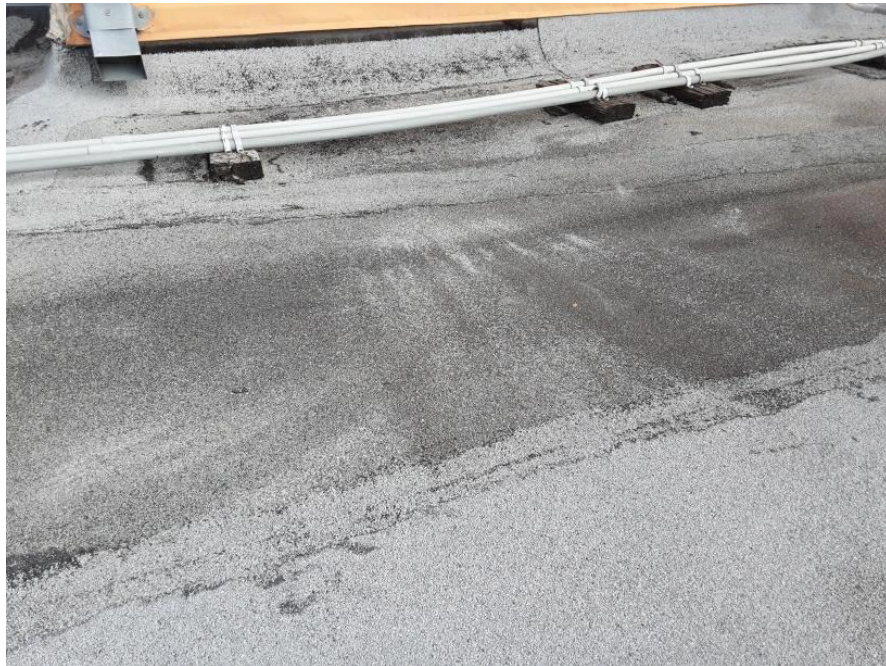
Loose Granules

Identified loose granules on the roof surface.

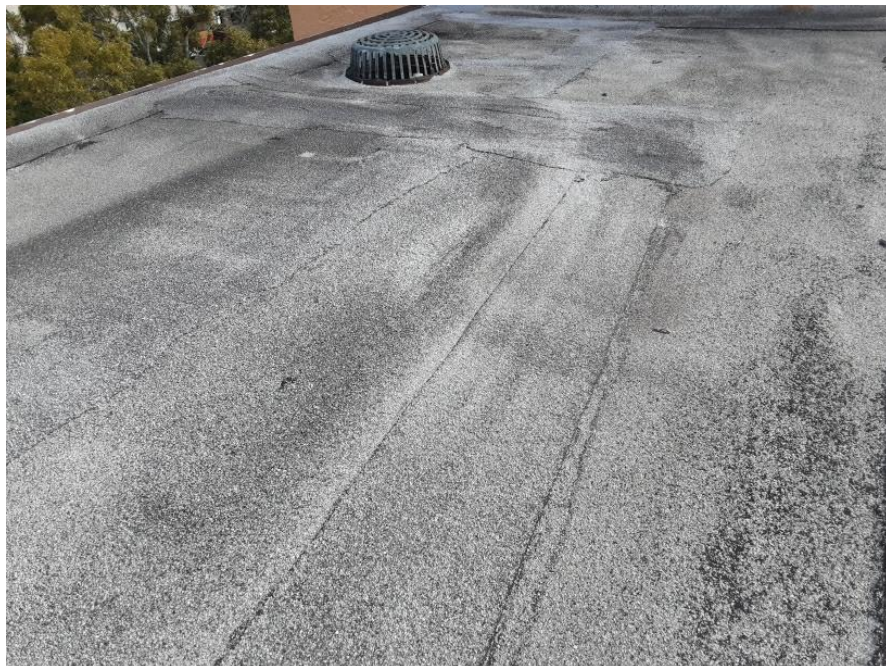
Loose Granules

Identified loose granules on the roof surface.

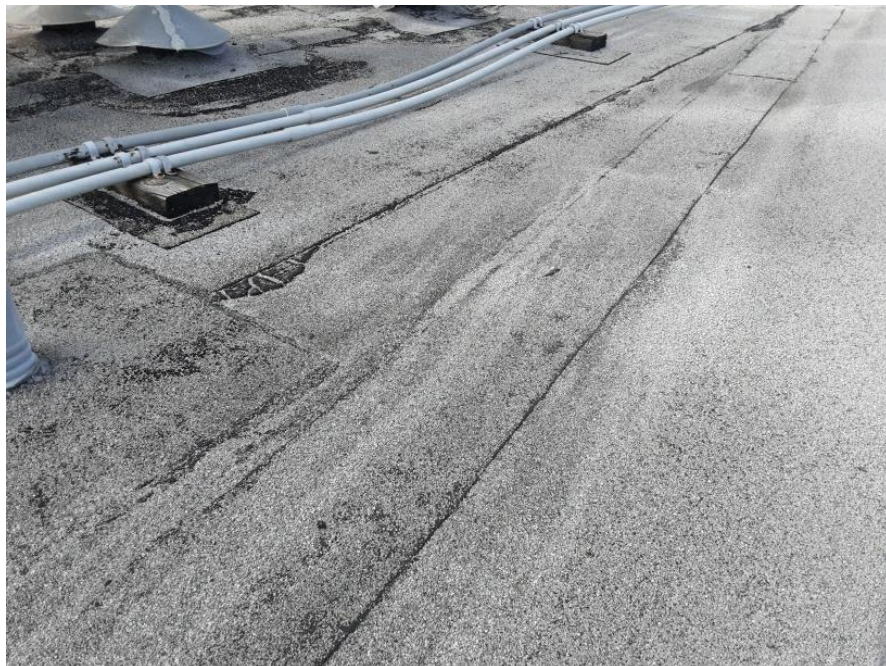
Loose Granules

Identified loose granules on the roof surface.

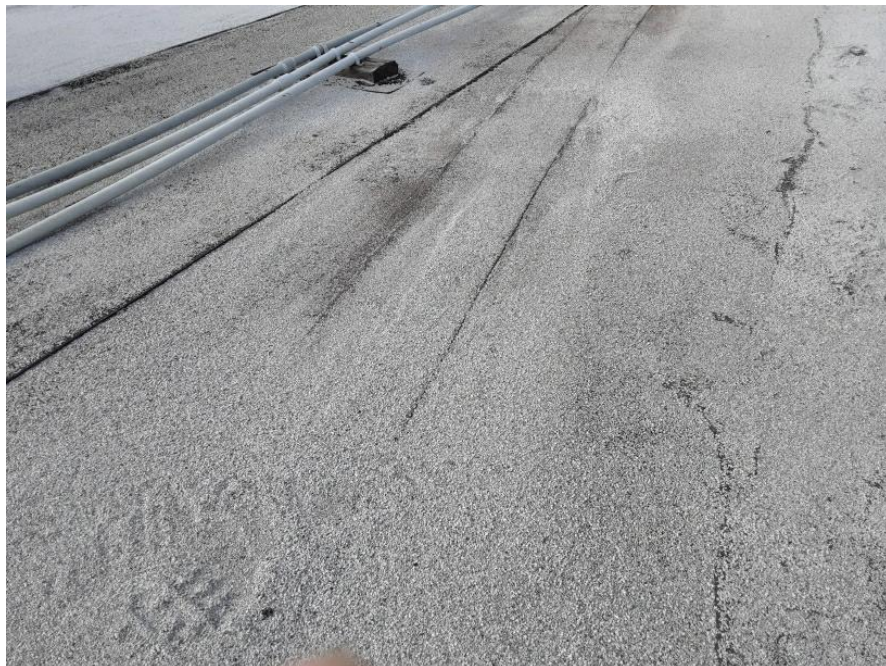
Loose Granules

Identified loose granules on the roof surface.

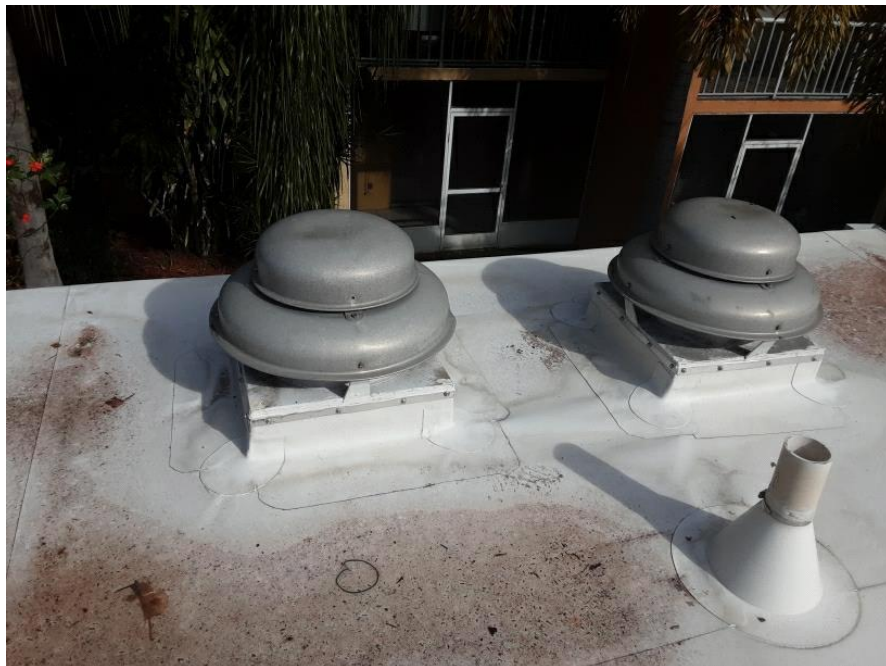
Tree Branches

Identified tree branches hanging over the roof surface. Branches on the roof surface can cause deterioration of membrane, and act as an access for rodents and unwanted bugs/pests.
