Inspection Report

Facility: Towers, The
Address: 2366 East Mall Dr,
Fort Myers, 33912

Inspection Date: Wednesday, February 28, 2018

Re.: **Inspection Report (1 of 6) for The Towers**

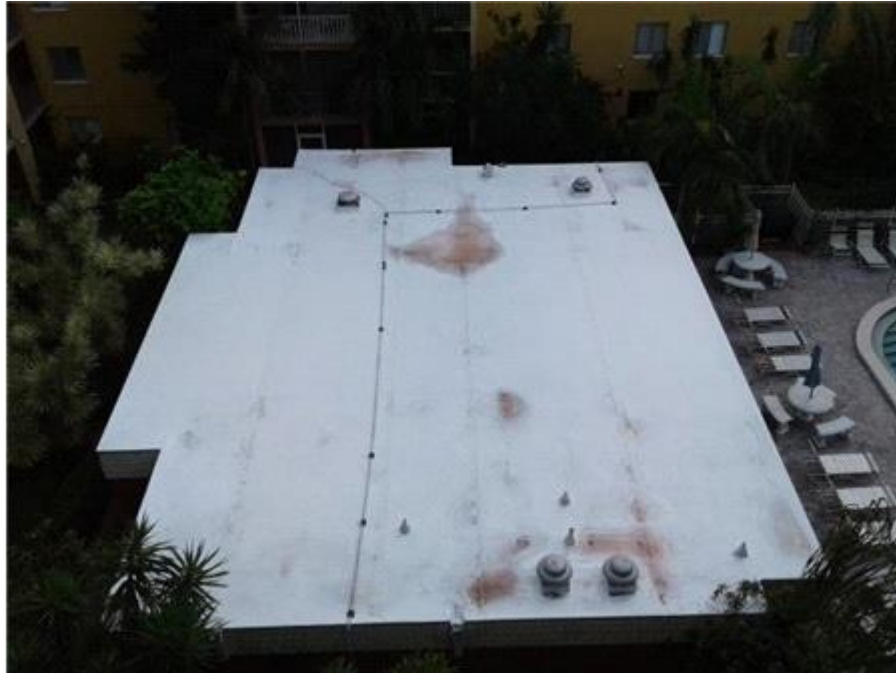
001G- The Towers - Clubhouse

The roof surface appears to be in good, maintainable condition at this time.

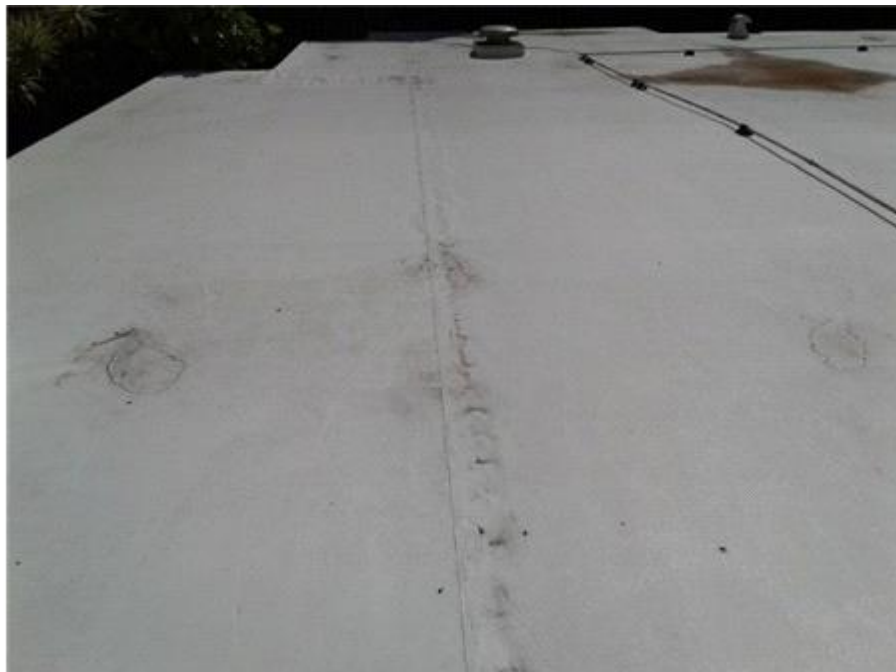
002G- Appearance Overview

The roof appearance is in good, maintainable condition at this time.

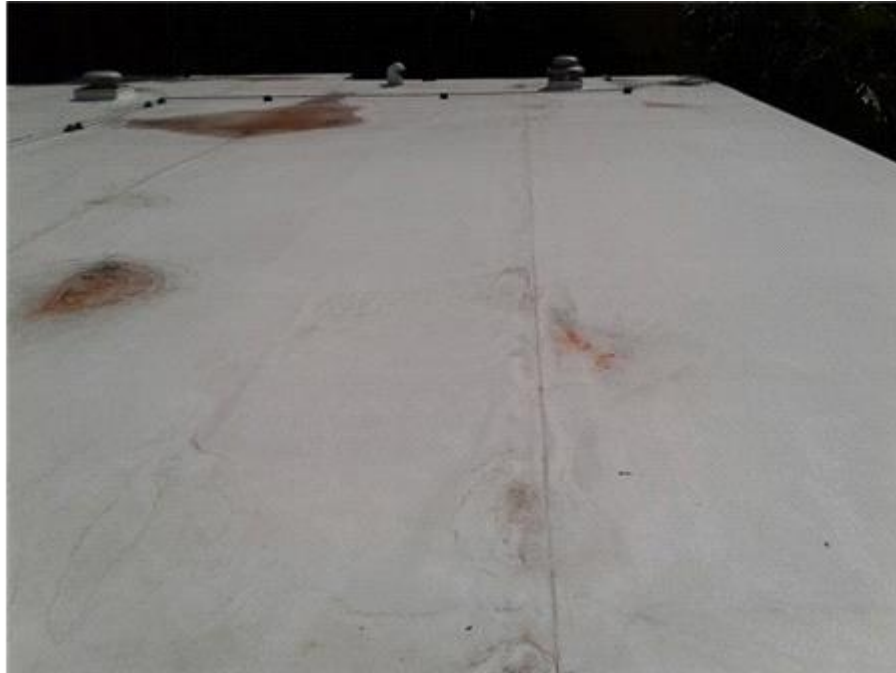
003G - Membrane Overview

The membrane appears to be in good, maintainable condition at this time.

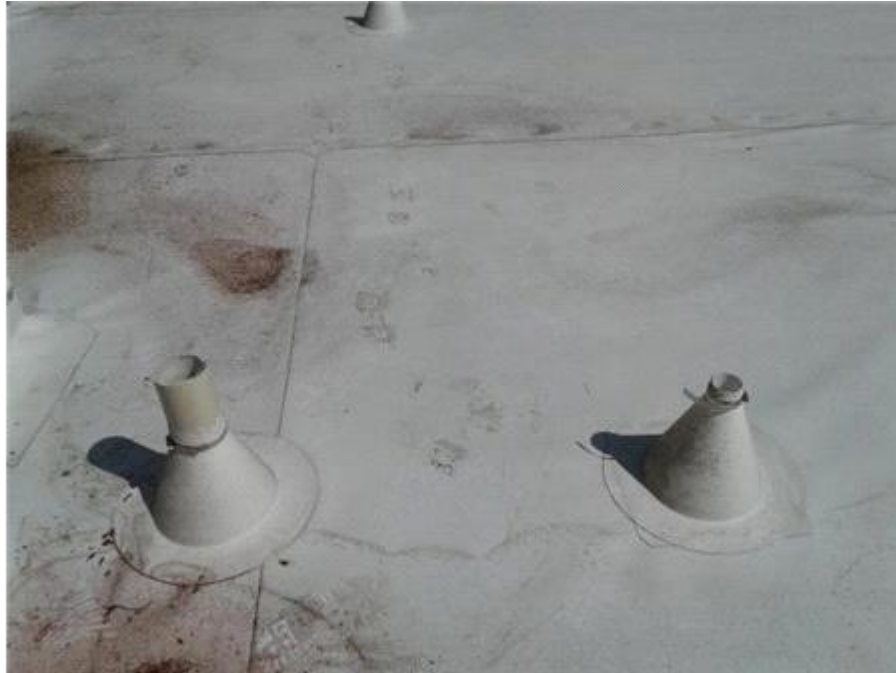
019G- Rubber Boots

Rubber boots appear to be in good condition.

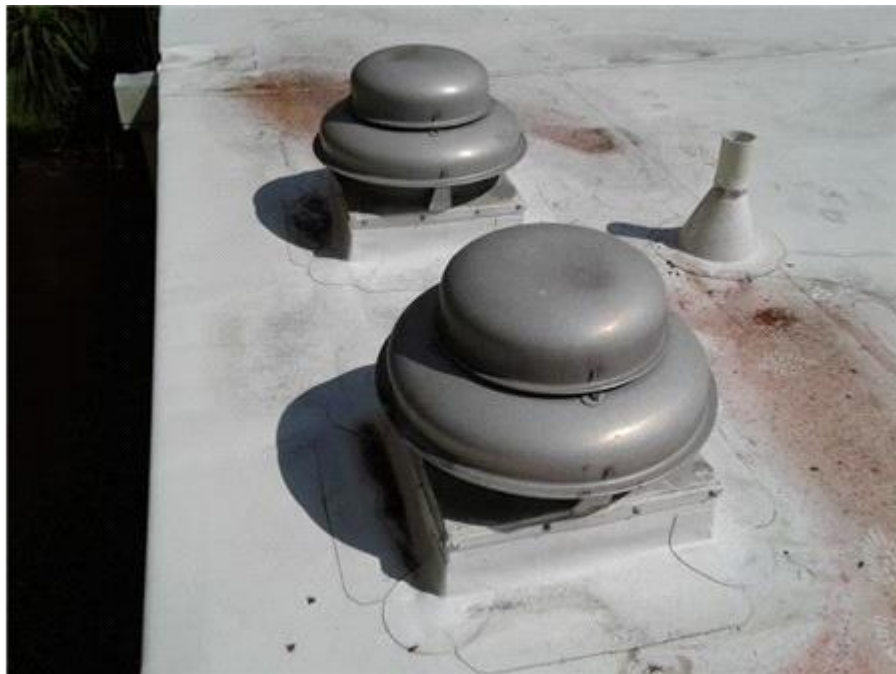
002G-Roof Vents

Roof vents appear to be in good condition at this time.

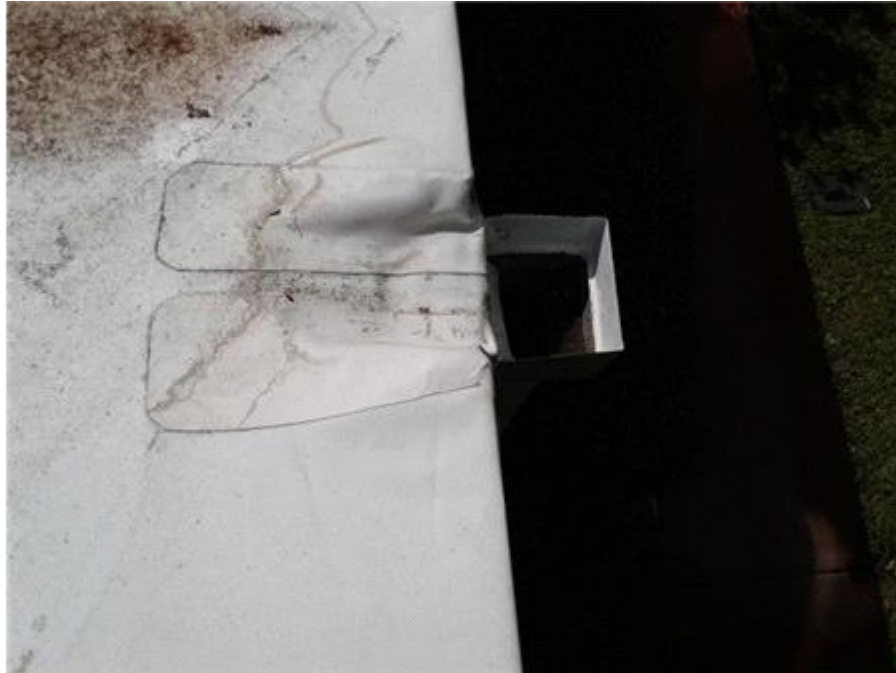
Scupper Overview

Scuppers appears to be in good condition.

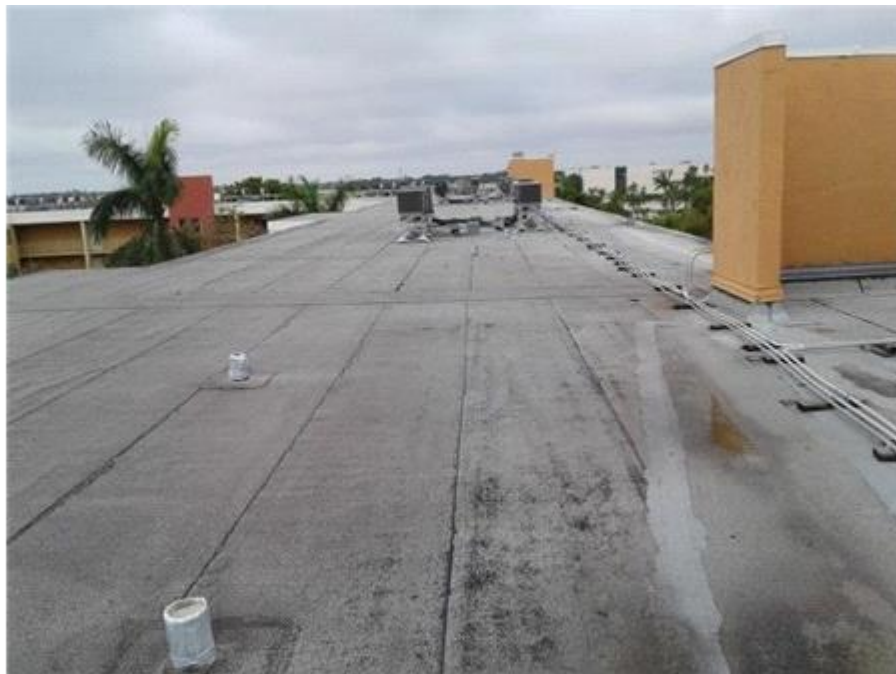
001G- The Towers - Main Roof

The roof surface appears to be in good, maintainable condition at this time.

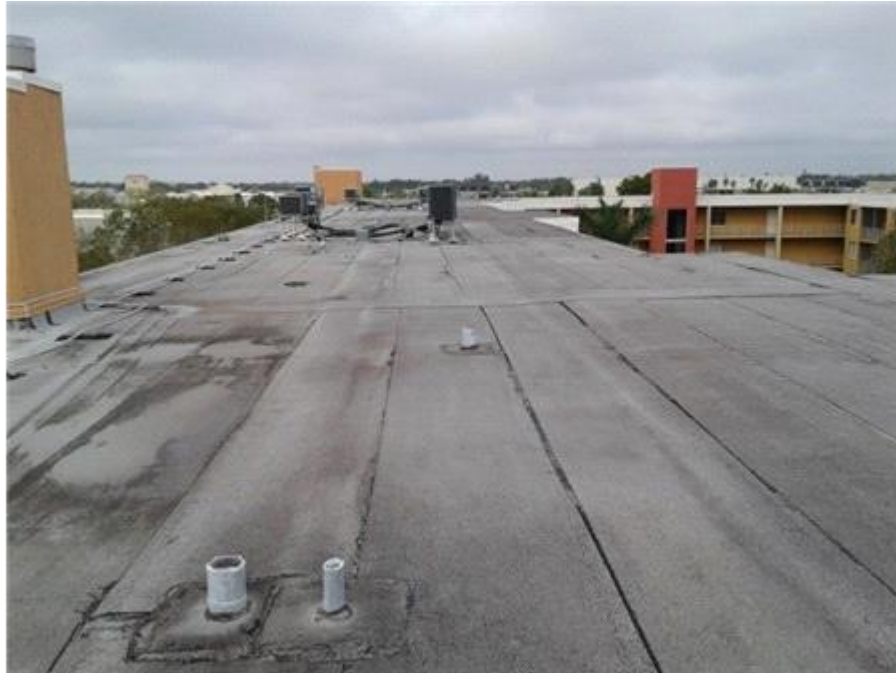
002G- Appearance Overview

The roof appearance is in good, maintainable condition at this time.

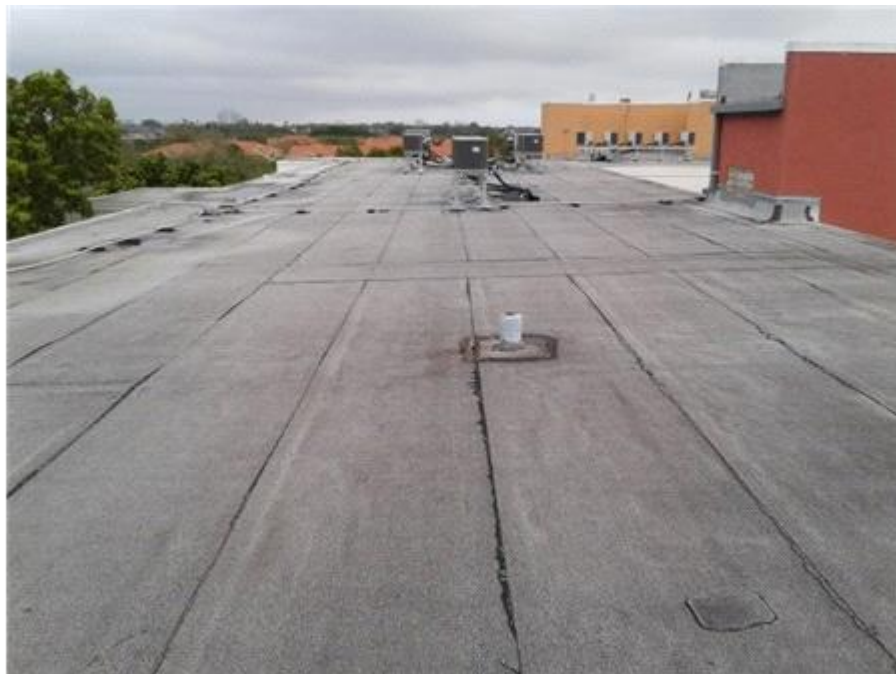
003G - Membrane Overview

The membrane appears to be in good, maintainable condition at this time.

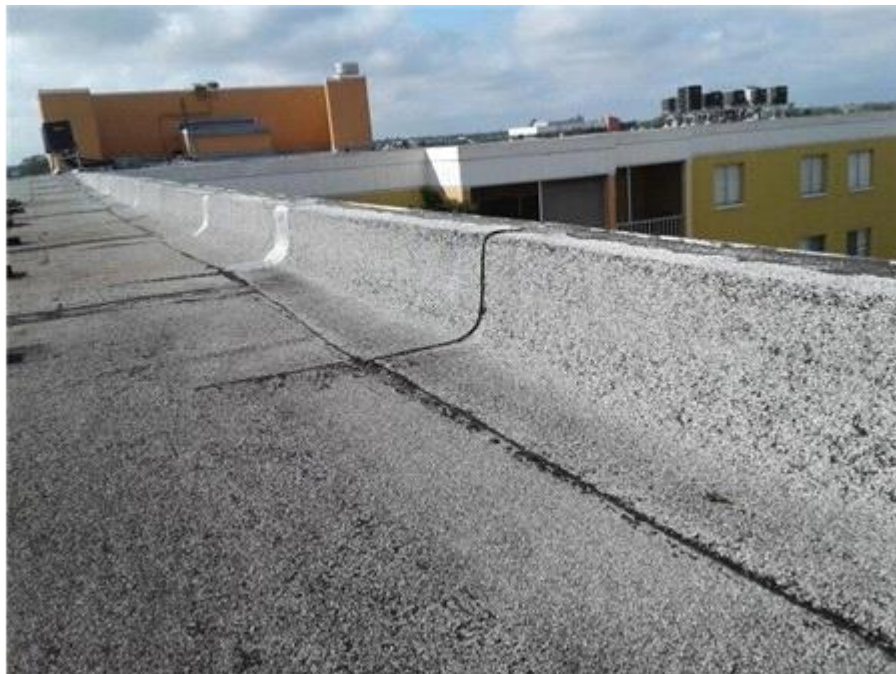
004G - Base Flashings
The base flashings appear to be in good condition.

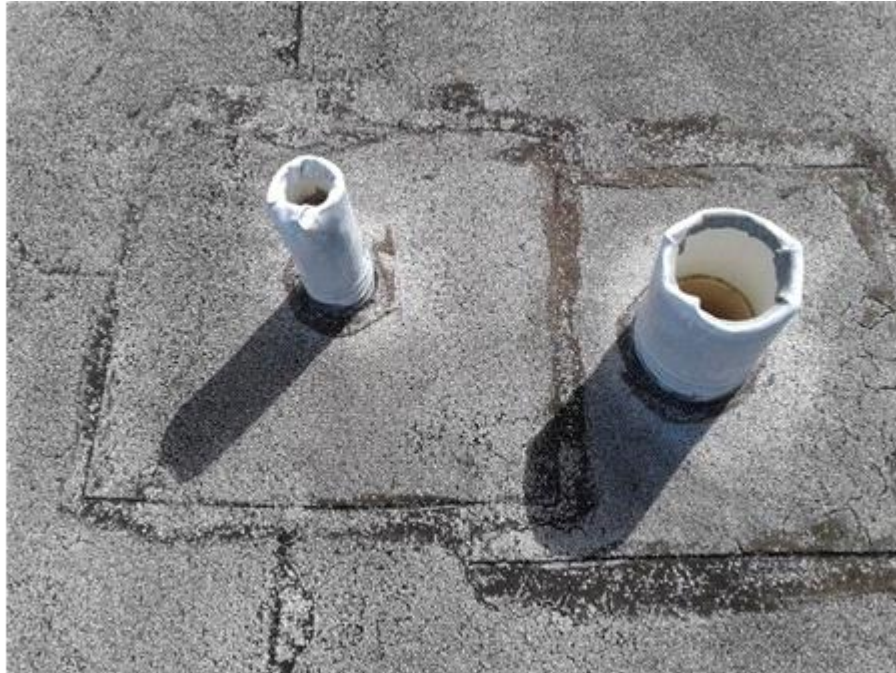
019G-Lead Boots

Lead boots appear to be in good condition.

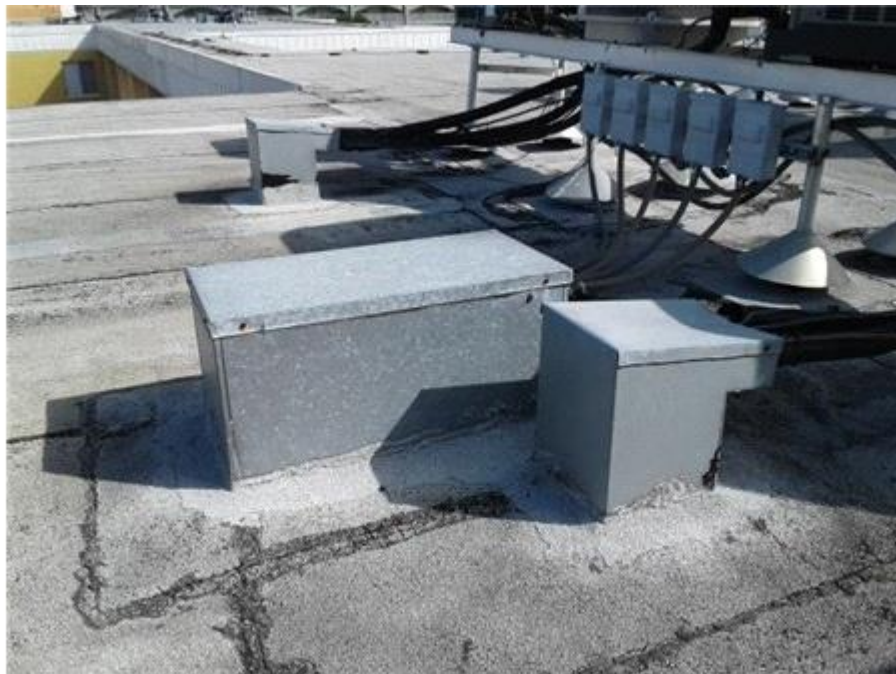
002G-Roof Vents

Roof vents appear to be in good condition at this time.

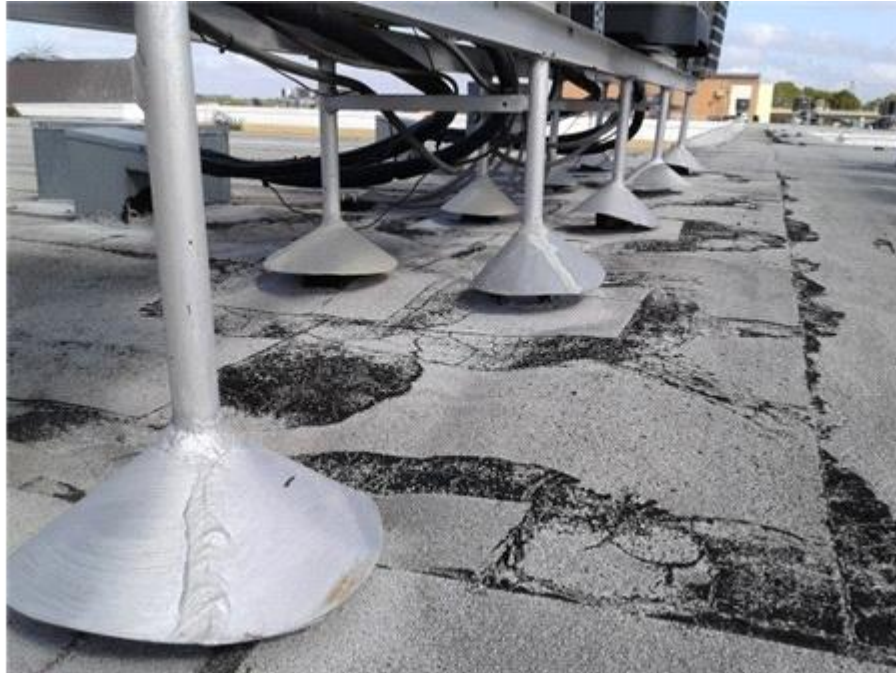
011G- Pitch Pans

The pitch pans appear to be in good condition.

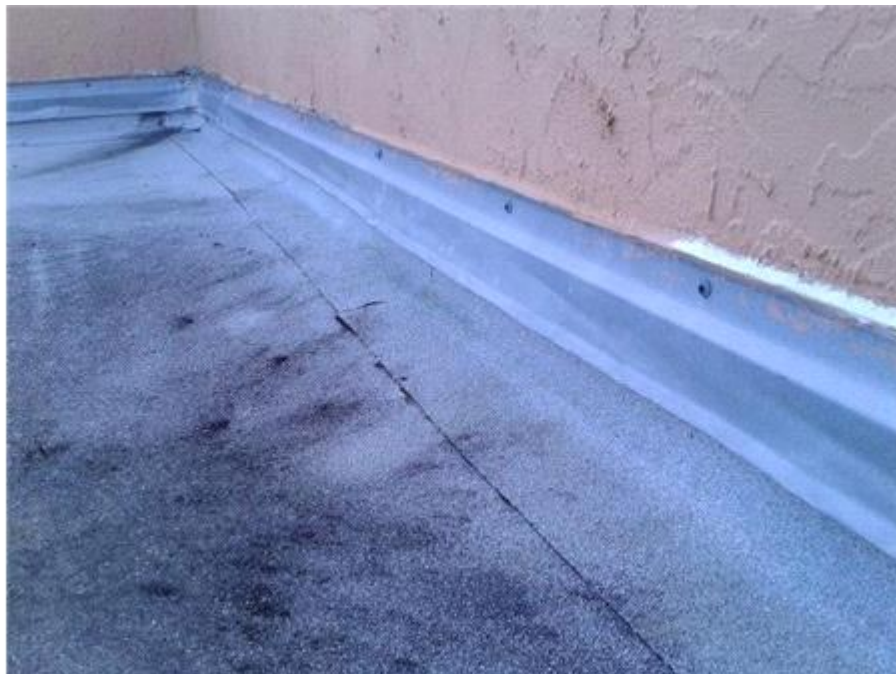
005G- Counter Flashing

The counter flashing appears to be in good condition.

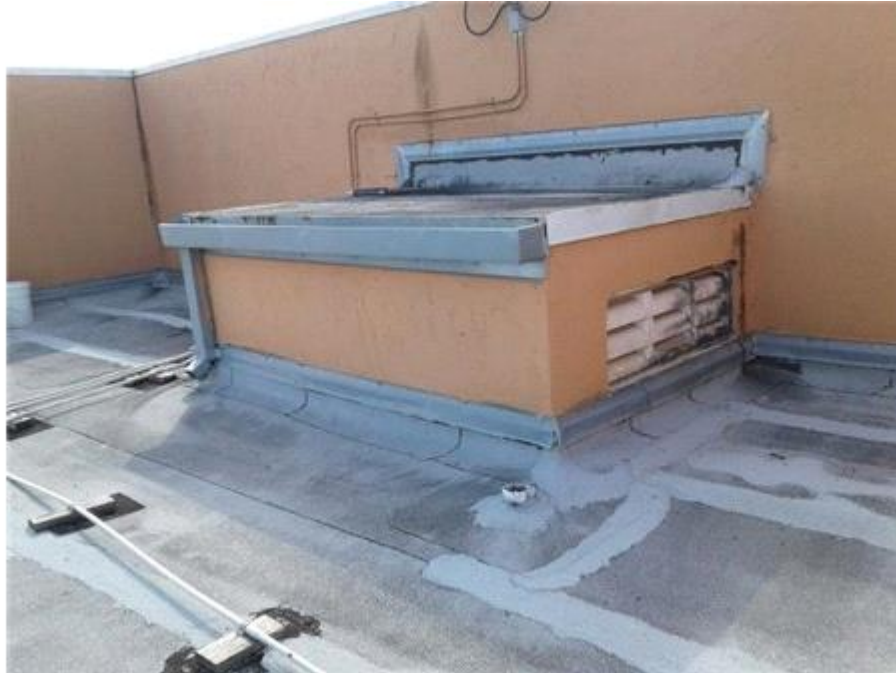
007G- Wall

The wall appears to be in good condition.

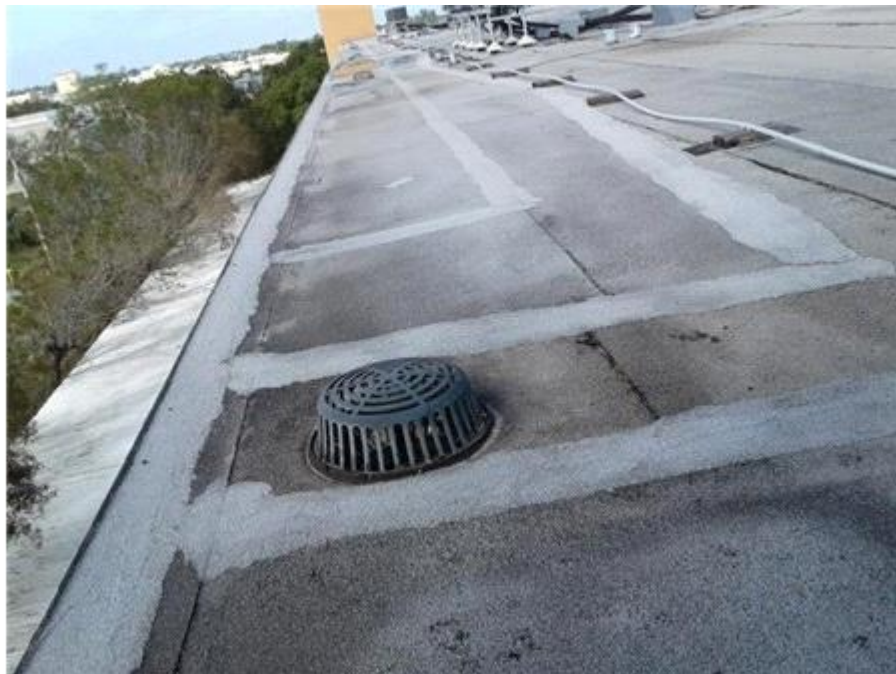
020G-Roof Drains

Roof drains appear to be in good condition.

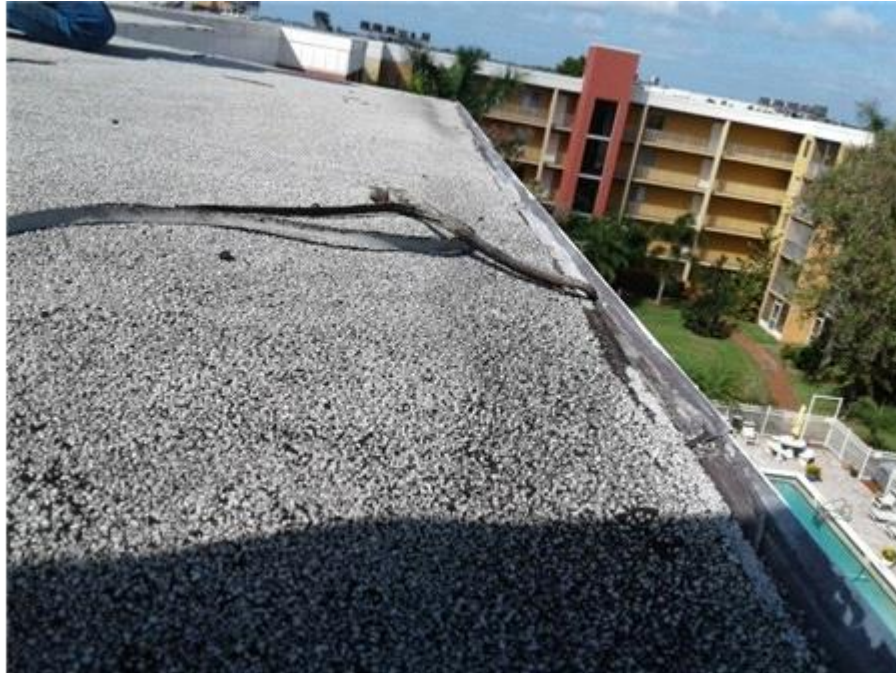
028- Sealant Deterioration/Failure

Sealant should be removed and replaced to prevent water entry.

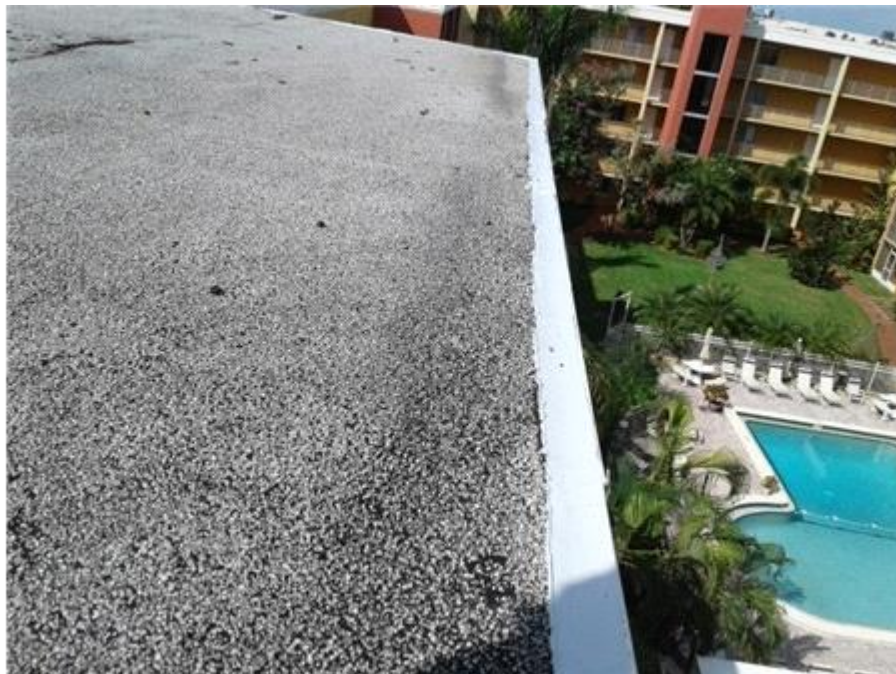
015-Sealant Repair

Removed existing sealant and replaced with M1 sealant.

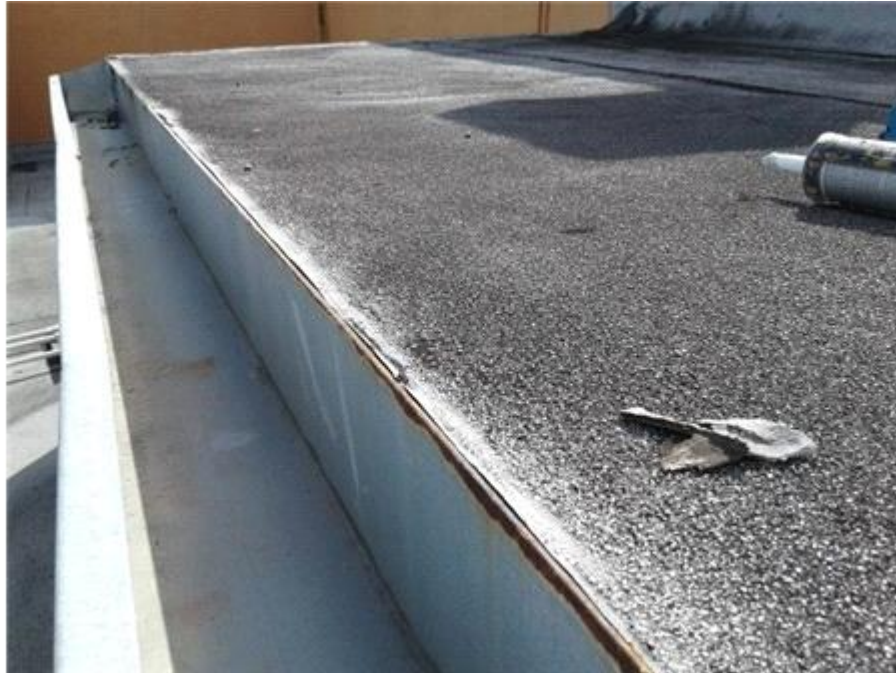
028- Sealant Deterioration/Failure

Sealant should be removed and replaced to prevent water entry.

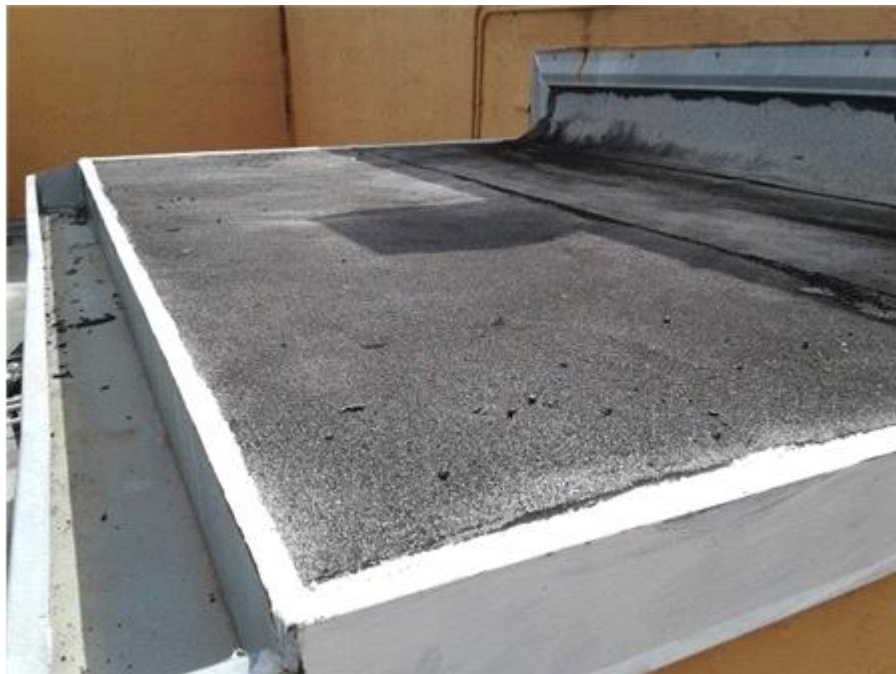
015-Sealant Repair

Removed existing sealant and replaced with M1 sealant.

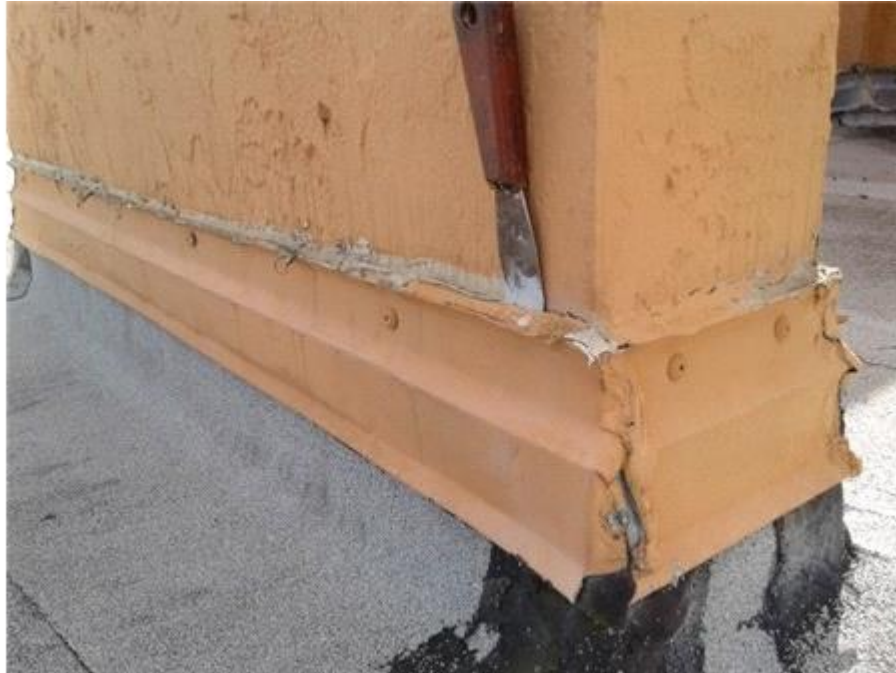
028- Sealant Deterioration/Failure

Sealant should be removed and replaced to prevent water entry.

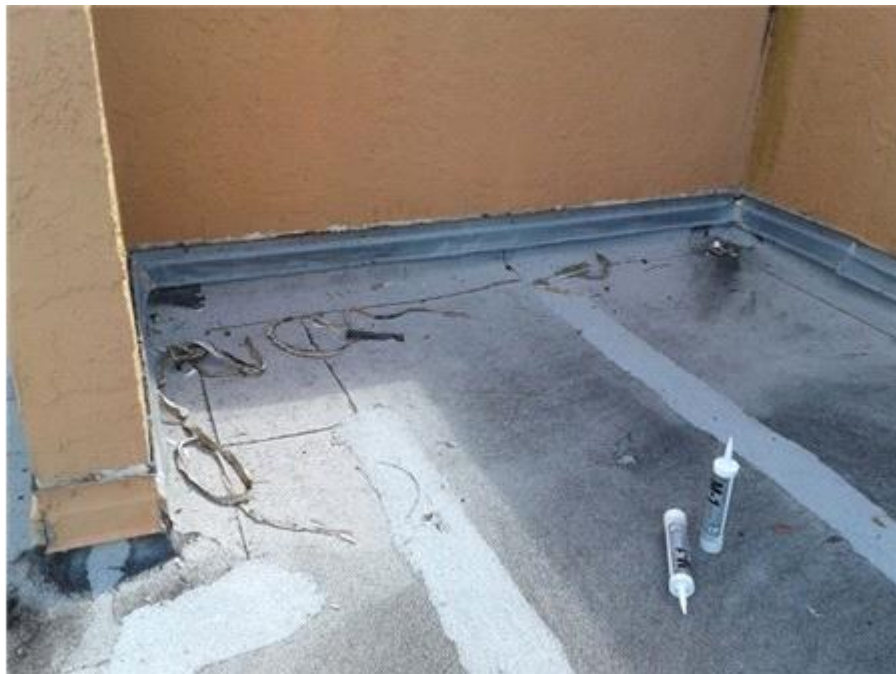
028- Sealant Deterioration/Failure

Sealant should be removed and replaced to prevent water entry.

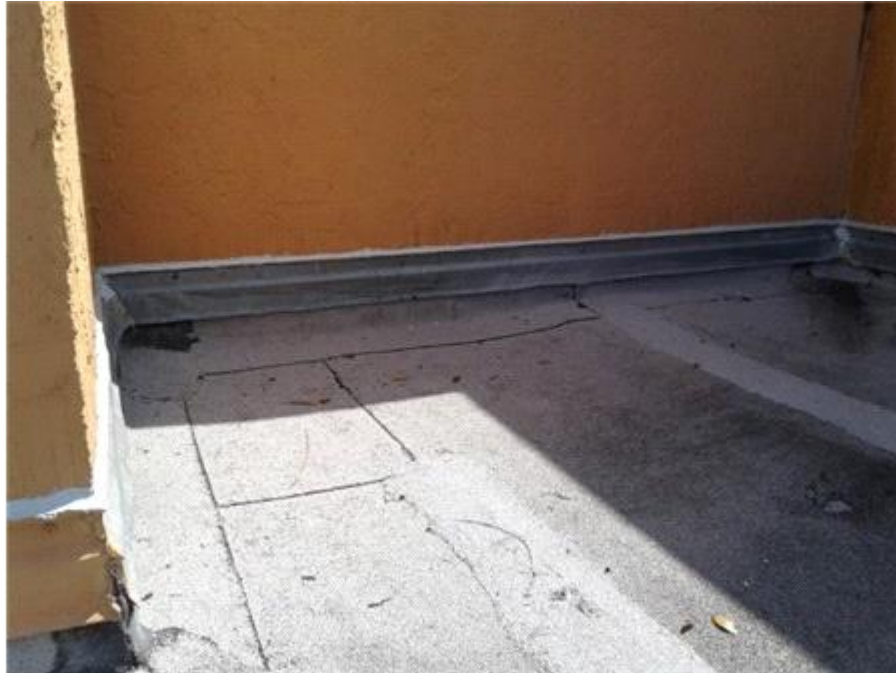
015-Sealant Repair

Removed existing sealant and replaced with M1 sealant.

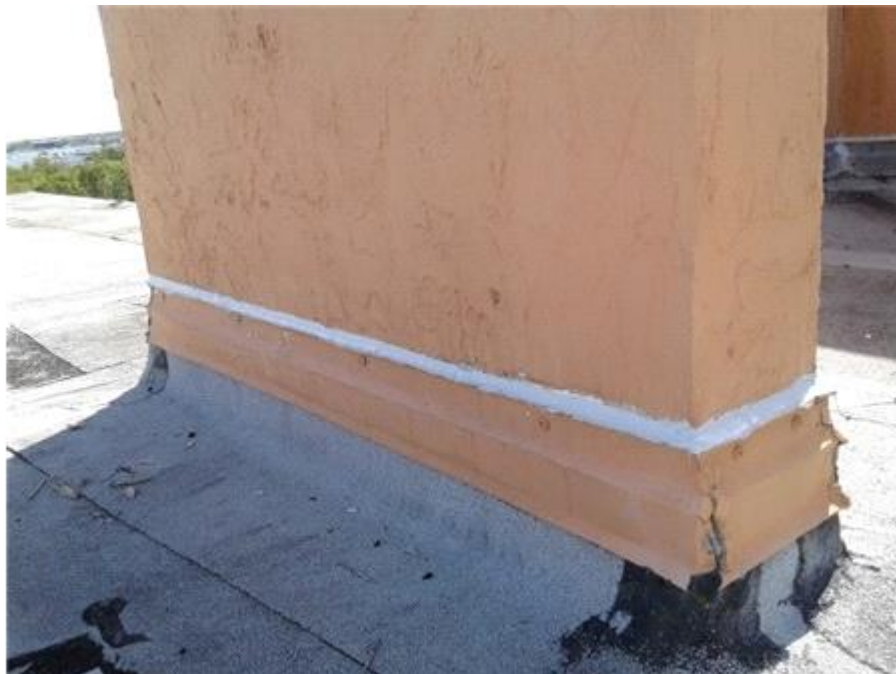
015-Sealant Repair

Removed existing sealant and replaced with M1 sealant.

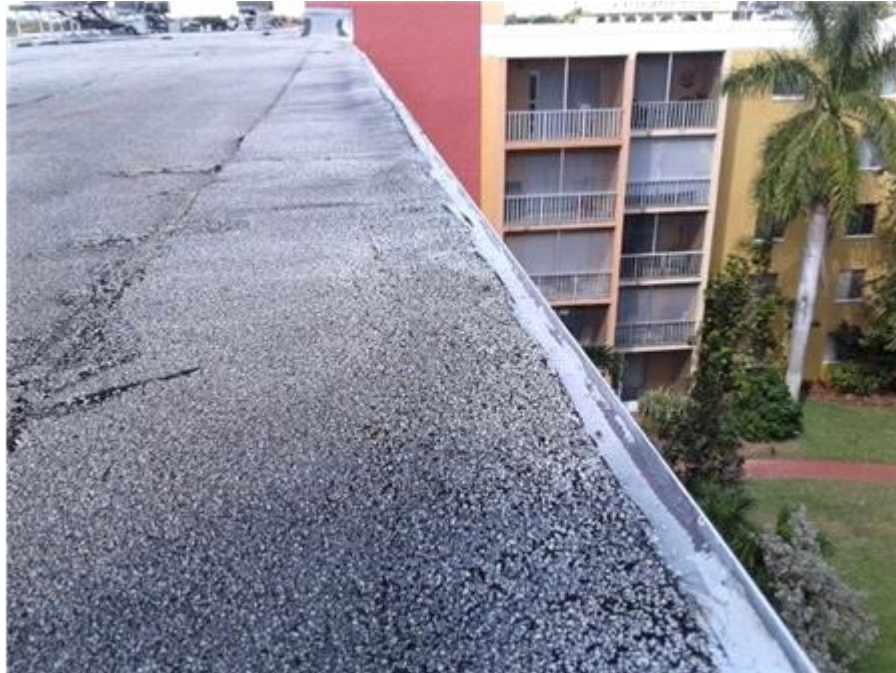
028- Sealant Deterioration/Failure

Sealant should be removed and replaced to prevent water entry.

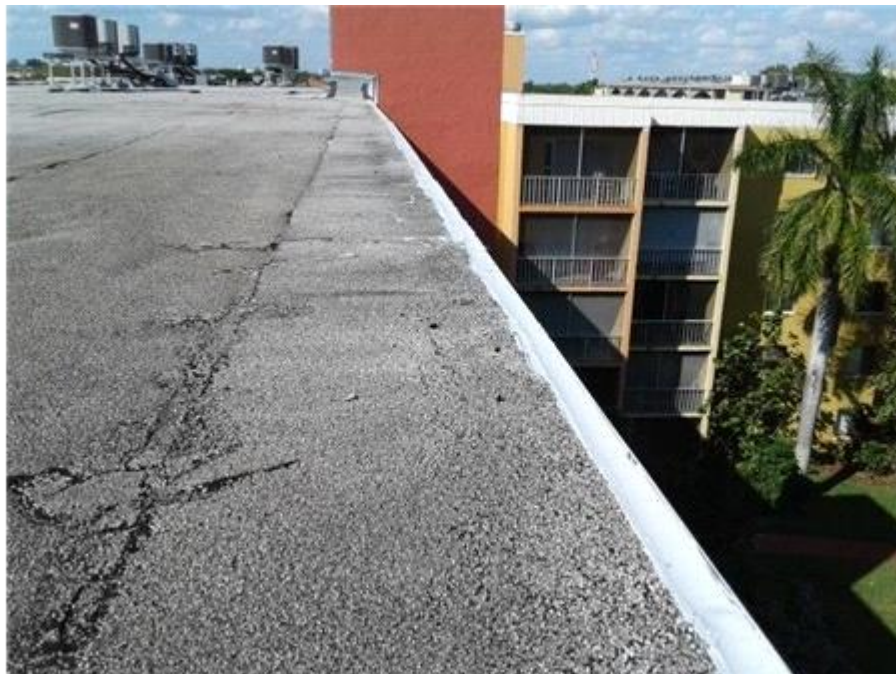
015-Sealant Repair

Removed existing sealant and replaced with M1 sealant - approximately 120 ft.

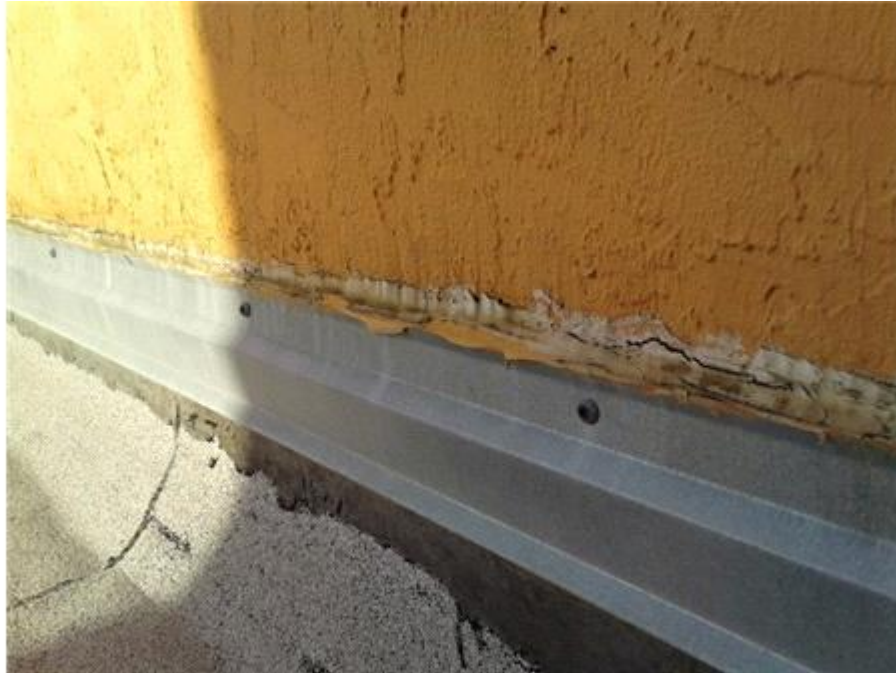
028- Sealant Deterioration/Failure

Sealant should be removed and replaced to prevent water entry.

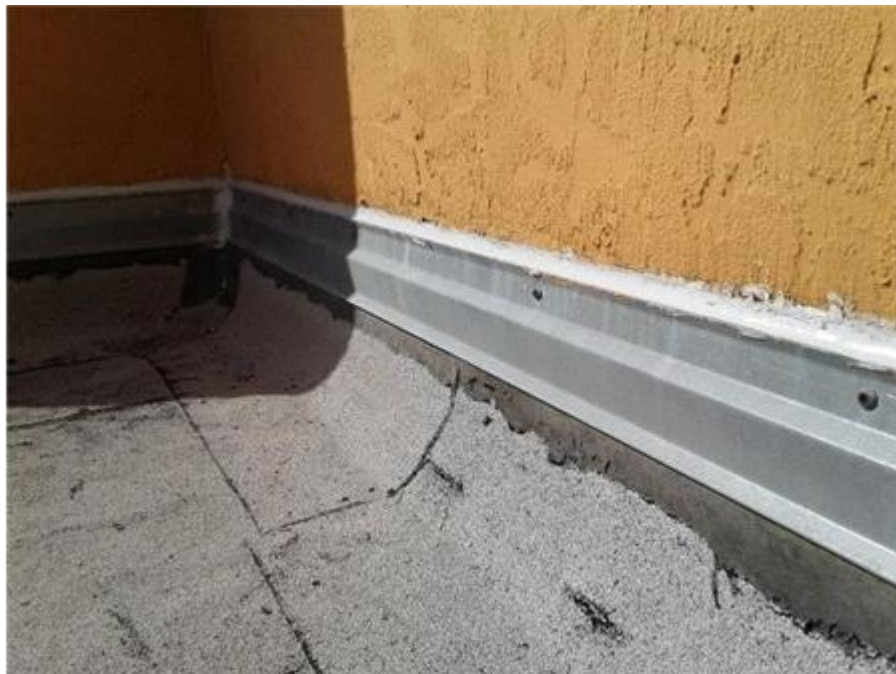
015-Sealant Repair

Removed existing sealant and replaced with M1 sealant - approximately 120 ft.

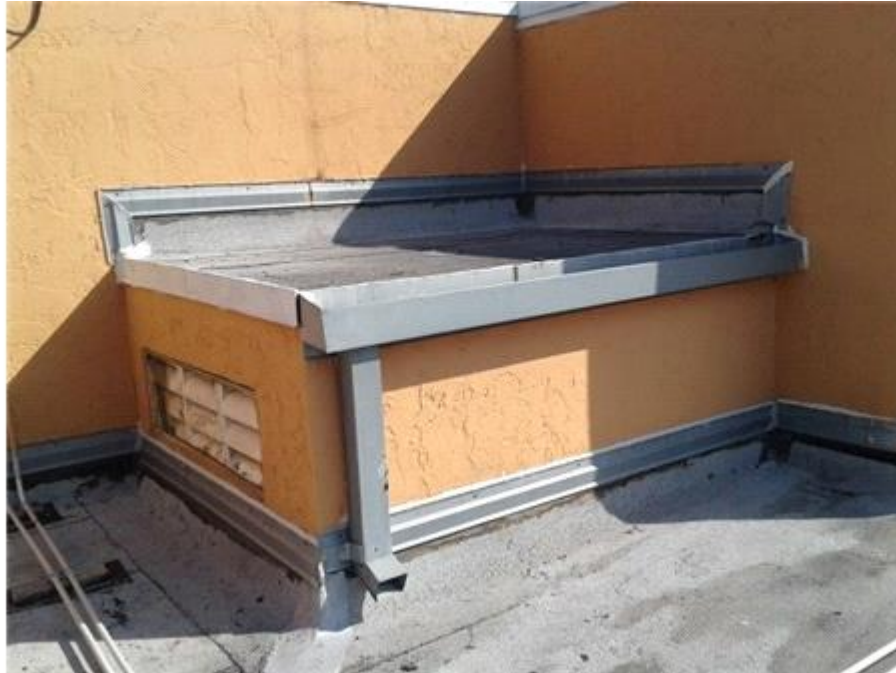
015-Sealant Repair

Removed existing sealant and replaced with M1 sealant.

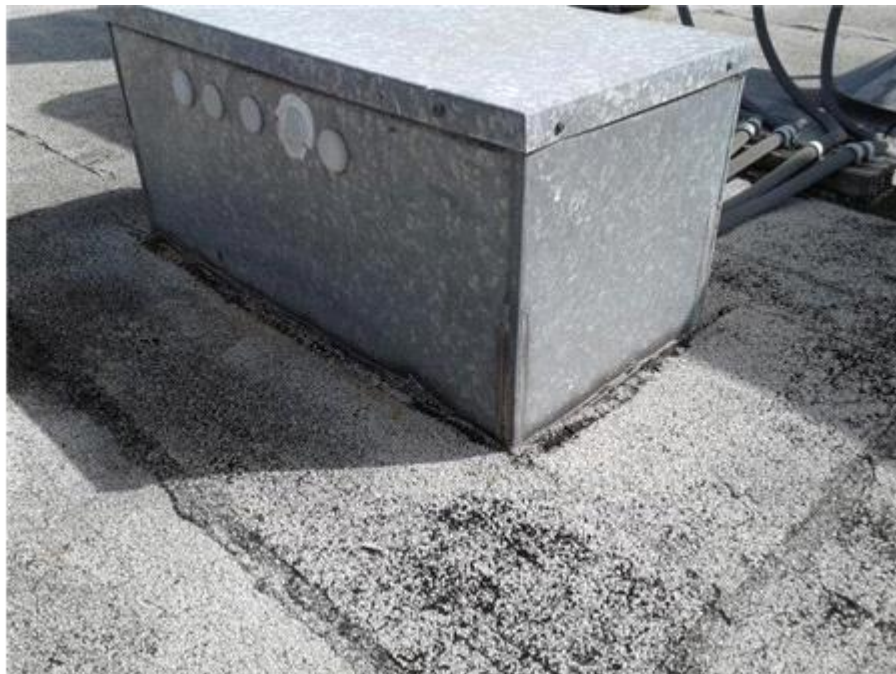
014-Sealant Failure

Identified void in sealant.

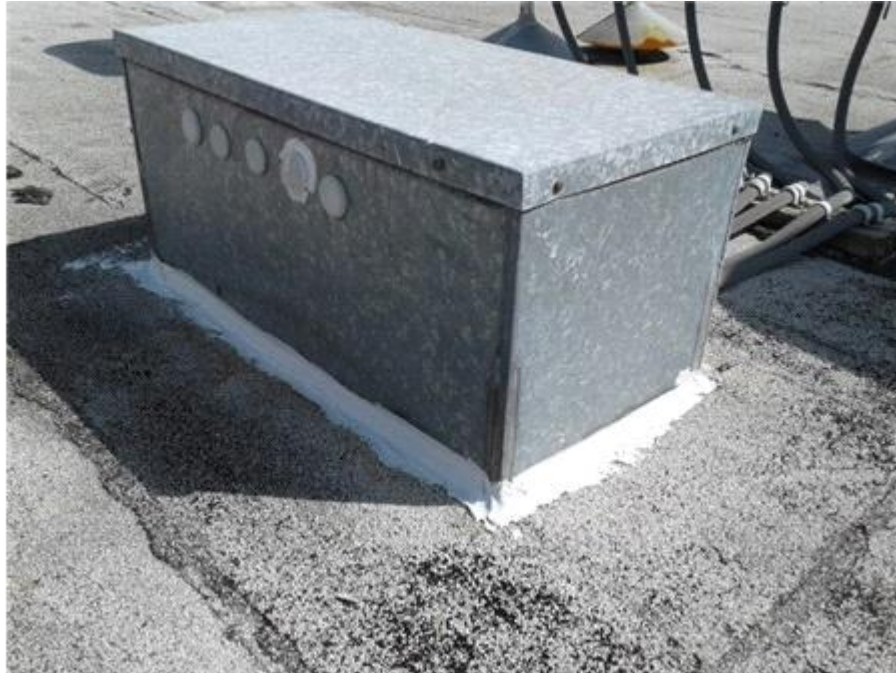
015-Sealant Repair

Removed existing sealant and replaced with M1 sealant.

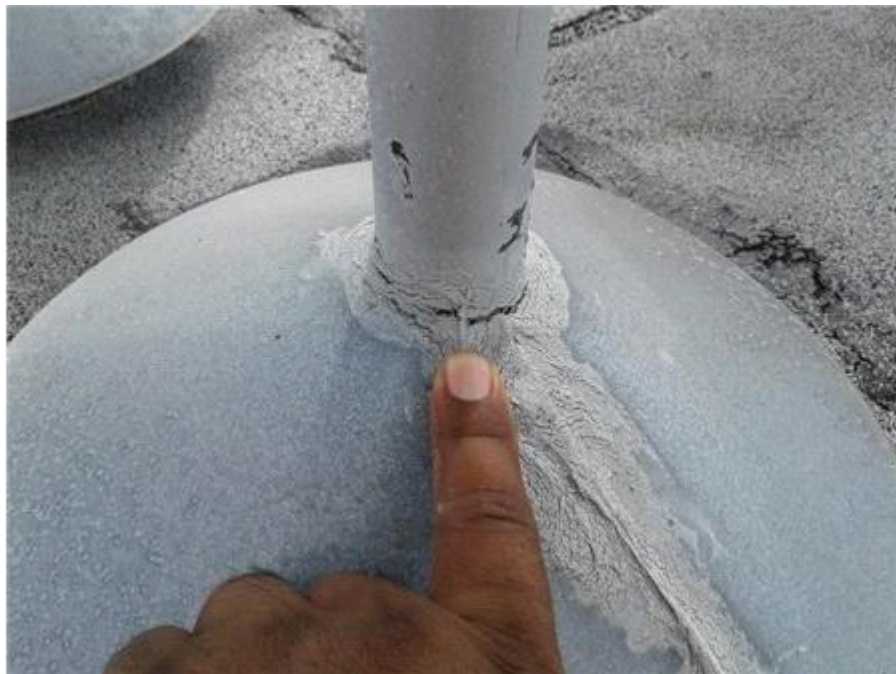
014-Sealant Failure

Identified void in sealant.

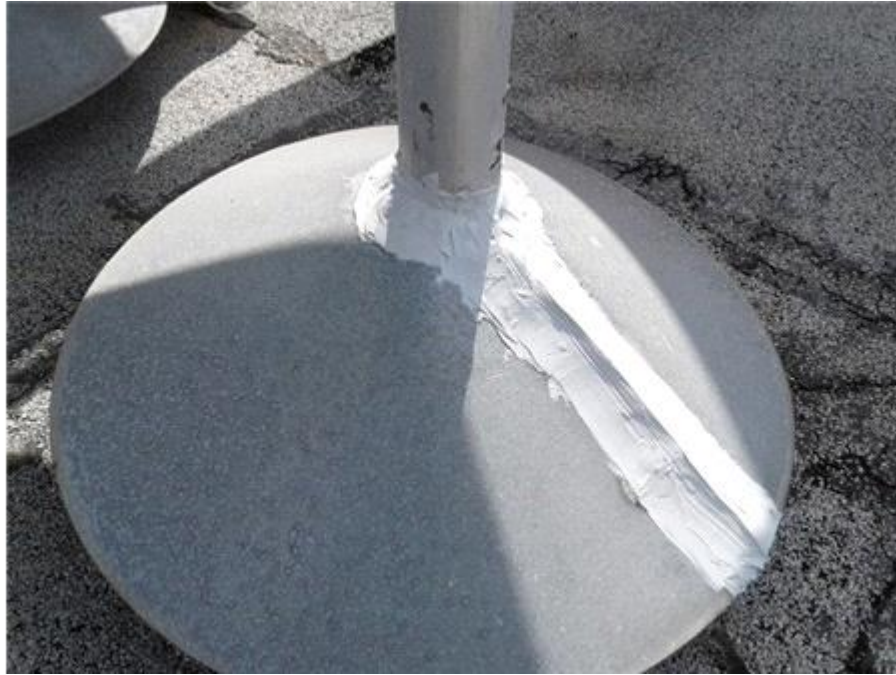
015-Sealant Repair

Removed existing sealant and replaced with M1 sealant.

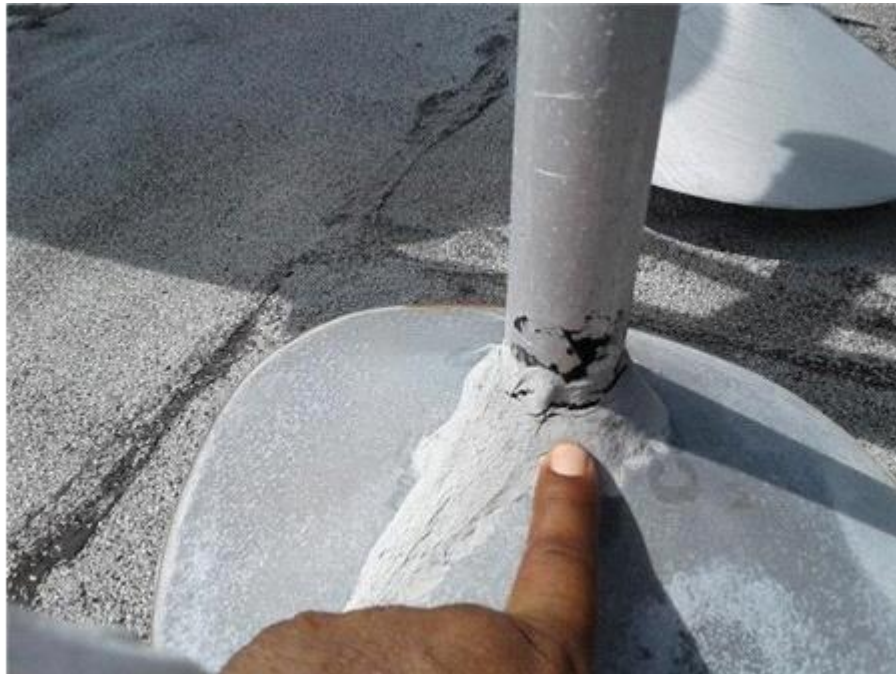
014-Sealant Failure

Identified void in sealant.

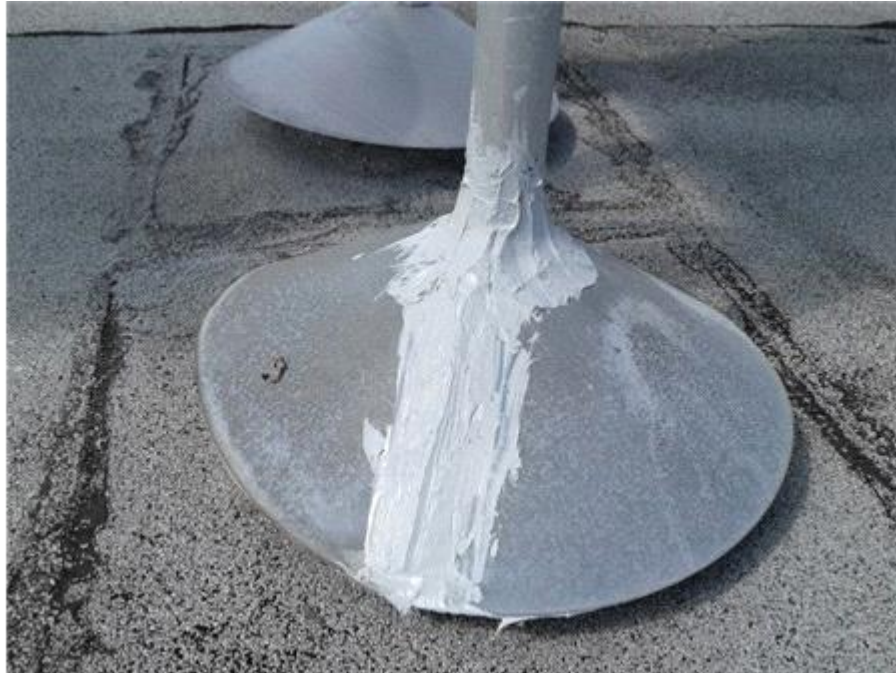
015-Sealant Repair

Removed existing sealant and replaced with M1 sealant.

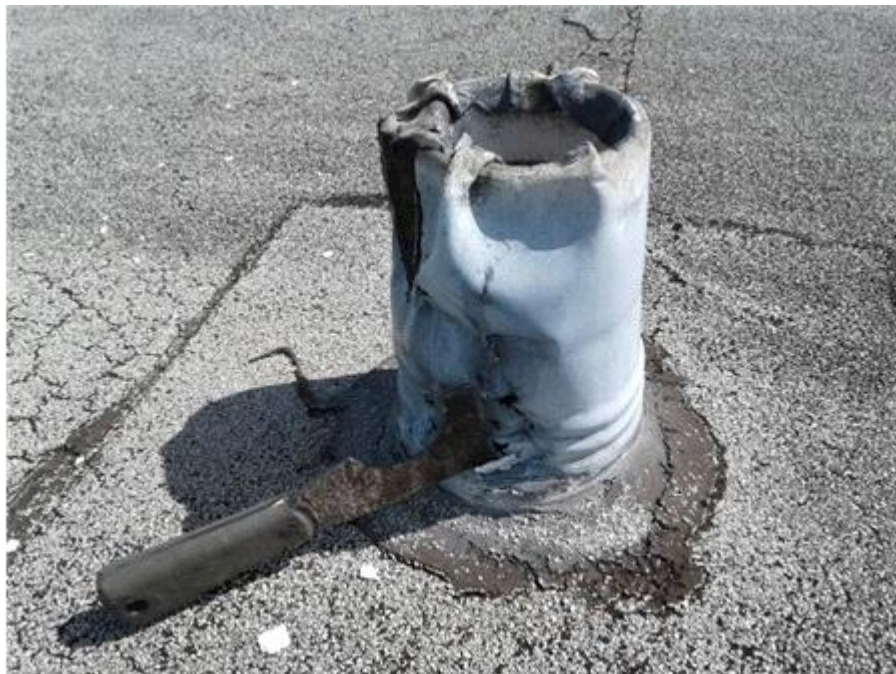
Damaged Lead Boot

Identified damaged lead boot.

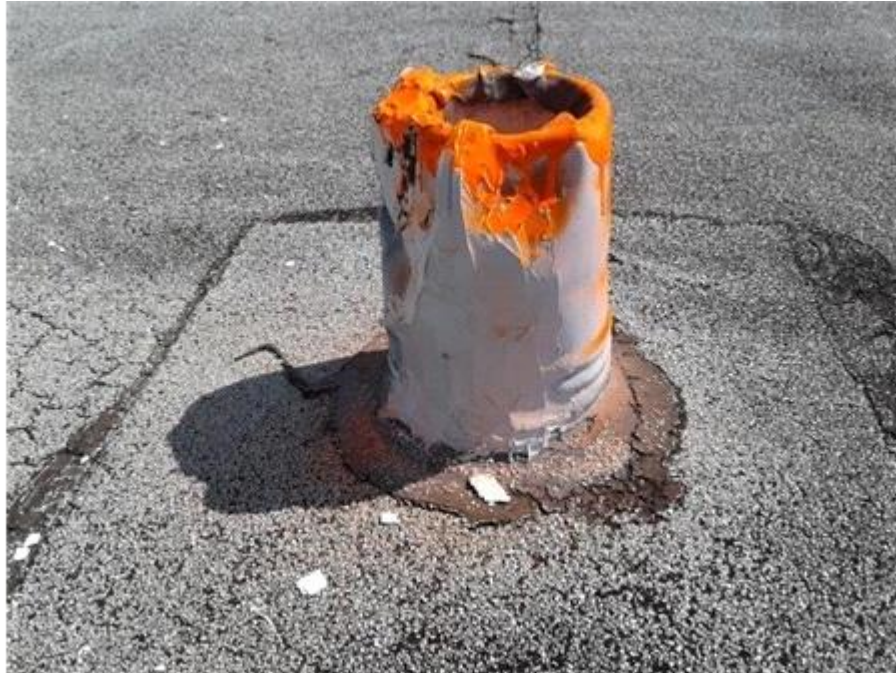
Temporary Repair

Temporarily repaired the lead boot with M-1 sealant.
