Inspection Report

Facility: Towers, The
Address: 2366 East Mall Dr,
Fort Myers, 33912

Inspection Date: Wednesday, February 28, 2018

Re.: **Inspection Report (1 of 6) for The Towers**

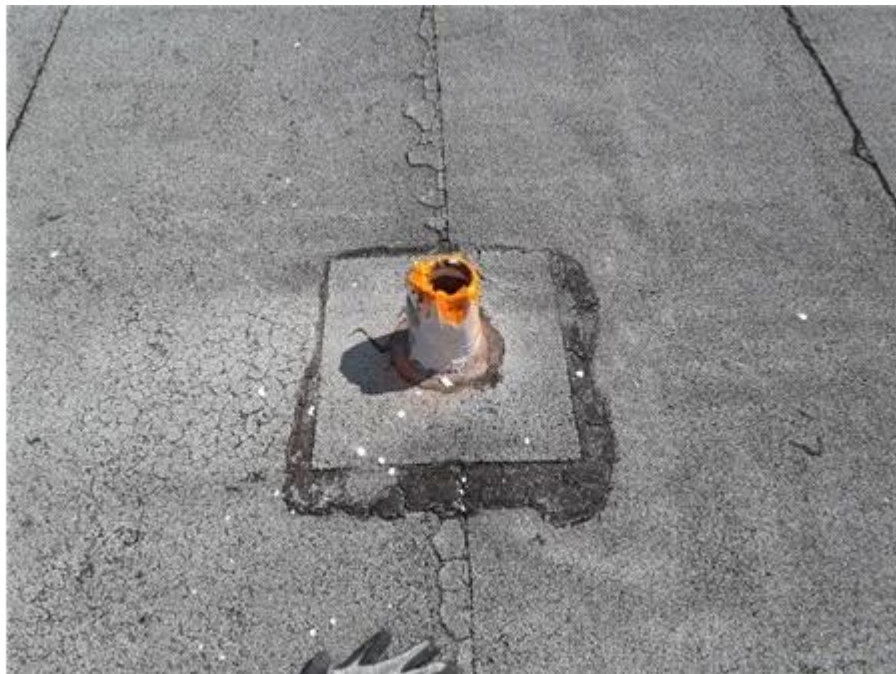
Damaged Lead Boot

Suggest replacing (1) 4" lead boot.

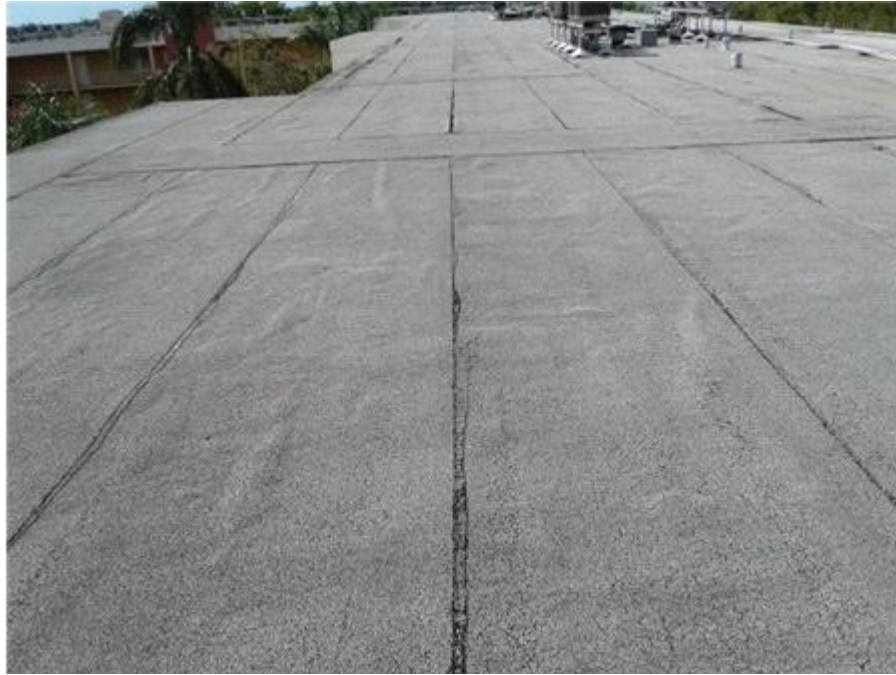
F-200 Field Membrane

Blisters are caused by gas trapped in the system and may be ruptured with foot traffic. Will monitor.

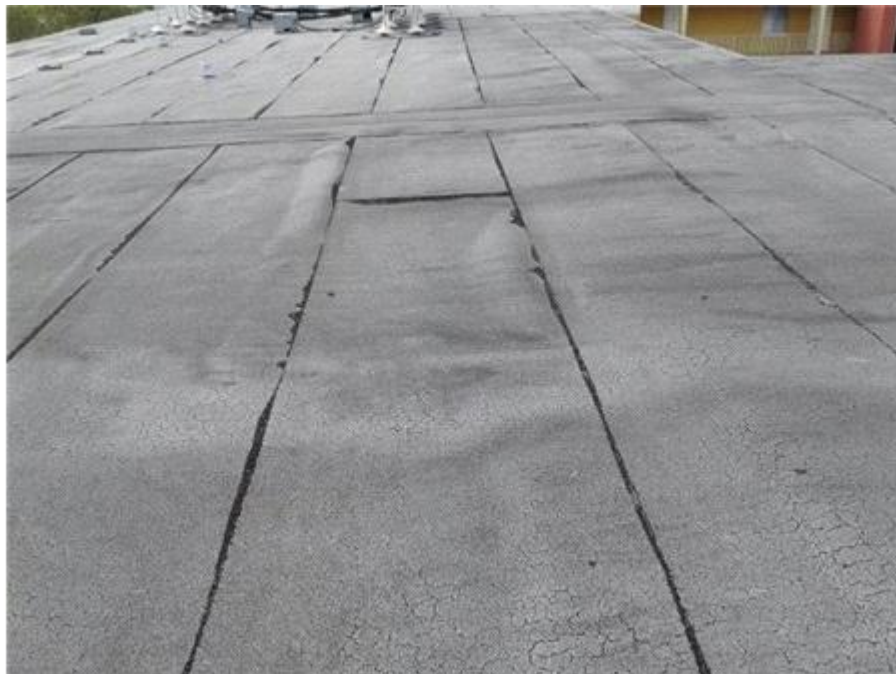
F-202 Field Membrane Blister

Blisters are caused by gas trapped in the system and may be ruptured with foot traffic. Felts are exposed and premature deterioration will occur. Suggest repairing blisters.

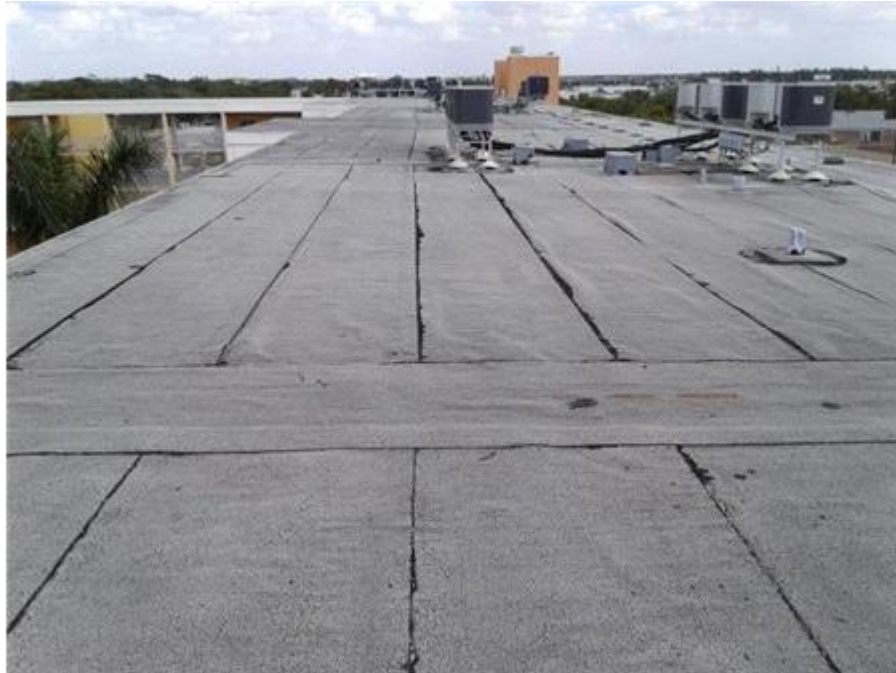
F-202 Field Membrane Blisters

Blisters are caused by gas trapped in the system and may be ruptured with foot traffic. Felts are exposed and premature deterioration will occur. suggest to monitor.
