# Inspection Report

**Facility:** Towers, The  
**Address:** 2366 East Mall Dr,  
Fort Myers, 33901

Work Order #: 6220

Re.: **Inspection Report (6 of 6) for The Towers**

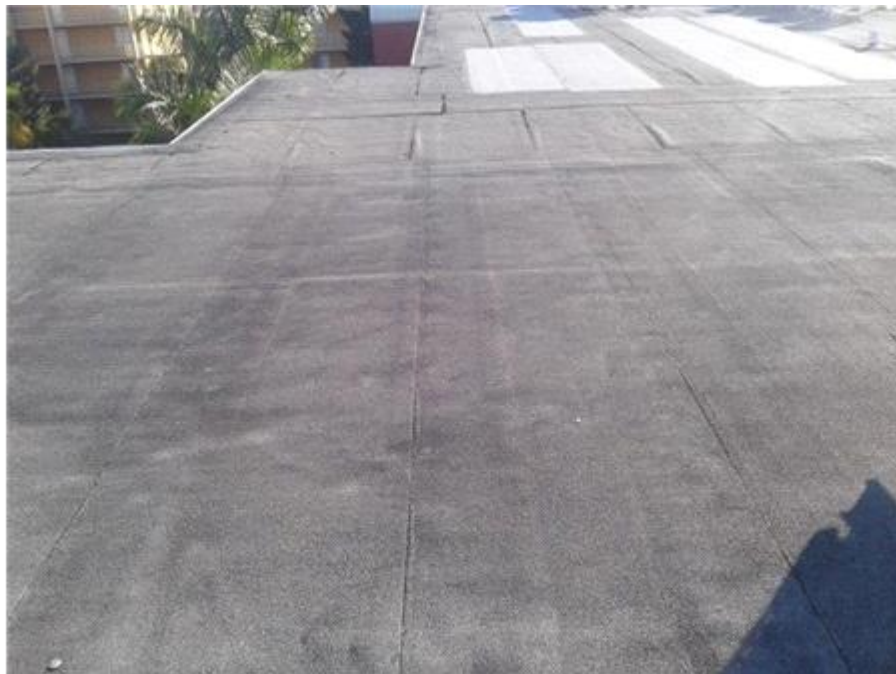
003F - The Towers - BUR - Membrane Overview

The roof membrane appears to be in fair condition at this time.

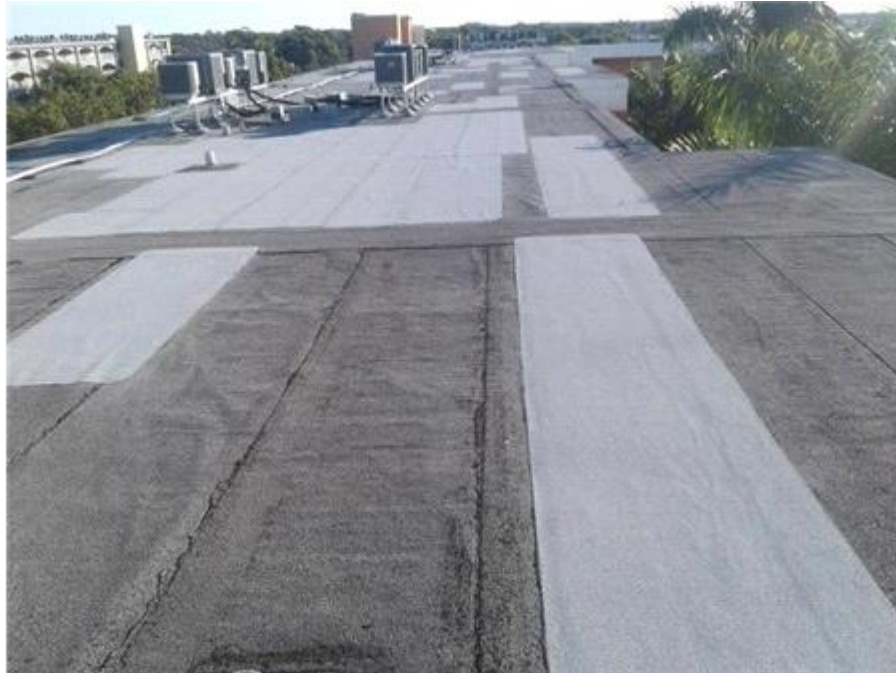
001F - The Towers - BUR - Surface Overview

The roof surface appears to be in fair condition at this time.

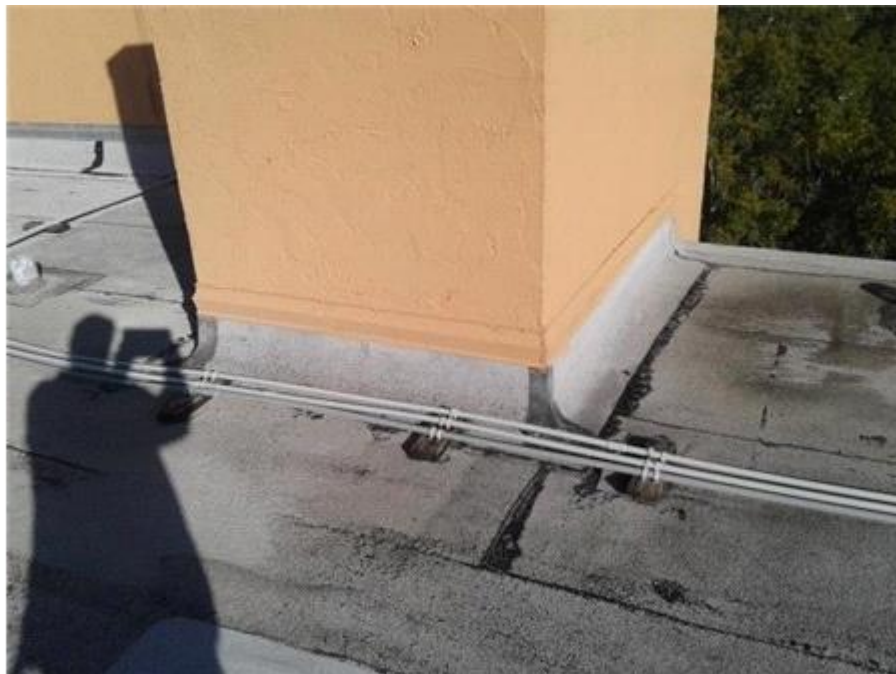
004F - The Towers - BUR - Base Flashings

The base flashings appear to be in fair condition.

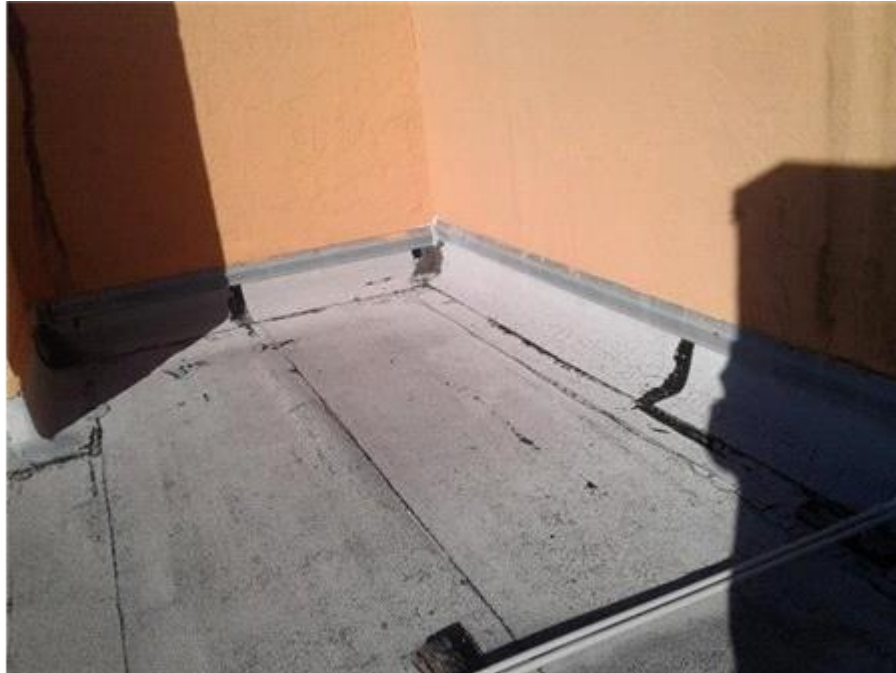
004F - The Towers - BUR - Base Flashings

The base flashings appear to be in fair condition.

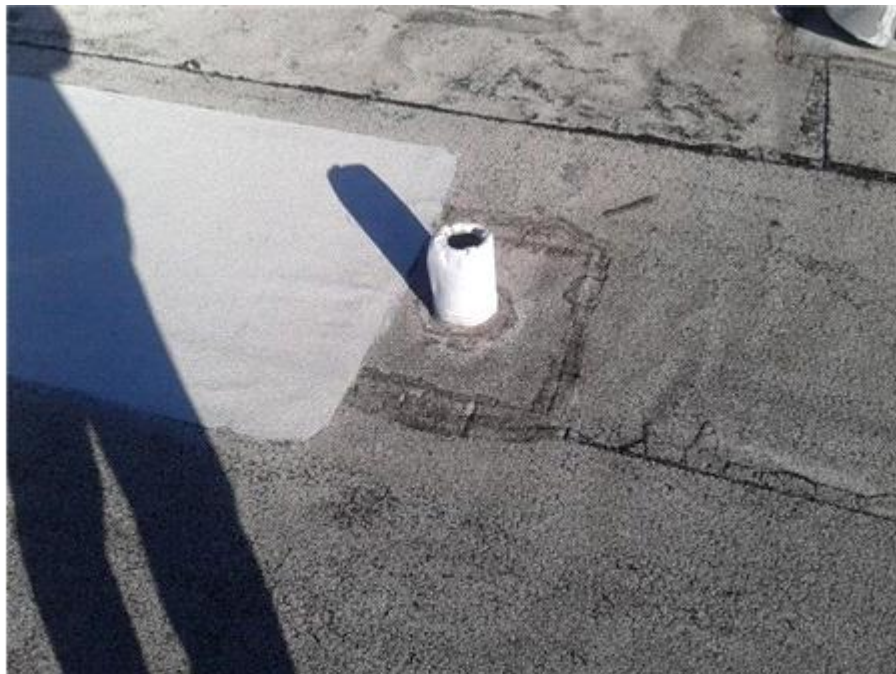
019F- The Towers - BUR - Lead Boots

Lead boots appear to be in fair condition.

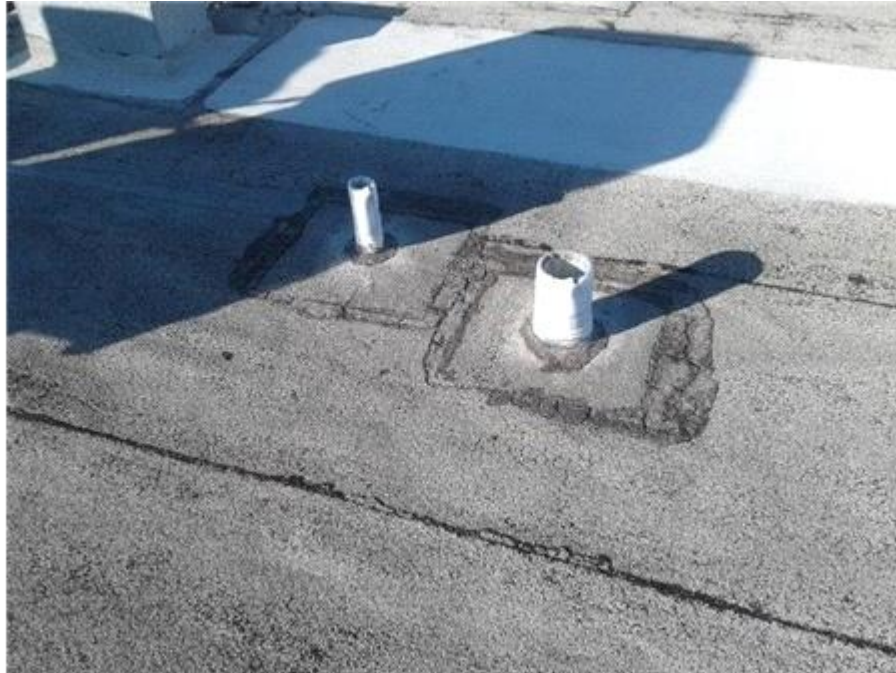
019F - The Towers - BUR - Lead Boots  
Lead boots appear to be in fair condition.

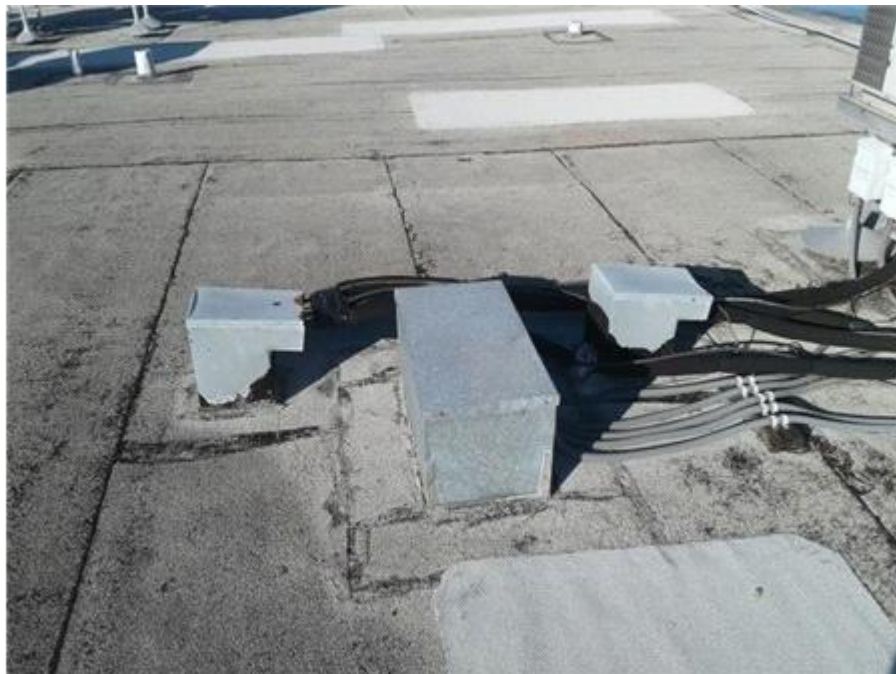
010F- The Towers - BUR - Equipment Housing  
The equipment housing appears to be in fair condition.

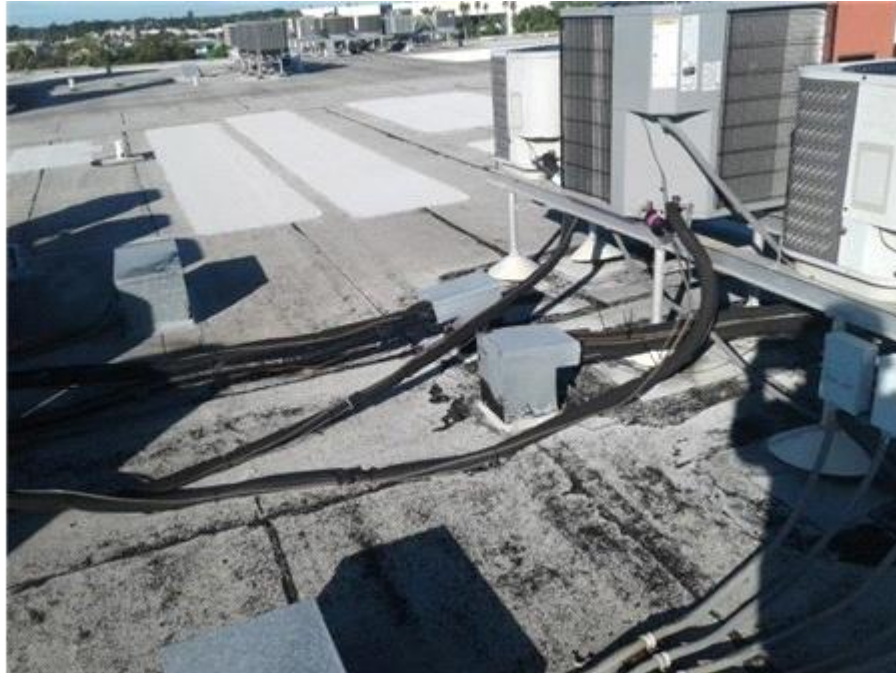
010F- The Towers - BUR - Equipment Housing

The equipment housing appears to be in fair condition.

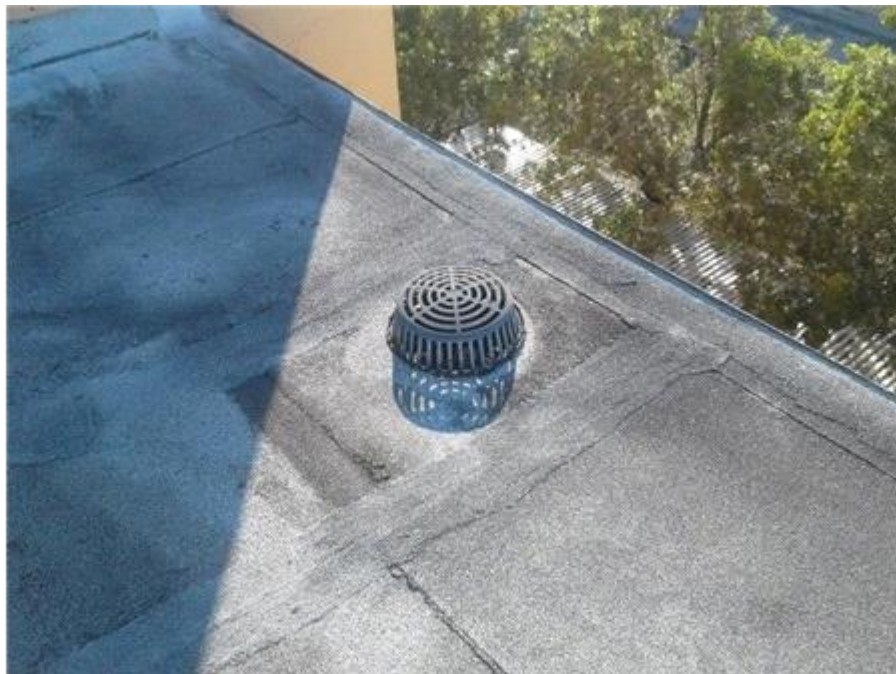
020F- The Towers - BUR - Roof Drains

Roof drains appear to be in fair condition.

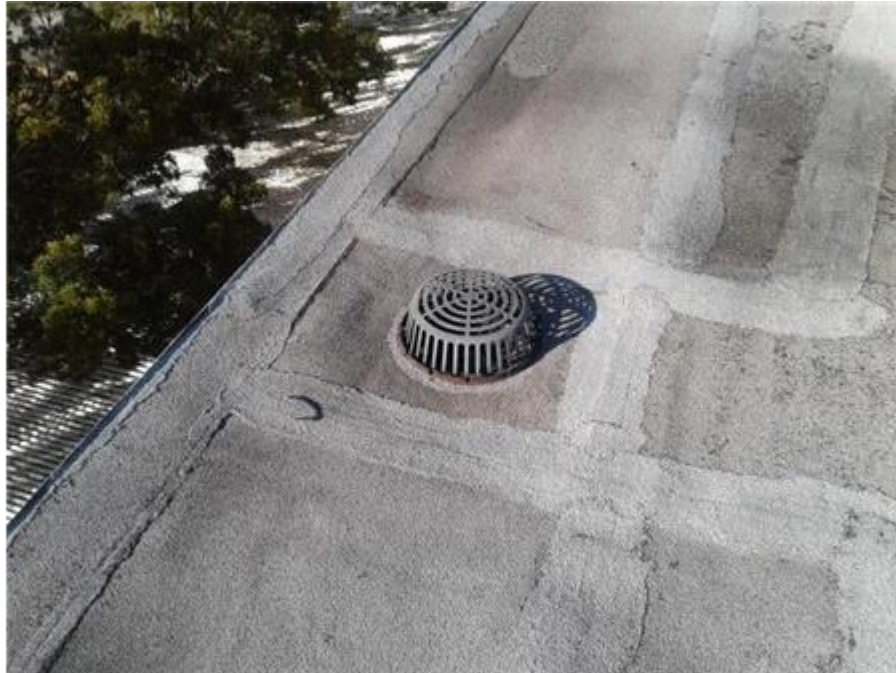
020F- The Towers - BUR - Roof Drains

Roof drains appear to be in fair condition.

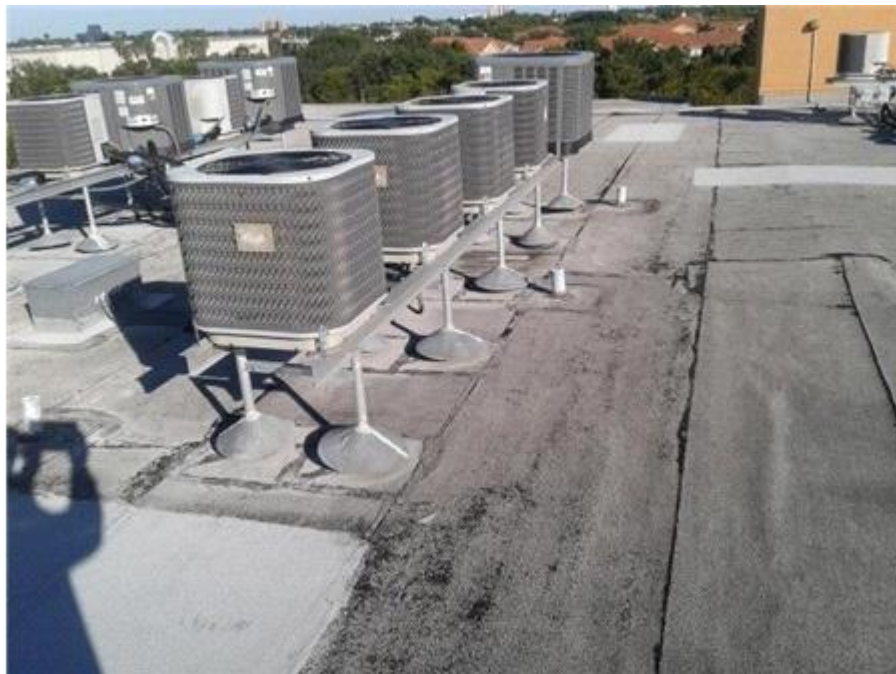
002F - The Towers - BUR - Appearance Overview

The appearance of the roof is in fair condition at this time.

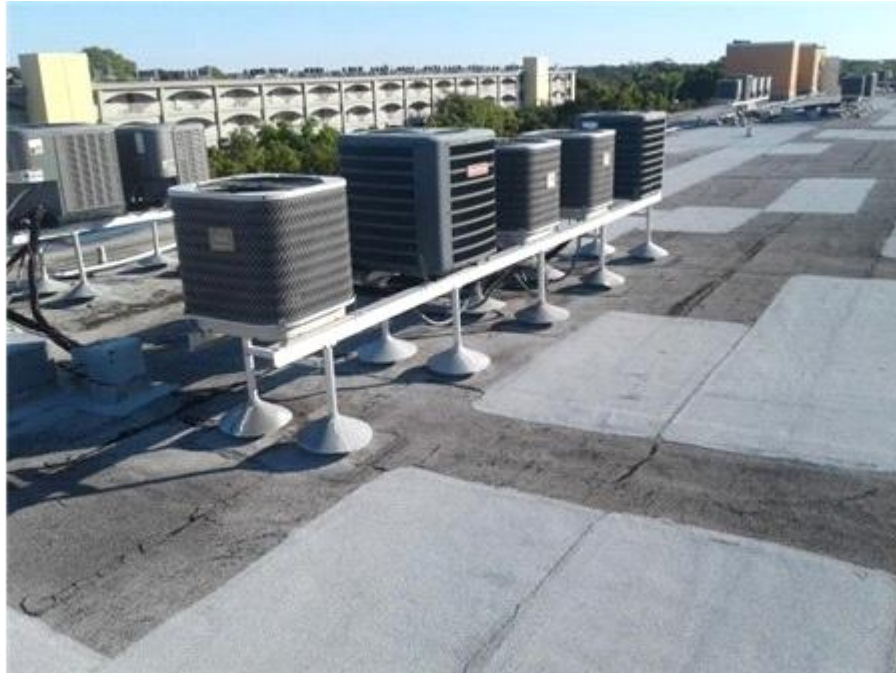
002F - The Towers - BUR - Appearance Overview

The appearance of the roof is in fair condition at this time.

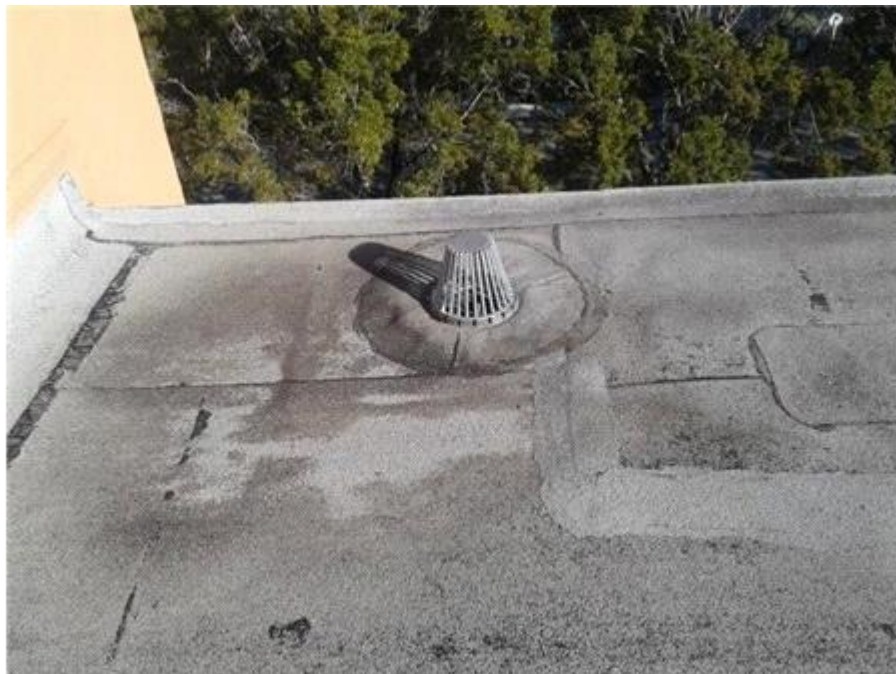
020F- The Towers - BUR - Roof Drains

Roof drains appear to be in fair condition.

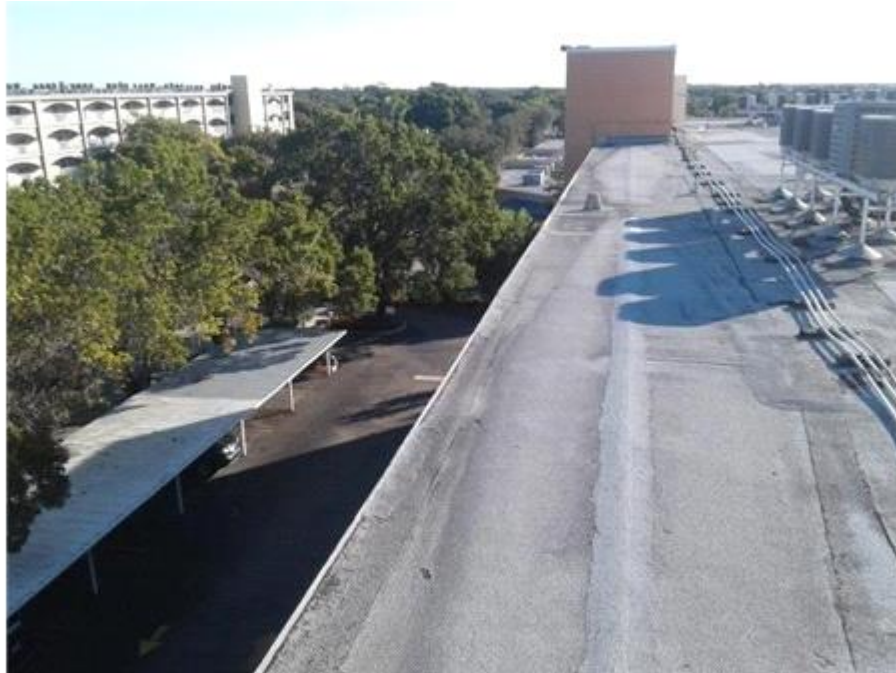
016F- The Towers - BUR - Roof Edge

Roof edge appears to be in fair condition.

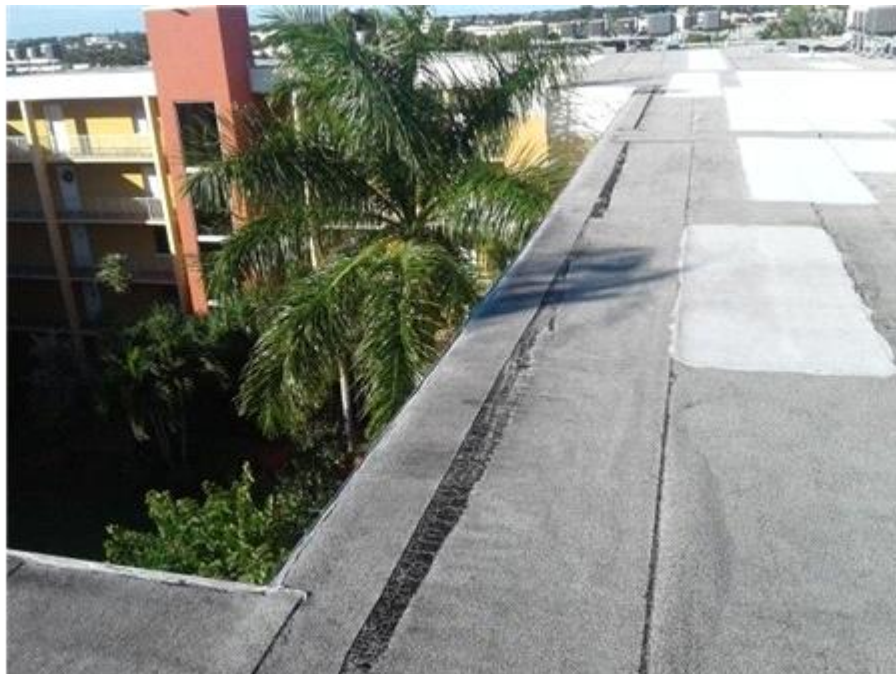
016F- The Towers - BUR - Roof Edge

Roof edge appears to be in fair condition.

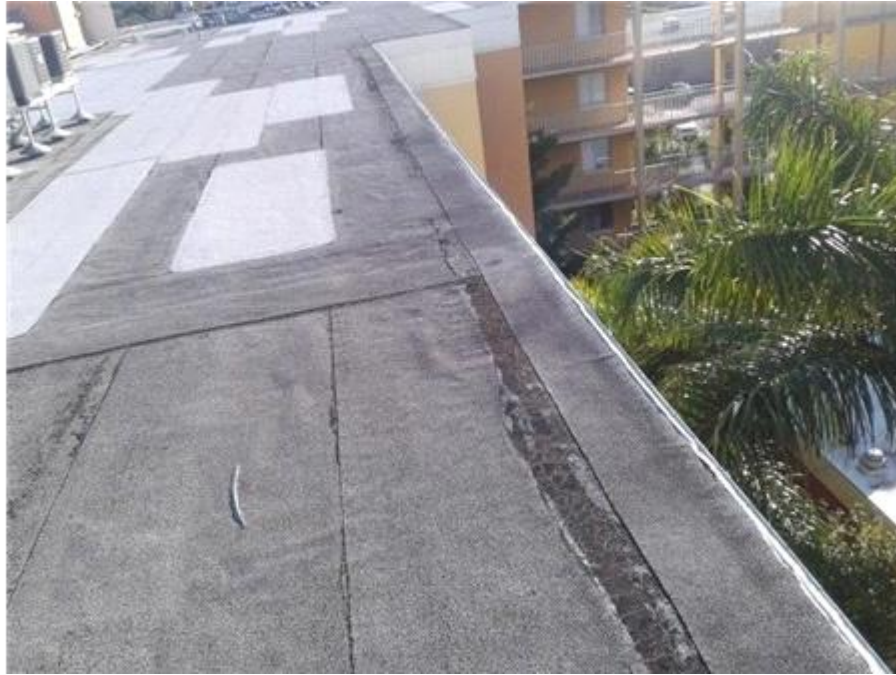
016F- The Towers - BUR - Roof Edge

Roof edge appears to be in fair condition.

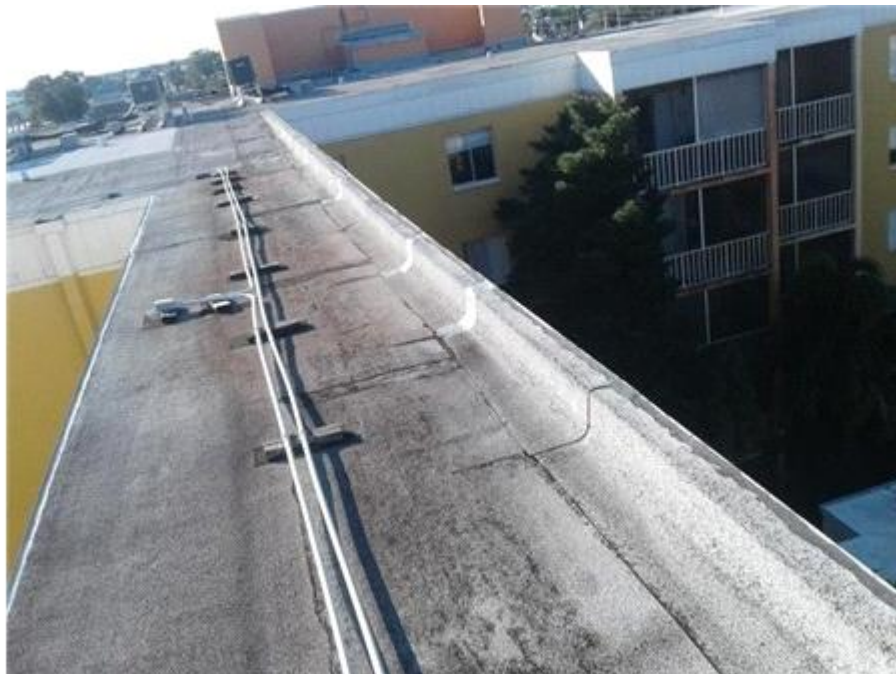
004F - The Towers - BUR - Base Flashings

The base flashings appear to be in fair condition.

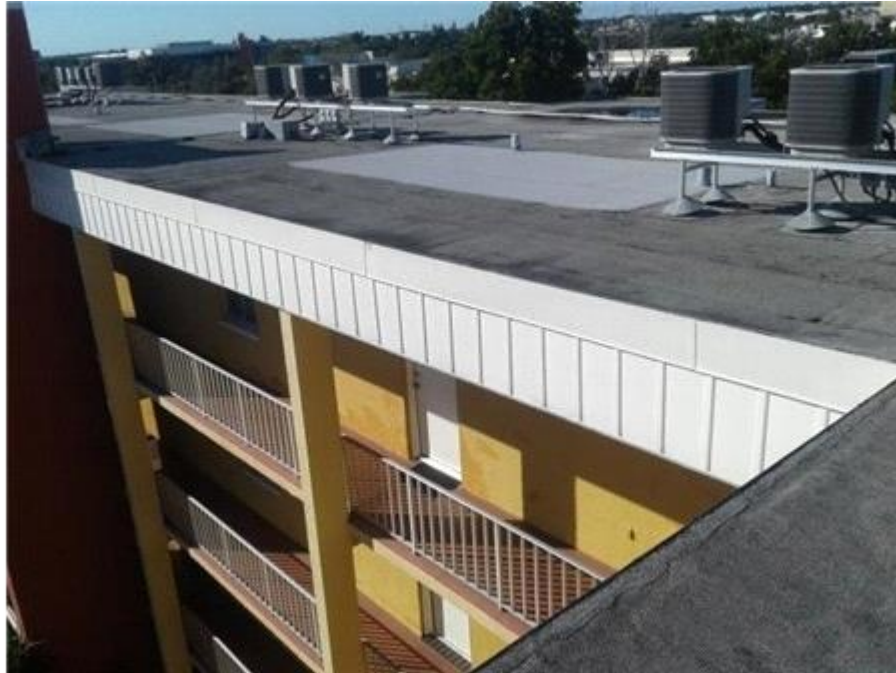
The Towers - BUR - Edge Metal/Fascia

Edge metal/fascia appears to be in good condition at this time.

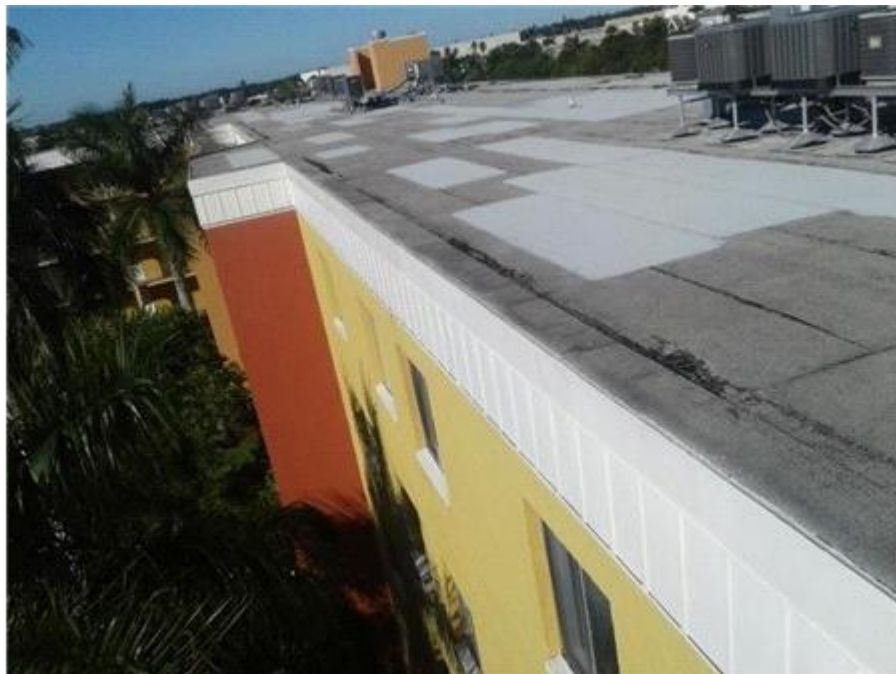
The Towers - BUR Edge Metal/Fascia

Edge metal/fascia appears to be in good condition at this time.

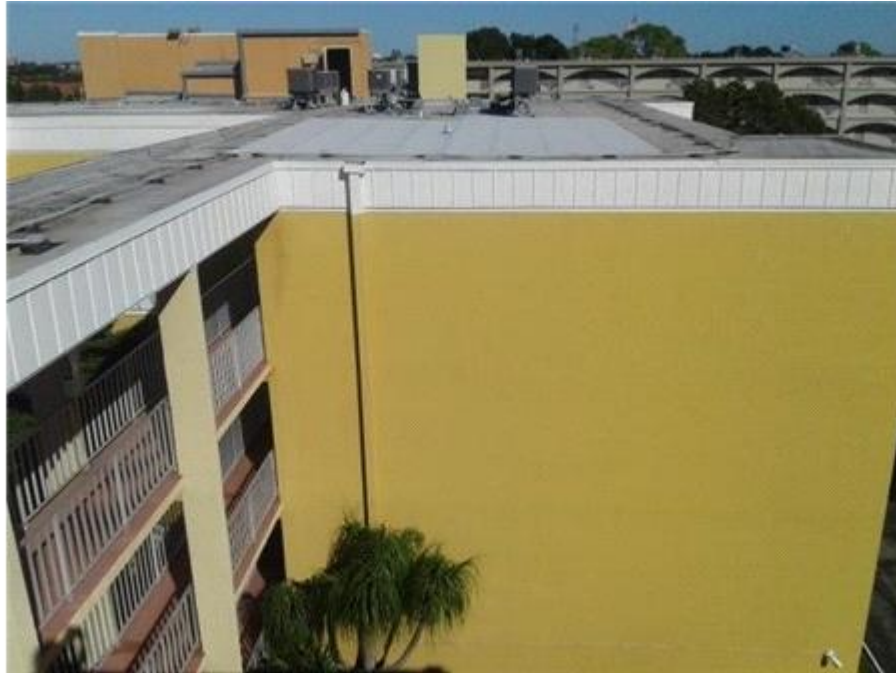
009G- The Towers - BUR - Downspouts

The downspouts appear to be in good condition.

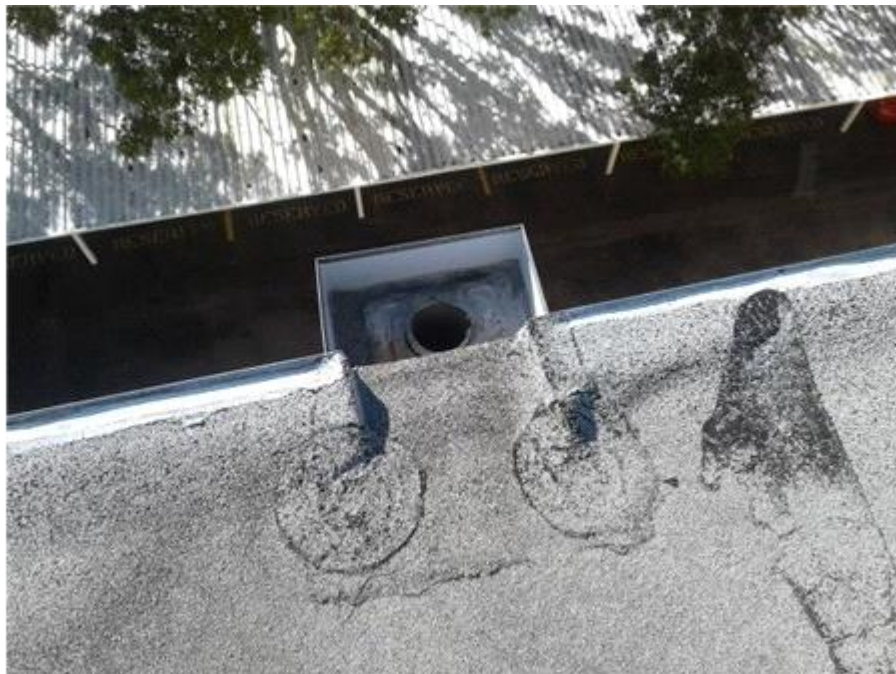
The Towers - BUR - Scupper Box

Scupper box appears to be in fair condition at this time.

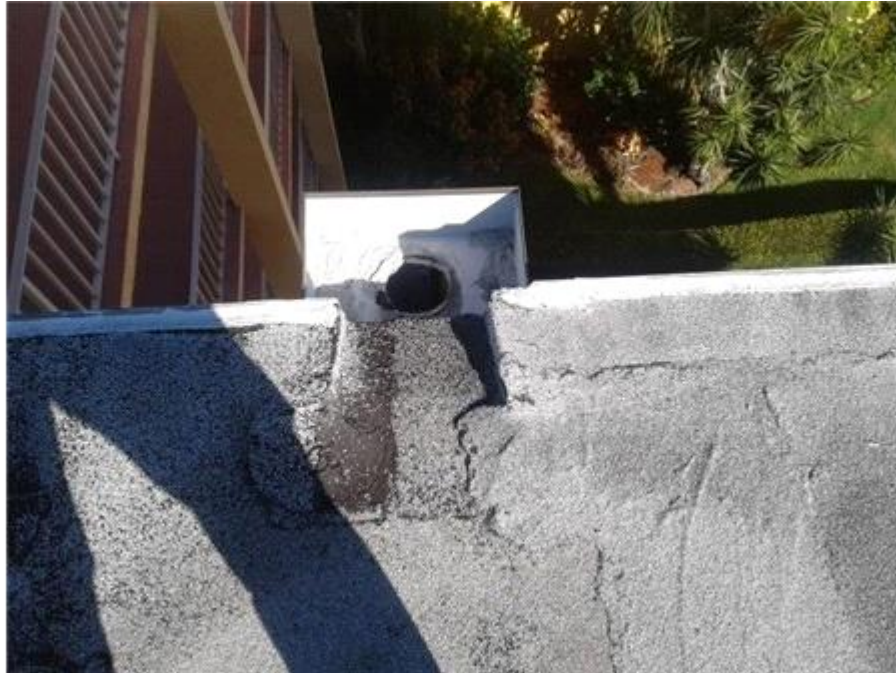
The Towers - BUR - Scupper Box

Scupper box appears to be in fair condition at this time.

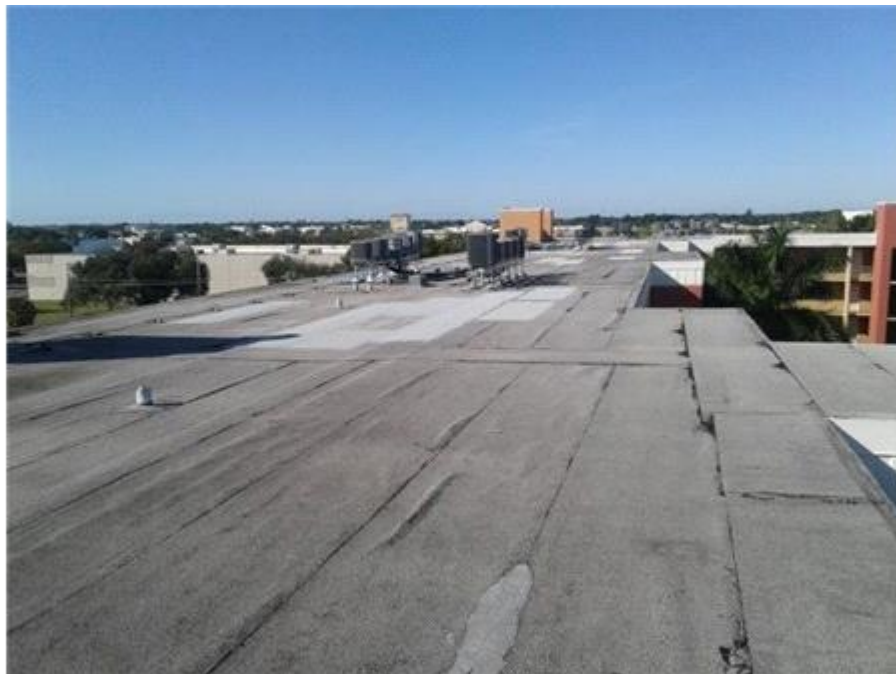
002F - The Towers - BUR - Appearance Overview

The appearance of the roof is in fair condition at this time.

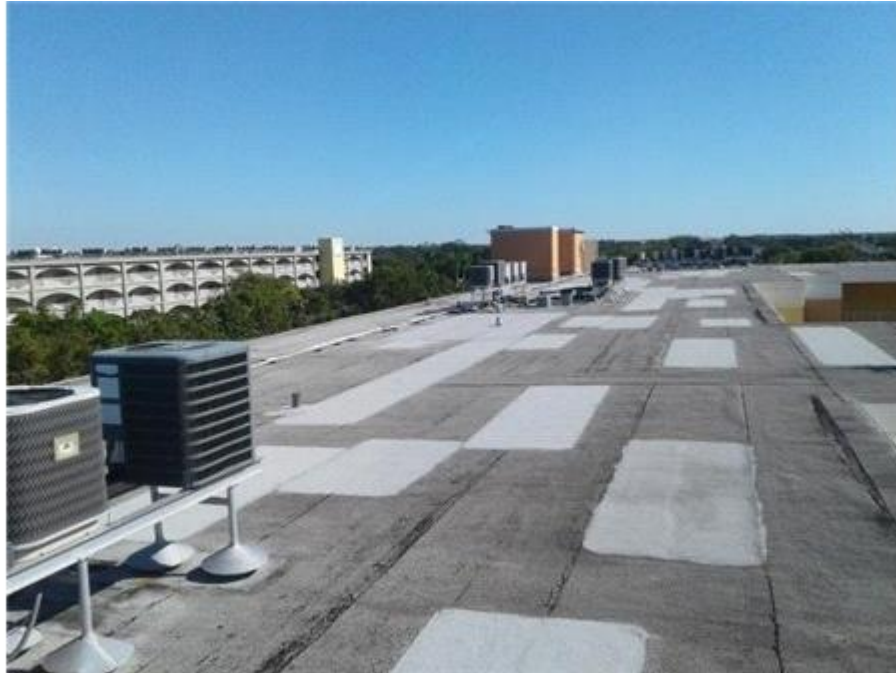
002F - The Towers - BUR - Appearance Overview

The appearance of the roof is in fair condition at this time.

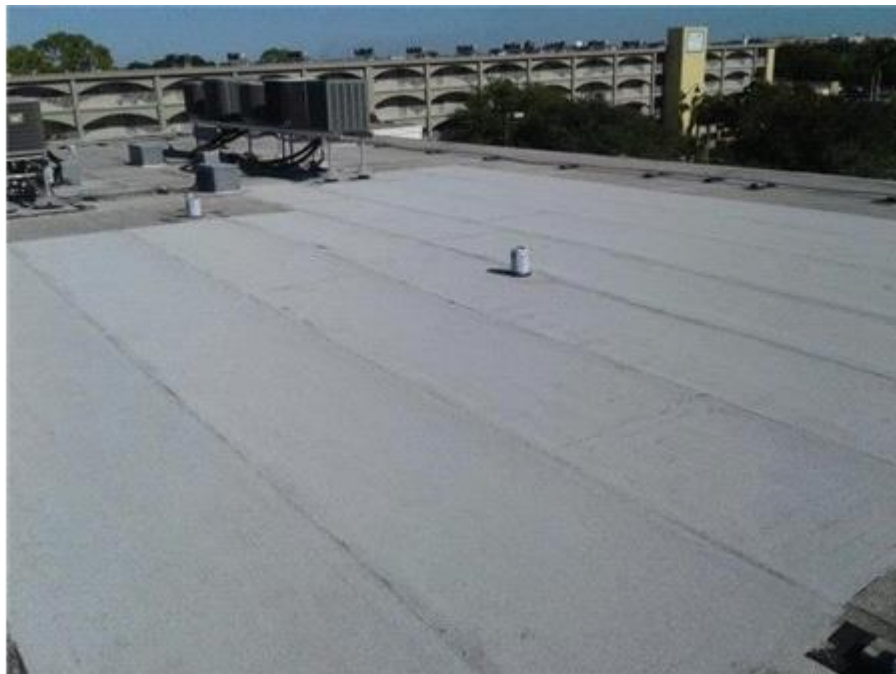
The Towers - BUR - Overlay

Overlay appears to be in good condition at this time.

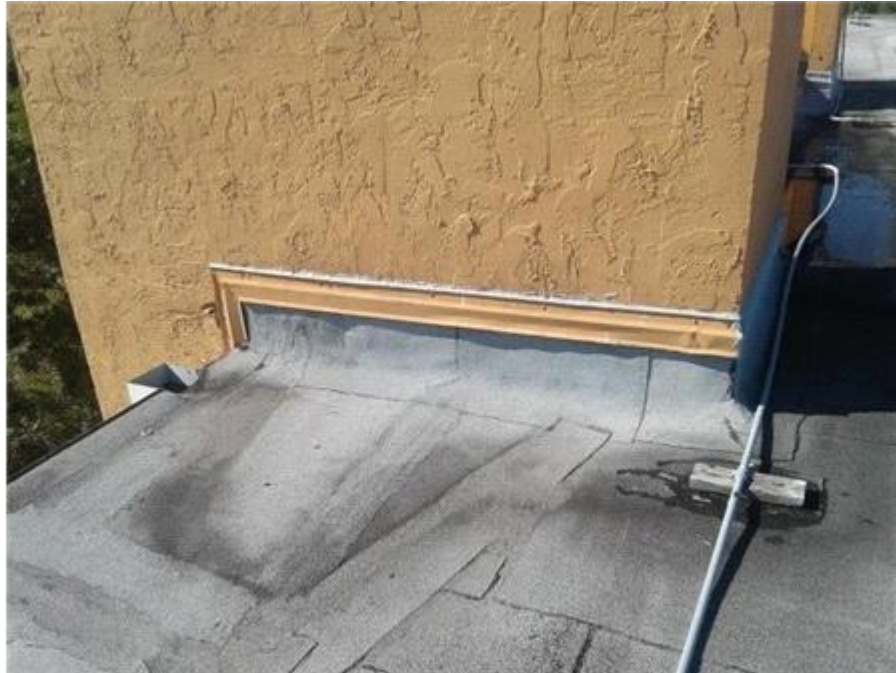
005F- The Towers - BUR - Counter Flashing

The counter flashing appears to be in fair condition.

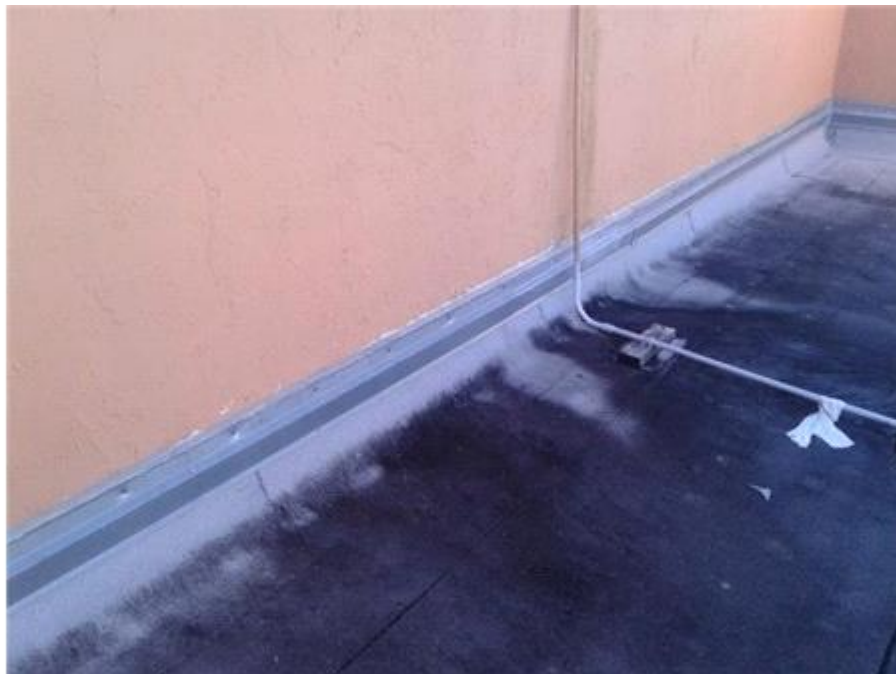
005G- The Towers - BUR - Counter Flashing

The counter flashing appears to be in good condition.

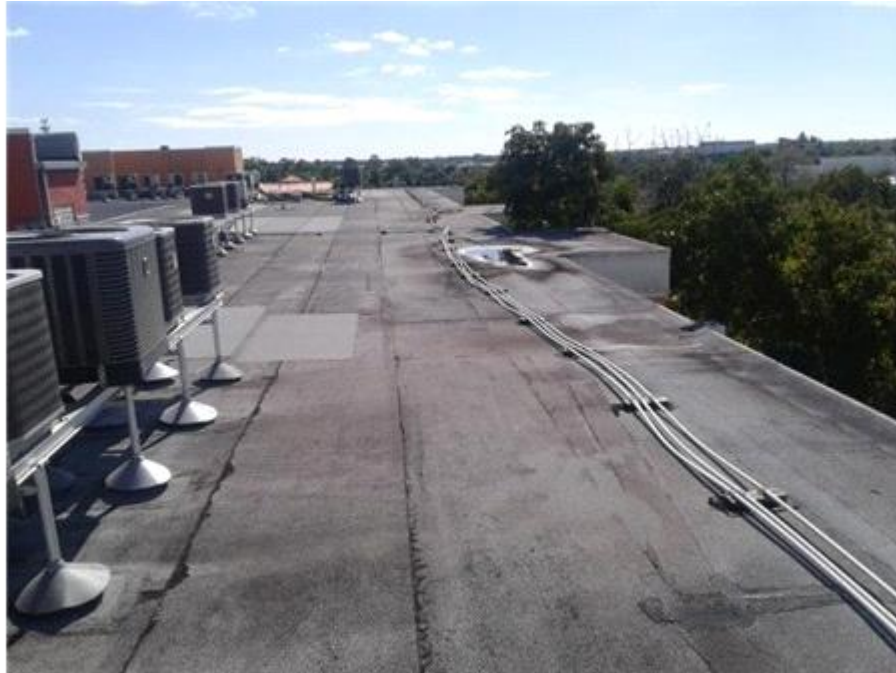
001F - The Towers - BUR - Surface Overview

The roof surface appears to be in fair condition at this time.

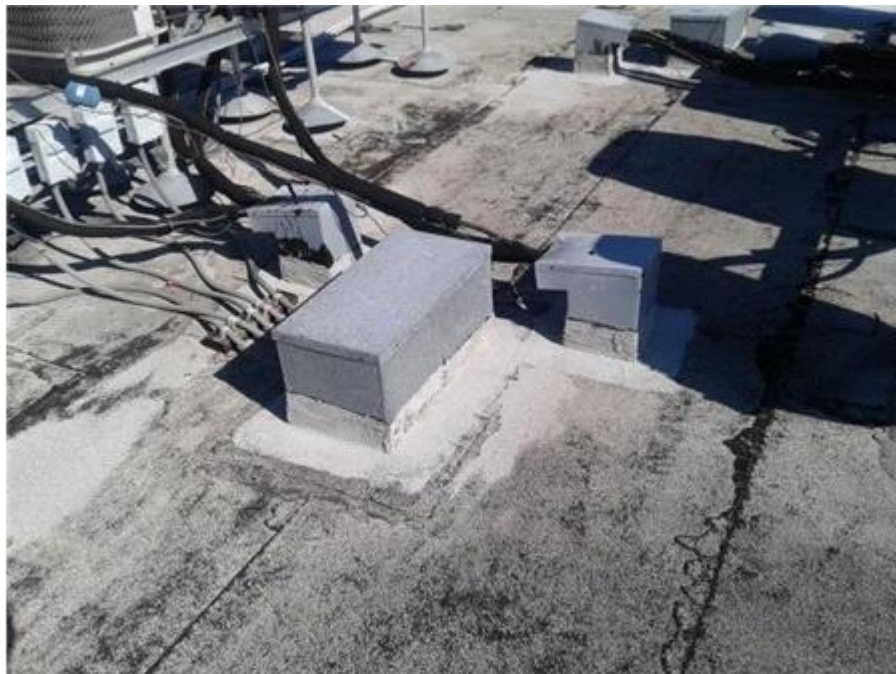
002F - The Towers - BUR - Appearance Overview

The appearance of the roof is in fair condition at this time.

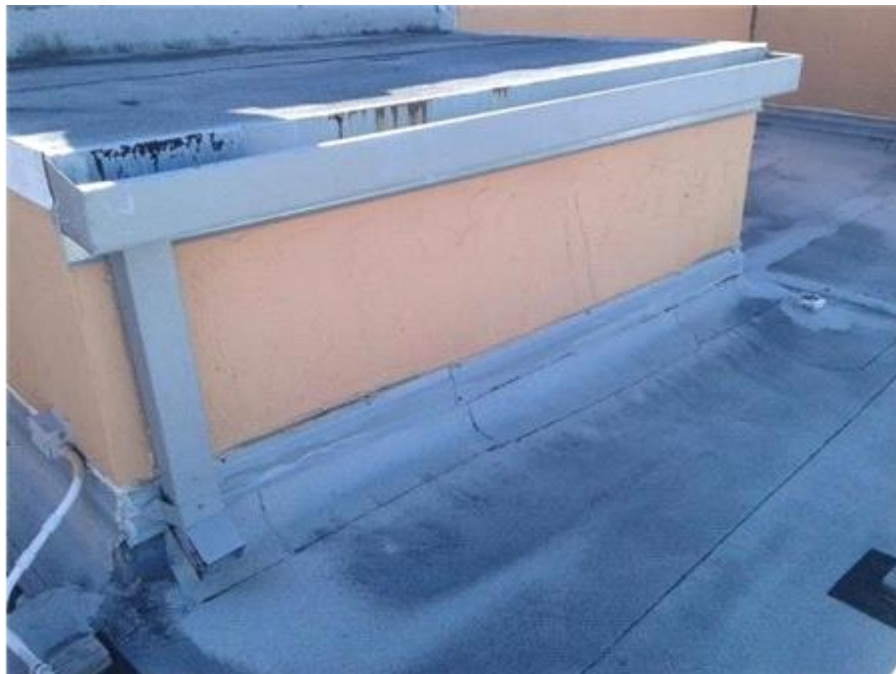
004F - The Towers - BUR - Base Flashings

The base flashings appear to be in fair condition.

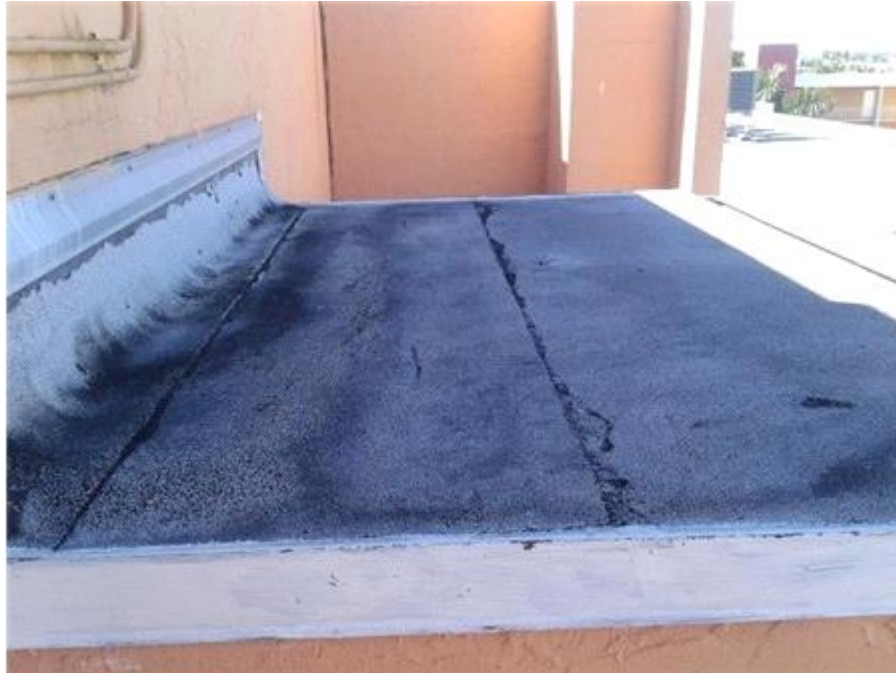
003F - The Towers - BUR - Membrane Overview

The roof membrane appears to be in fair condition at this time.

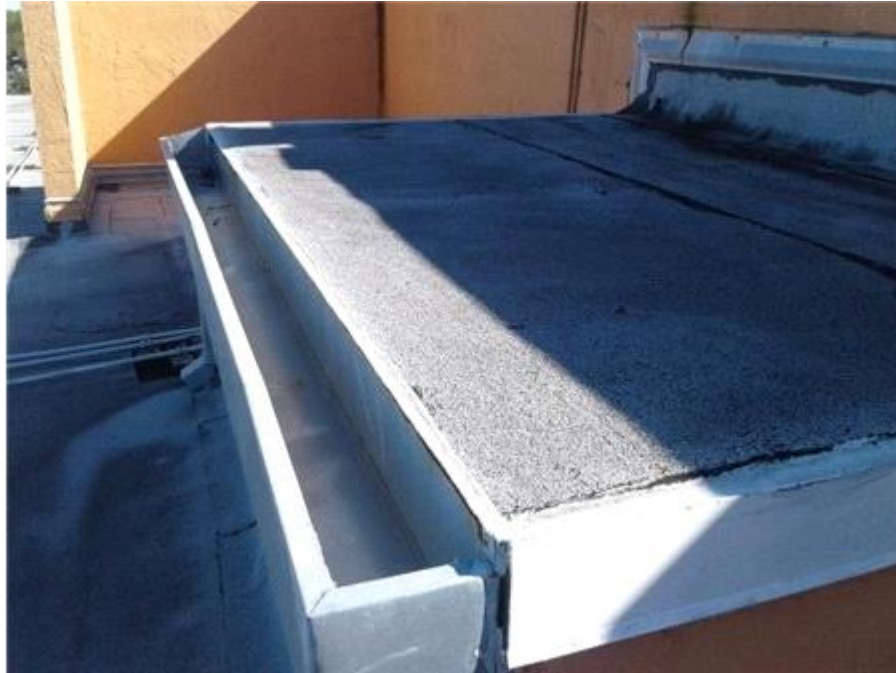
008F- The Towers - BUR - Gutters

The gutters appear to be in fair condition.

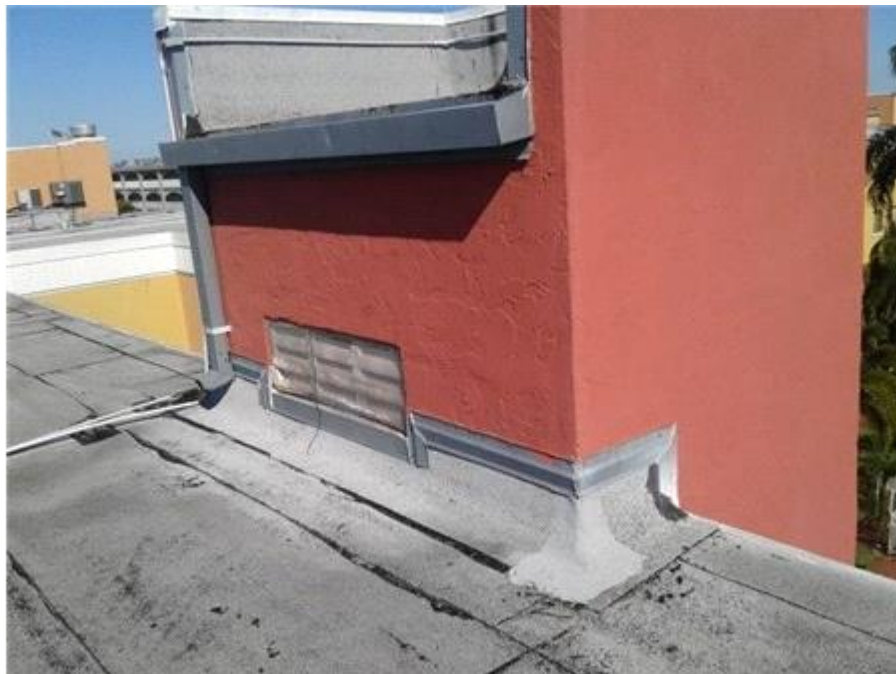
004F - The Towers - BUR - Base Flashings

The base flashings appear to be in fair condition.

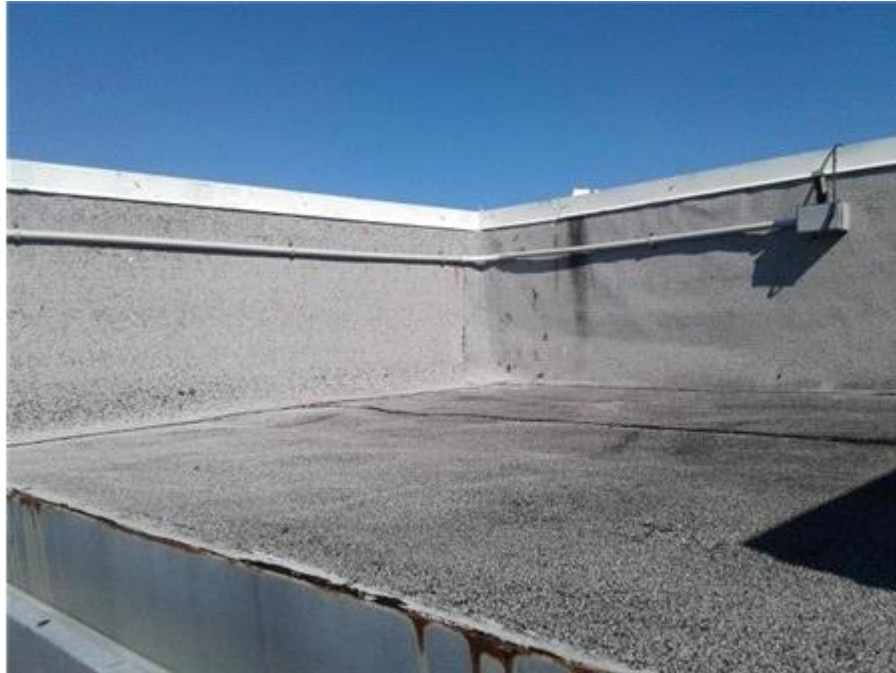
002F - The Towers - BUR - Appearance Overview

The appearance of the roof is in fair condition at this time.

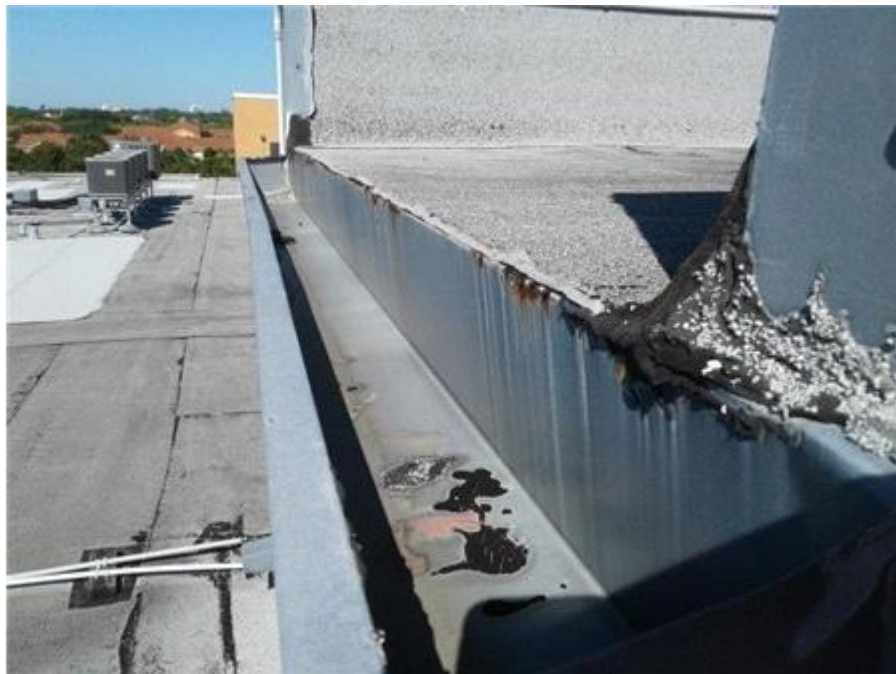
008F- The Towers - BUR - Gutters

The gutters appear to be in fair condition.

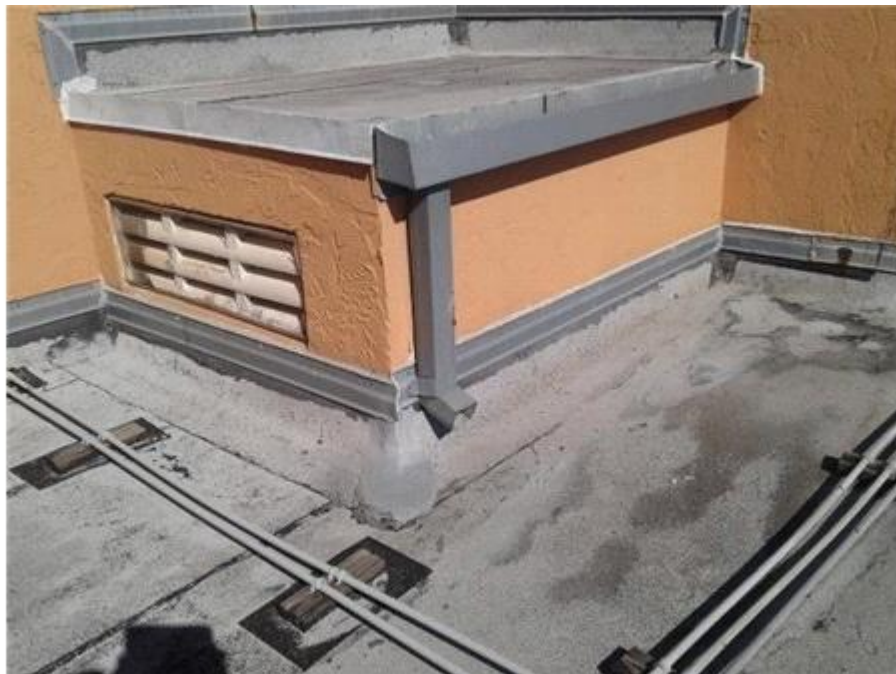
004F - The Towers - BUR - Base Flashings  
The base flashings appear to be in fair condition.

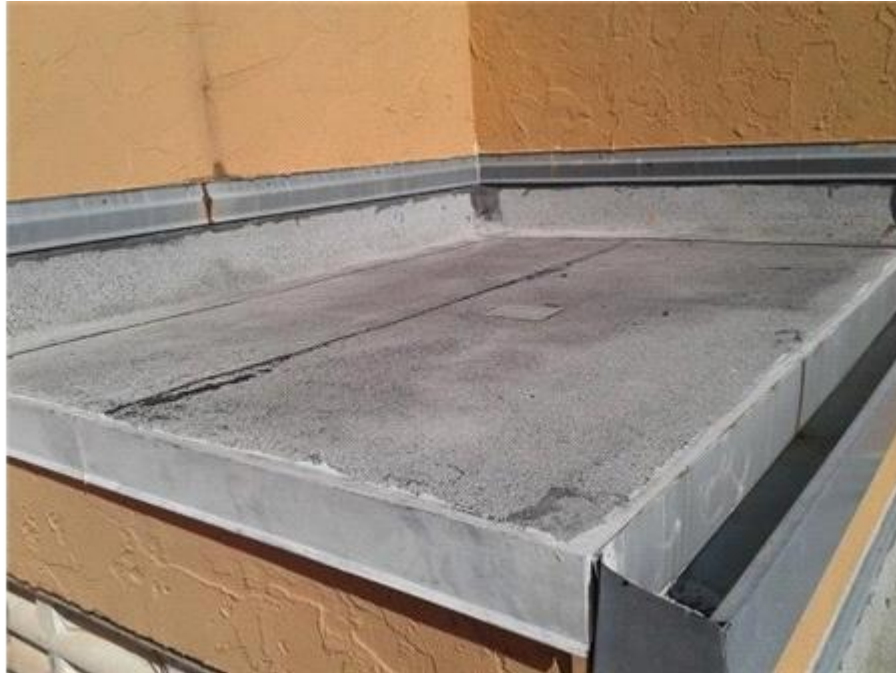
003F - The Towers - BUR - Membrane Overview

The roof membrane appears to be in fair condition at this time.
