# Inspection Report

**Facility:** Towers, The  
**Address:** 2366 East Mall Dr,  
Fort Myers, 33901

Work Order #: 6220

Re.: **Inspection Report (6 of 6) for The Towers**

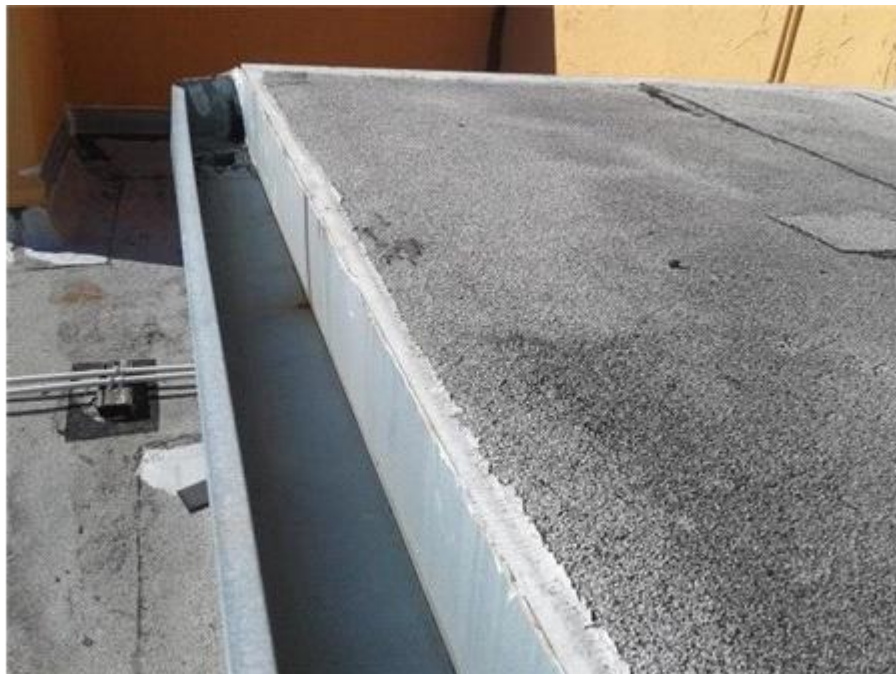
008F- The Towers - BUR - Gutters

The gutters appear to be in fair condition.

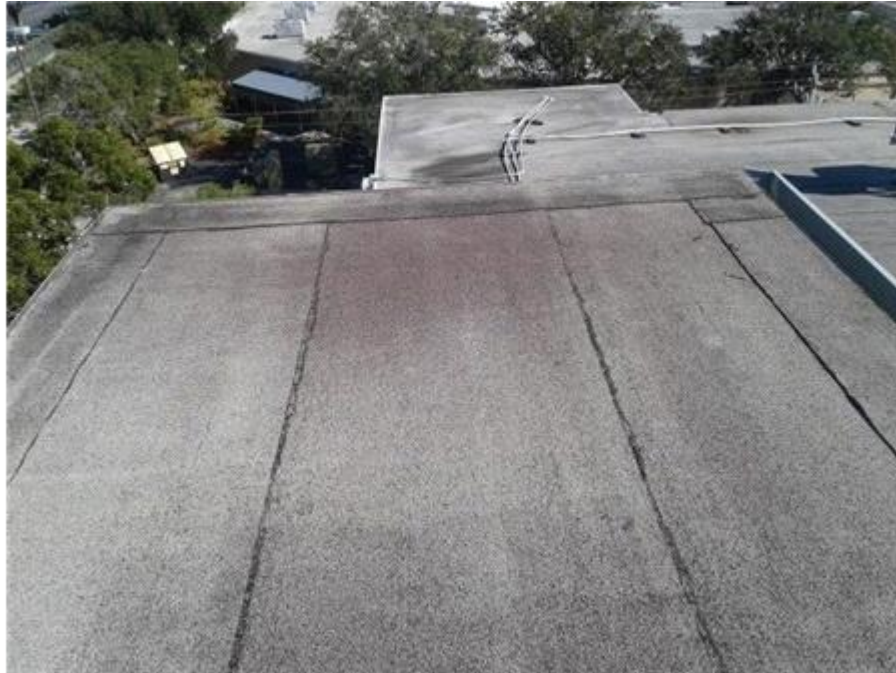
003F - The Towers - BUR - Membrane Overview-Stairwell Roof

The roof membrane appears to be in fair condition at this time.

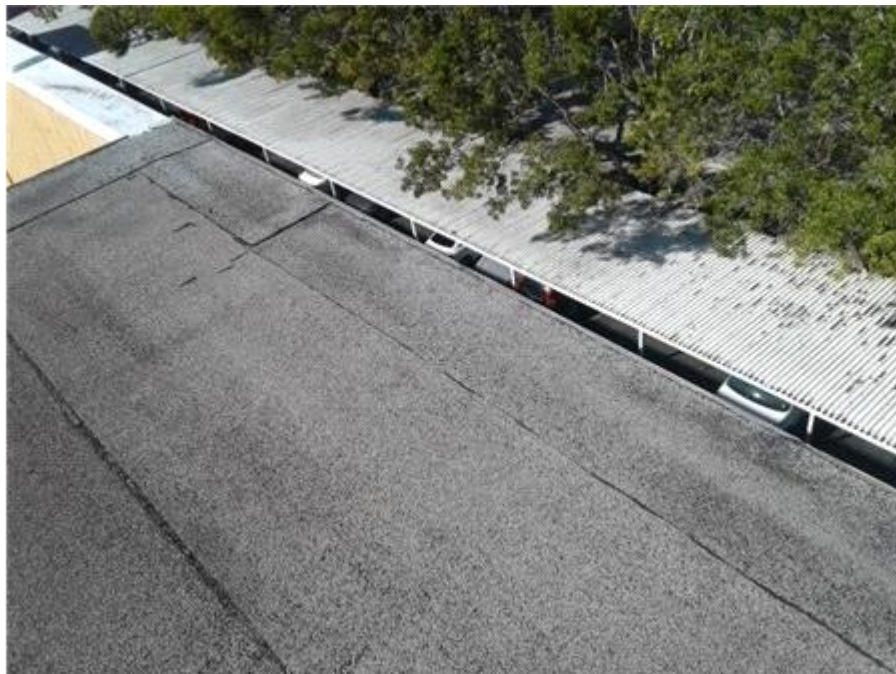
016F- The Towers - BUR - Roof Edge

Roof edge appears to be in fair condition.

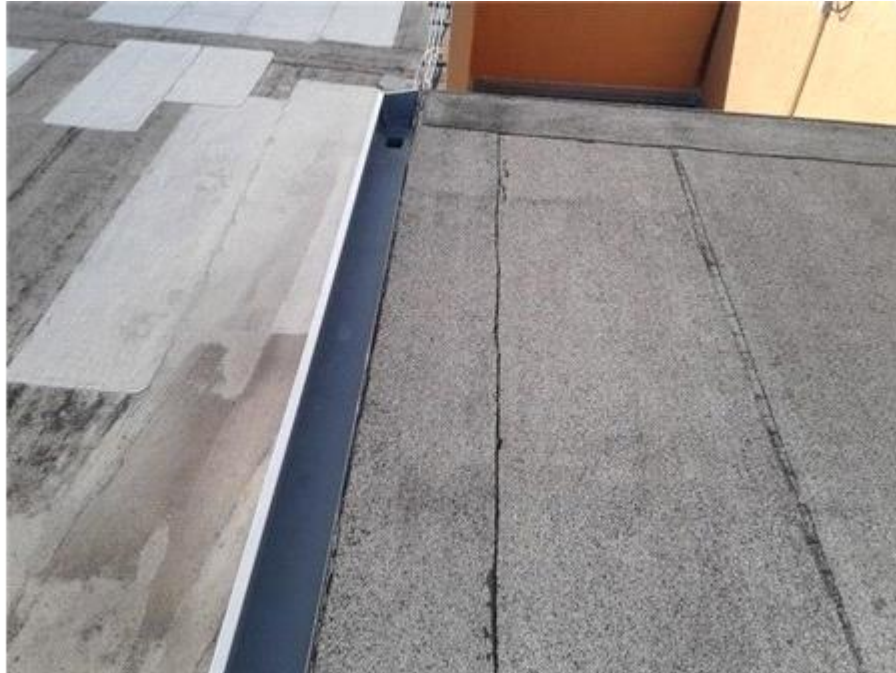
008F- The Towers - BUR - Gutters

The gutters appear to be in fair condition.

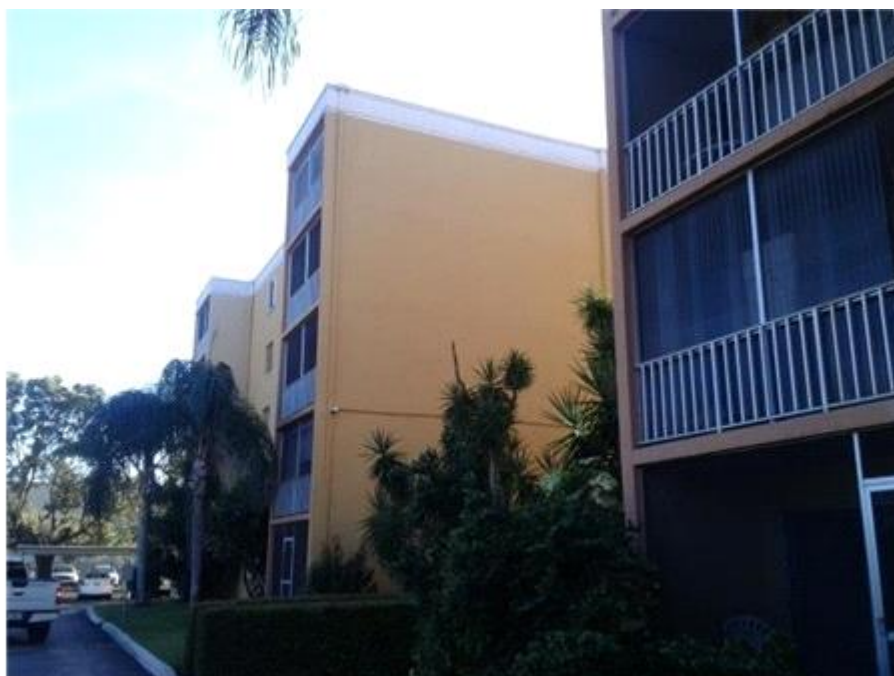
009G- The Towers - BUR - Downspouts

The downspouts appear to be in good condition.

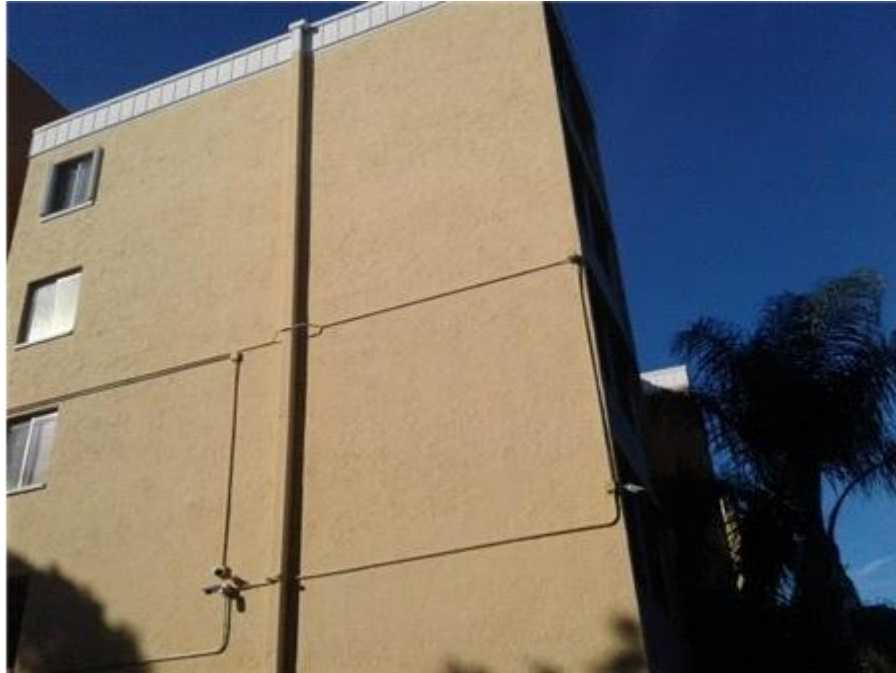
009G- The Towers - BUR - Downspouts

The downspouts appear to be in good condition.

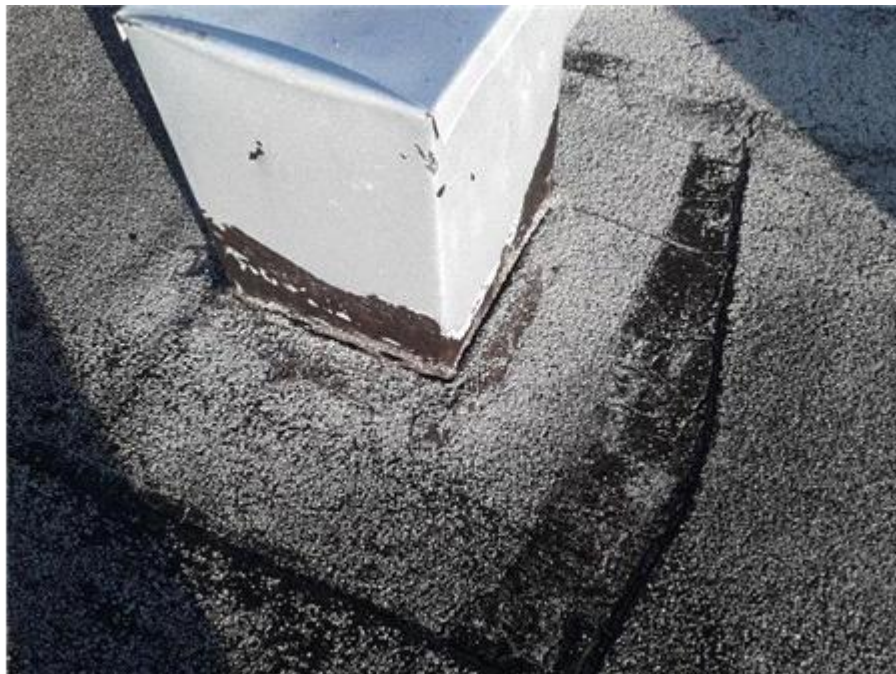
028- The Towers - BUR - Sealant Deterioration/Failure

Sealant should be removed and replaced to prevent water entry.

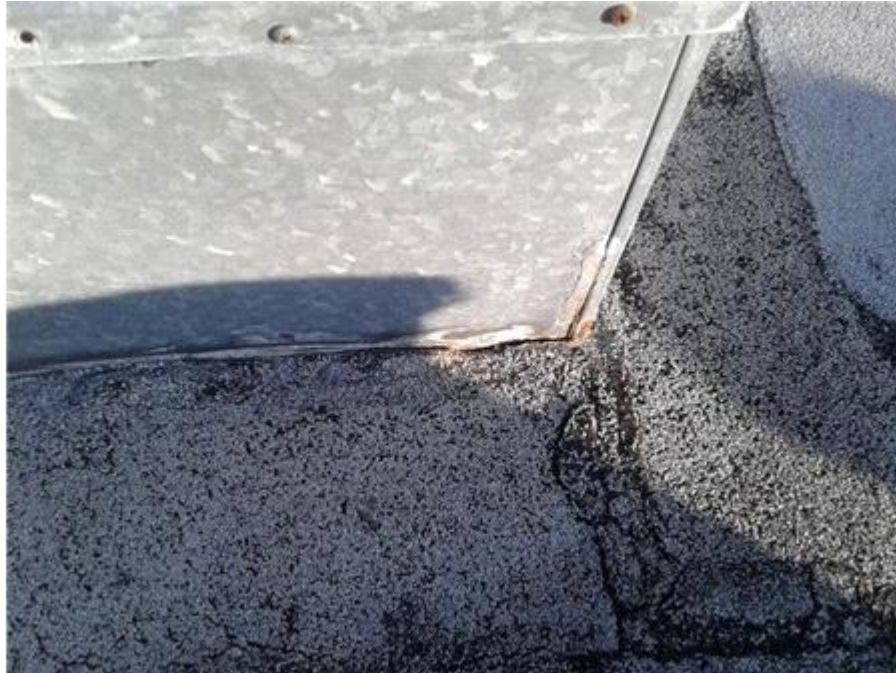
028- The Towers - BUR - Sealant Deterioration/Failure

Sealant should be removed and replaced to prevent water entry.

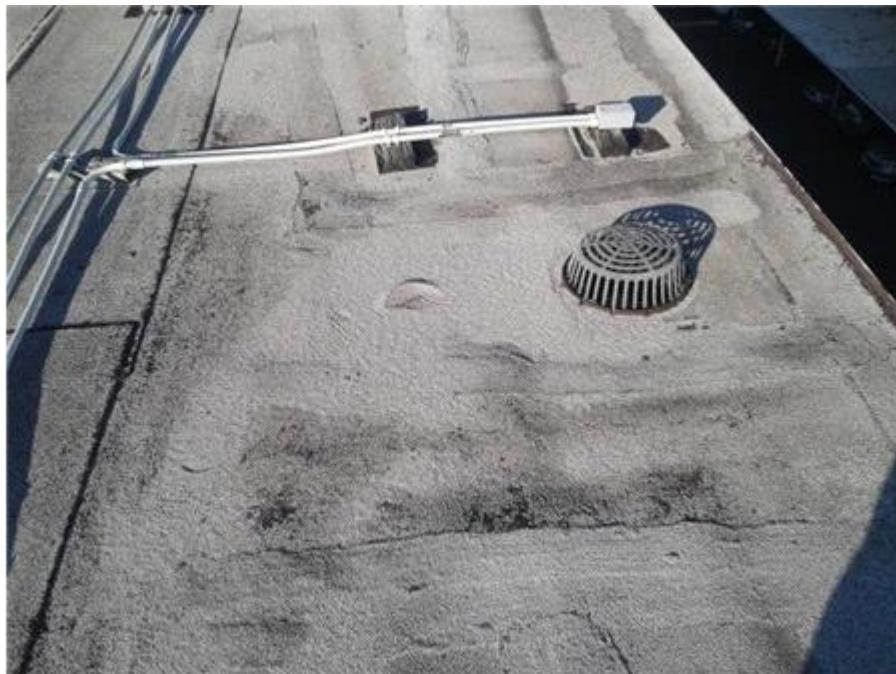
F-247- The Towers - BUR - Loose Granules

Identified loose granules on the roof surface.

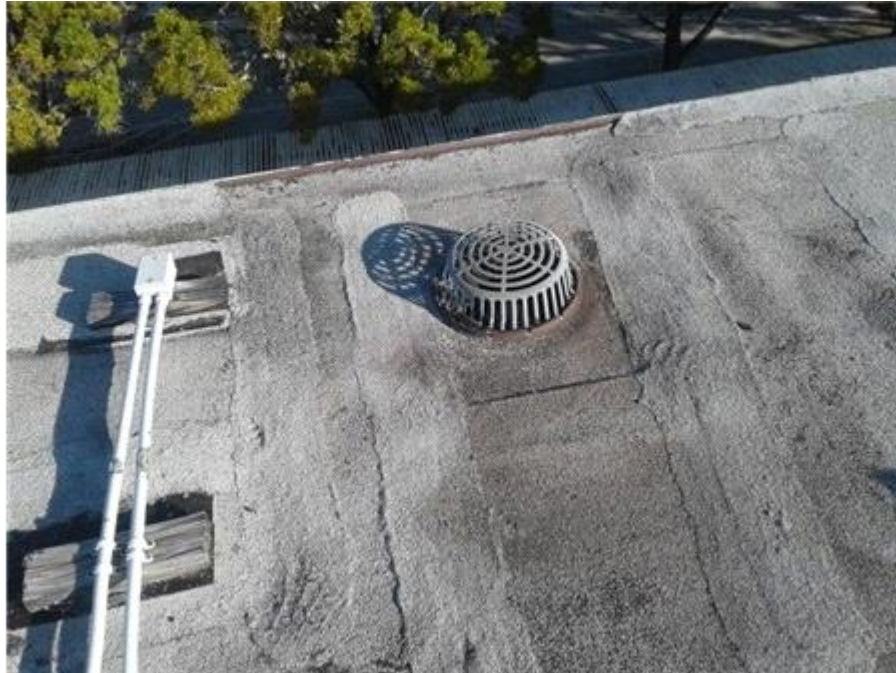
F-247R- The Towers - BUR - Loose Granules

Removed the loose granules from the roof surface, and disposed of properly.

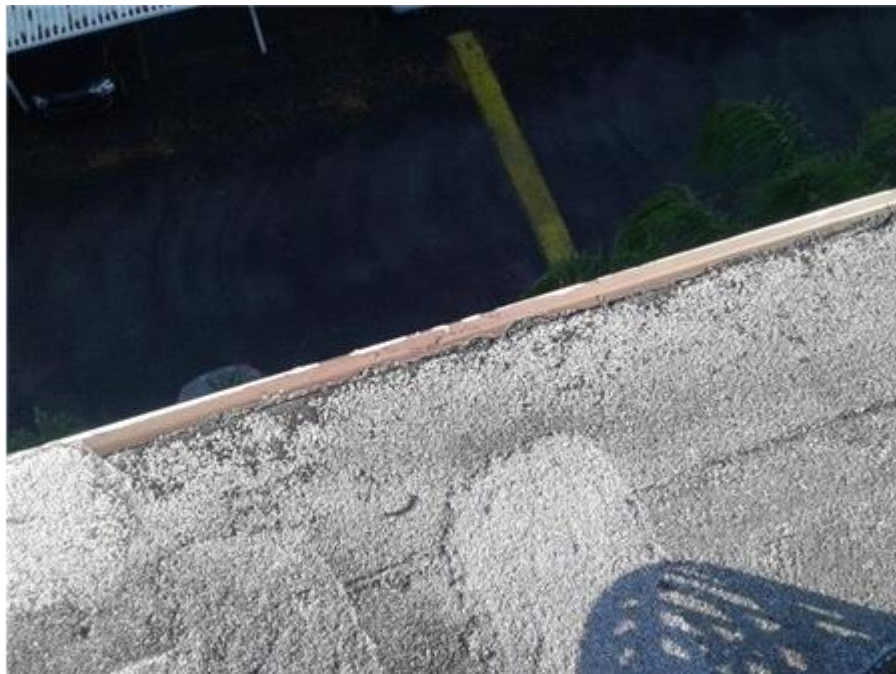
028- The Towers - BUR - Sealant Deterioration/Failure

Sealant should be removed and replaced to prevent water entry.

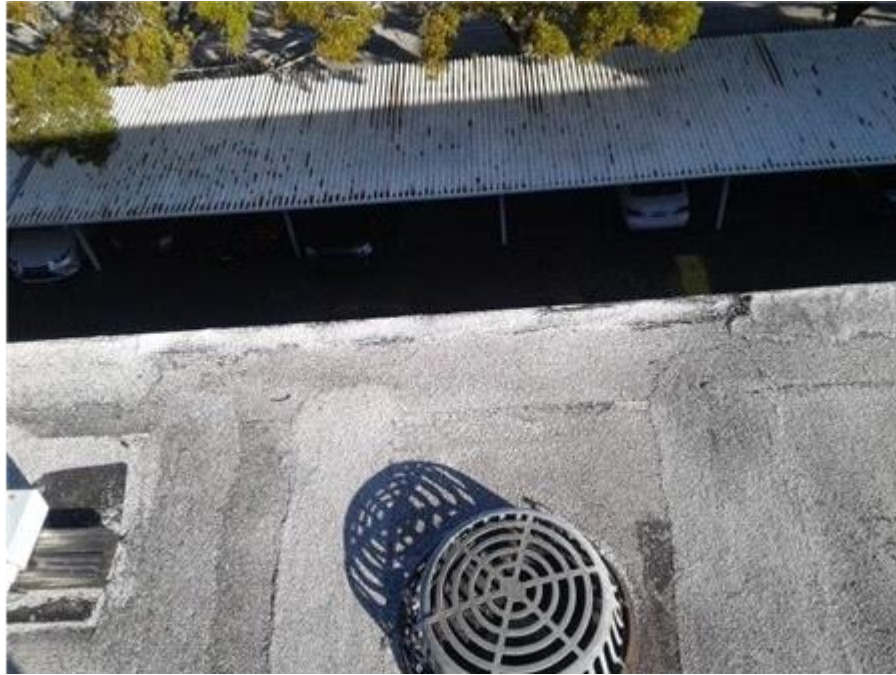
015- The Towers - BUR - Sealant Repair

Removed existing sealant and replaced with roof cement and granules.

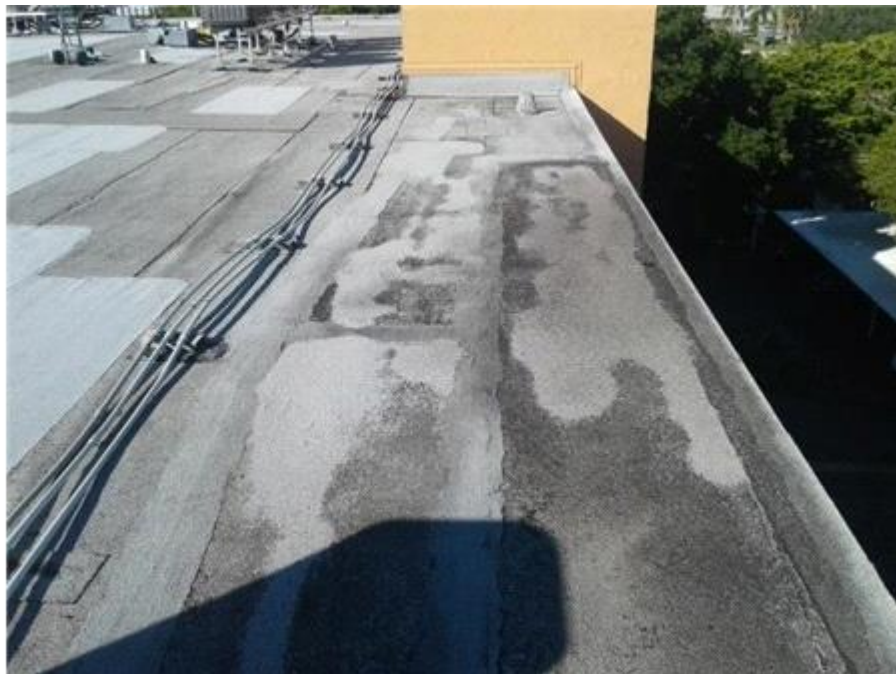
F-247- The Towers - BUR - Loose Granules

Identified loose granules on the roof surface.

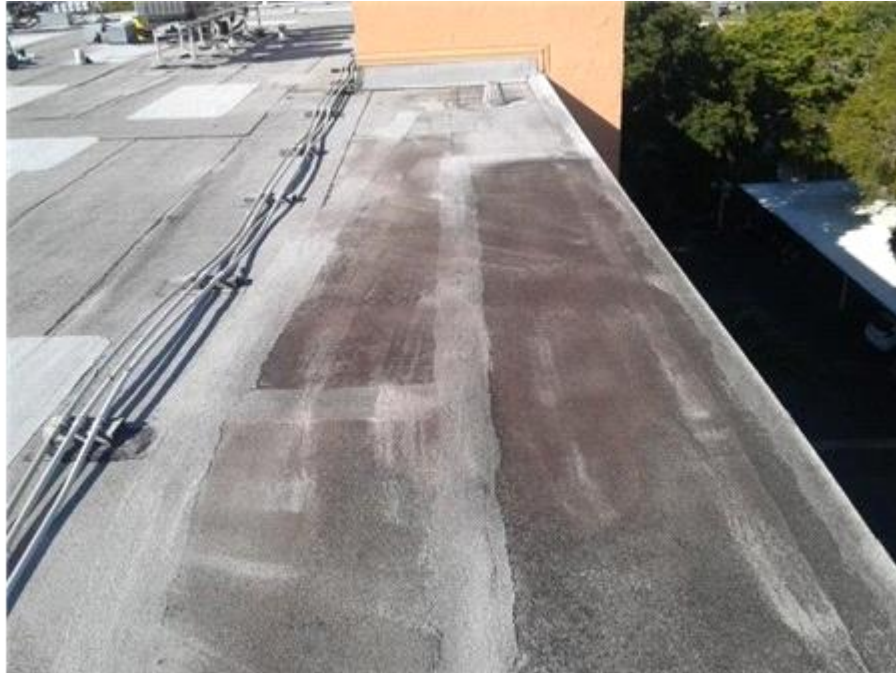
F-247R- The Towers - BUR - Loose Granules

Removed the loose granules from the roof surface, and disposed of properly.

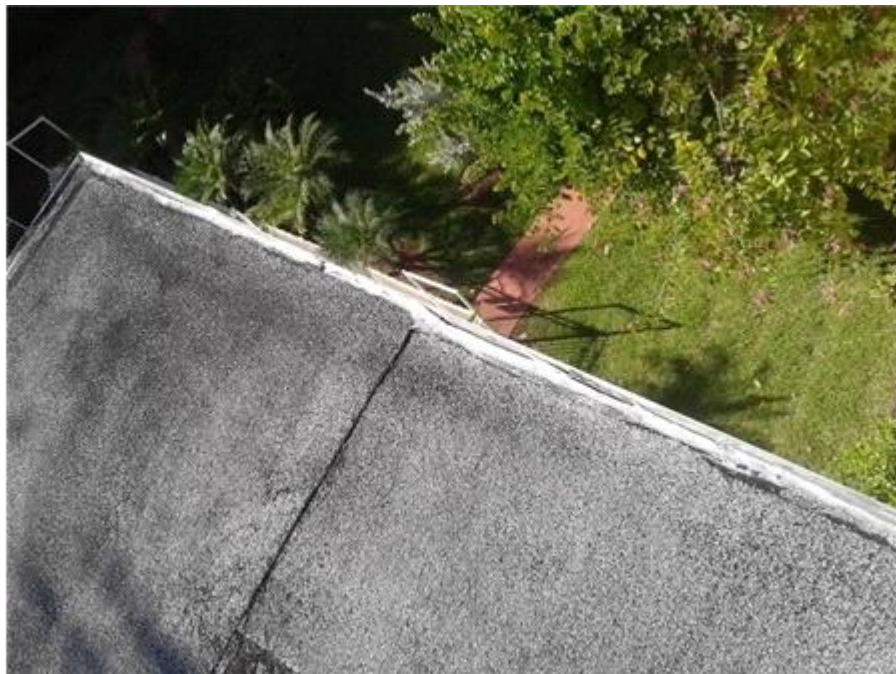
028- The Towers - BUR - Sealant Deterioration/Failure

Sealant should be removed and replaced to prevent water entry.

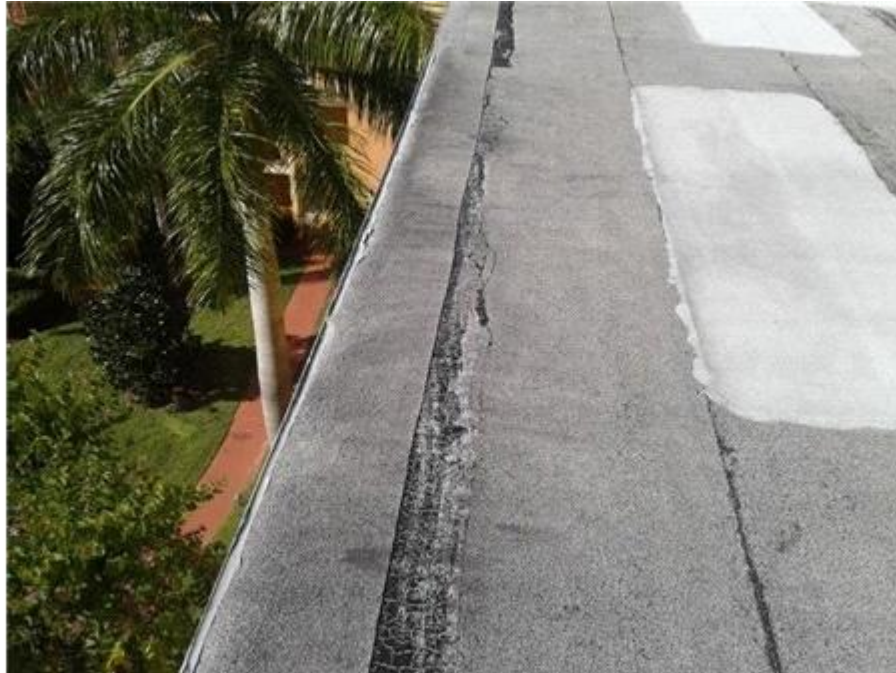
028- The Towers - BUR - Sealant Deterioration/Failure

Sealant should be removed and replaced to prevent water entry.

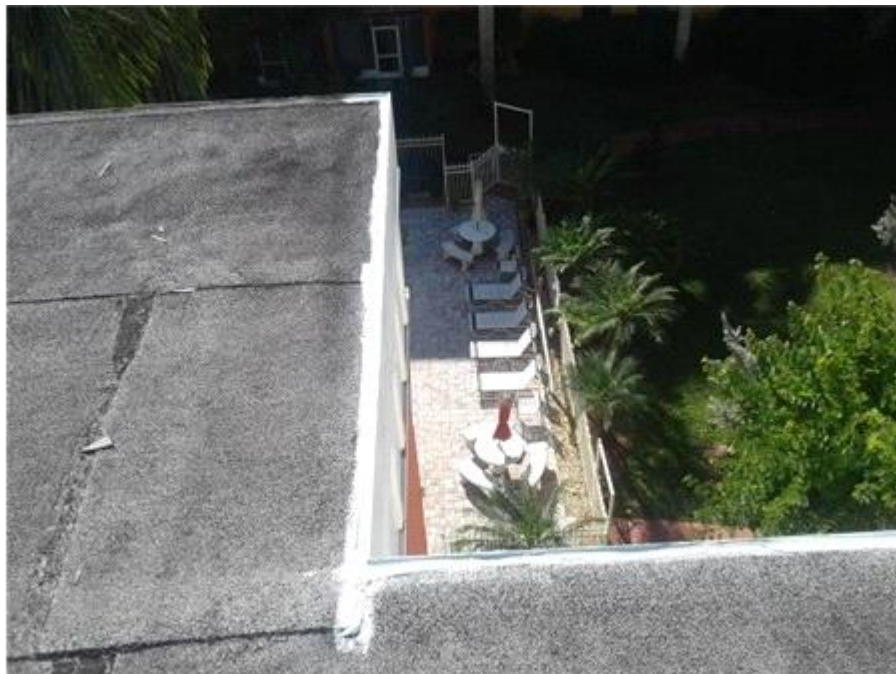
015- The Towers - BUR - Sealant Repair

Removed existing sealant and replaced with M1 sealant.

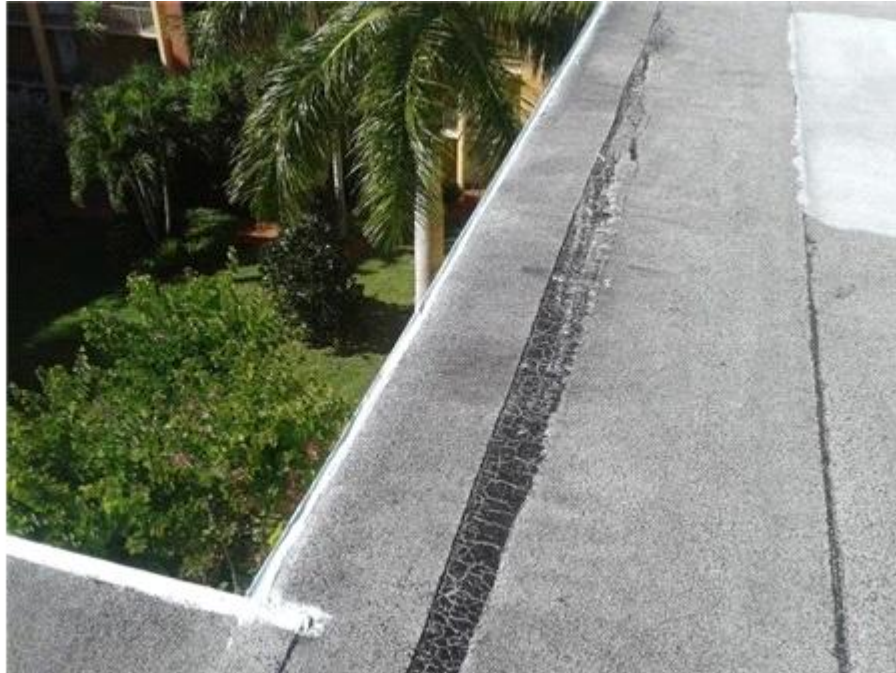
015- The Towers - BUR - Sealant Repair

Removed existing sealant and replaced with M1 sealant.

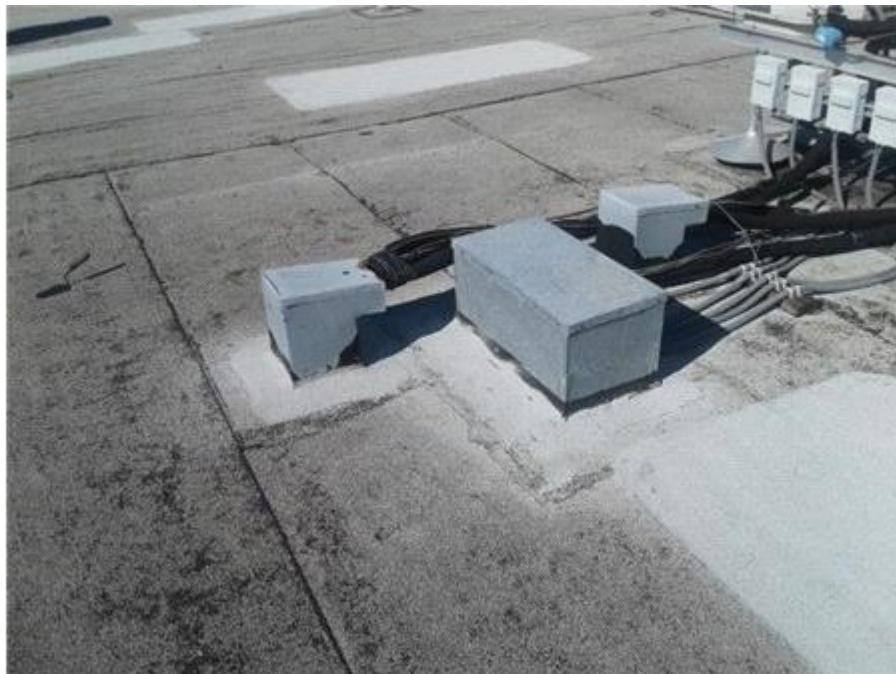
The Towers - BUR - Equipment Housing

Three coursed and granulated base of equipment housing.

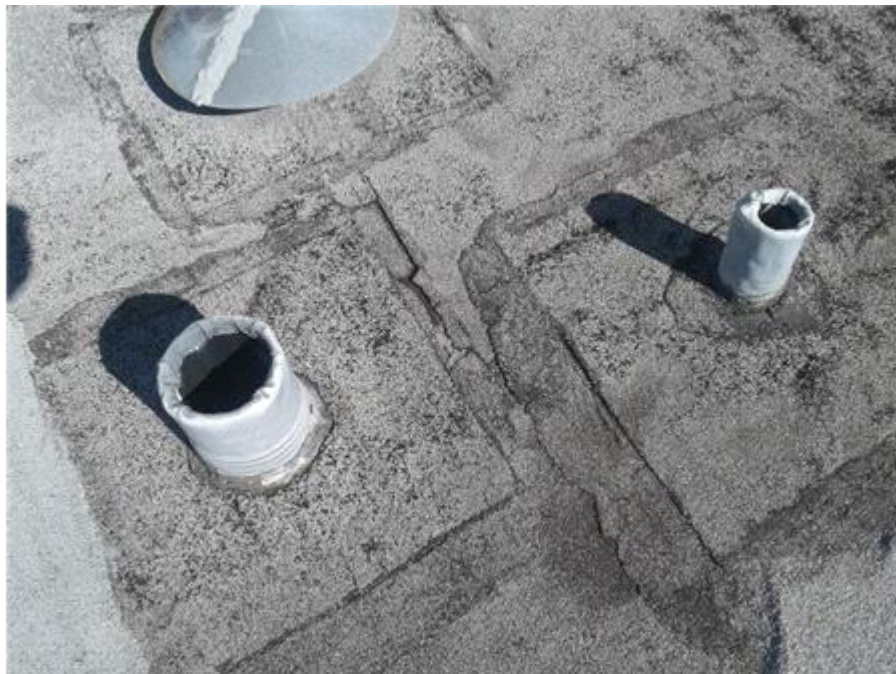
028- The Towers - BUR - Sealant Deterioration/Failure

Sealant should be removed and replaced to prevent water entry.

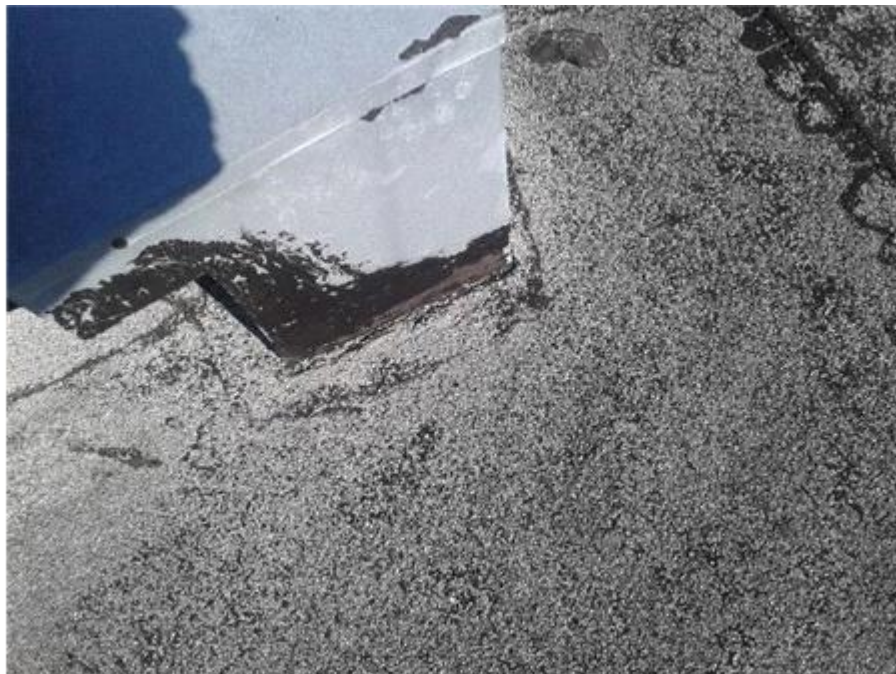
028- The Towers - BUR - Sealant Deterioration/Failure

Sealant should be removed and replaced to prevent water entry.

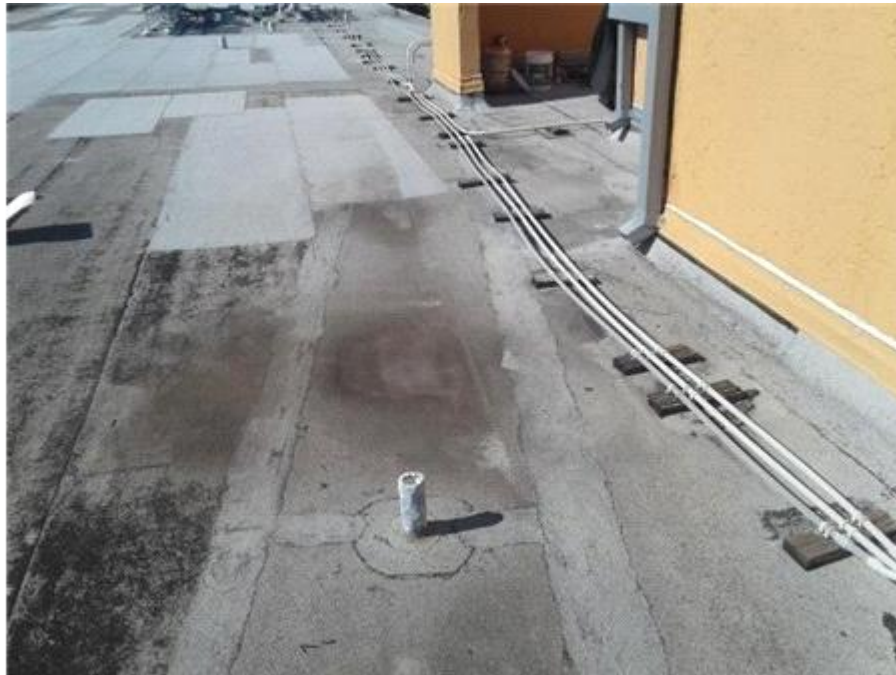
F-247R- The Towers - BUR - Loose Granules

Removed the loose granules from the roof surface, and disposed of properly.

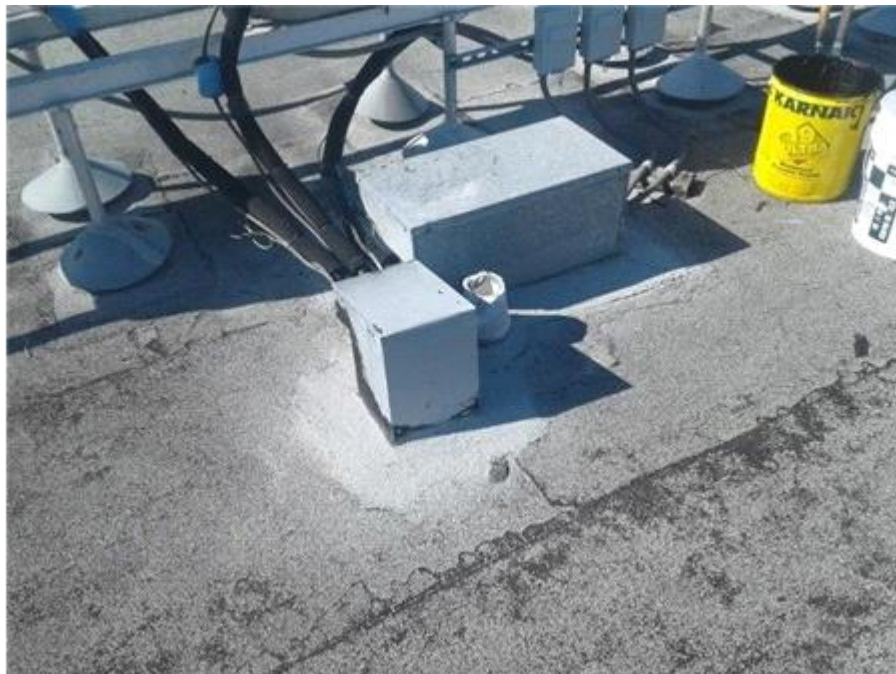
The Towers - BUR - Equipment Housing

Three coursed and granulated base of equipment housing and lead boot.

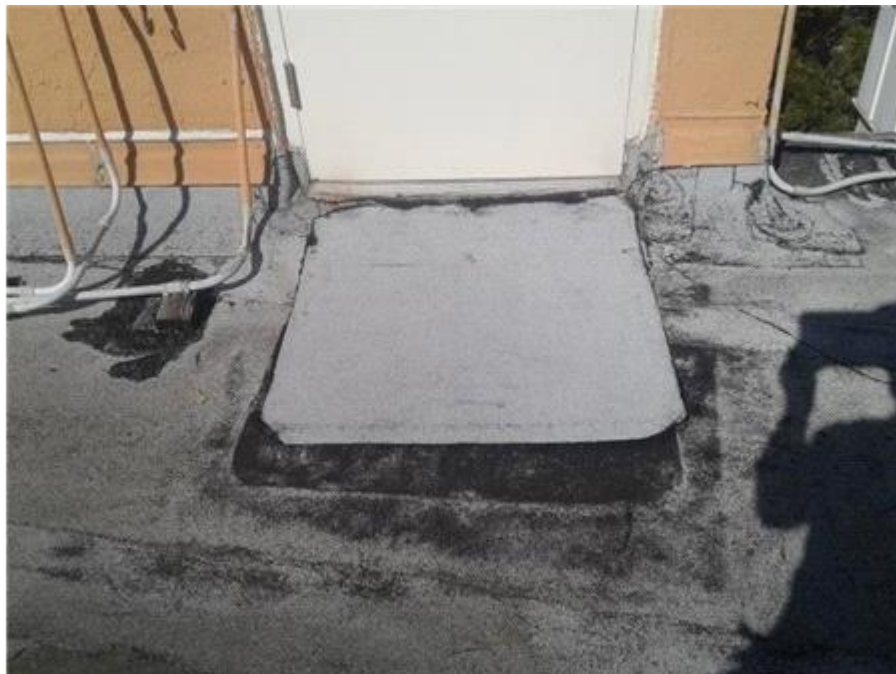
The Towers - BUR - Field Walkway

Installed 3'x3' T/G target to support existing walkpad.

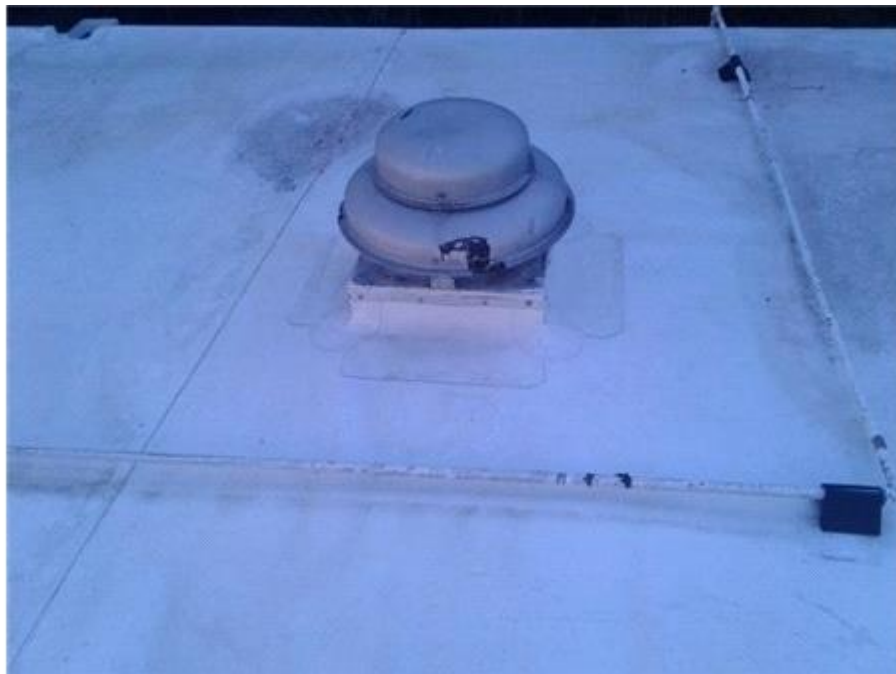
004G - TPO Roof - Base Flashings

The base flashings appear to be in good condition.

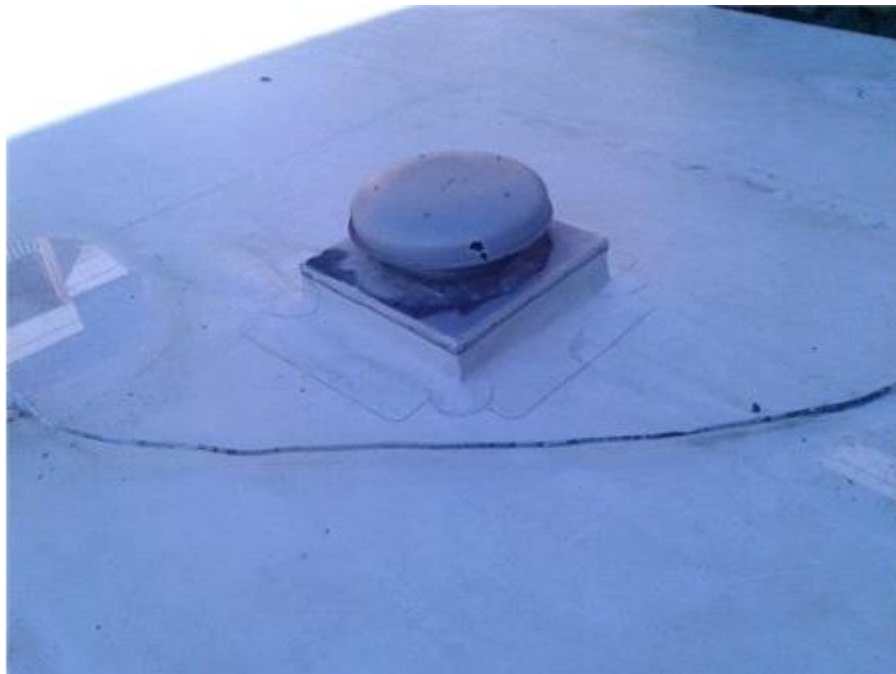
004G - TPO Roof - Base Flashings

The base flashings appear to be in good condition.

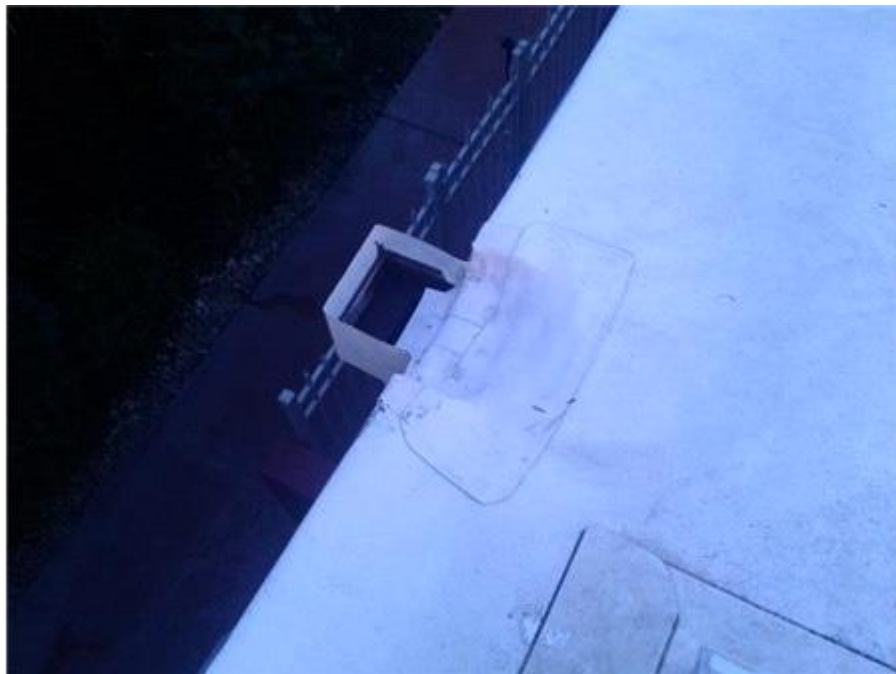
TPO Roof - Scuppers

Scuppers appear to be in good condition at this time.

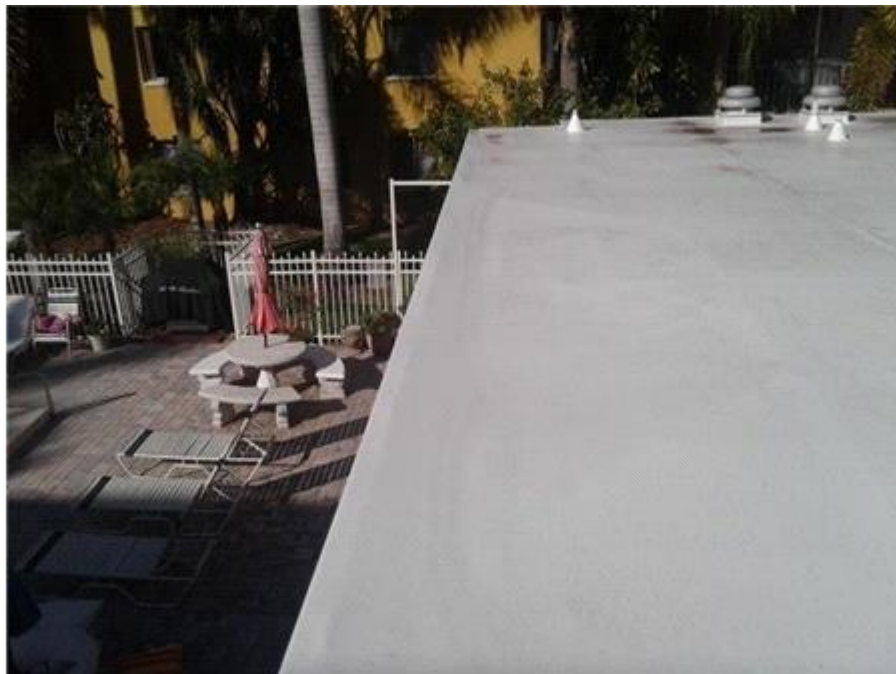
016G- TPO Roof - Roof Edge

Roof edge appears to be in good condition.

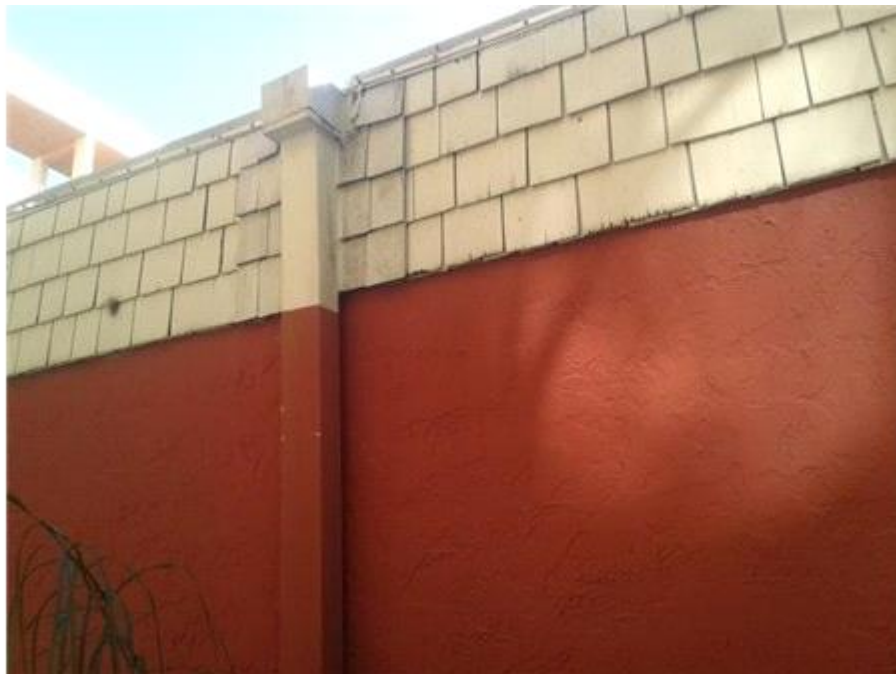
009G- TPO Roof - Downspouts

The downspouts appear to be in good condition.

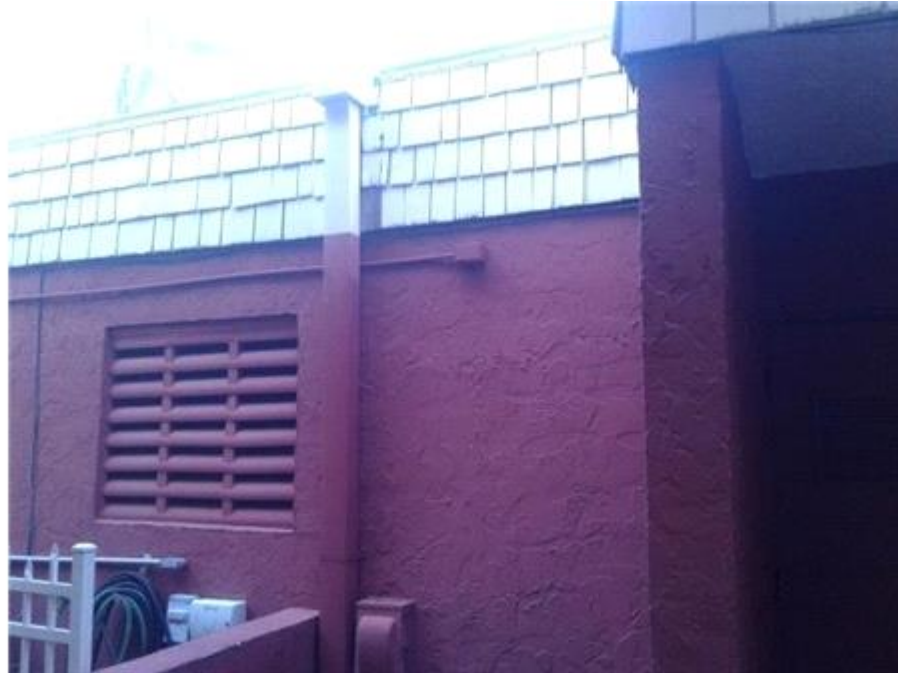
009G- TPO Roof - Downspouts

The downspouts appear to be in good condition.

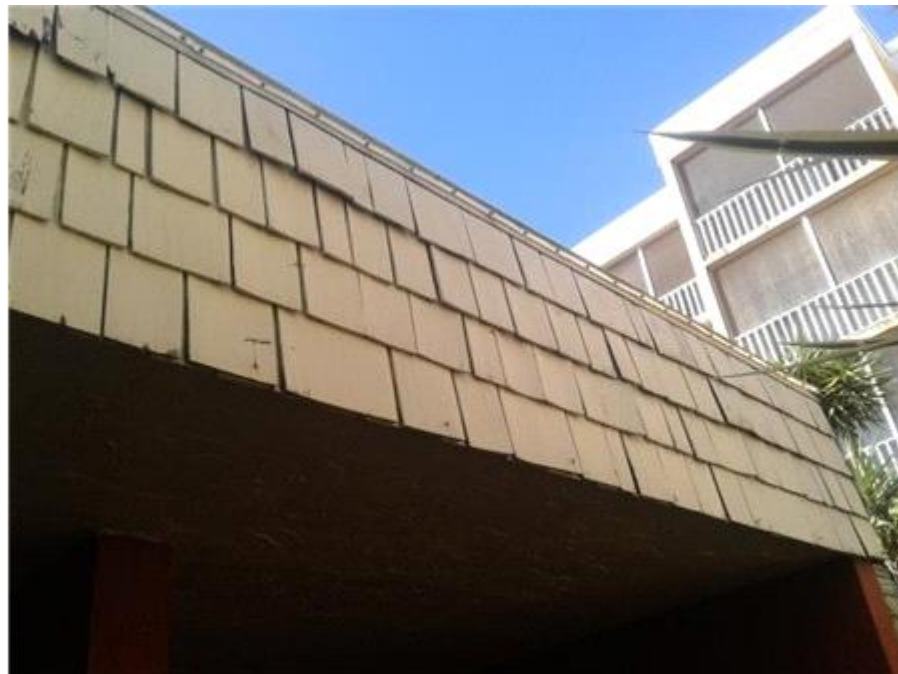
TPO Roof - T-Bar

T-Bar appears to be in good condition at this time.
