# Inspection Report

**Facility:** Towers, The  
**Address:** 2366 East Mall Dr,  
Fort Myers, 33901

Work Order #: 5715

Re.: **Inspection Report (5 of 6) for The Towers**

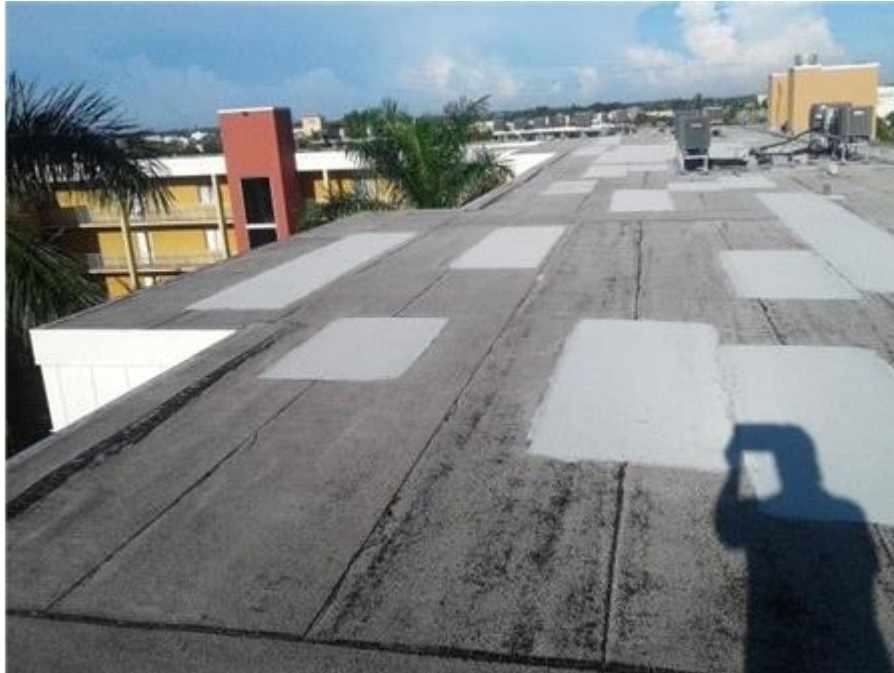
Membrane Overview

The roof membrane appears to be in fair condition at this time.

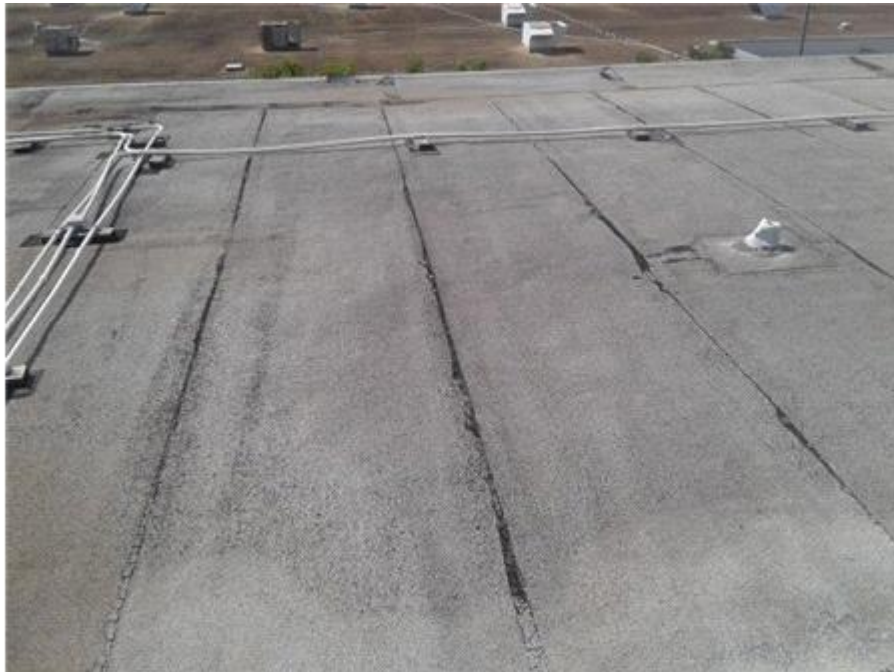
Membrane Overview

The roof membrane appears to be in fair condition at this time.

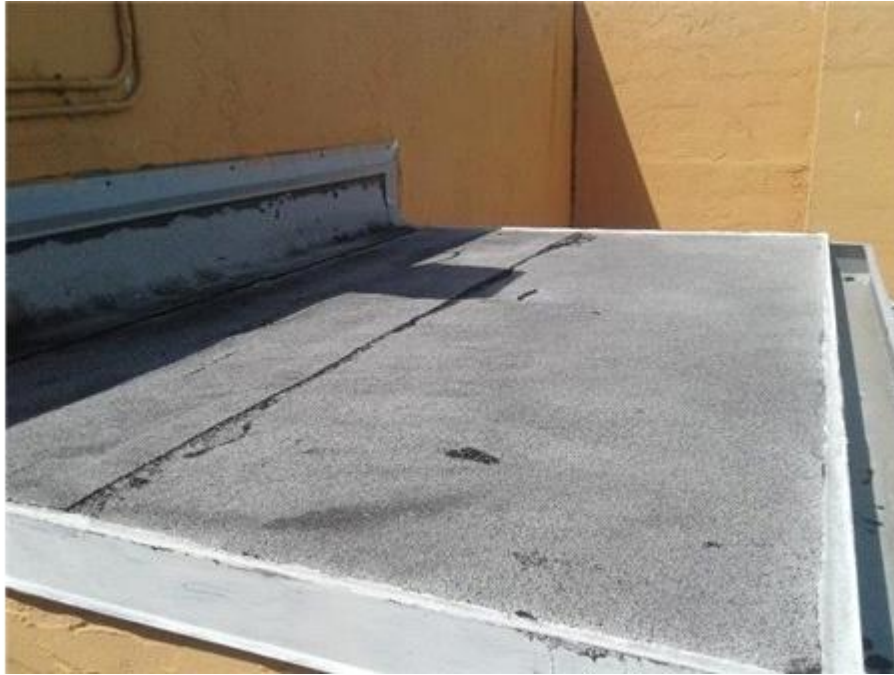
Membrane Overview

The roof membrane appears to be in fair condition at this time.

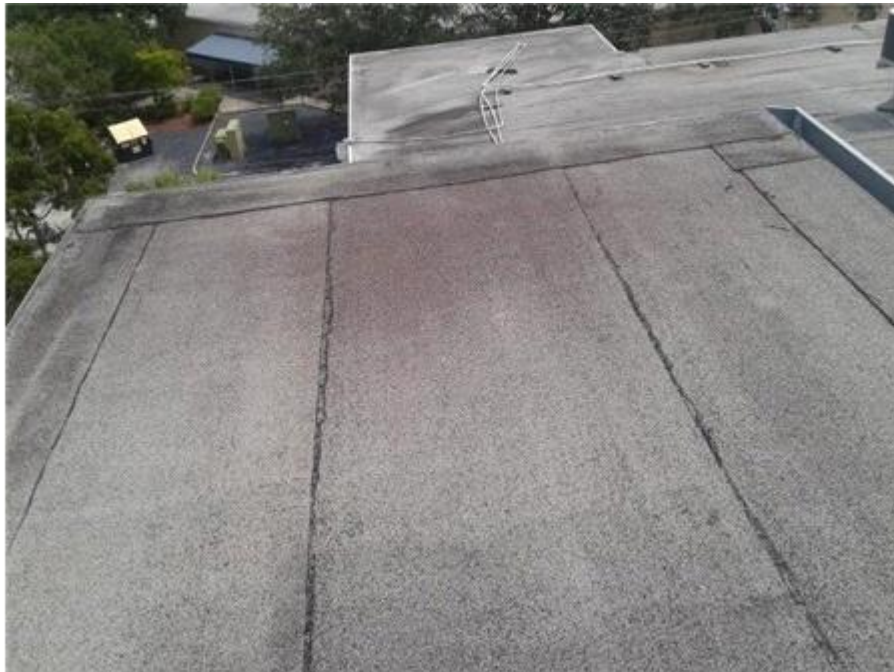
Membrane Overview

The roof membrane appears to be in fair condition at this time.

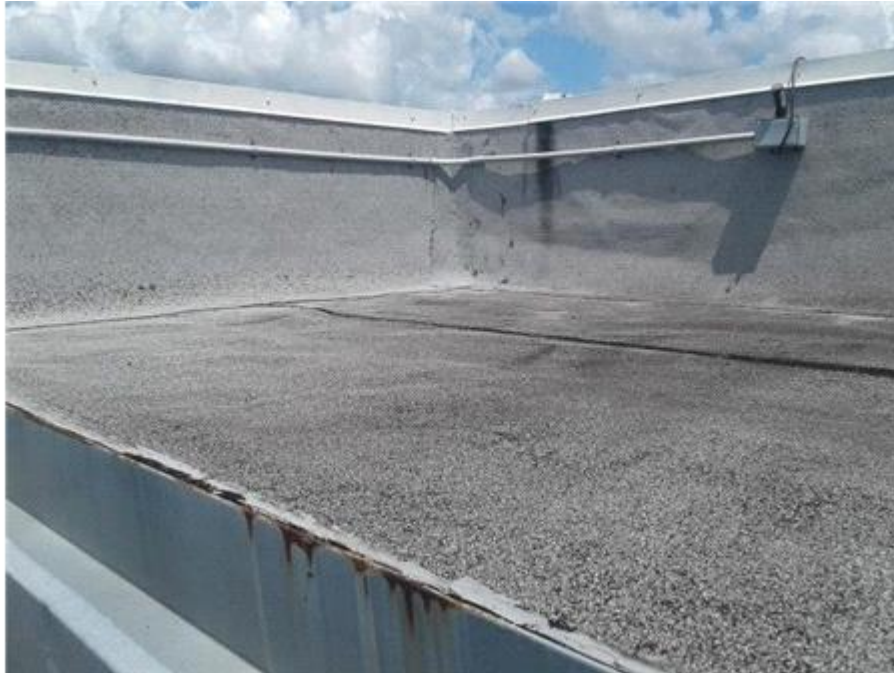
Membrane Overview

The roof membrane appears to be in fair condition at this time.

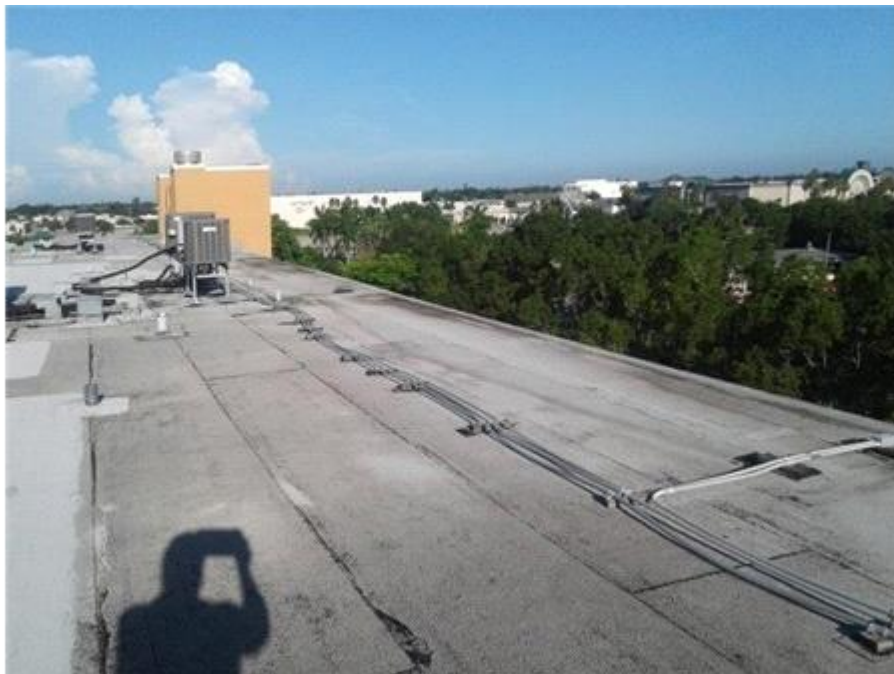
Surface Overview

The roof surface appears to be in fair condition at this time.

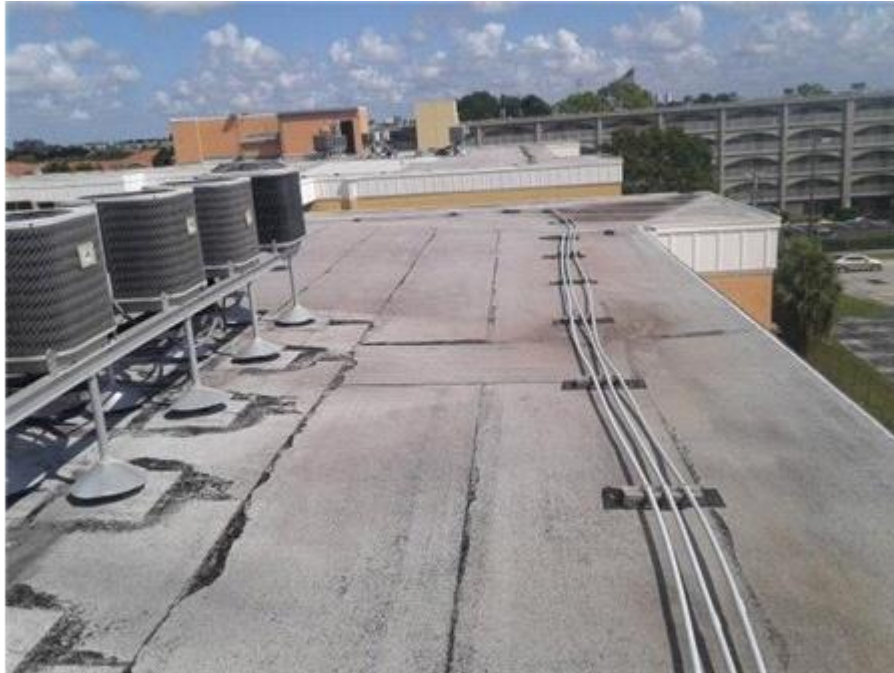
Surface Overview

The roof surface appears to be in fair condition at this time.

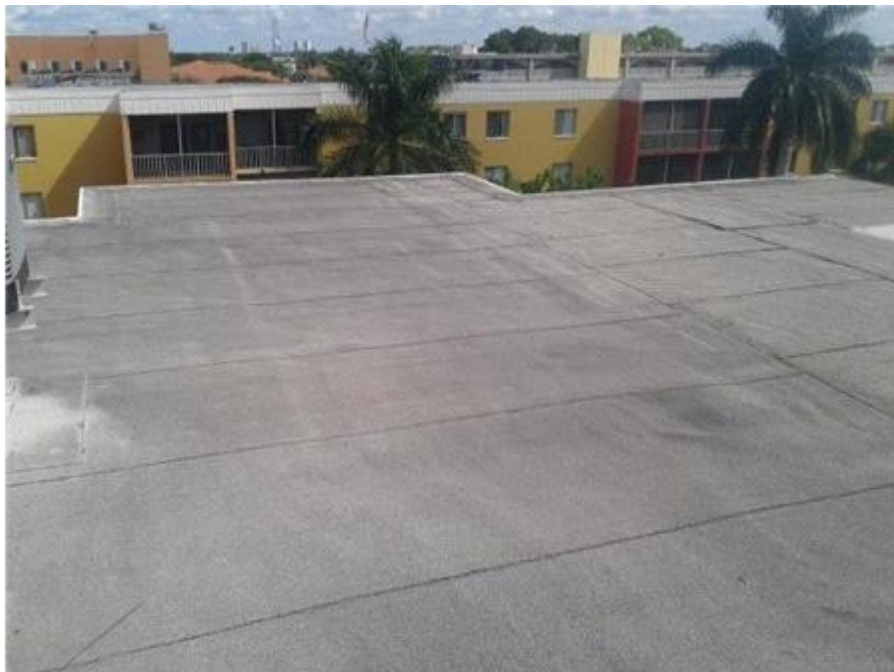
Surface Overview

The roof surface appears to be in fair condition at this time.

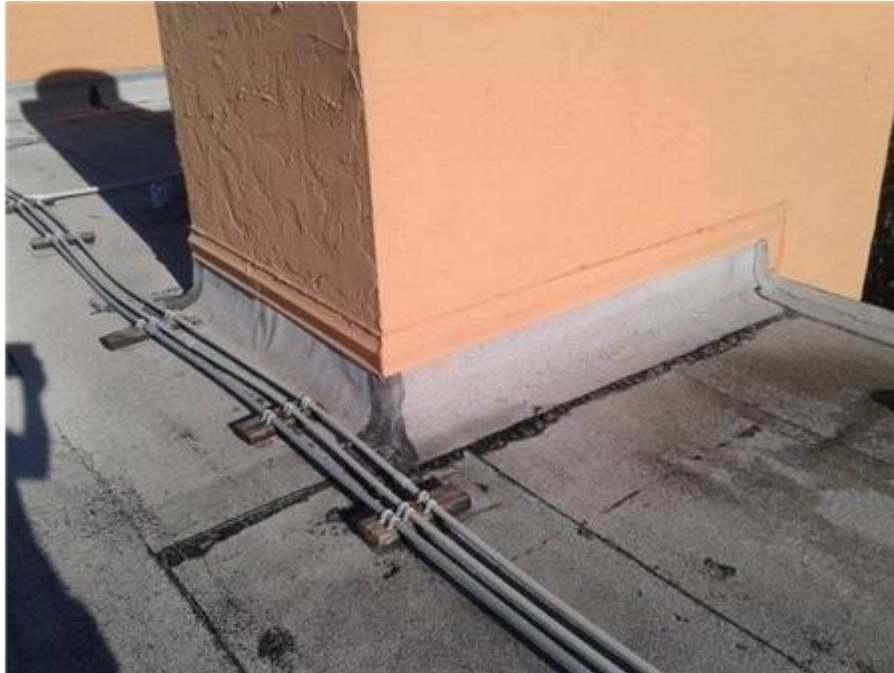
Base Flashings

The base flashings appear to be in fair condition.

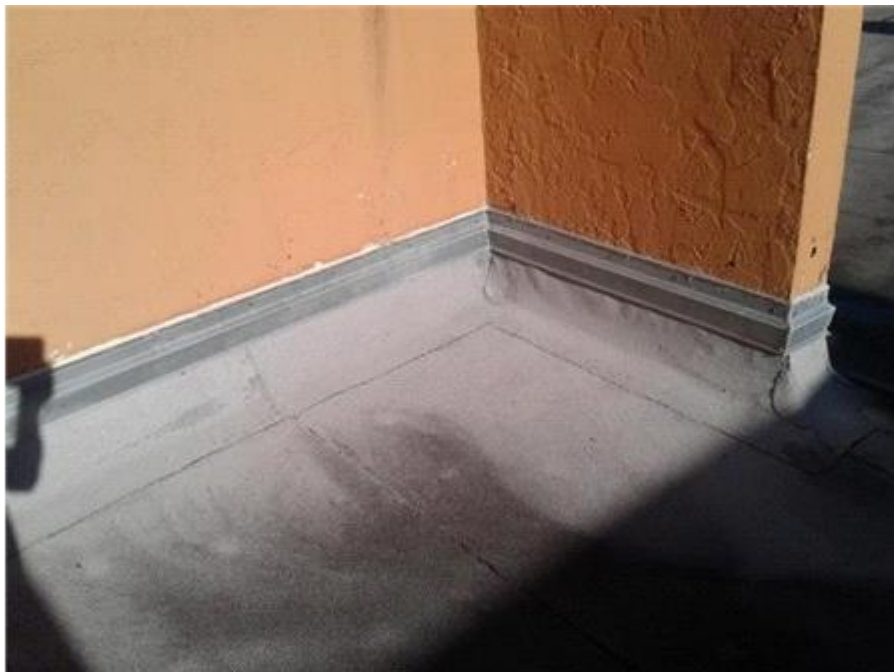
Base Flashings

The base flashings appear to be in fair condition.

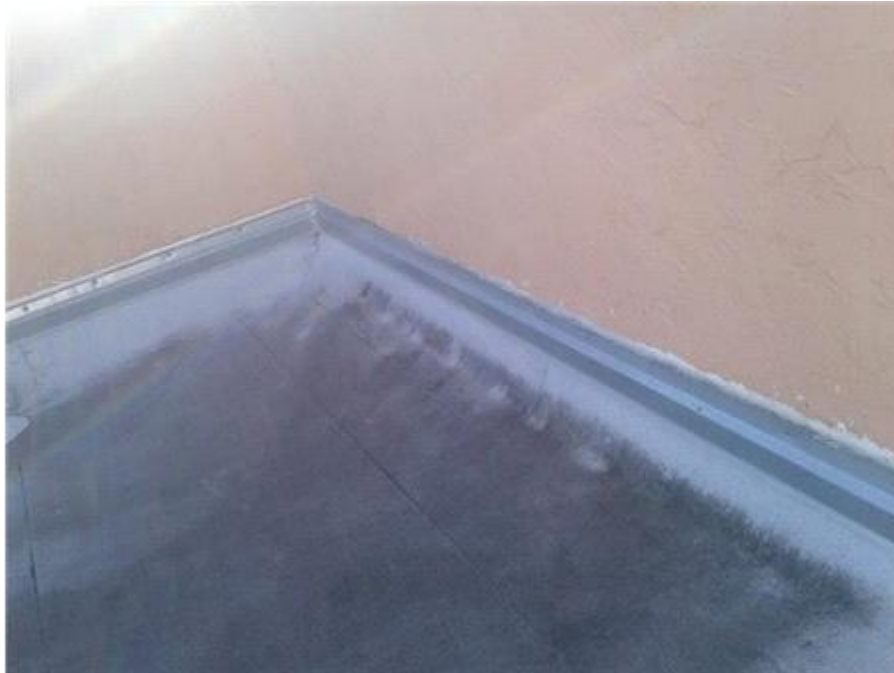
Counter Flashings

The counter flashing appear to be in fair condition.

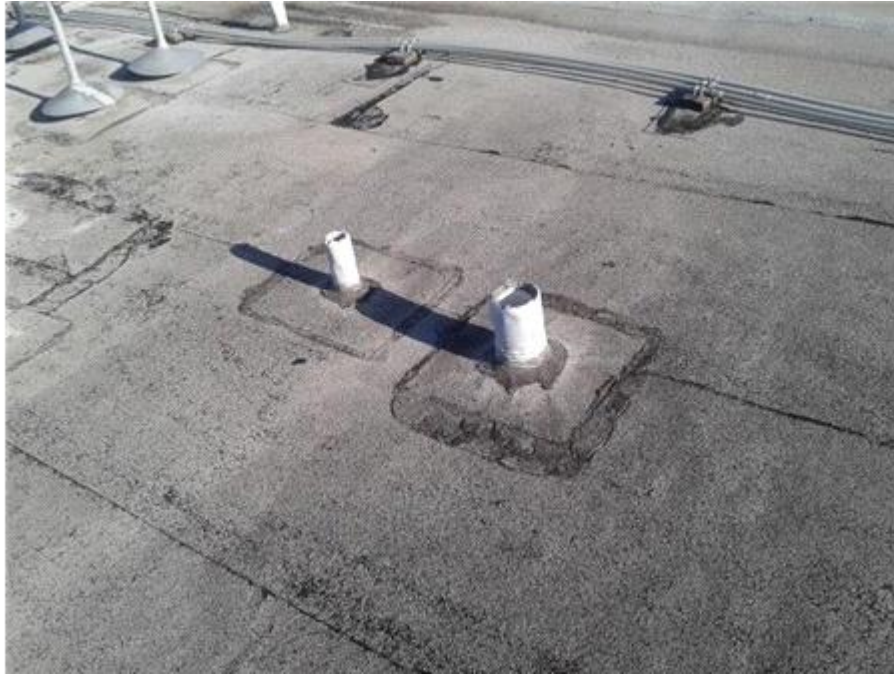
Lead Boots

Lead boots appear to be in fair condition.

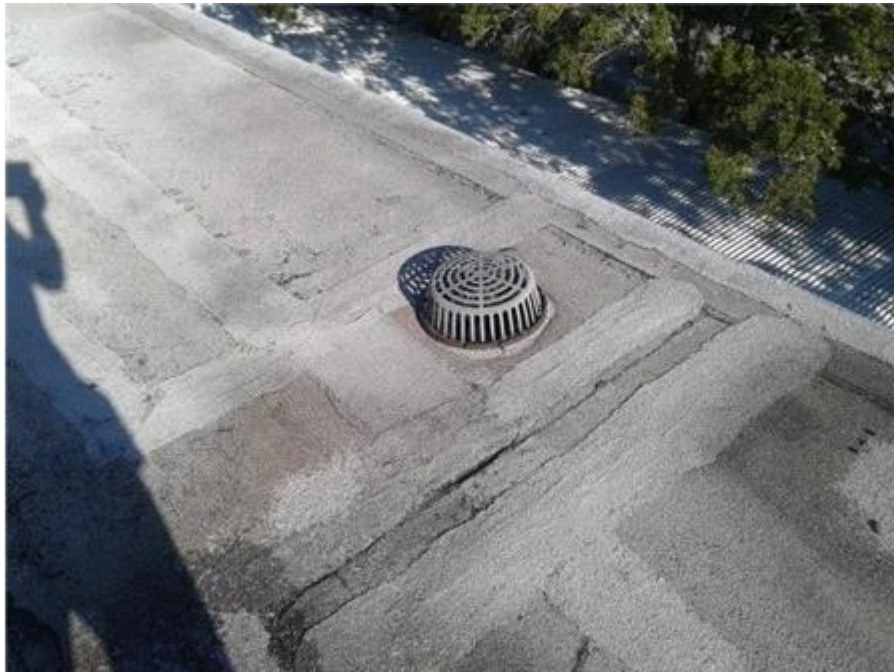
**Roof Drains**

Roof drains appear to be in fair condition.

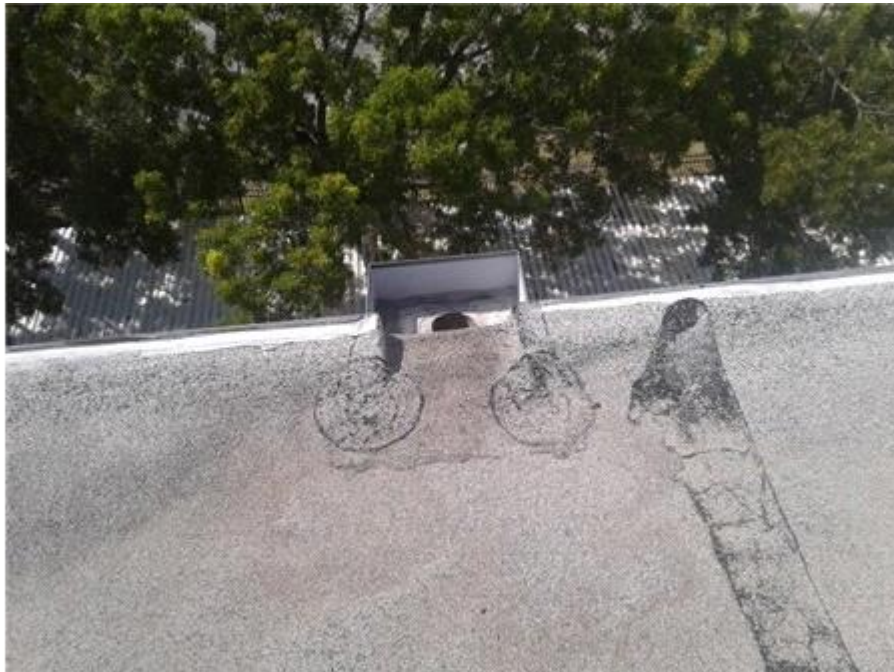
**Scuppers**

Scuppers appear to be in fair condition at this time.

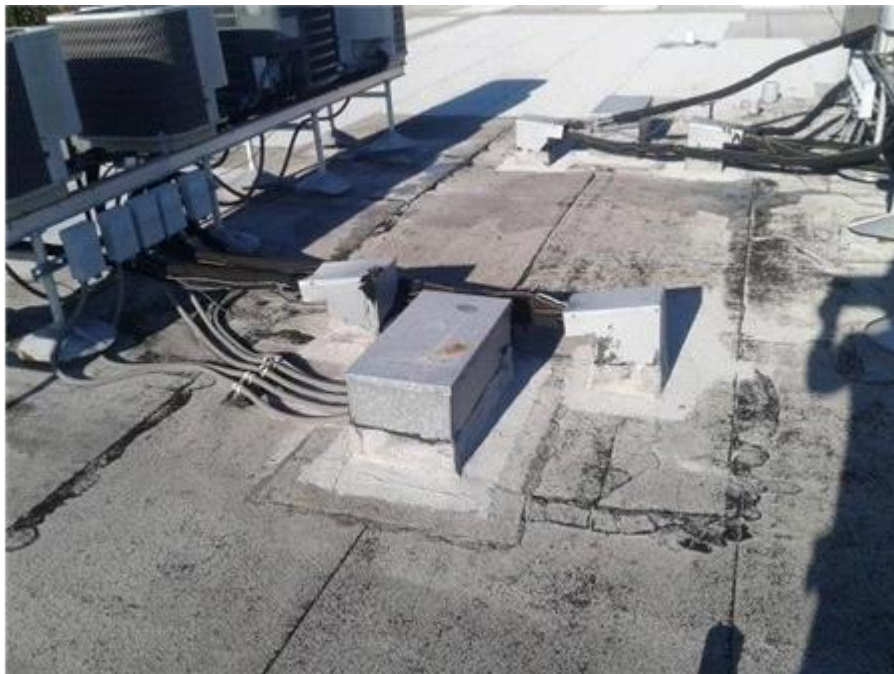
**Equipment Housing**

The equipment housing appears to be in fair condition.

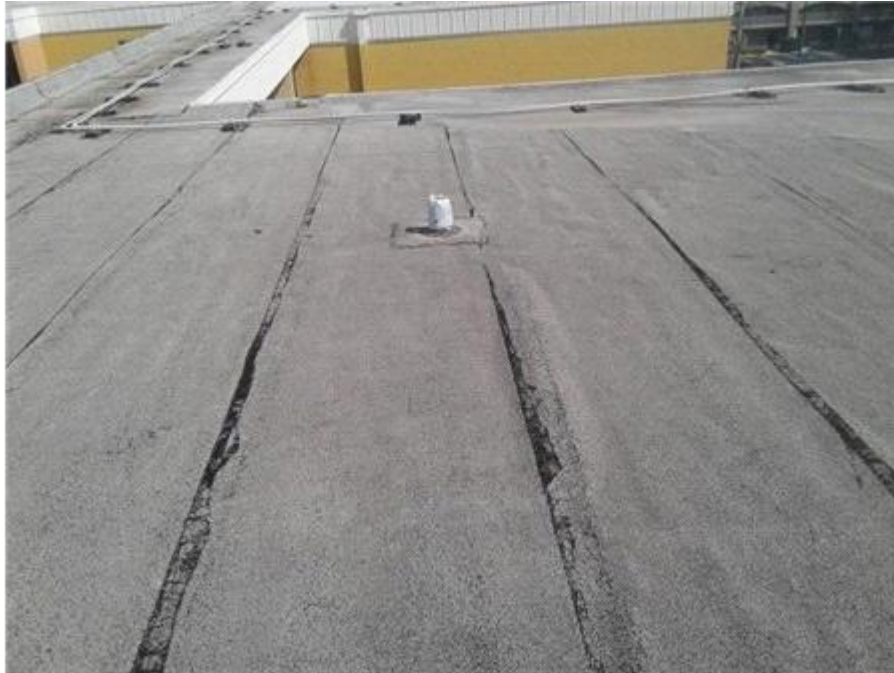
Field Membrane

Blisters are caused by gas trapped in the system and may be ruptured with foot traffic.

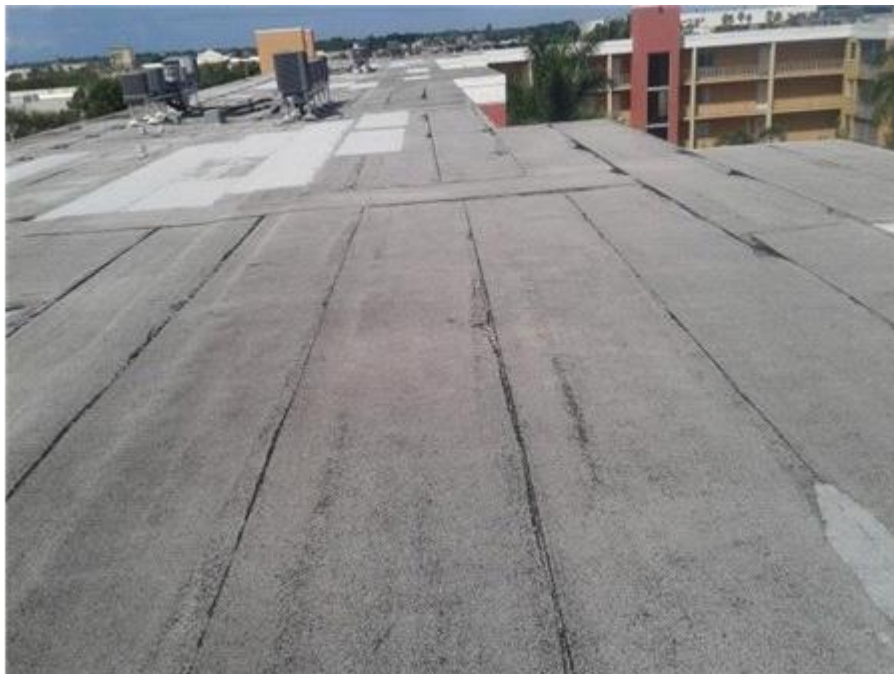
Field Membrane

Blisters are caused by gas trapped in the system and may be ruptured with foot traffic.

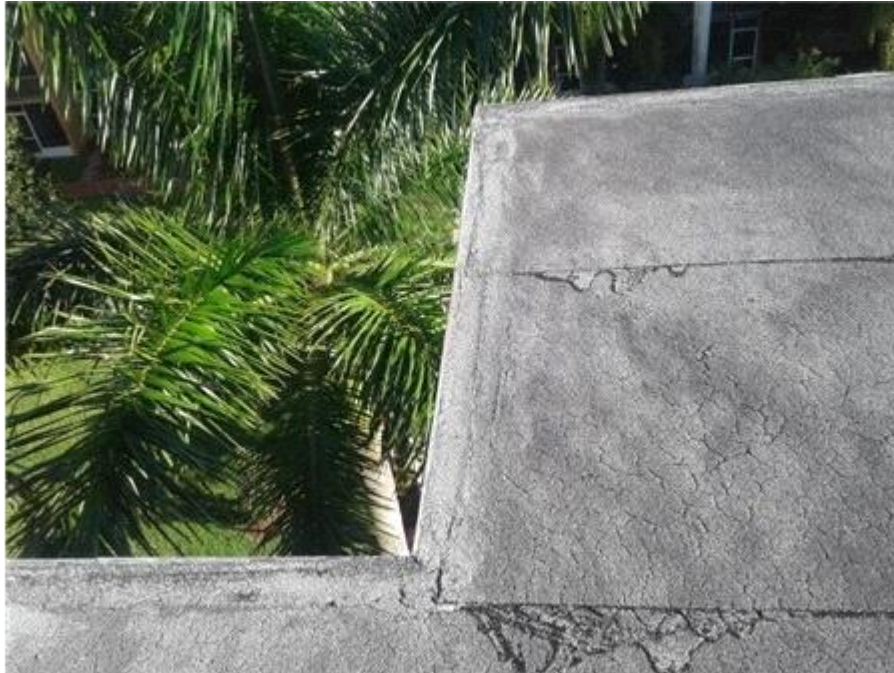
Roof Edge

Roof edge appears to be in fair condition.

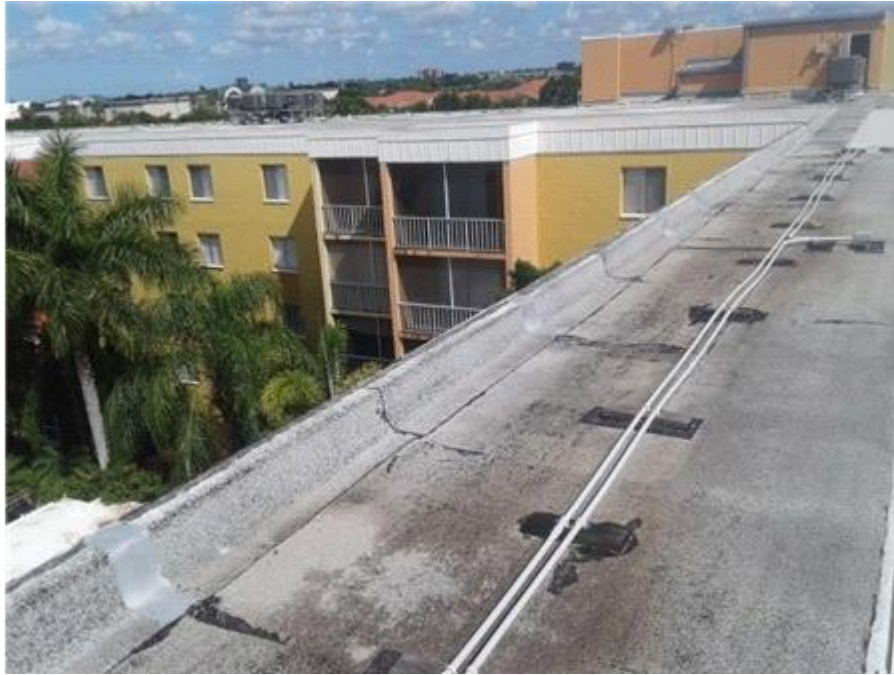
Wall Flashing

Wall flashing appears to be in fair condition at this time.

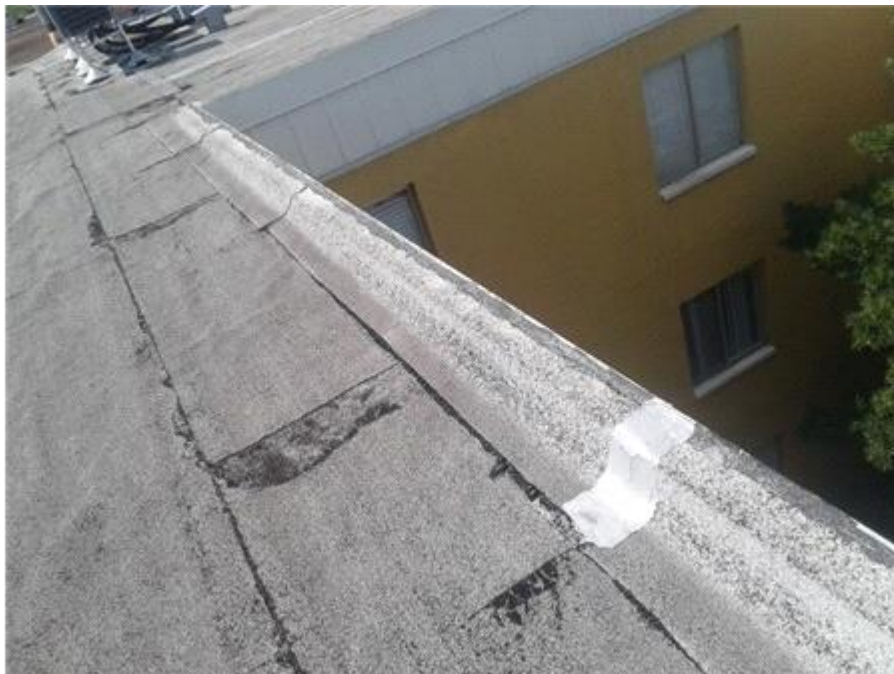
Wall Flashing

Wall flashing appears to be in fair condition at this time.

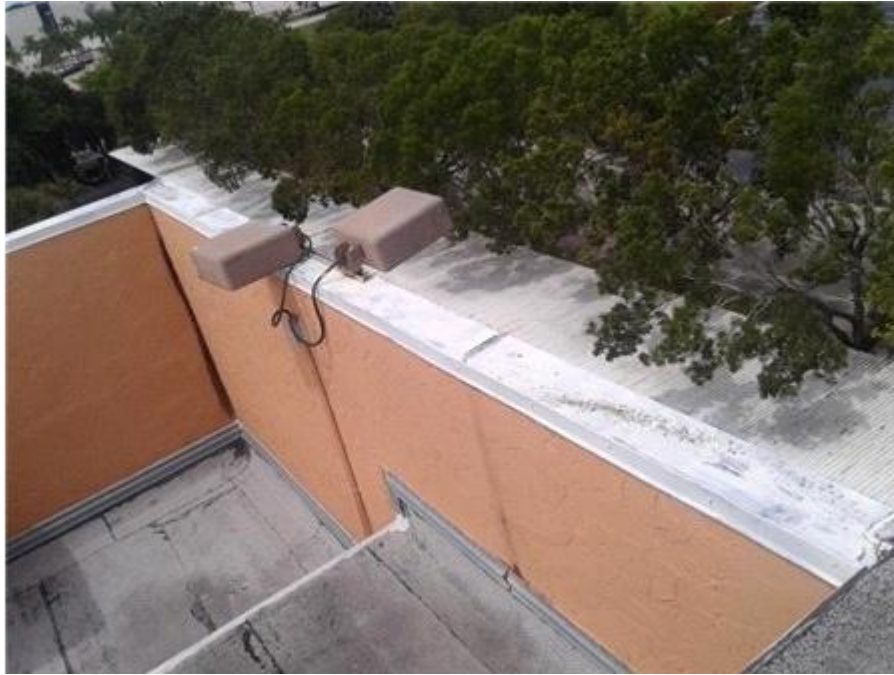
Coping

The coping appears to be in fair condition.

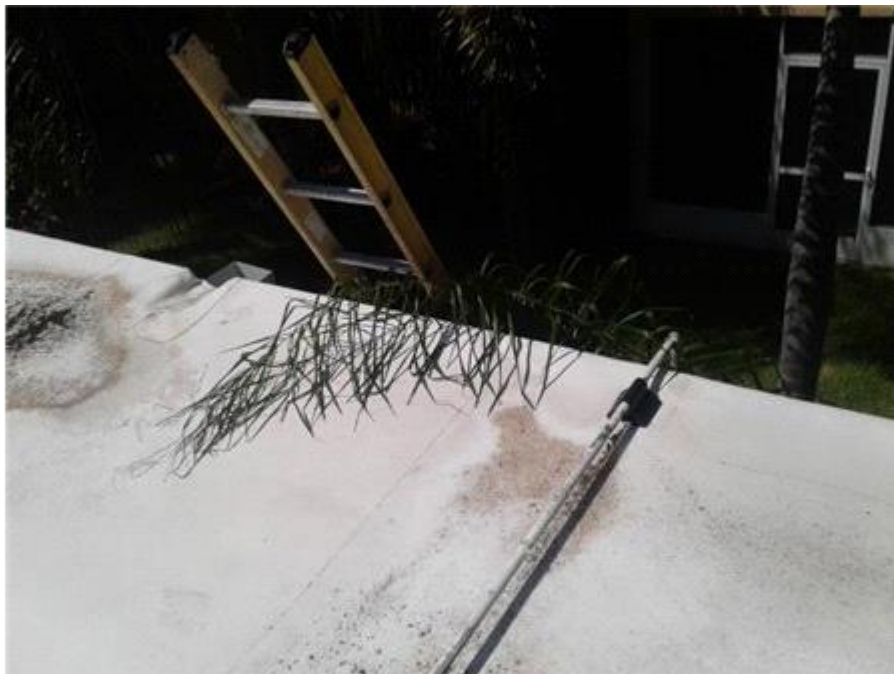
**Tree Branches**

Identified tree branches hanging over the roof surface. Branches on the roof surface can cause deterioration of membrane, and act as an access for rodents and unwanted bugs/pests.

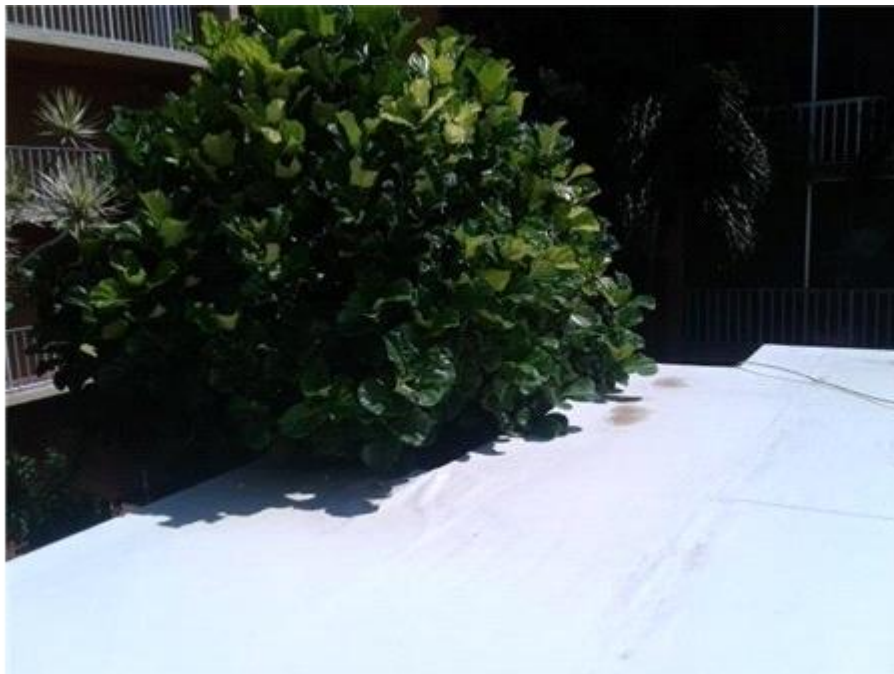
Tree Branches

Identified tree branches hanging over the roof surface. Branches on the roof surface can cause deterioration of membrane, and act as an access for rodents and unwanted bugs/pests.
