Inspection Report

Facility: Towers, The
Address: 2366 East Mall Dr,
Fort Myers, 33912

Inspection Date: Tuesday, June 12, 2018

Re.: **Inspection Report (2 of 6) for The Towers**

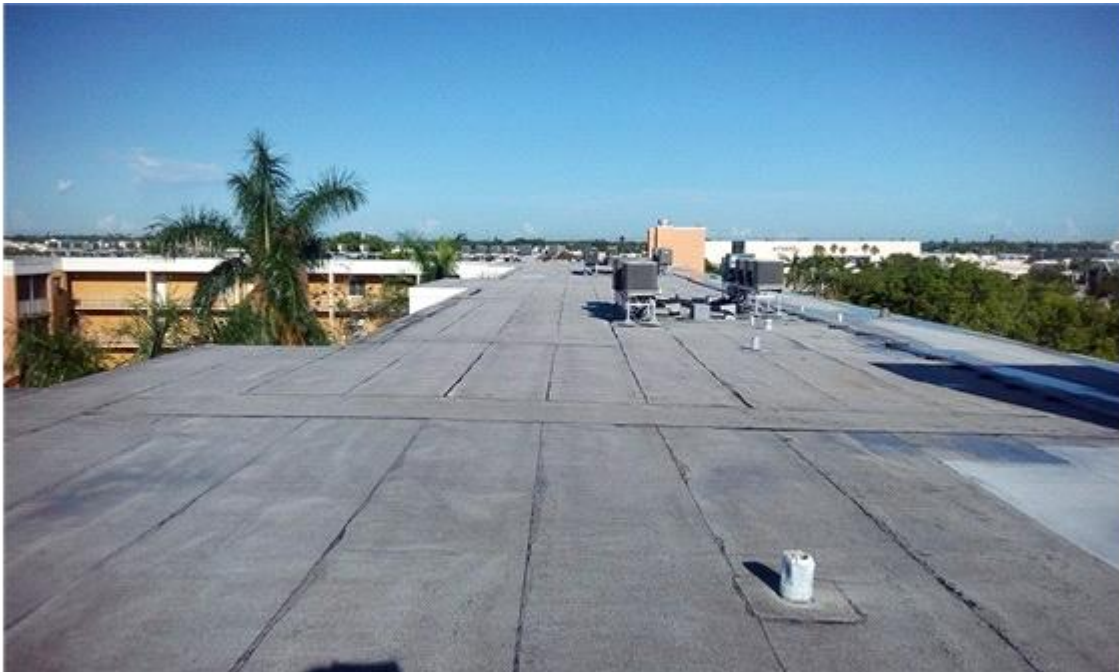
001F - Surface Overview
The roof surface appears to be in fair condition at this time.

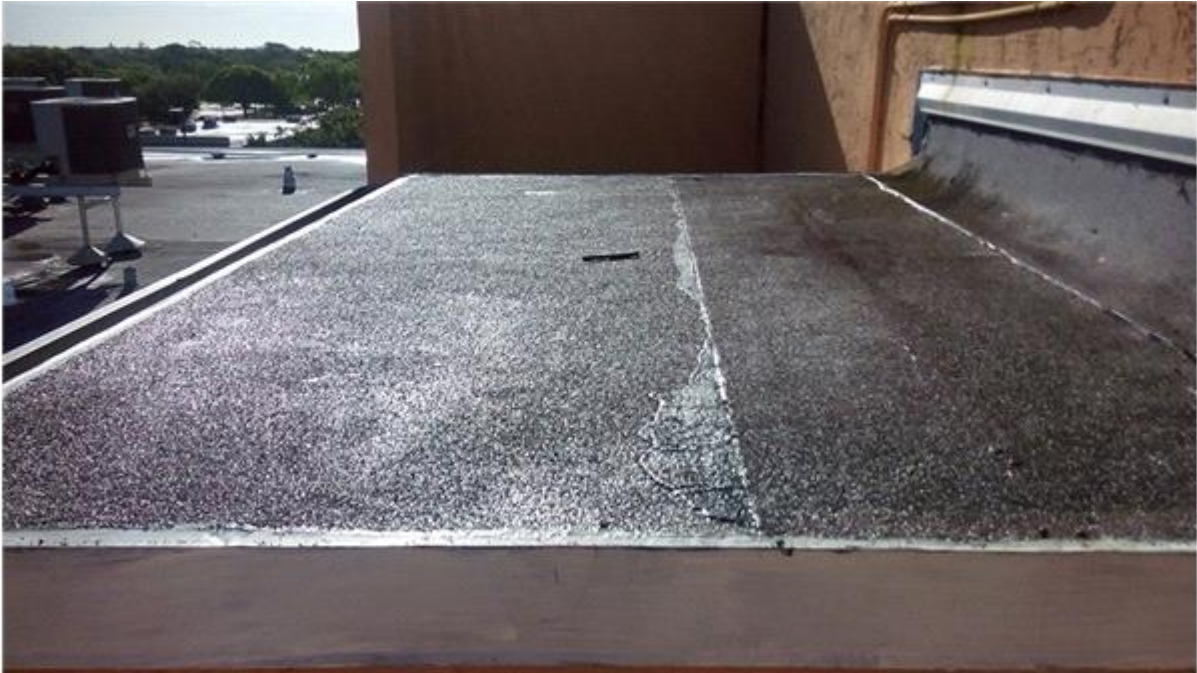
001F - Surface Overview

The roof surface appears to be in fair condition at this time.

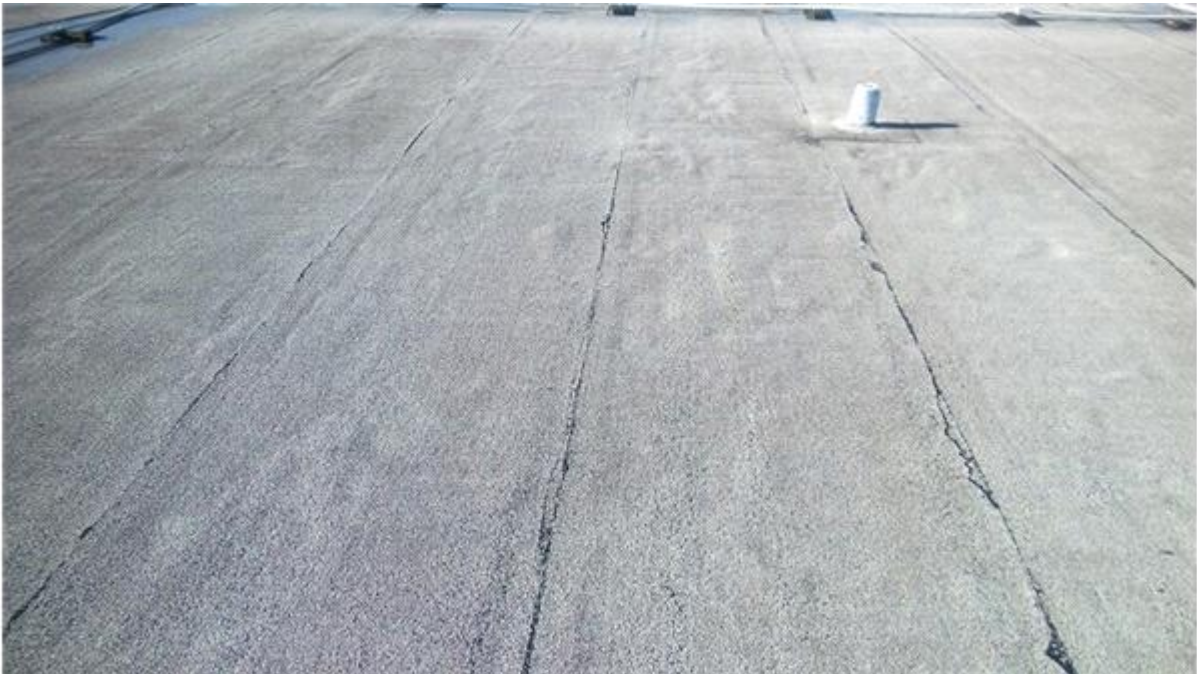
003F -Membrane Overview

The roof membrane appears to be in fair condition at this time.

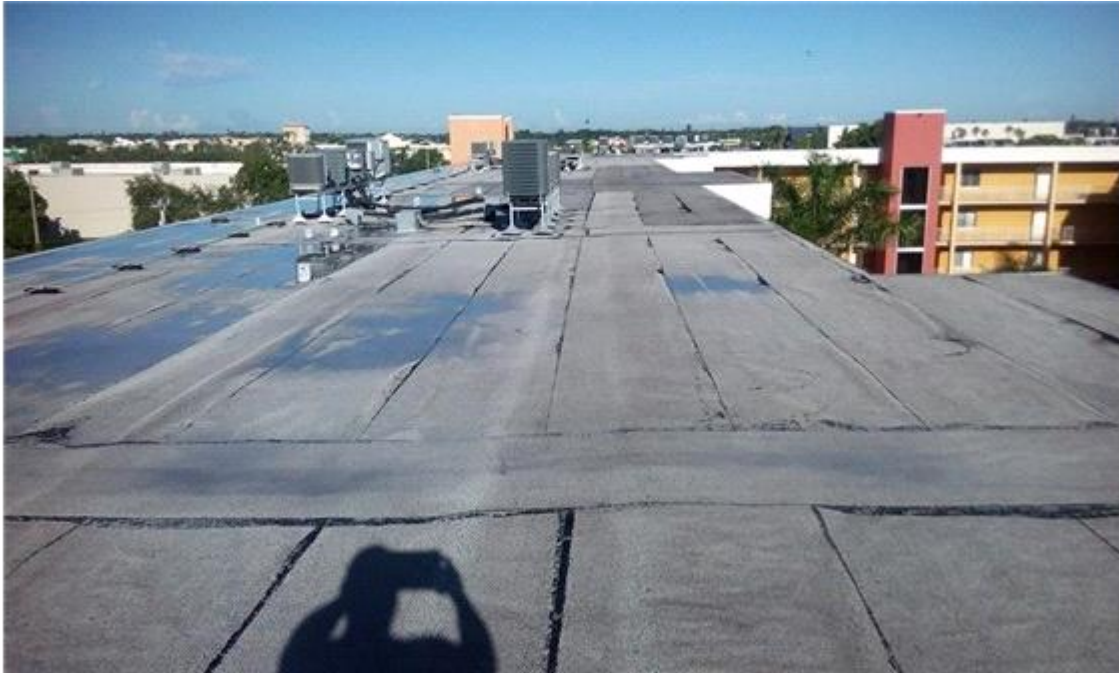
002F - Appearance Overview

The appearance of the roof is in fair condition at this time.

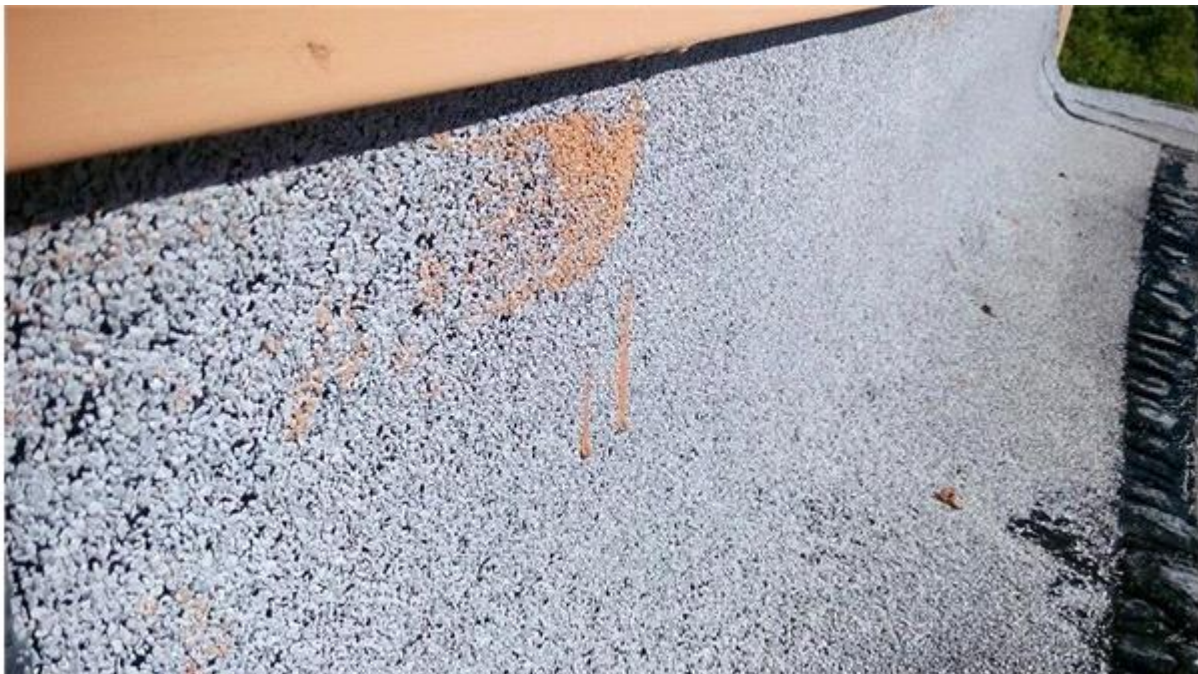
004G -Base Flashings

The base flashings appear to be in fair condition at this time.

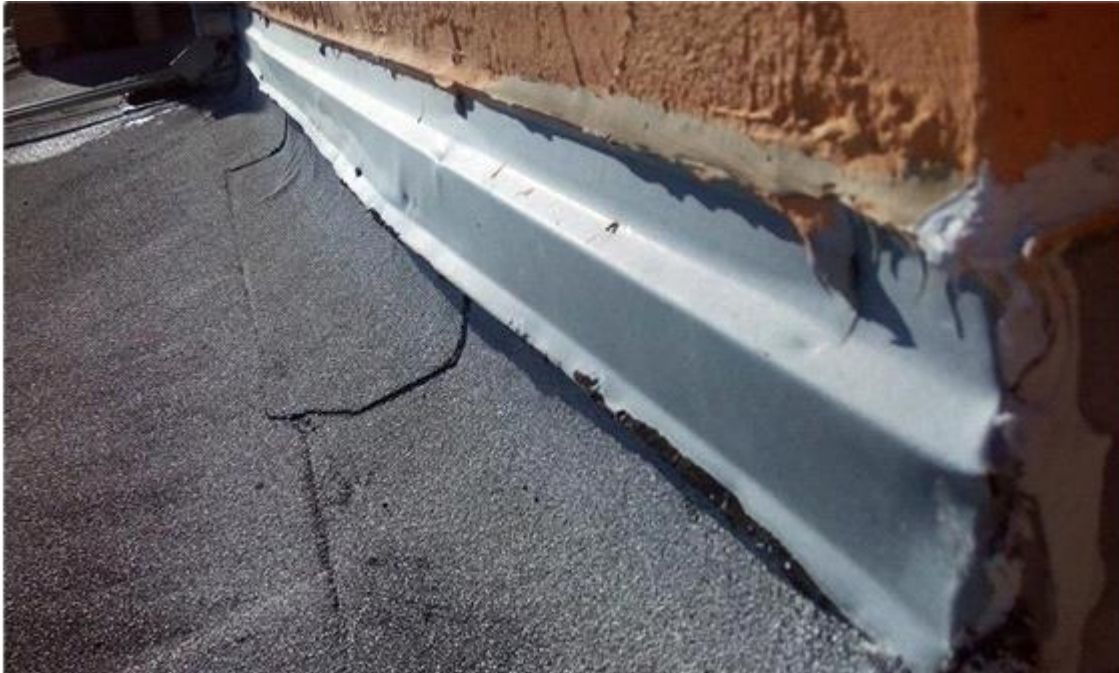
005F- Counter Flashings

The counter flashing appears to be in fair condition at this time.

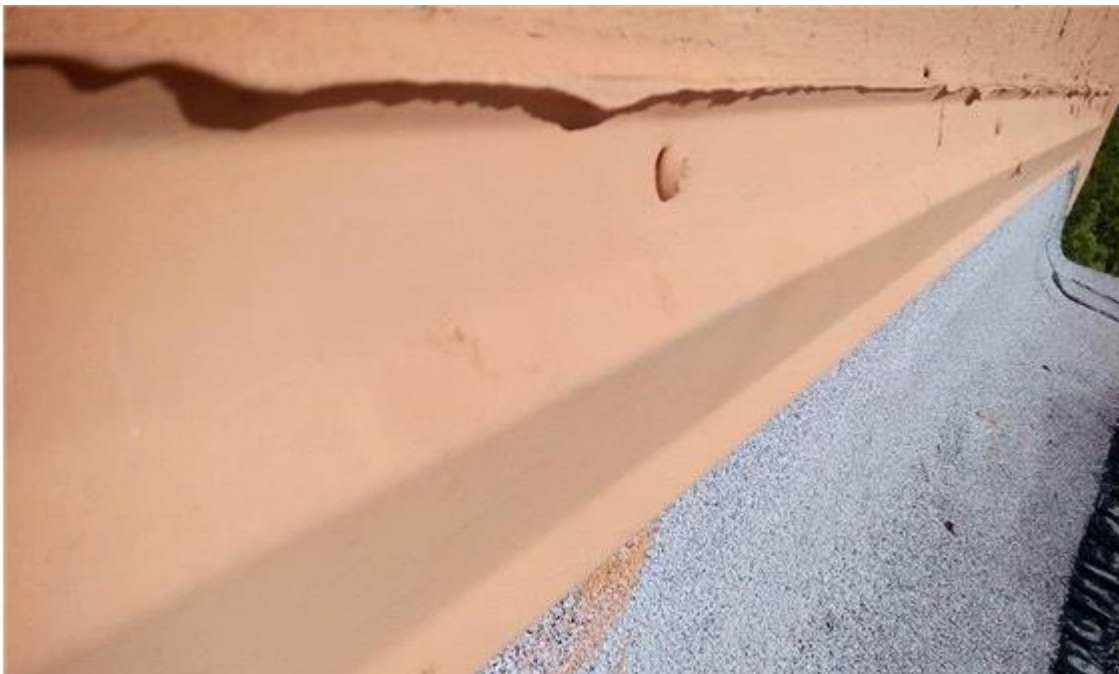
005G- Counter Flashings

The counter flashing appears to be in fair condition at this time.

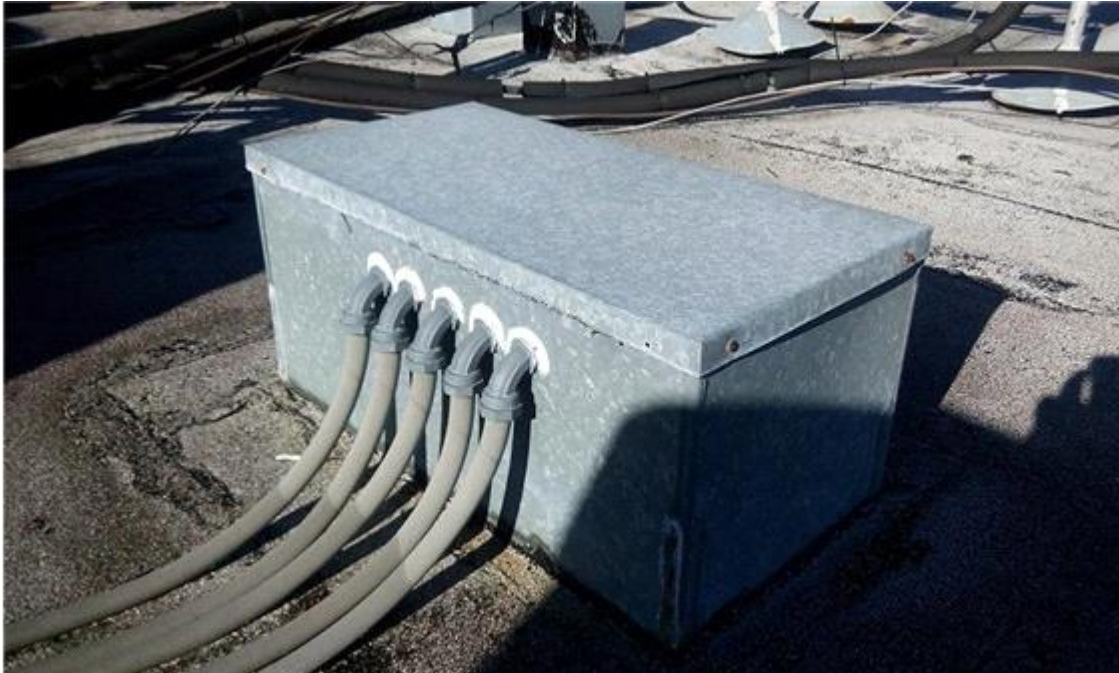
010G- Equipment Housing

The equipment housing appears to be in fair condition at this time.

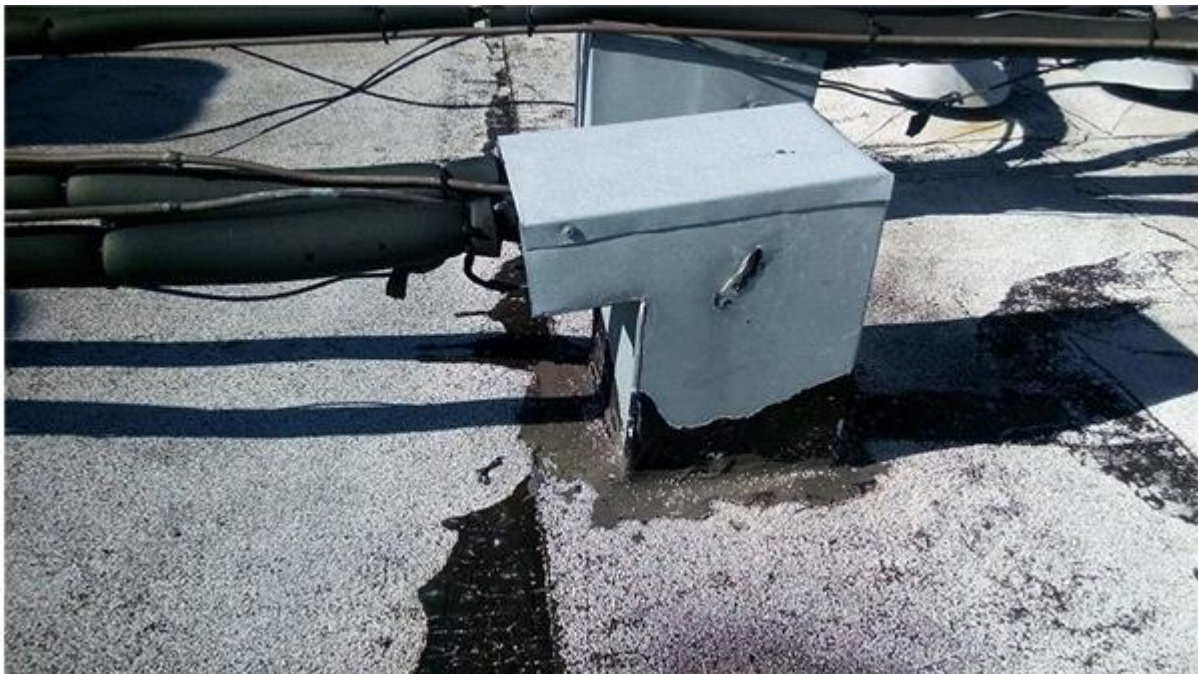
010G- Equipment Housing

The equipment housing appears to be in fair condition at this time.

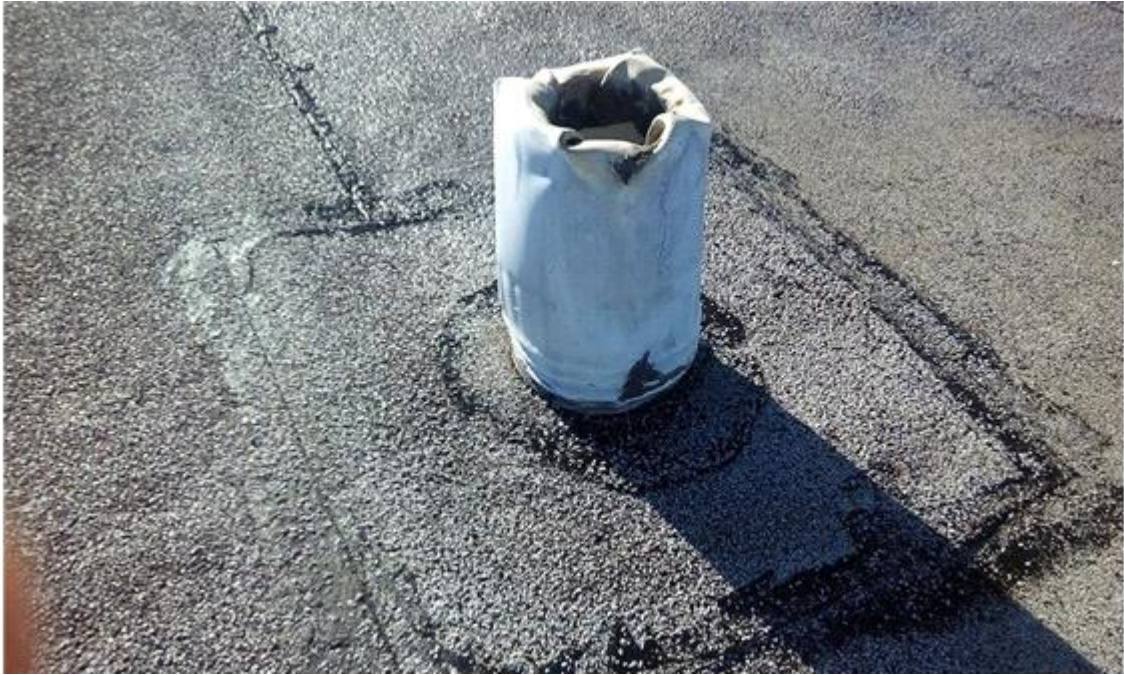
Lead boot

The lead boots appear to be in fair condition at this time.

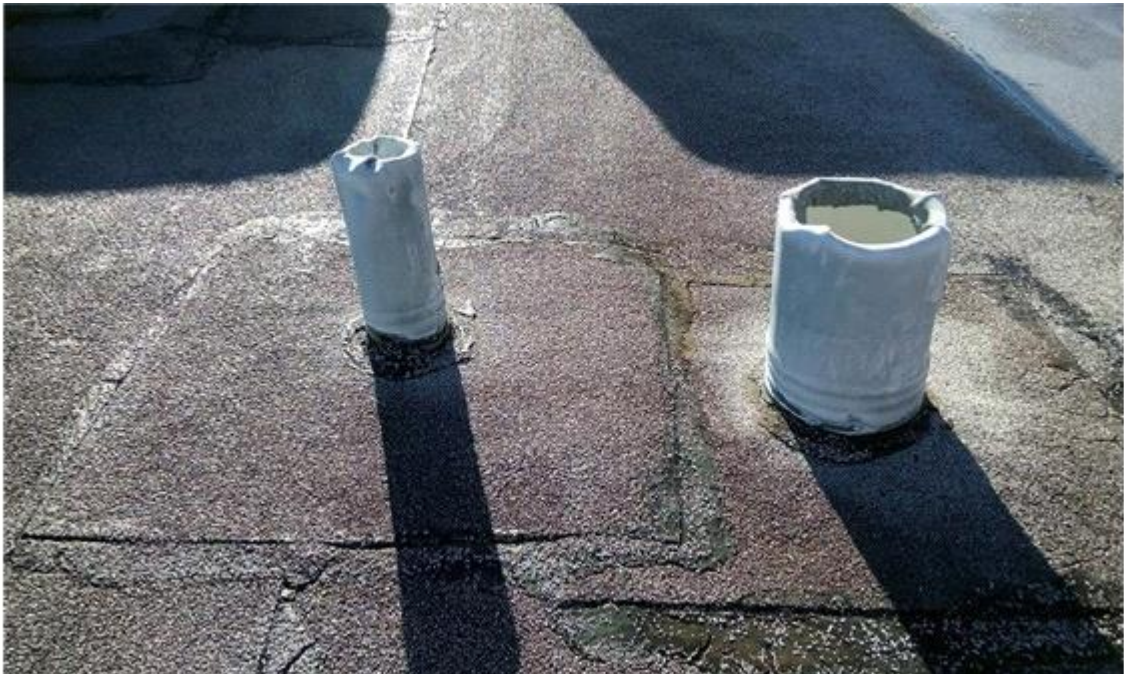
019F-Lead Boots

The lead boots appear to be in fair condition at this time.

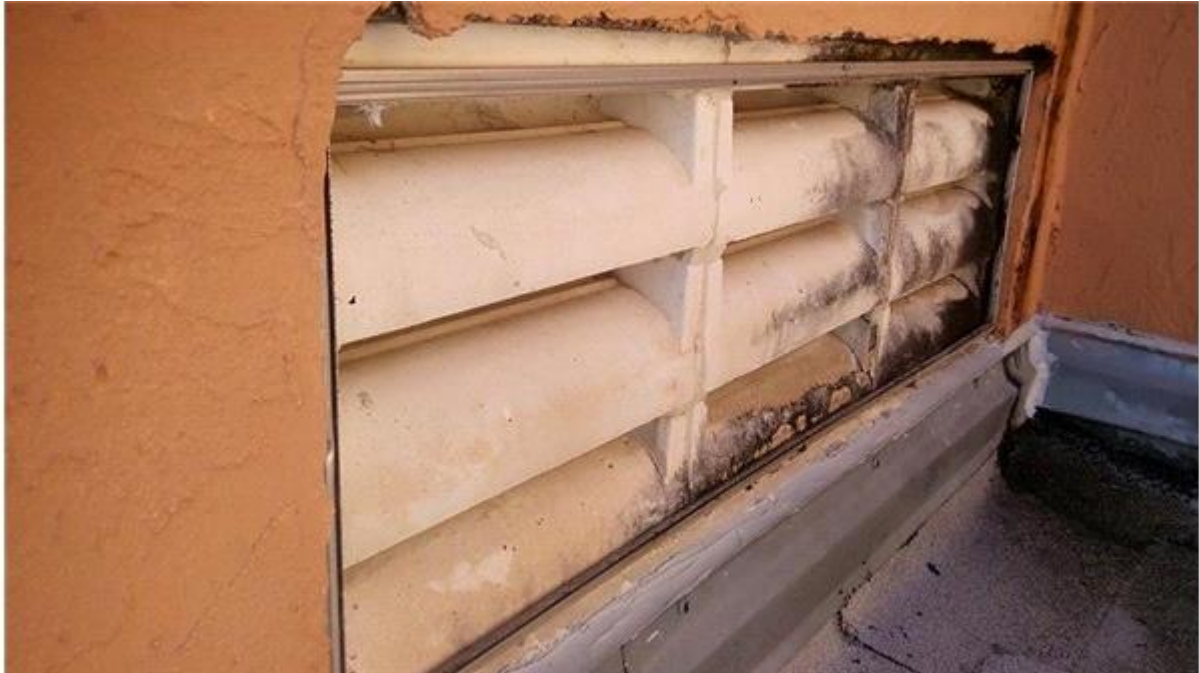
002G-Roof Vents

The roof vents appear to be in fair condition at this time.

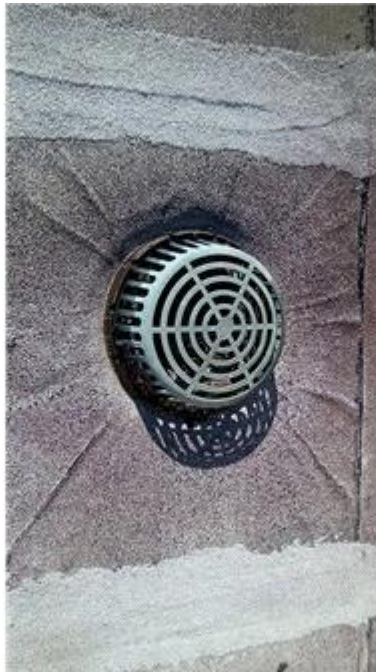
020G-Roof Drains

The roof drains appear to be in fair condition at this time.

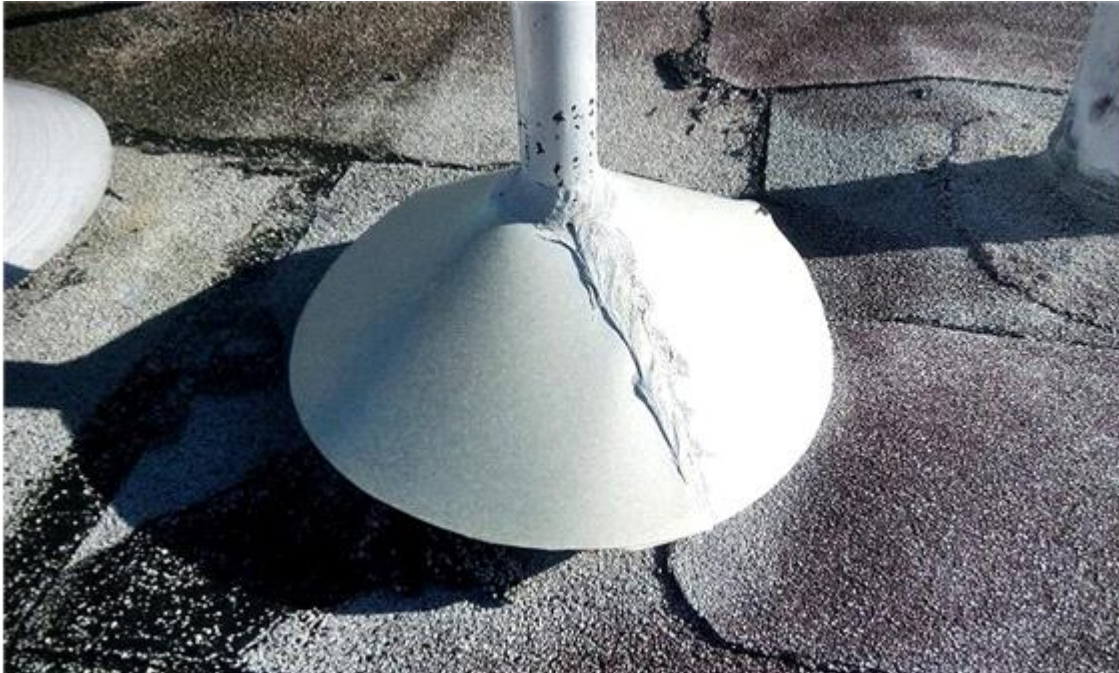
012G- Chem Curbs

The chem curbs appear to be in fair, maintainable condition at this time.

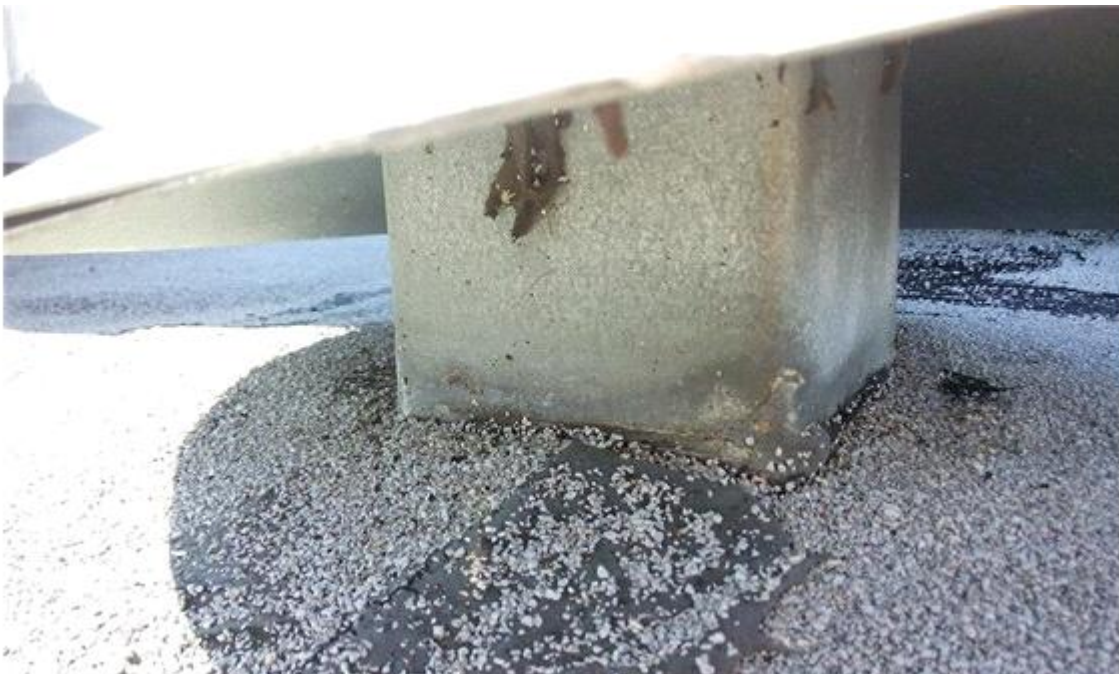
011F- Pitch Pans

The pitch pans appear to be in fair condition at this time.

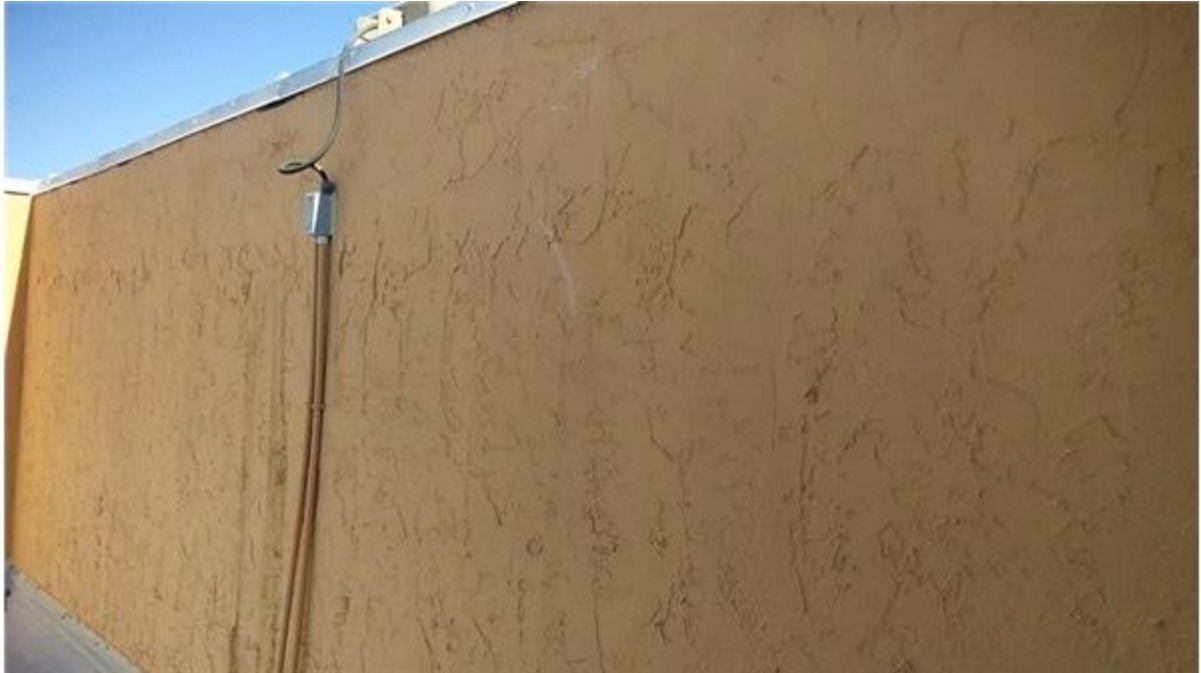
007G- Wall

The walls appear to be in good condition at this time.

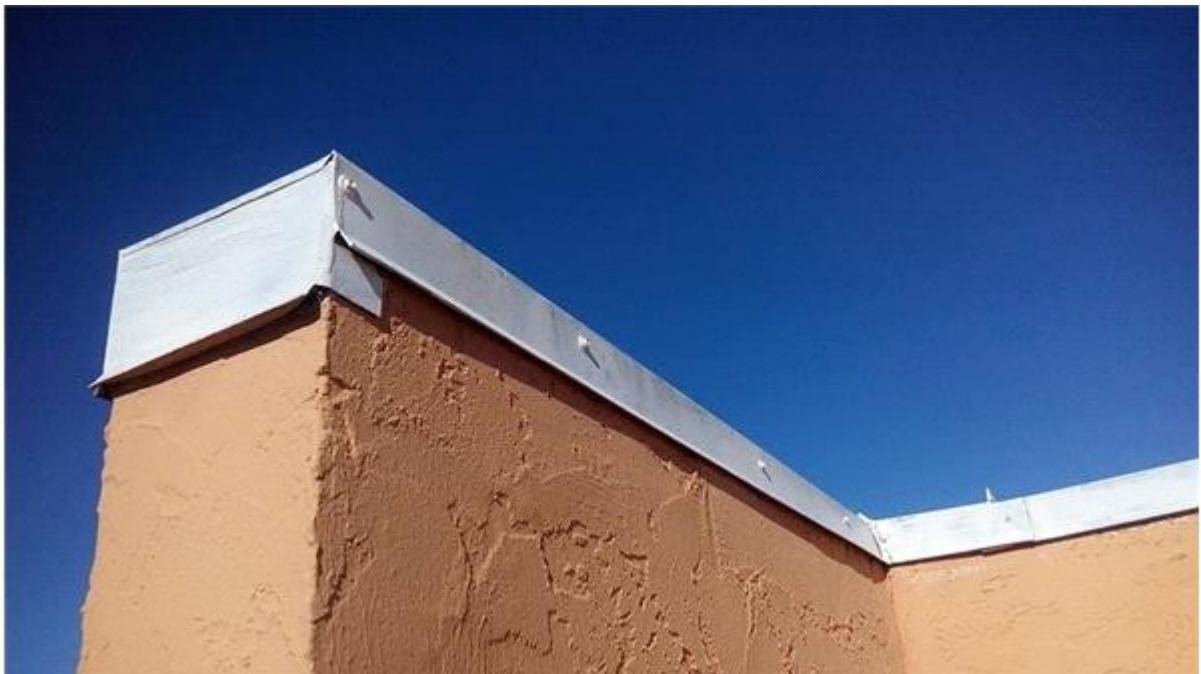
006G- Coping

The coping appears to be in good condition at this time.

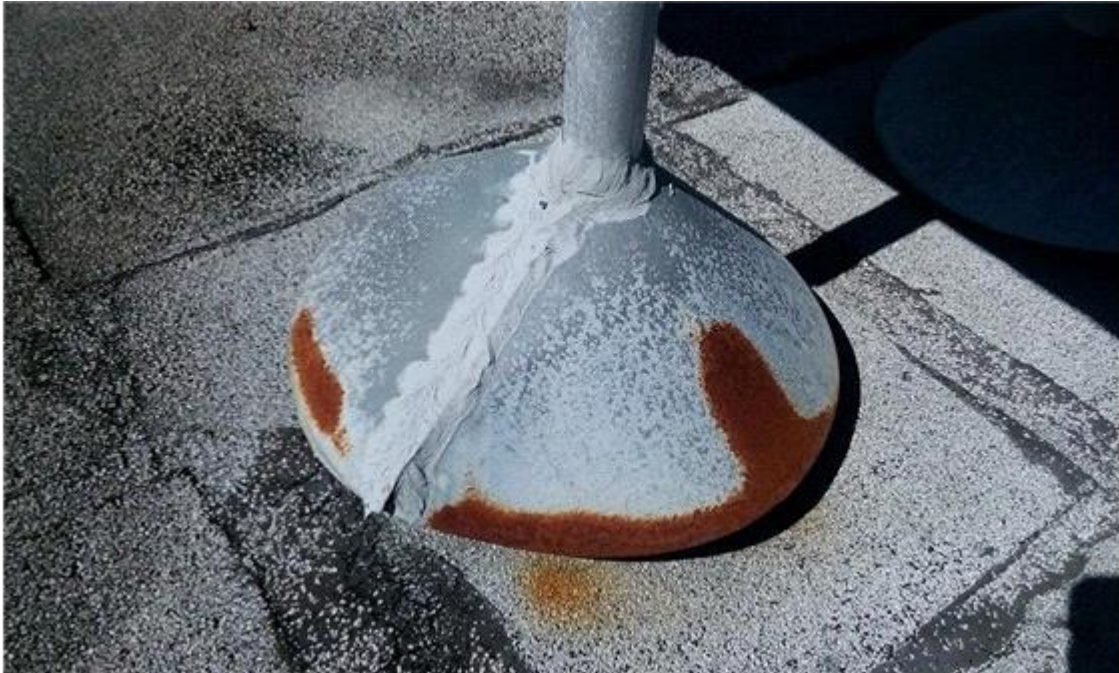
MC-302 Metal Cap

The metal flashing has corroded which can eventually lead to perforations in the metal. Crowther Roofing suggests applying a rust inhibitor.

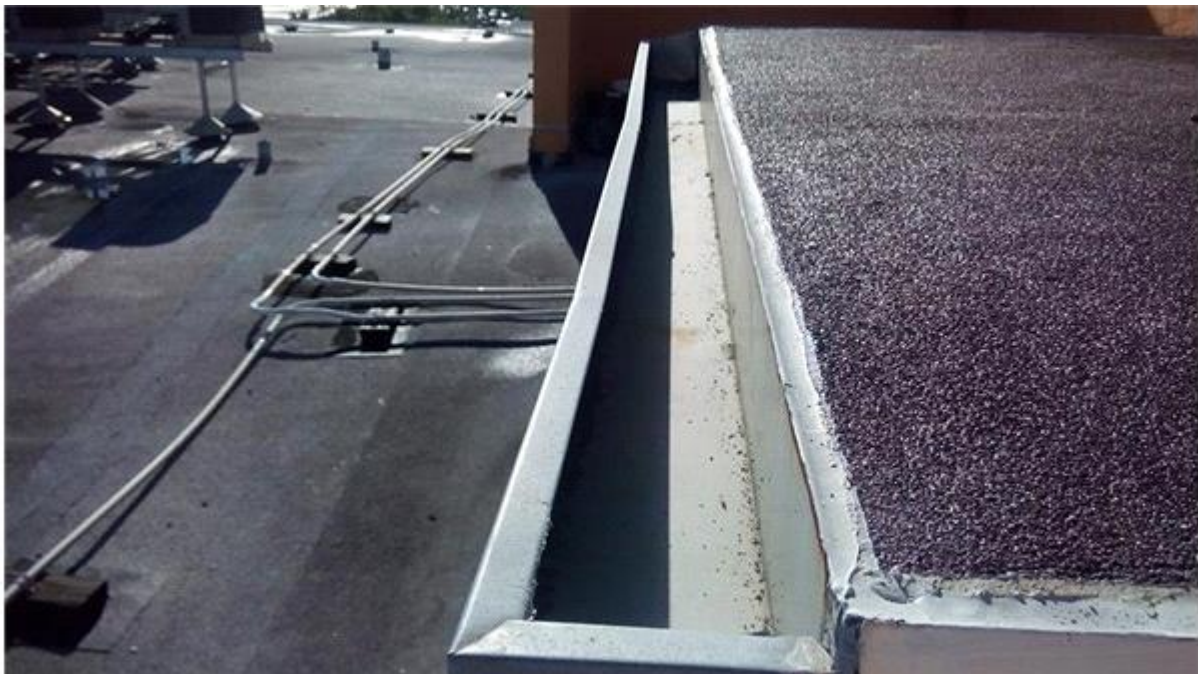
008G- Gutters

The gutters appear to be in good condition at this time.

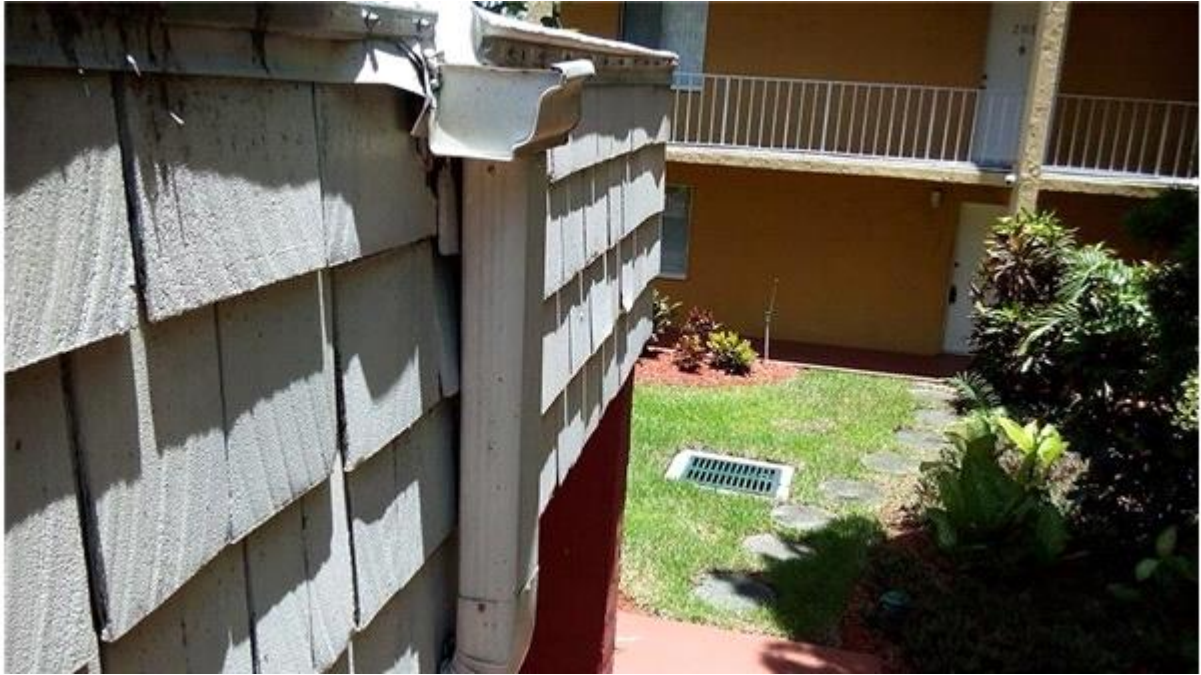
008G- Gutters

The gutters appear to be in good condition at this time.

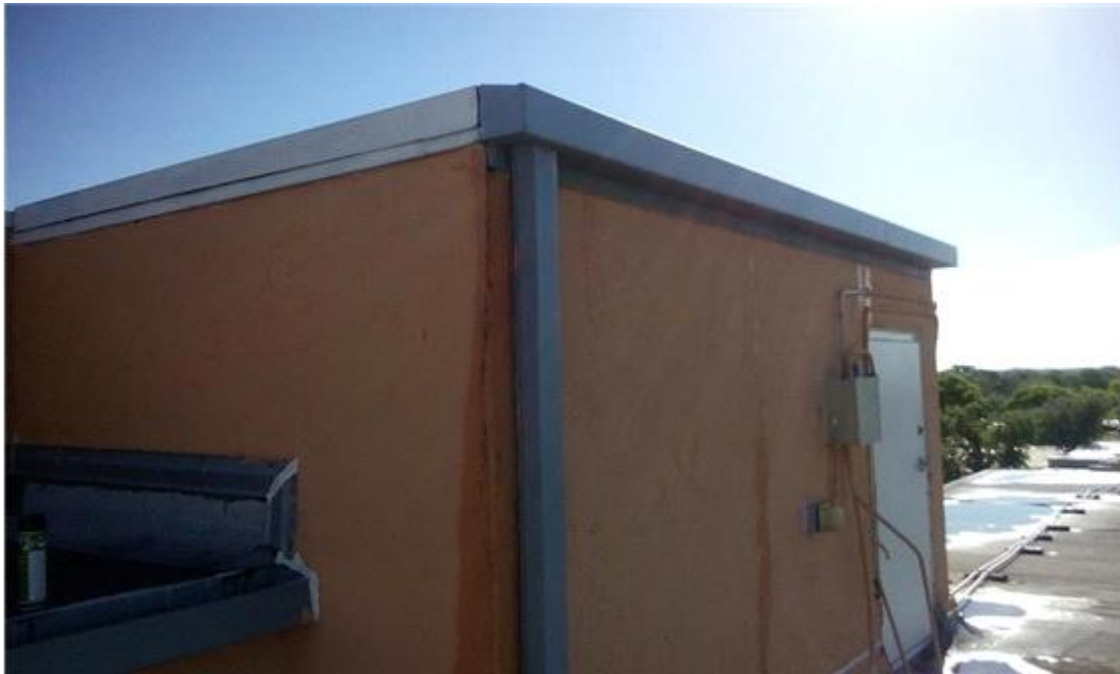
009G- Downspouts

The downspouts appear to be in good condition at this time.

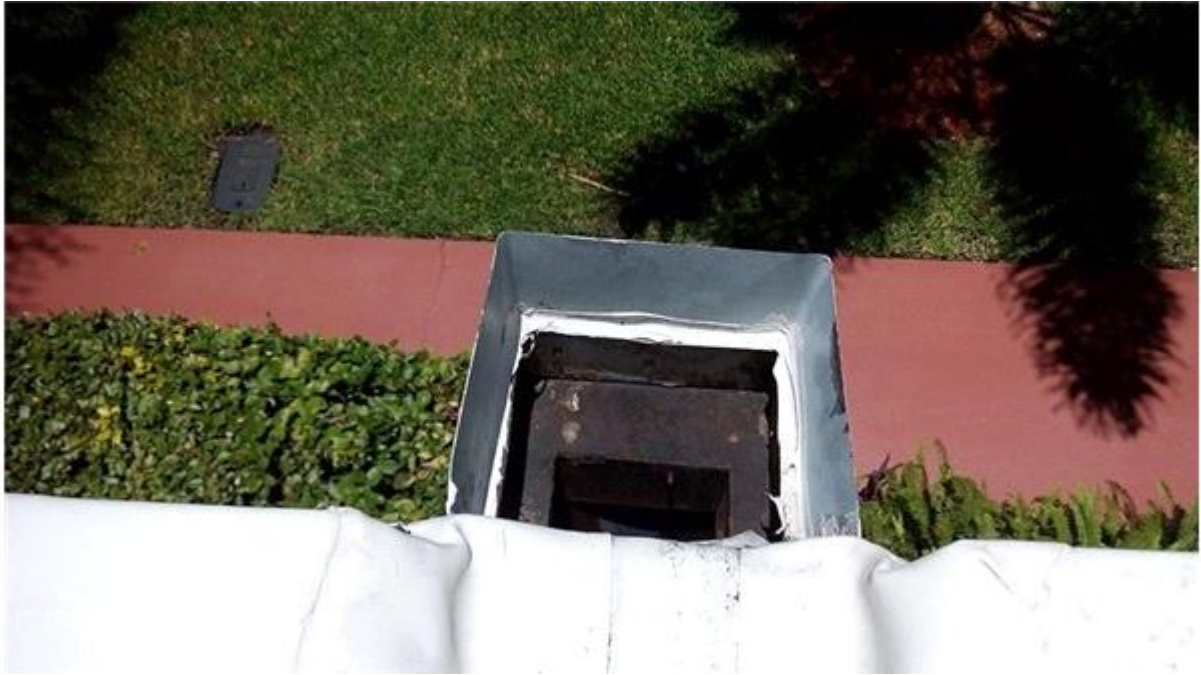
009G- Downspouts

The downspouts appear to be in good condition at this time.

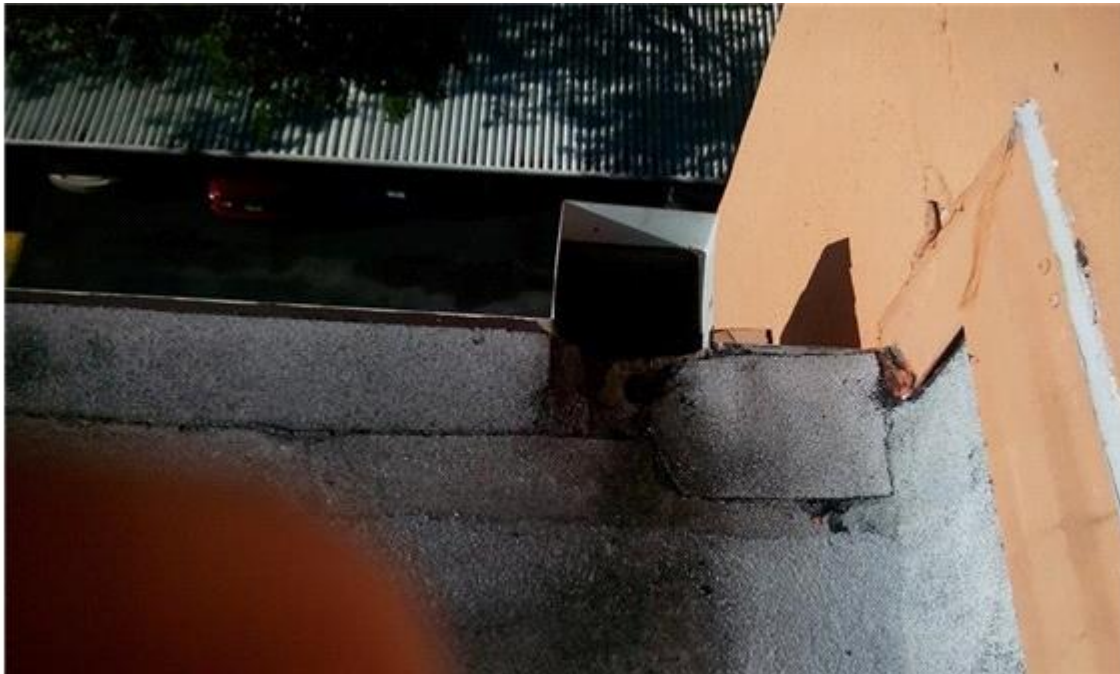
009G- Downspouts

The downspouts appear to be in good condition at this time.
