Inspection Report

Facility: Towers, The
Address: 2366 East Mall Dr,
Fort Myers, 33912

Inspection Date: Tuesday, June 12, 2018

Re.: **Inspection Report (2 of 6) for The Towers**

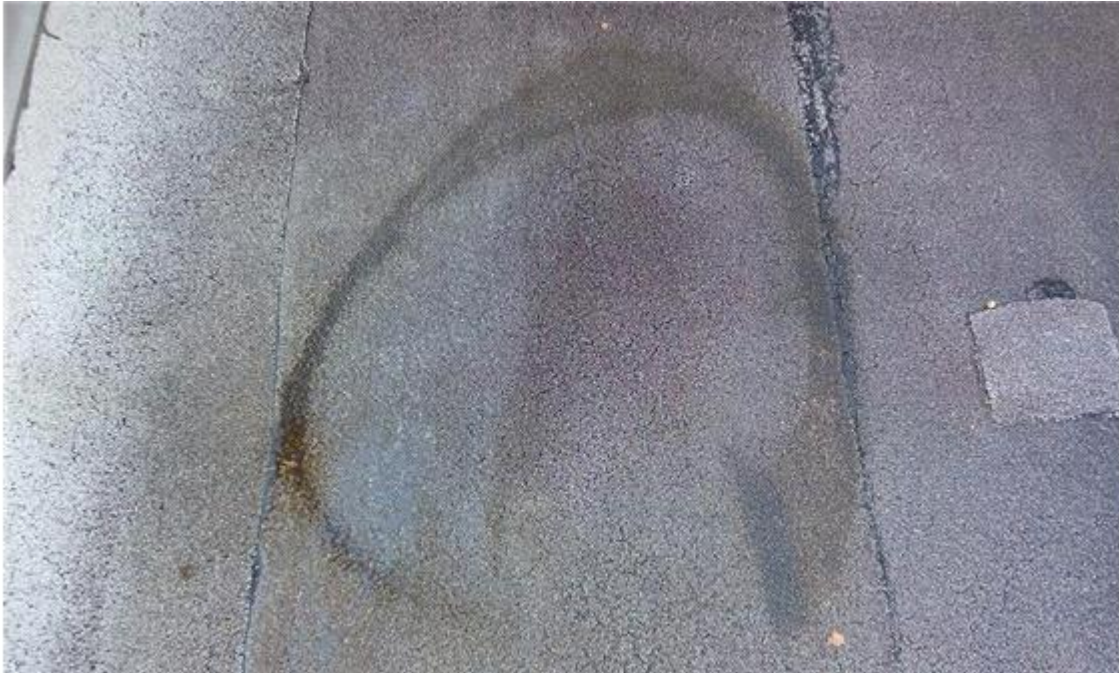
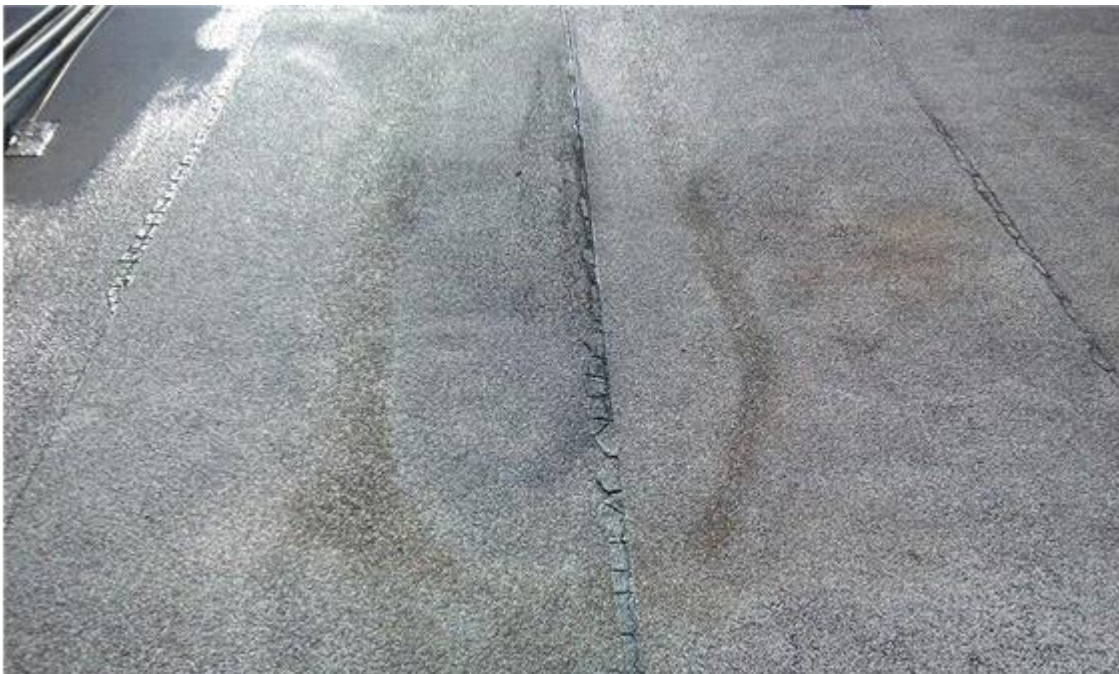
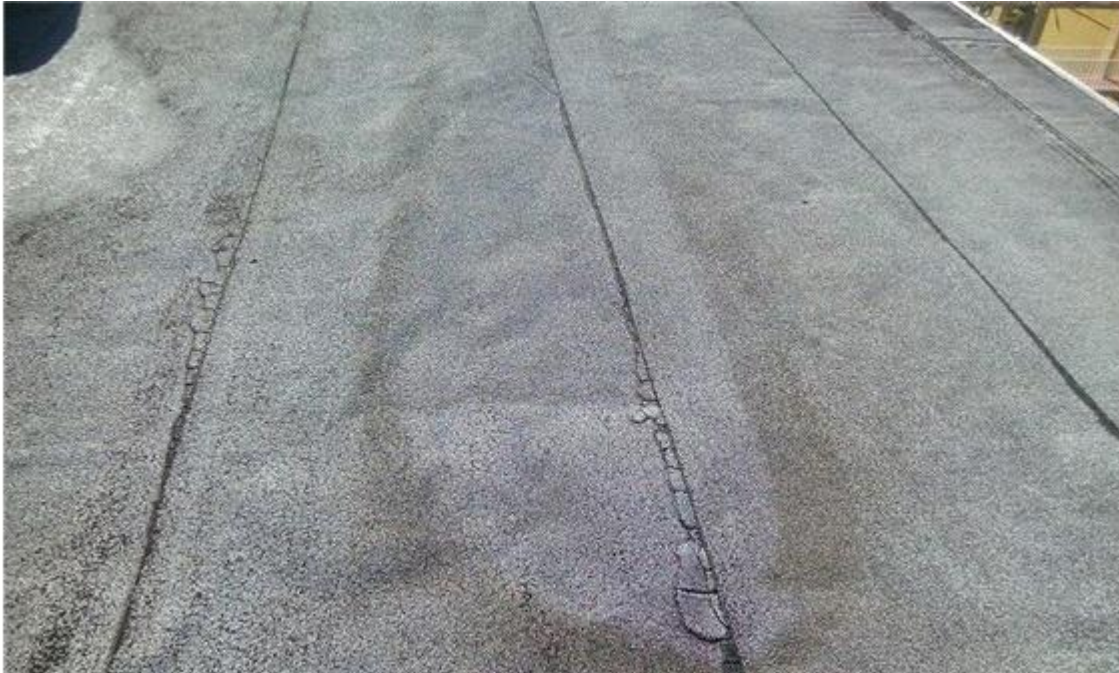
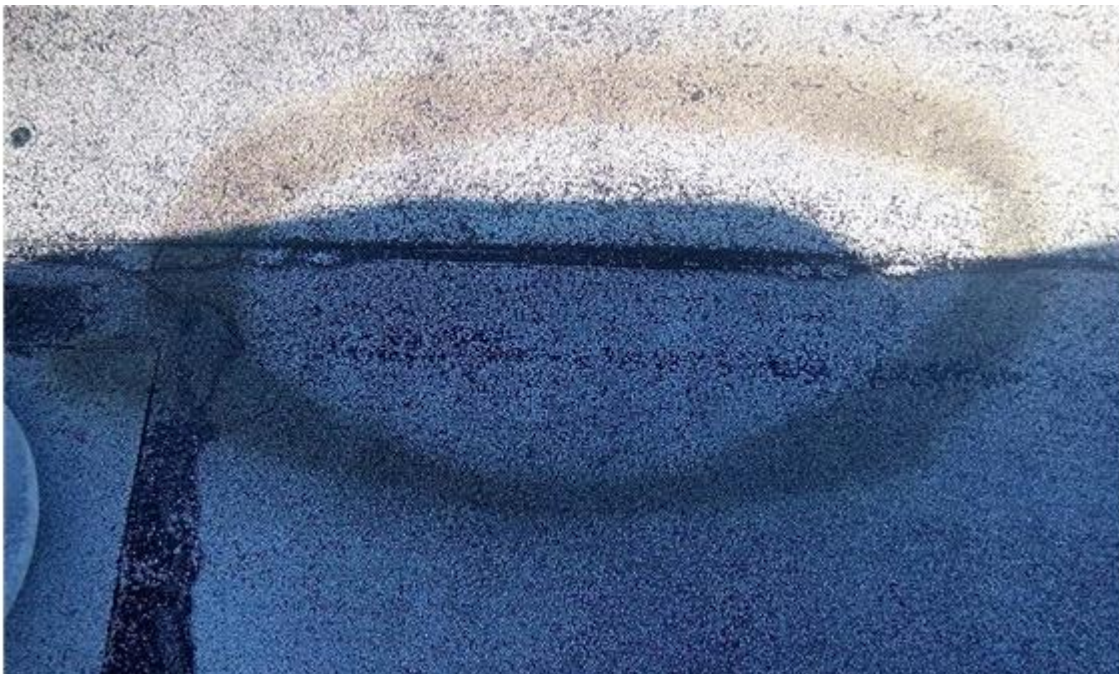
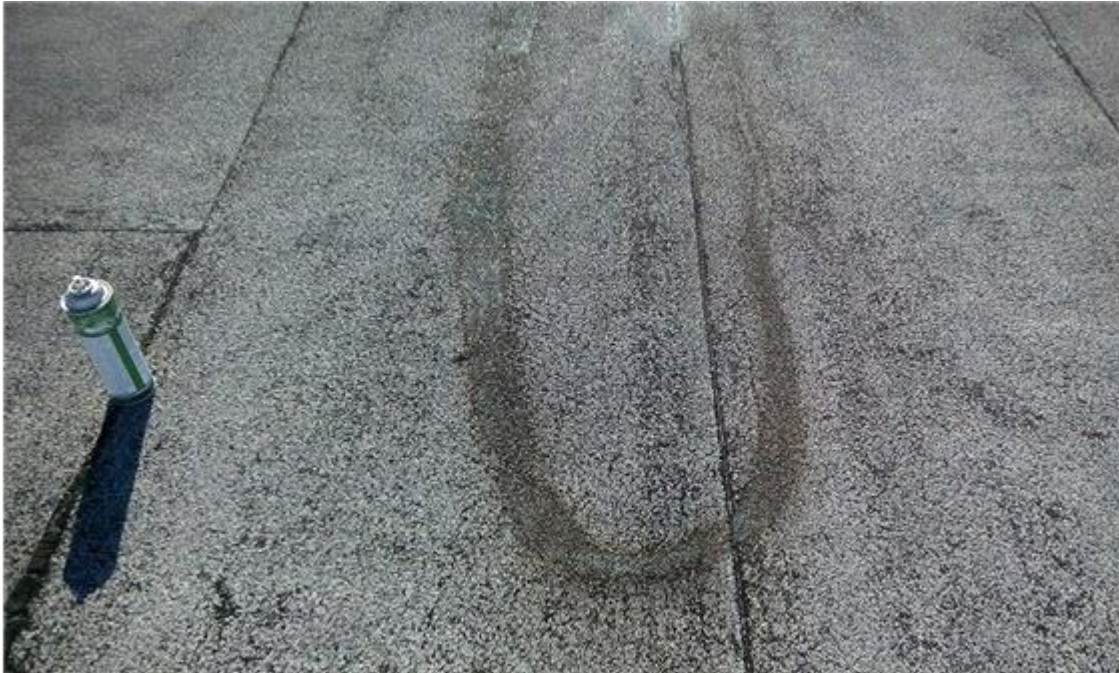
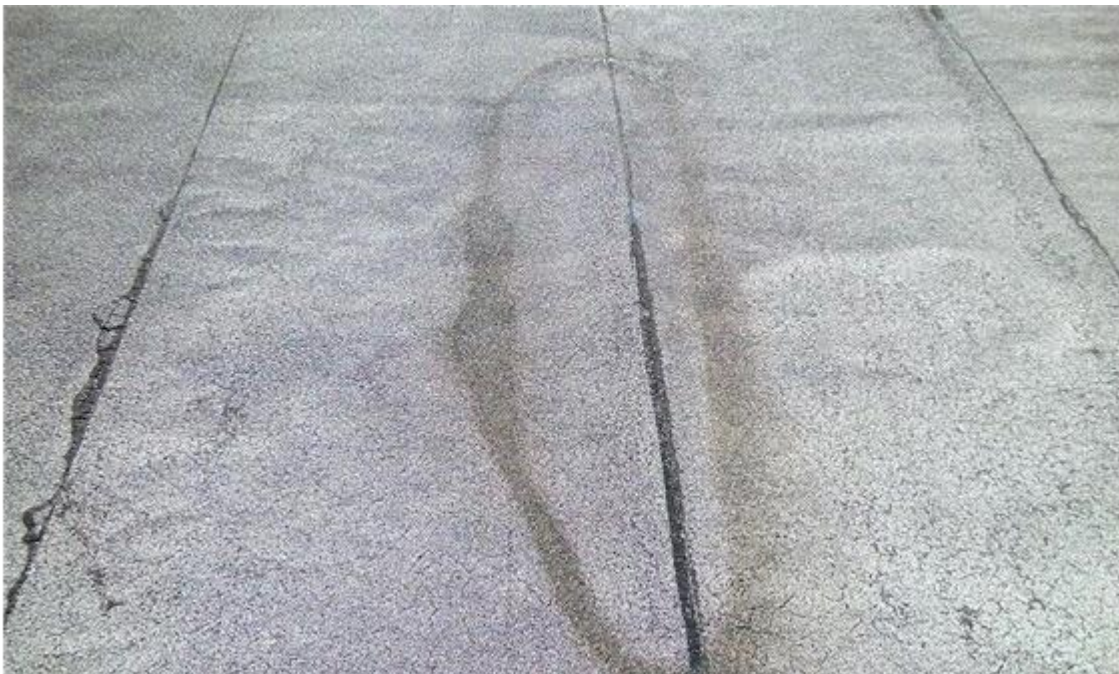
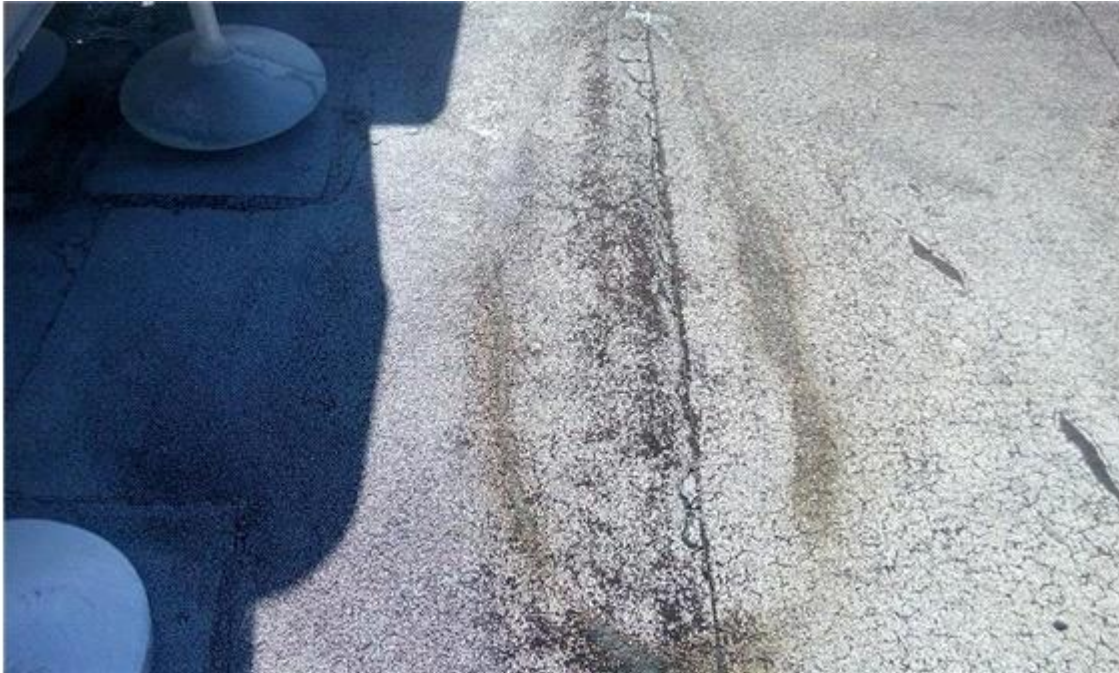
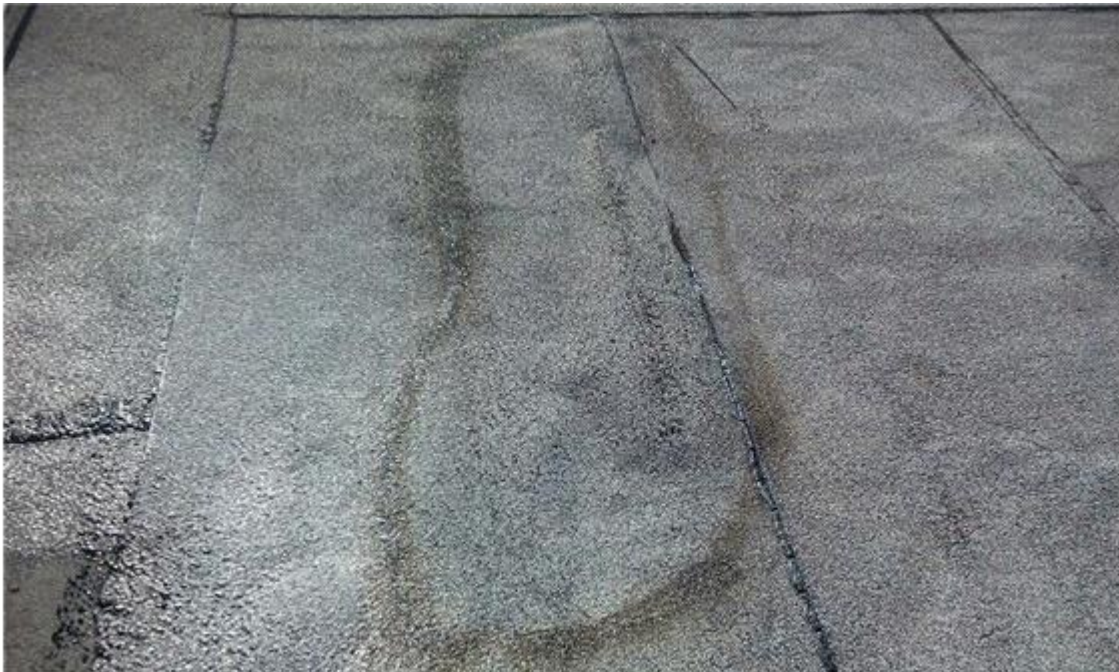
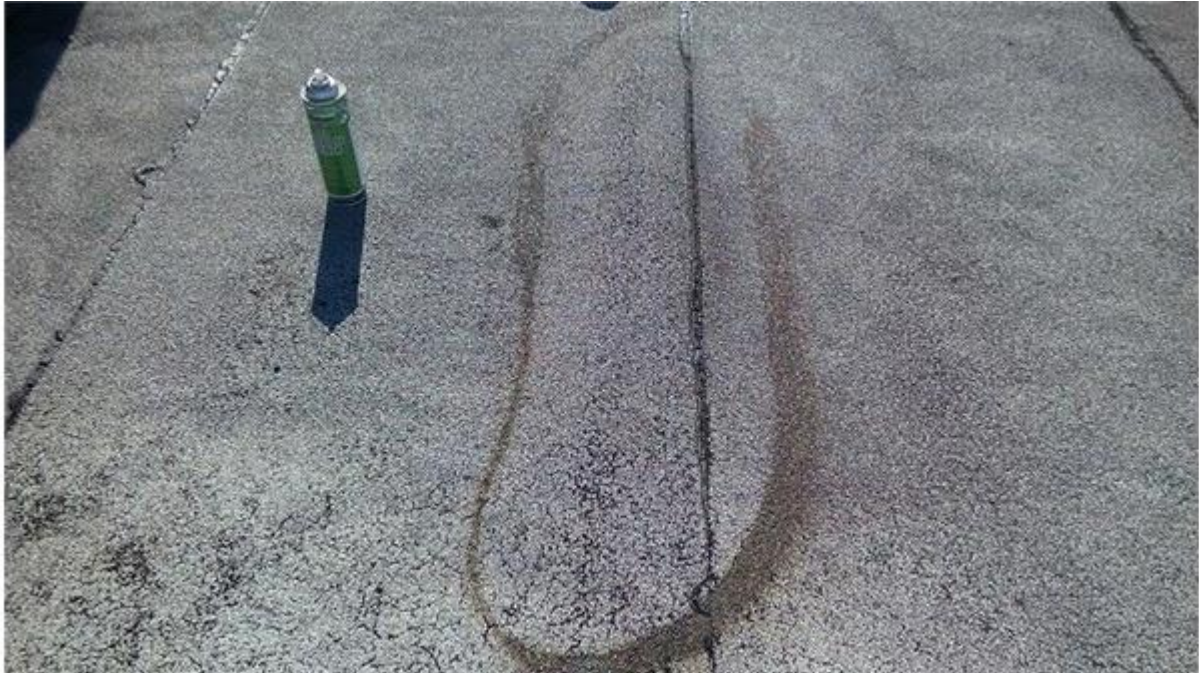
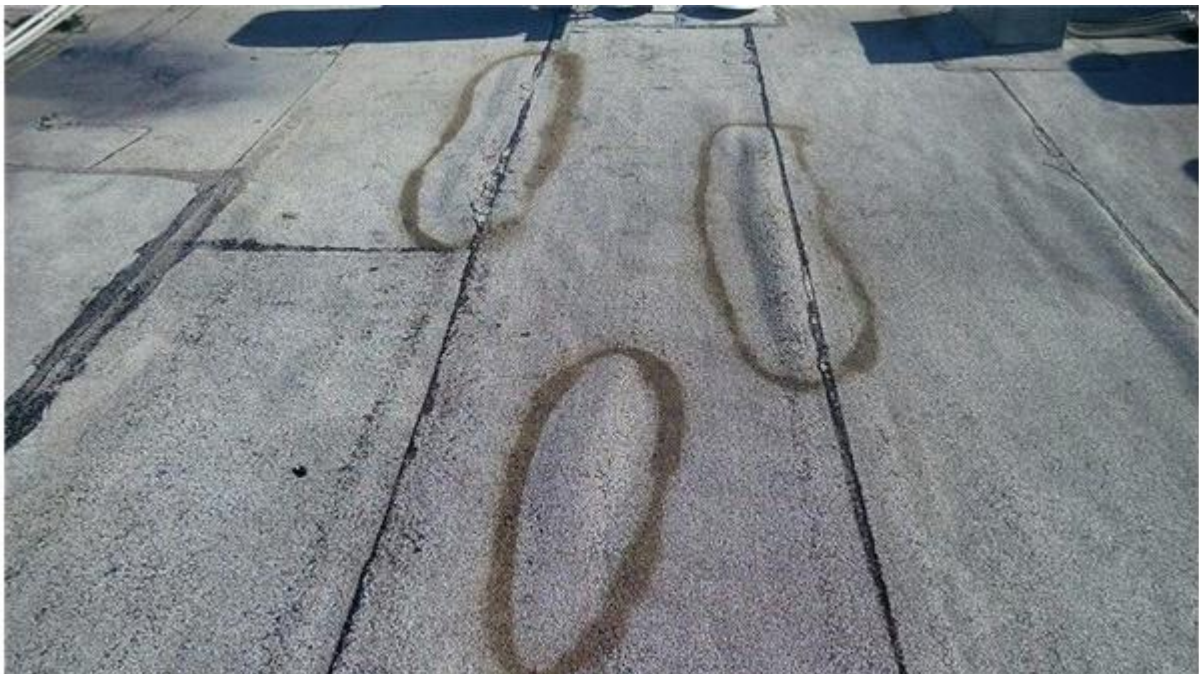
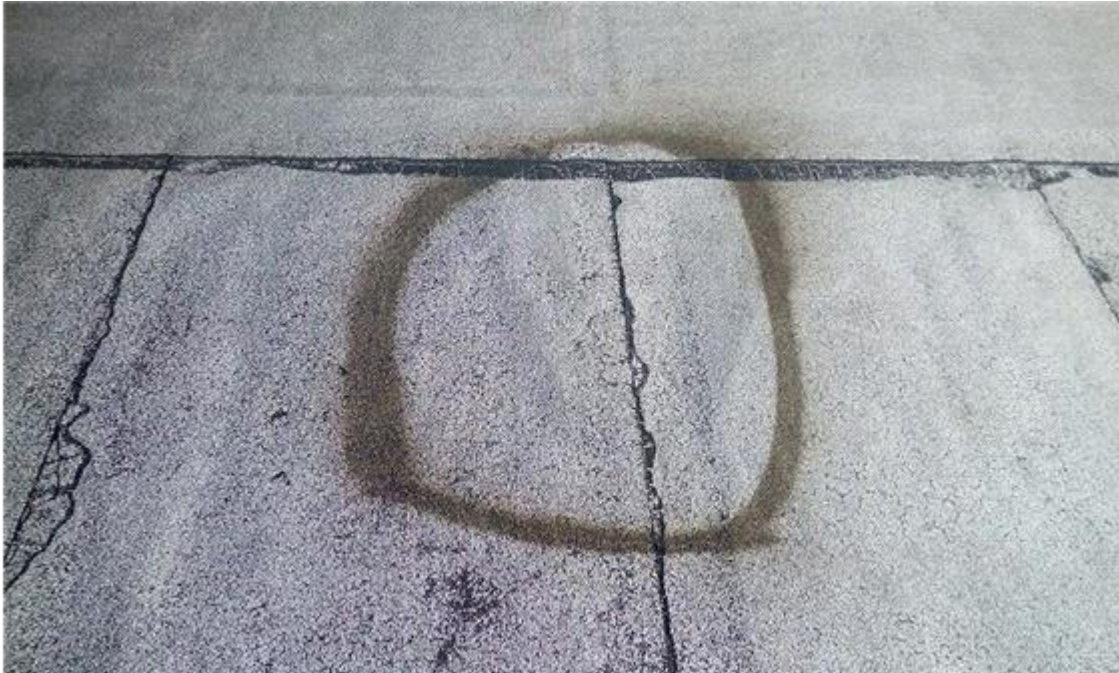
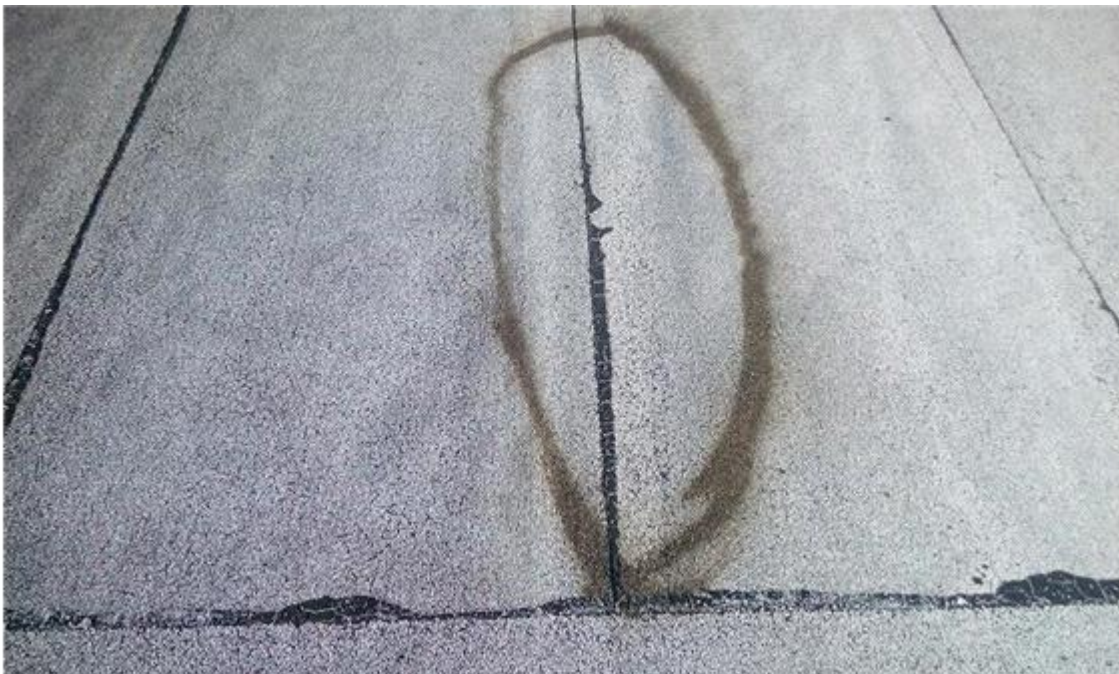
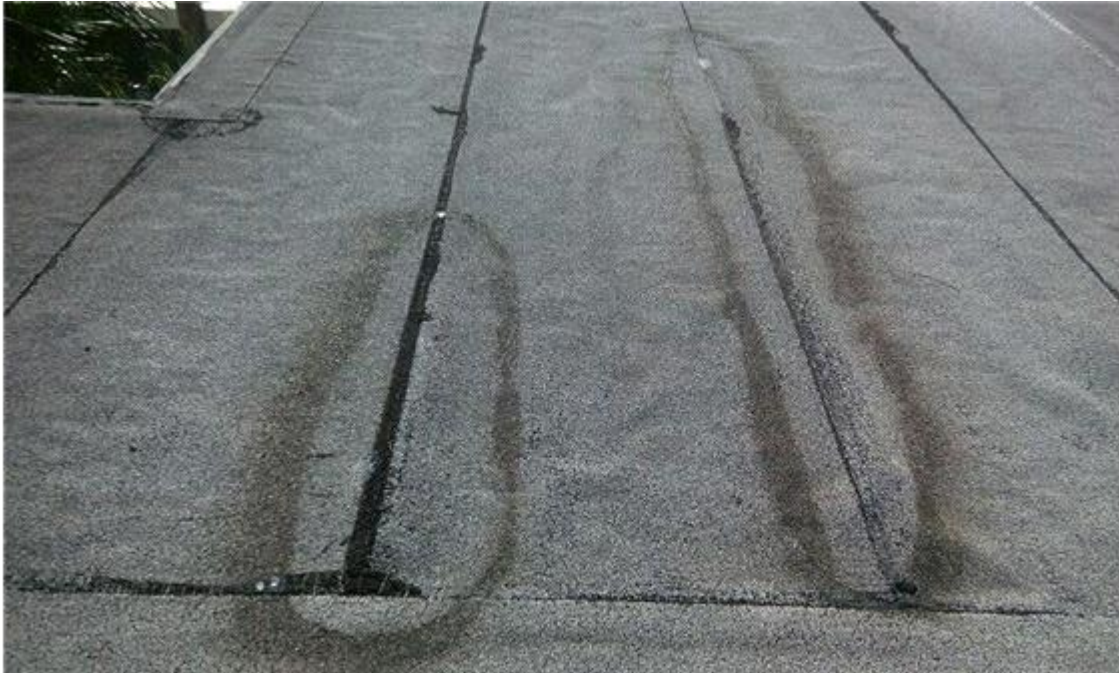
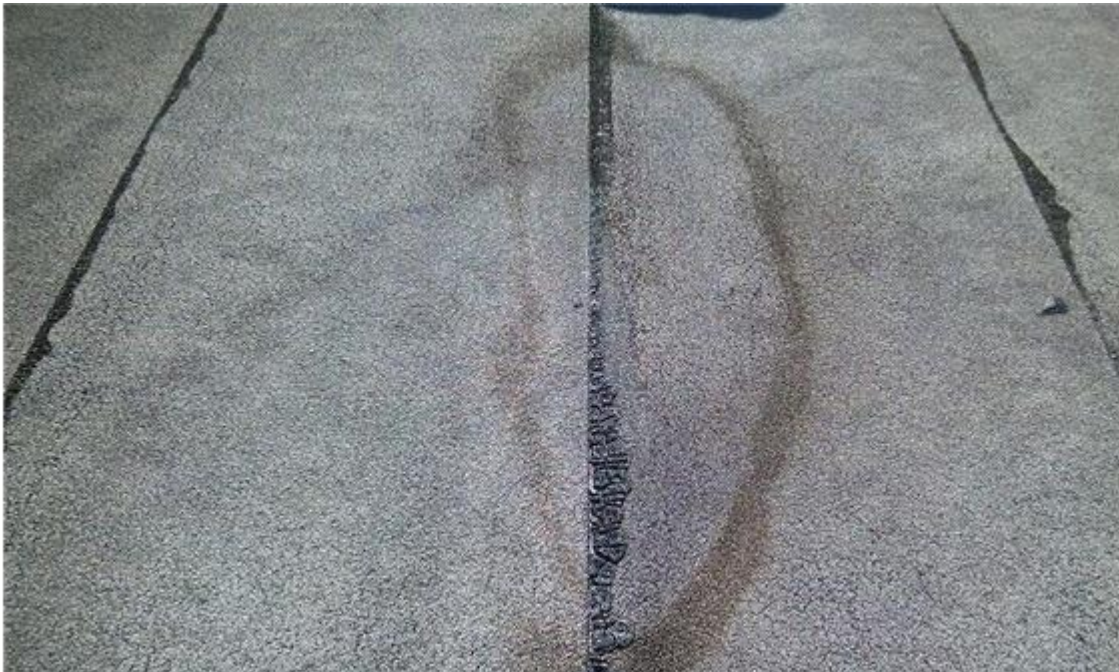
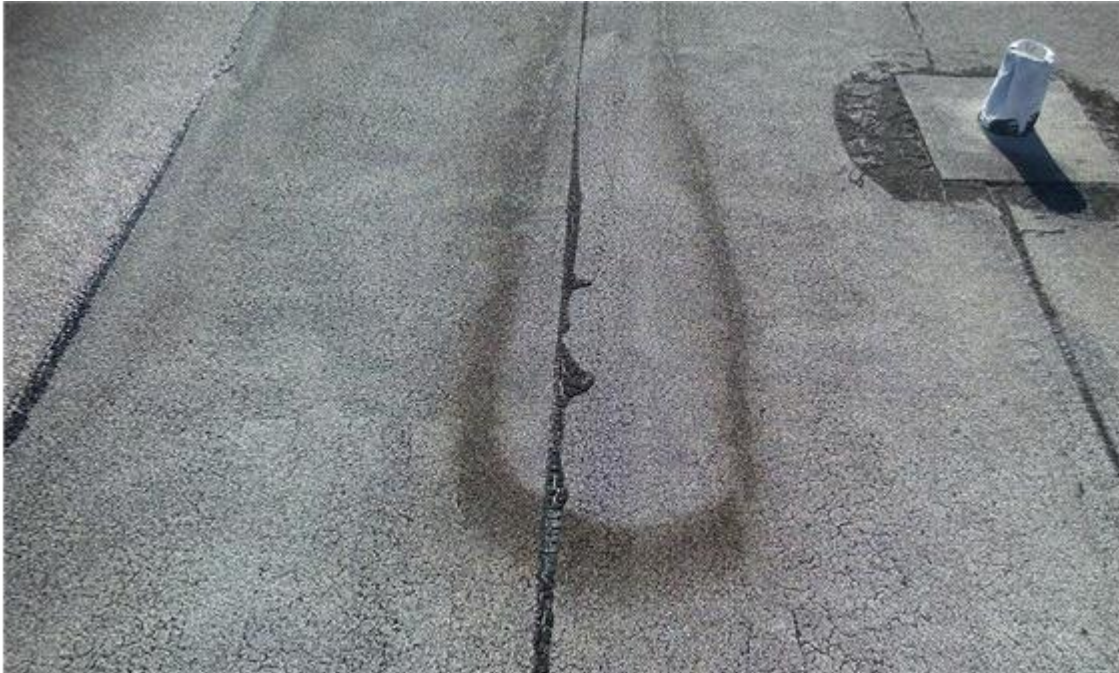
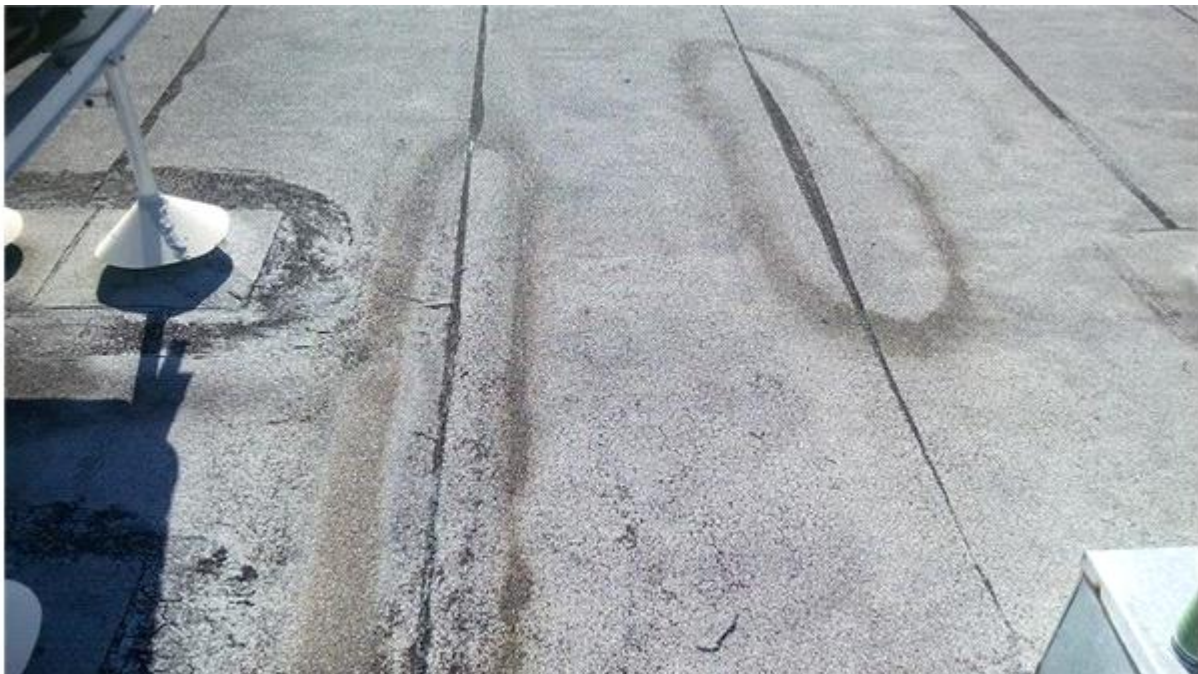
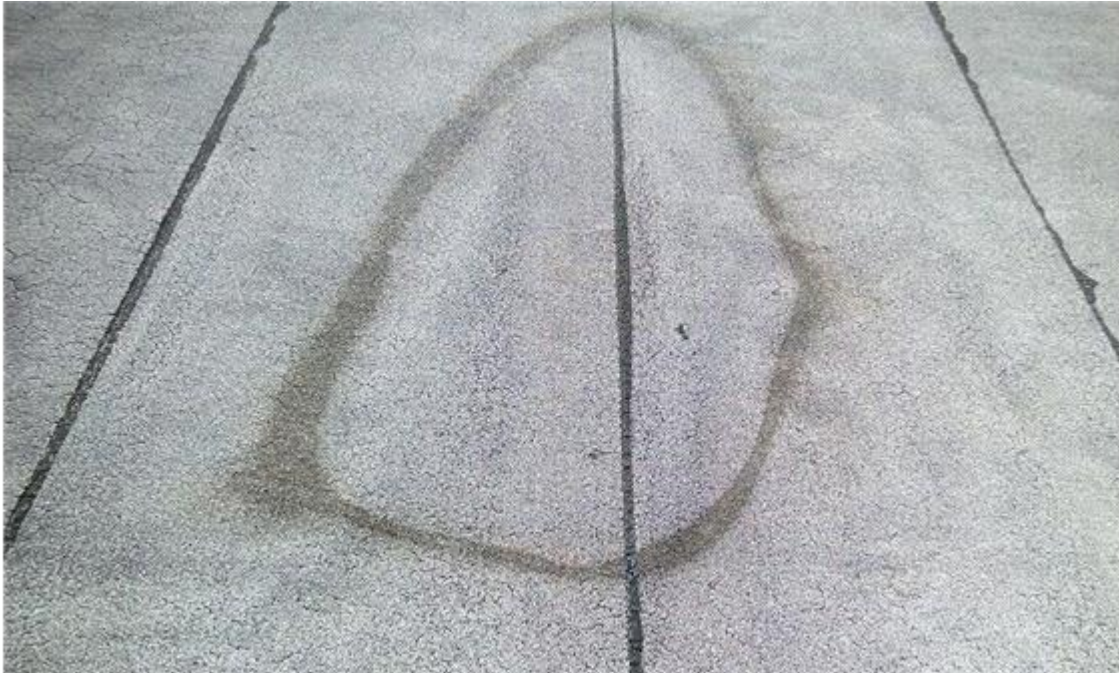
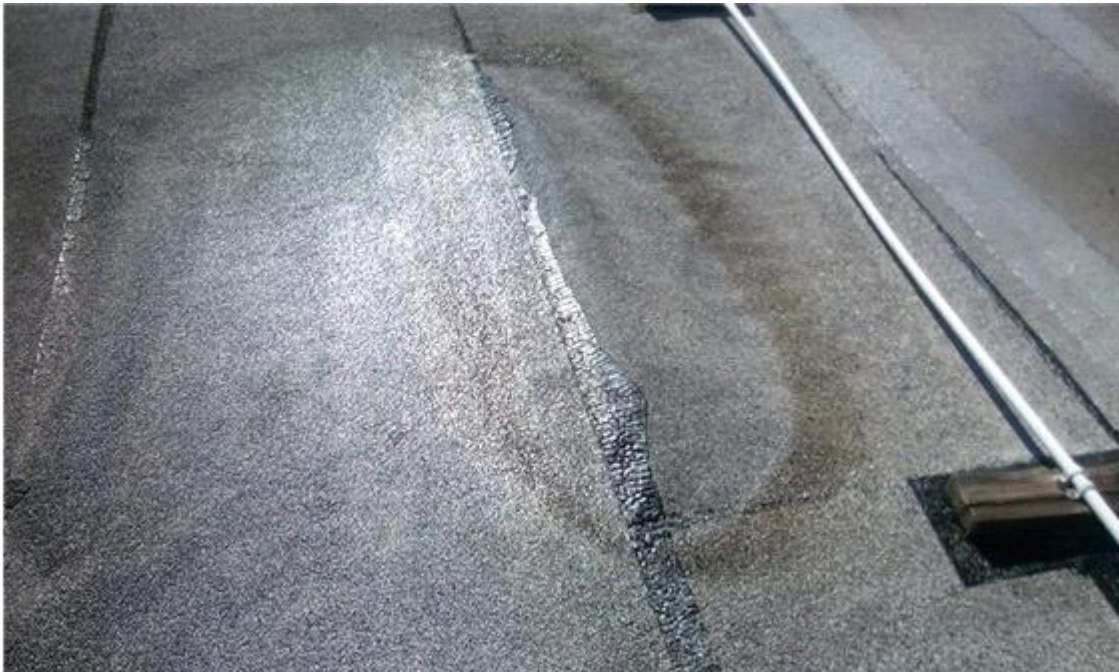
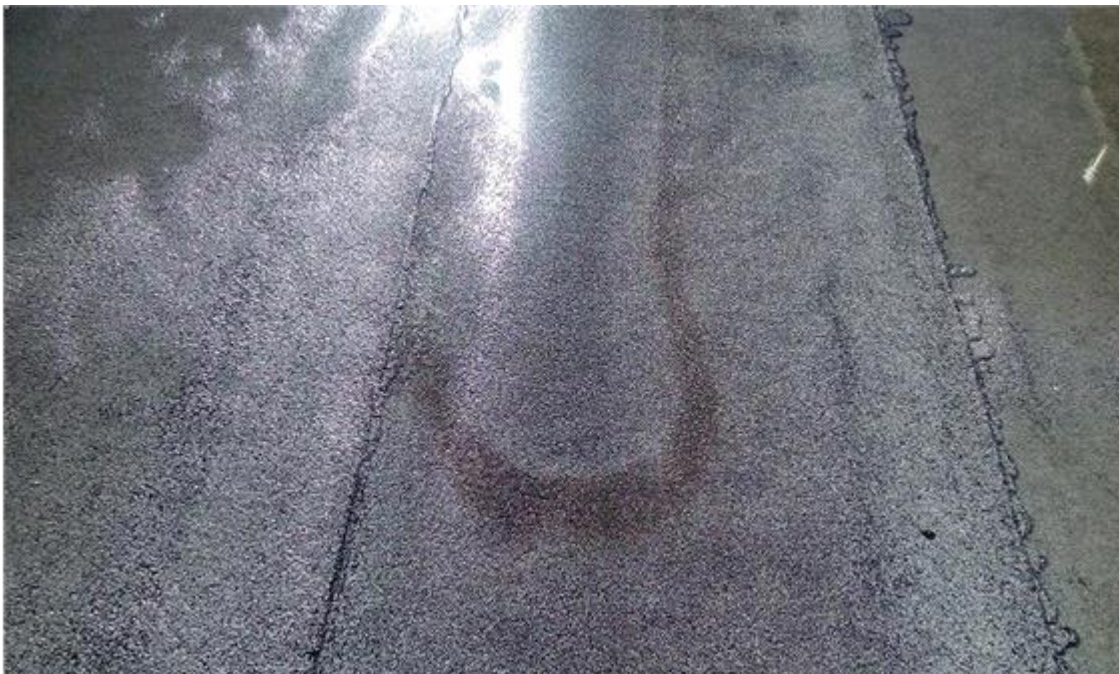
Blisters are caused by gas trapped in the system and may be ruptured with foot traffic.

Blisters are scheduled to be repaired bi-monthly, per the maintenance program. Blisters will be repaired based on time and materials and by order of severity.

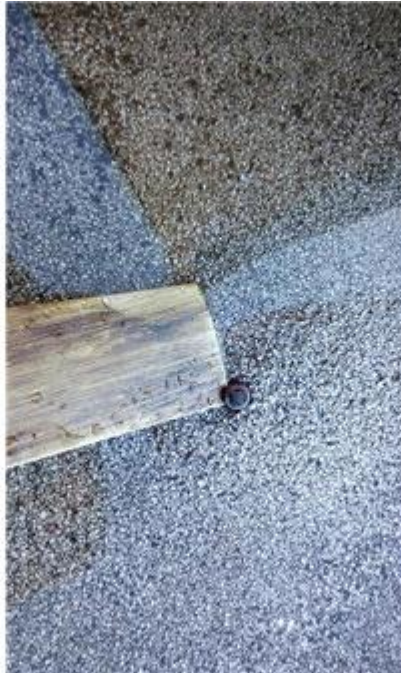
P-102 Penetration

Identified a puncture in the flashing membrane which is considered high severity due to their high leak potential.

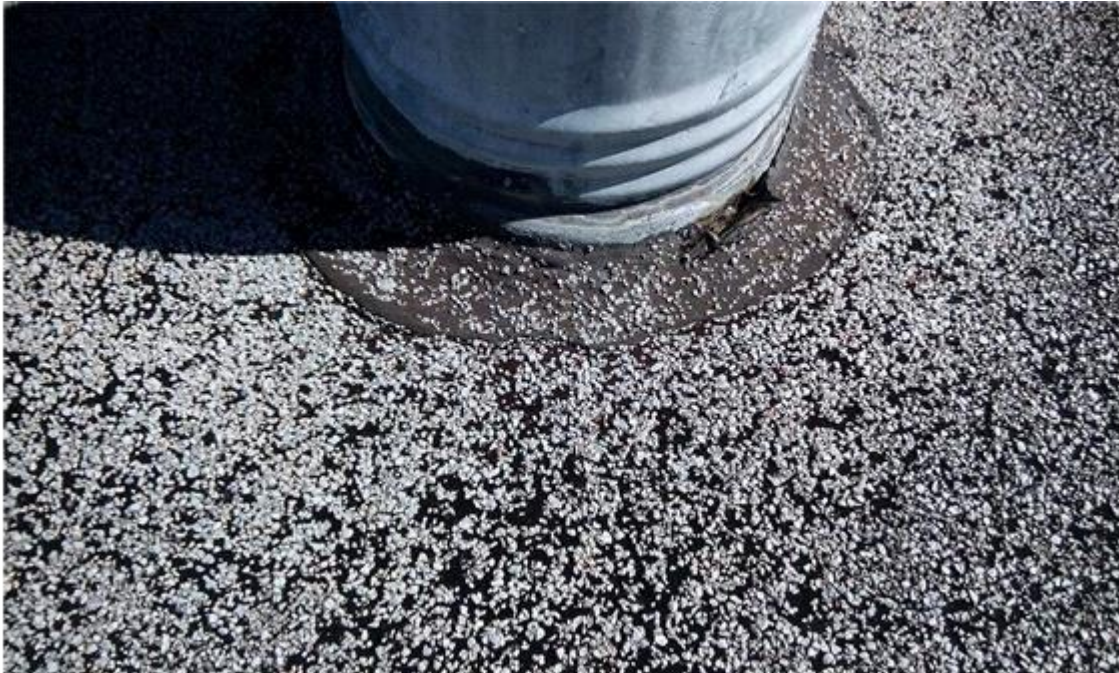
P-102 Penetration

Identified a puncture in the flashing membrane which is considered high severity due to their high leak potential.

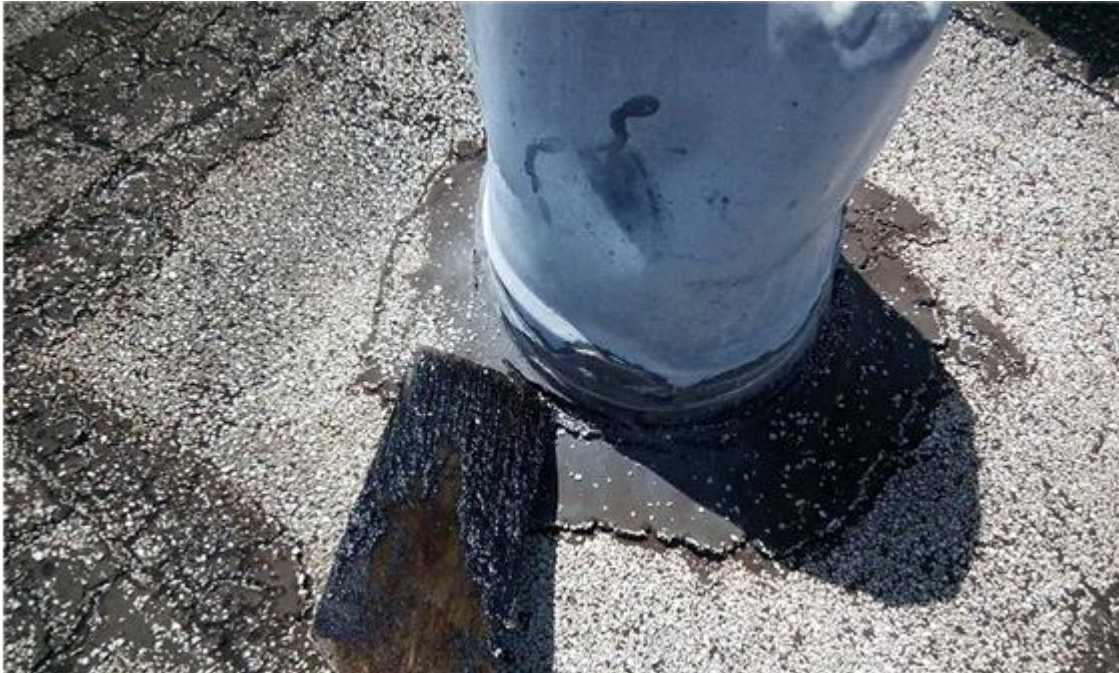
P-116 Penetration

No surface coating exists or there is a loss of surface coating which will lead to membrane degradation. The flashing needs to be recoated.

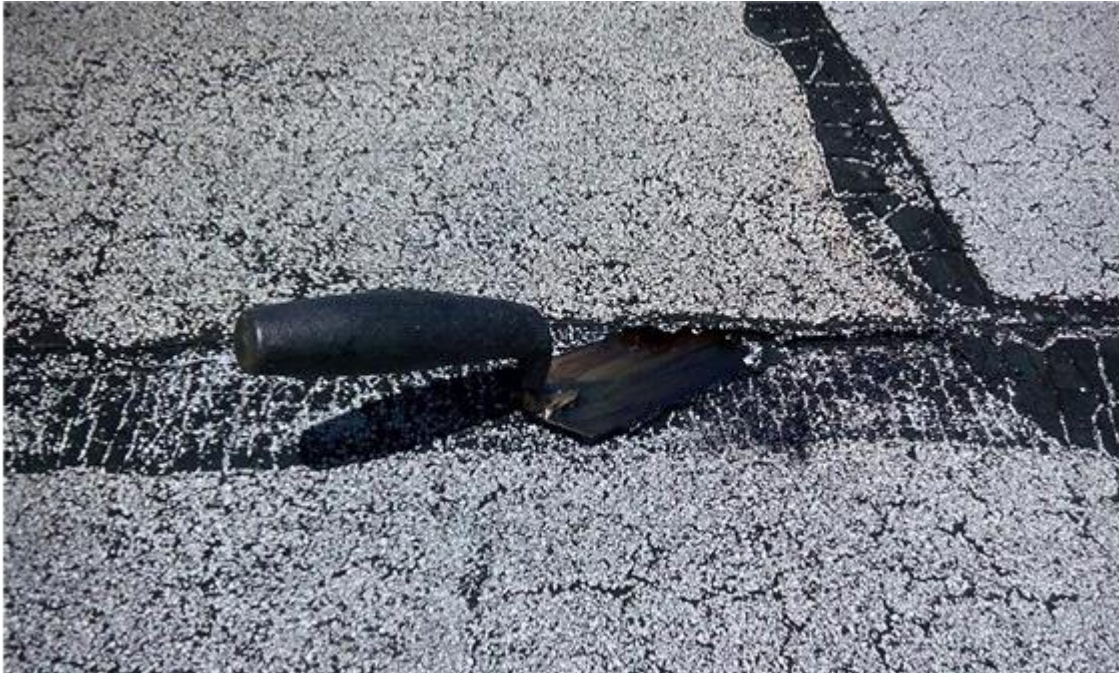
P-110 Penetration

The flashing membrane lap is open through the entire width, allowing water to penetrate the flashing.

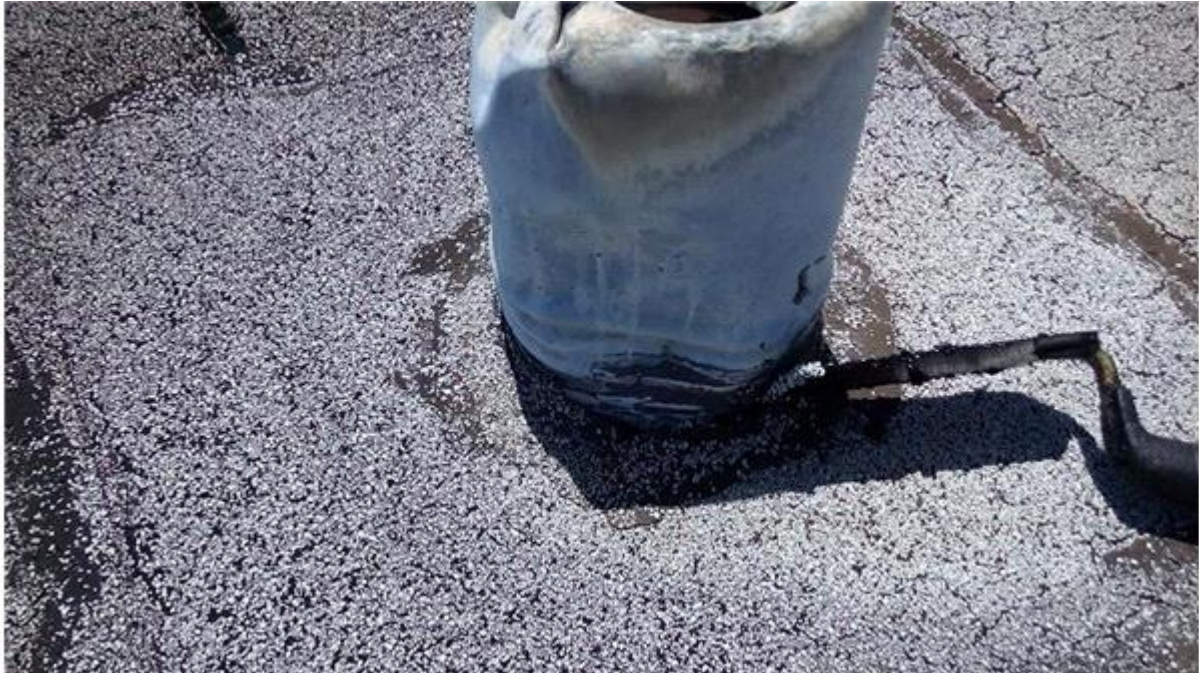
P-102 Penetration

Identified a puncture in the flashing membrane which is considered high severity due to their high leak potential.

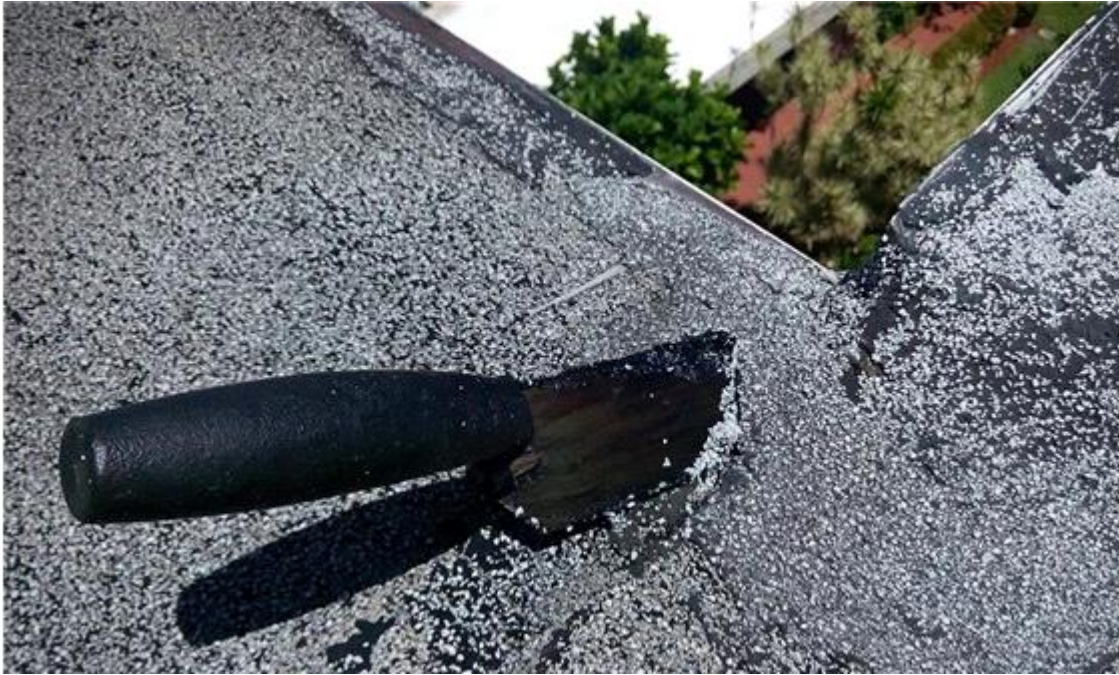
P-110 Penetration

The flashing membrane lap is open through the entire width, allowing water to penetrate the flashing.

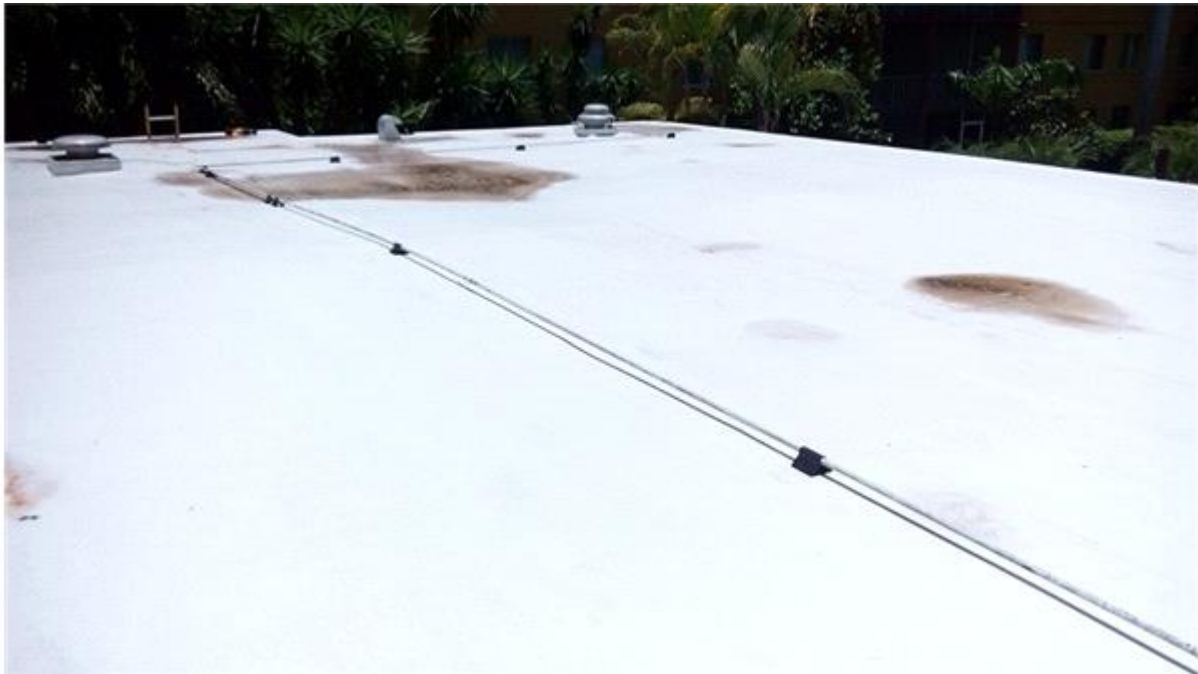
001G- Surface Overview

The roof surface appears to be in good, maintainable condition at this time.

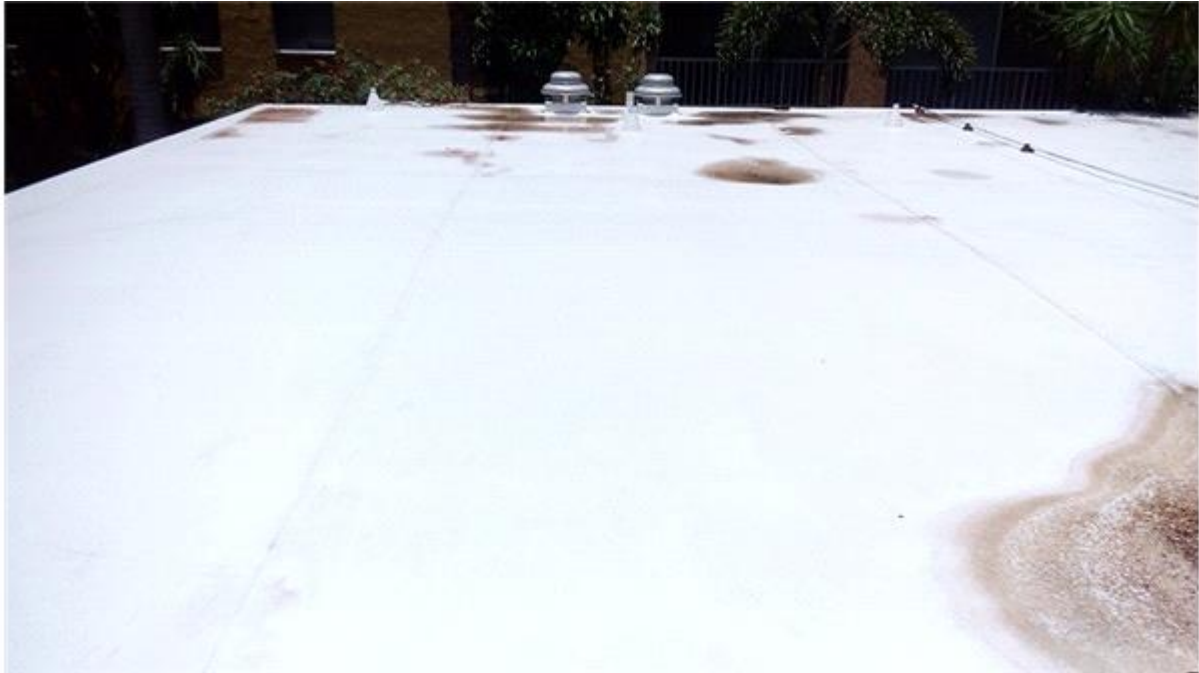
003G - Membrane Overview

The membrane appears to be in good, maintainable condition at this time.

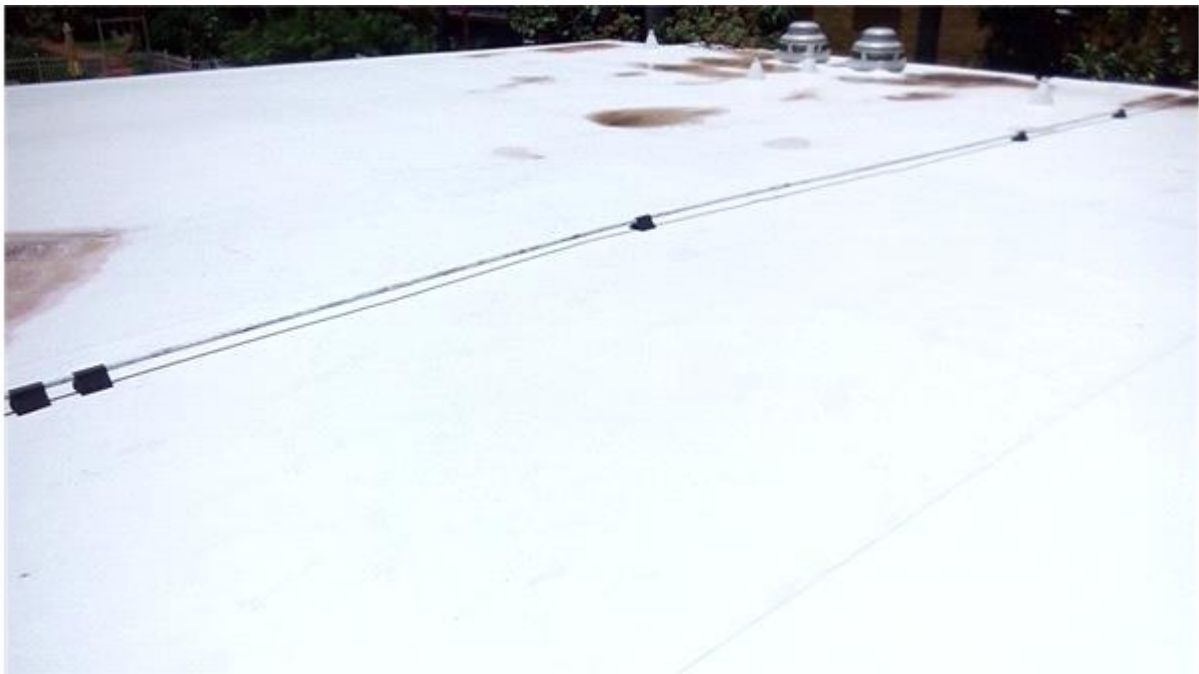
002G- Appearance Overview

The roof appearance is in good, maintainable condition at this time.

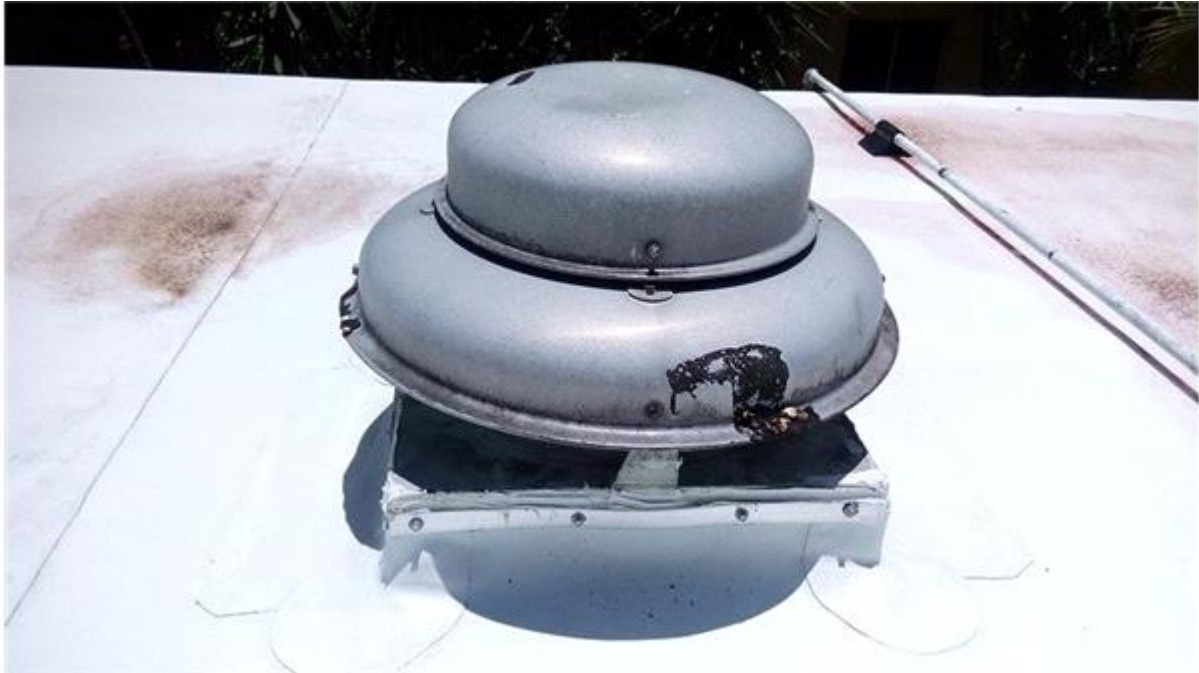
002F-Roof Vents

The roof vents appear to be in fair condition at this time.

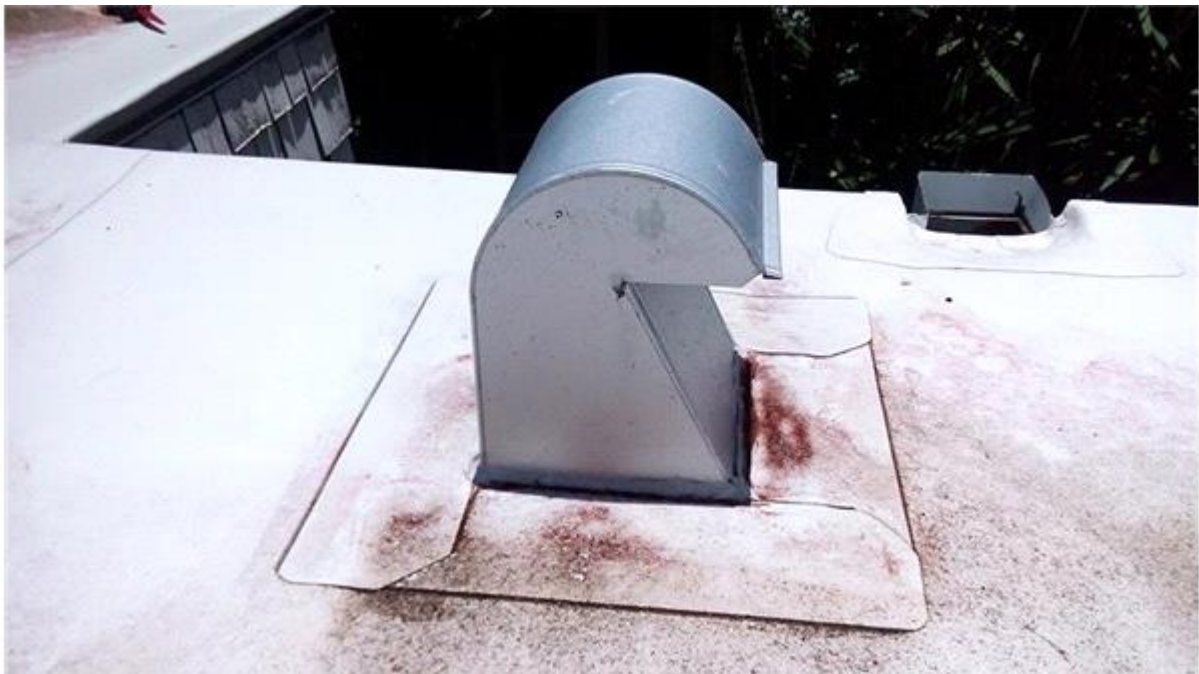
002F-Roof Vents

The roof vents appear to be in good condition at this time.
