Inspection Report

Facility: Towers, The
Address: 2366 East Mall Dr,
Fort Myers, 33912

Inspection Date: Tuesday, June 12, 2018

Re.: **Inspection Report (2 of 6) for The Towers**

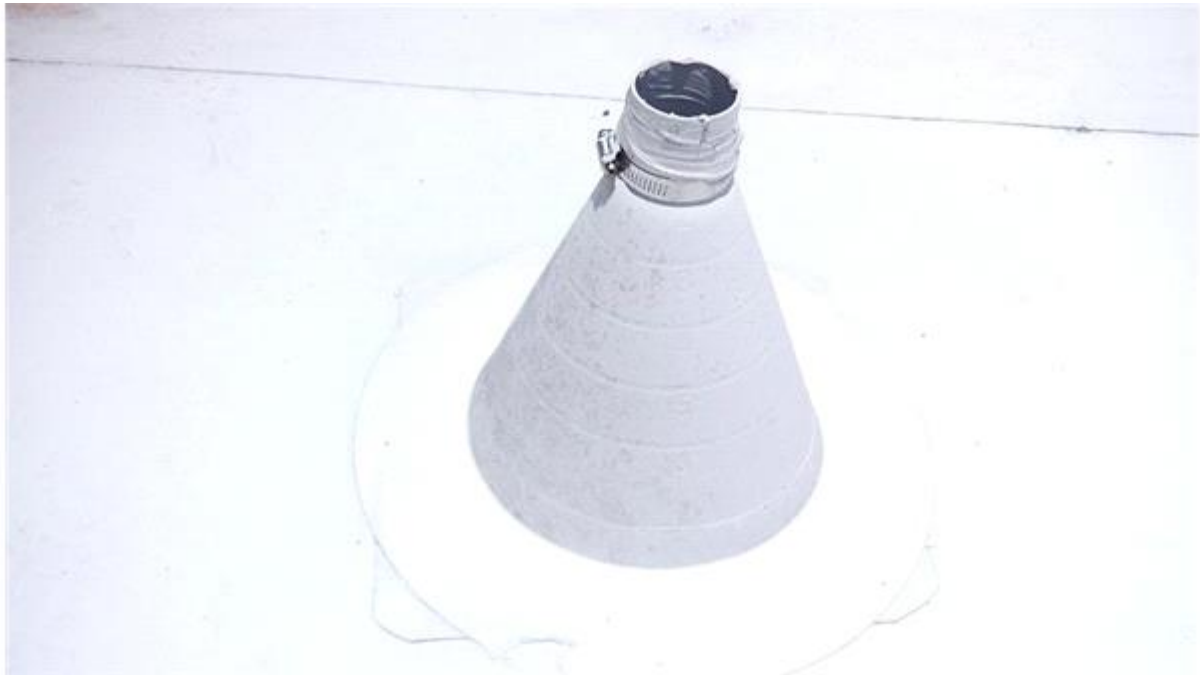
019G-TPO Boots

The TPO boots appear to be in good condition at this time.

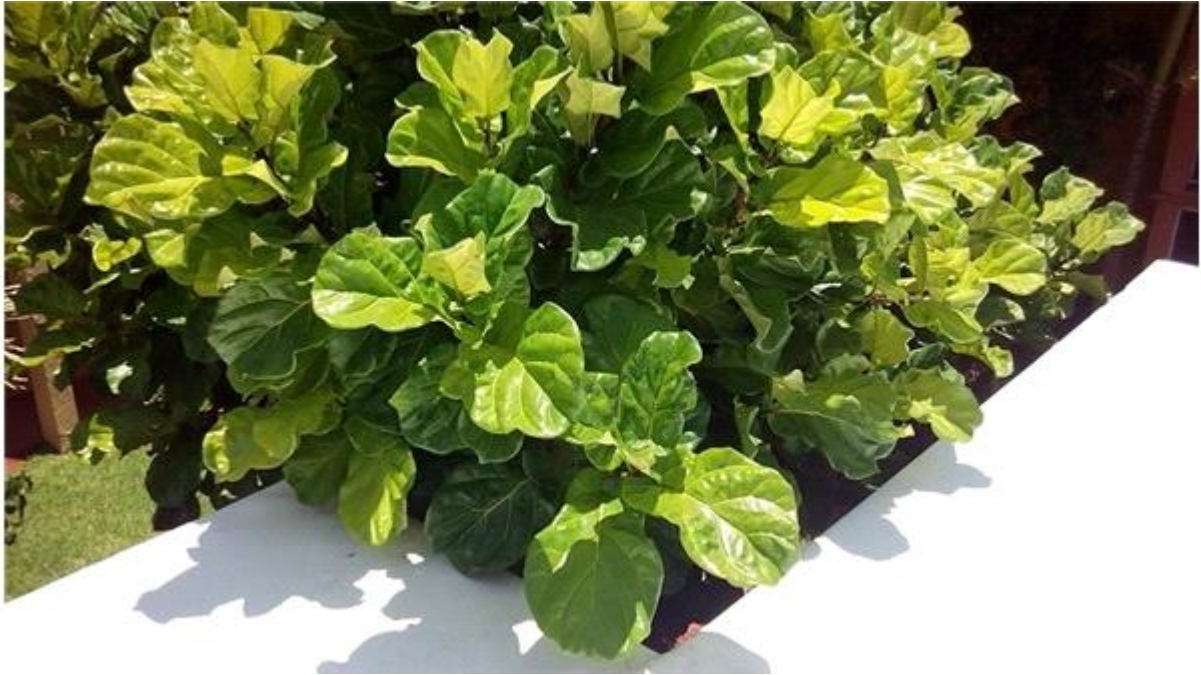
031- Tree Branches

Identified tree branches hanging over the roof surface, which can cause deterioration of the membrane and act as an access for rodents and unwanted bugs/pests.

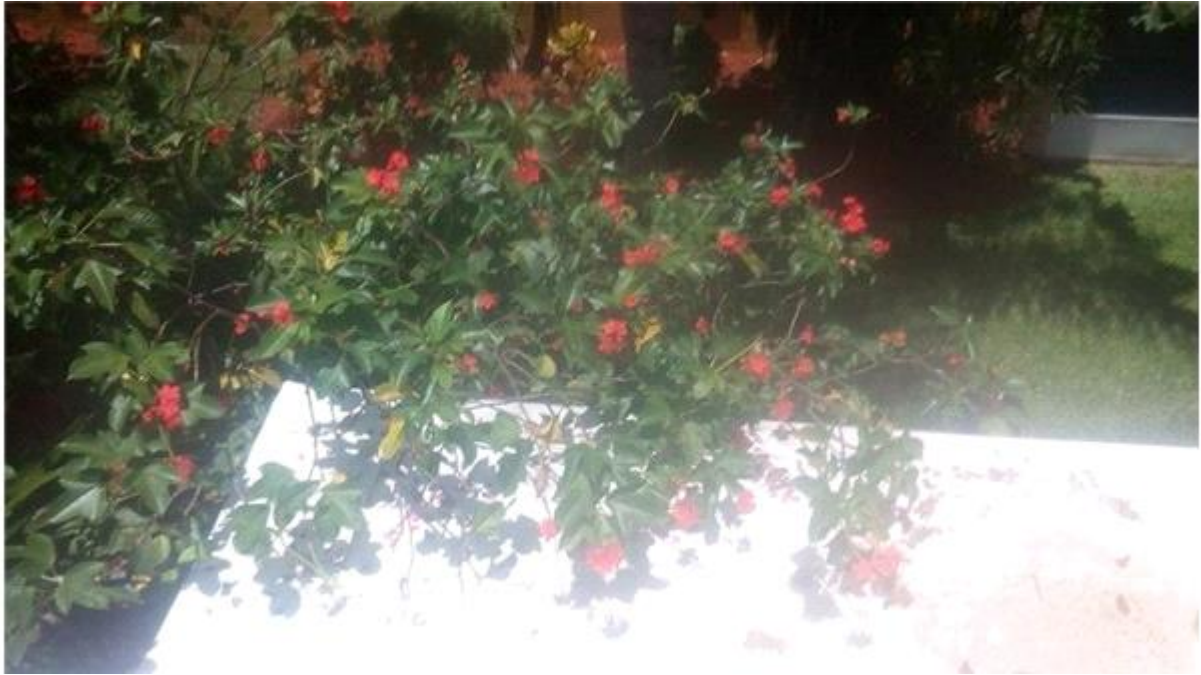
031- Tree Branches

Identified tree branches hanging over the roof surface, which can cause deterioration of membrane and act as an access for rodents and unwanted bugs/pests.

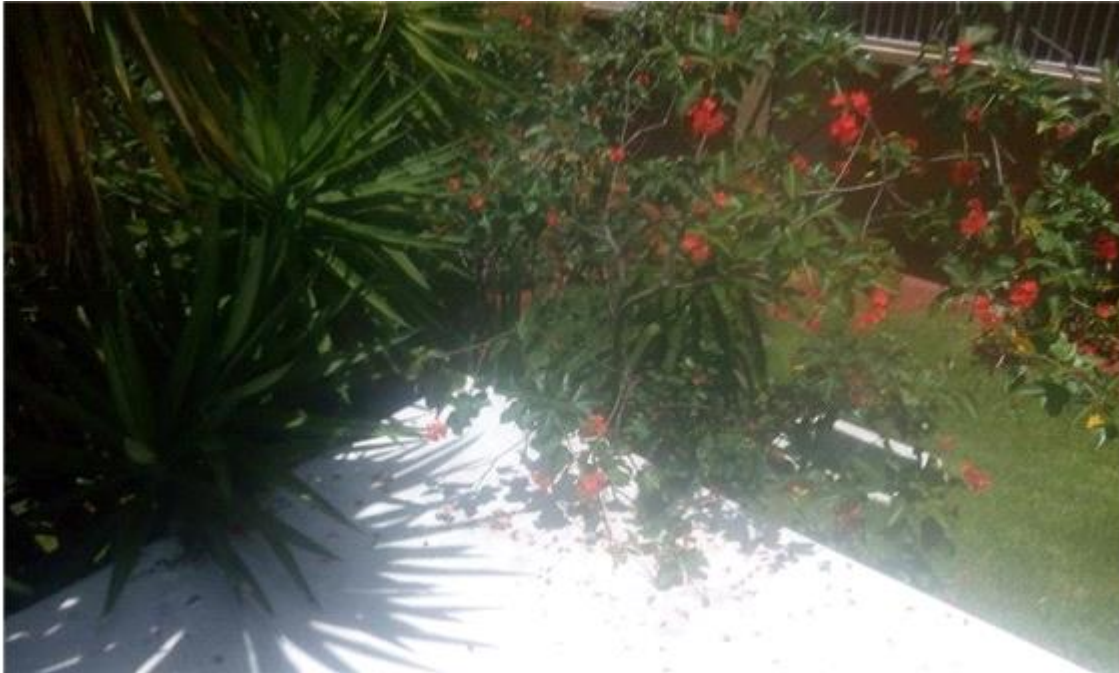
031- Tree Branches

Identified tree branches hanging over the roof surface, which can cause deterioration of membrane and act as an access for rodents and unwanted bugs/pests.
