**Maintenance and Service Plan** 2543 Rockfill Road Fort Myers, FL 33916

Re.: **Inspection Report (3 of 6) for The Towers**

**THE TOWERS**  
2366 EAST MALL DRIVE  
FORT MYERS, FL 33912

*Crowther Roof Check Maintenance Program-Inspection Report*

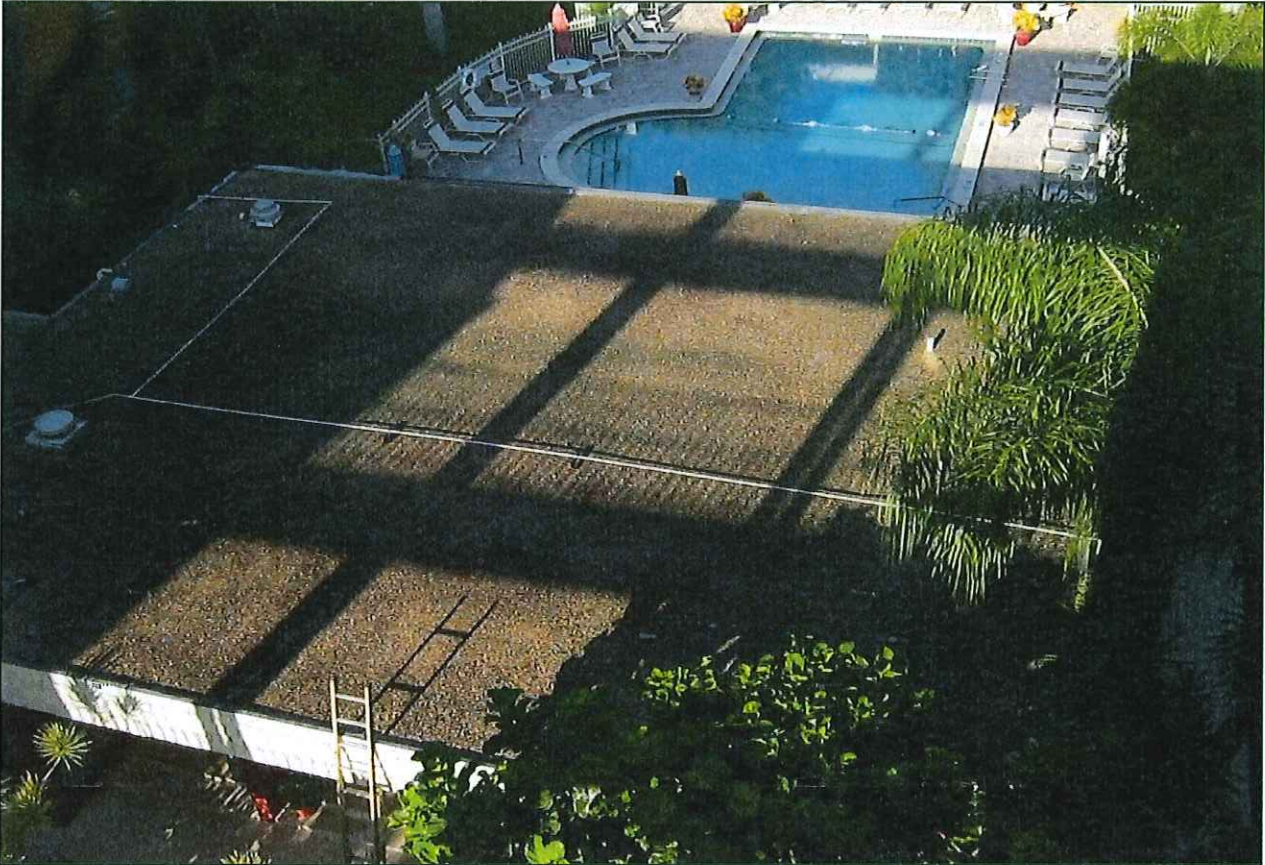
**EXHIBIT #: 2**

Main Roof Overview

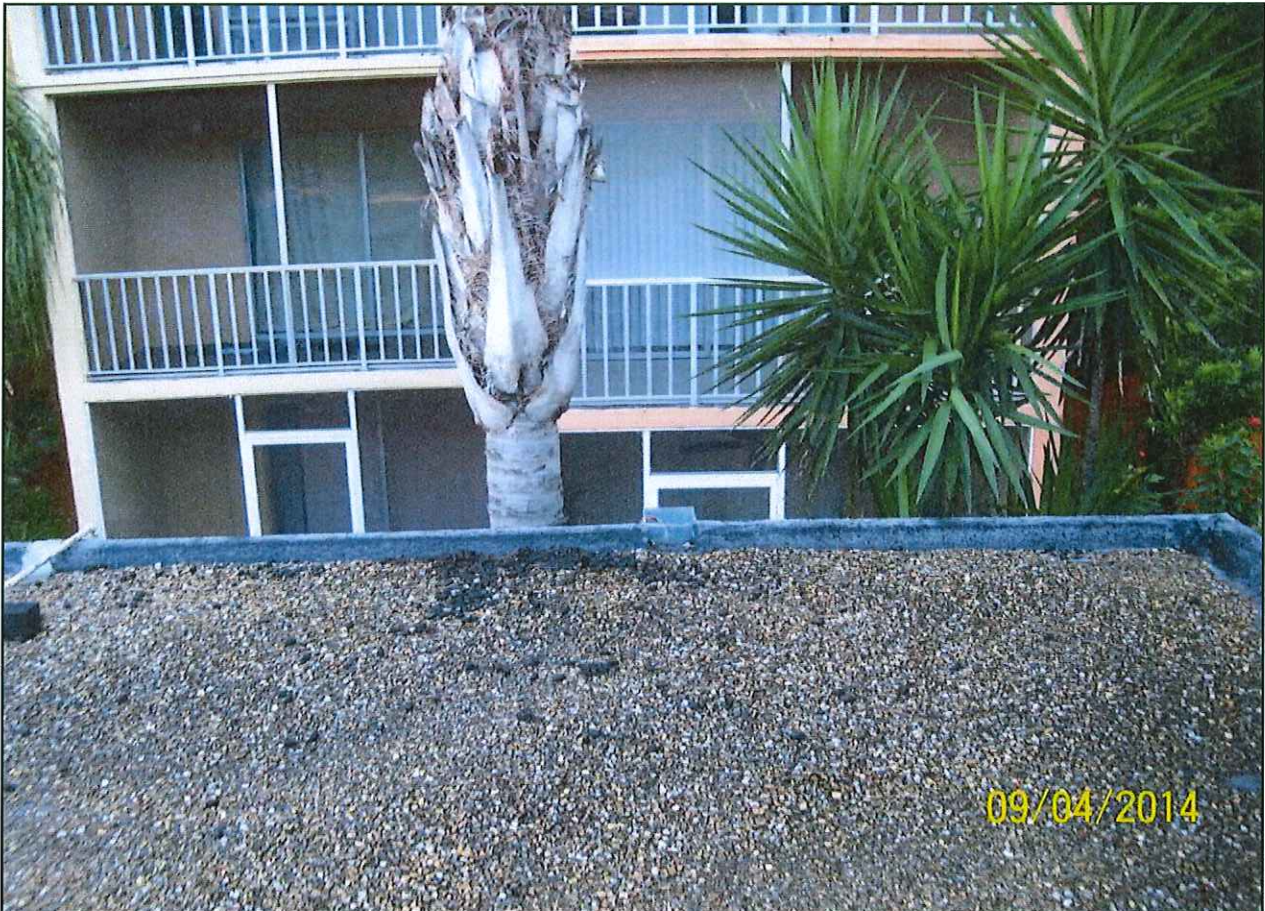
**EXHIBIT #: 3**

- Found an area of deteriorated base flashing
- Found tree branches hanging over the roof surface

Found areas of deteriorated  
base flashings

Suggest coating the base flashing with  
aluminum coating

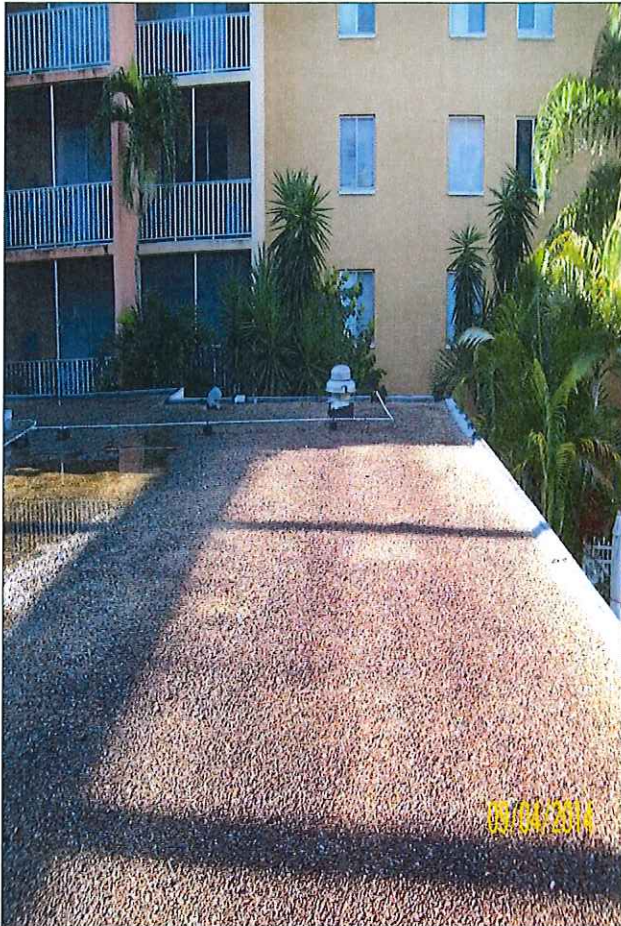
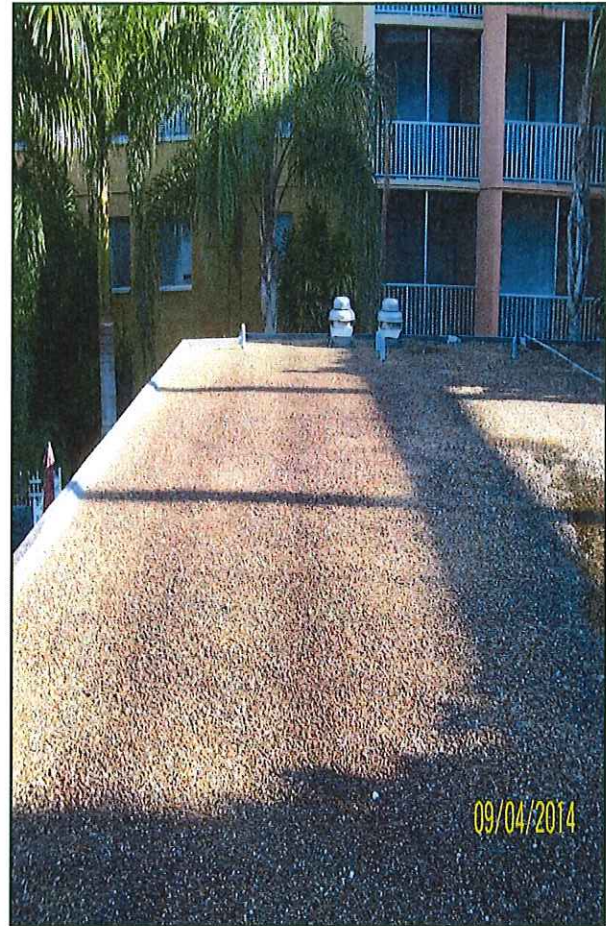
**EXHIBIT #: 4**

Found tree branches hanging over the roof surface

- Cut back the branches away from the roof surface

Cut back the branches away from the roof surface

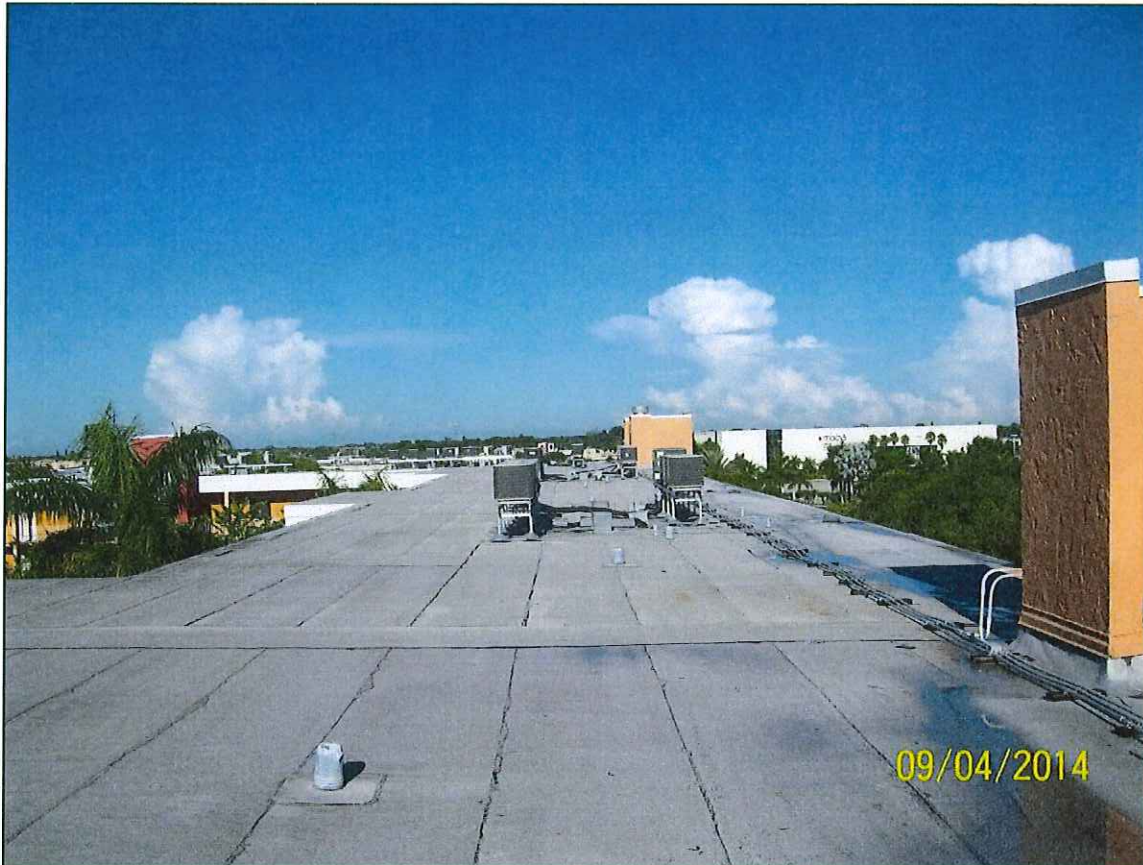
**EXHIBIT #: 5**

Main Roof Overview

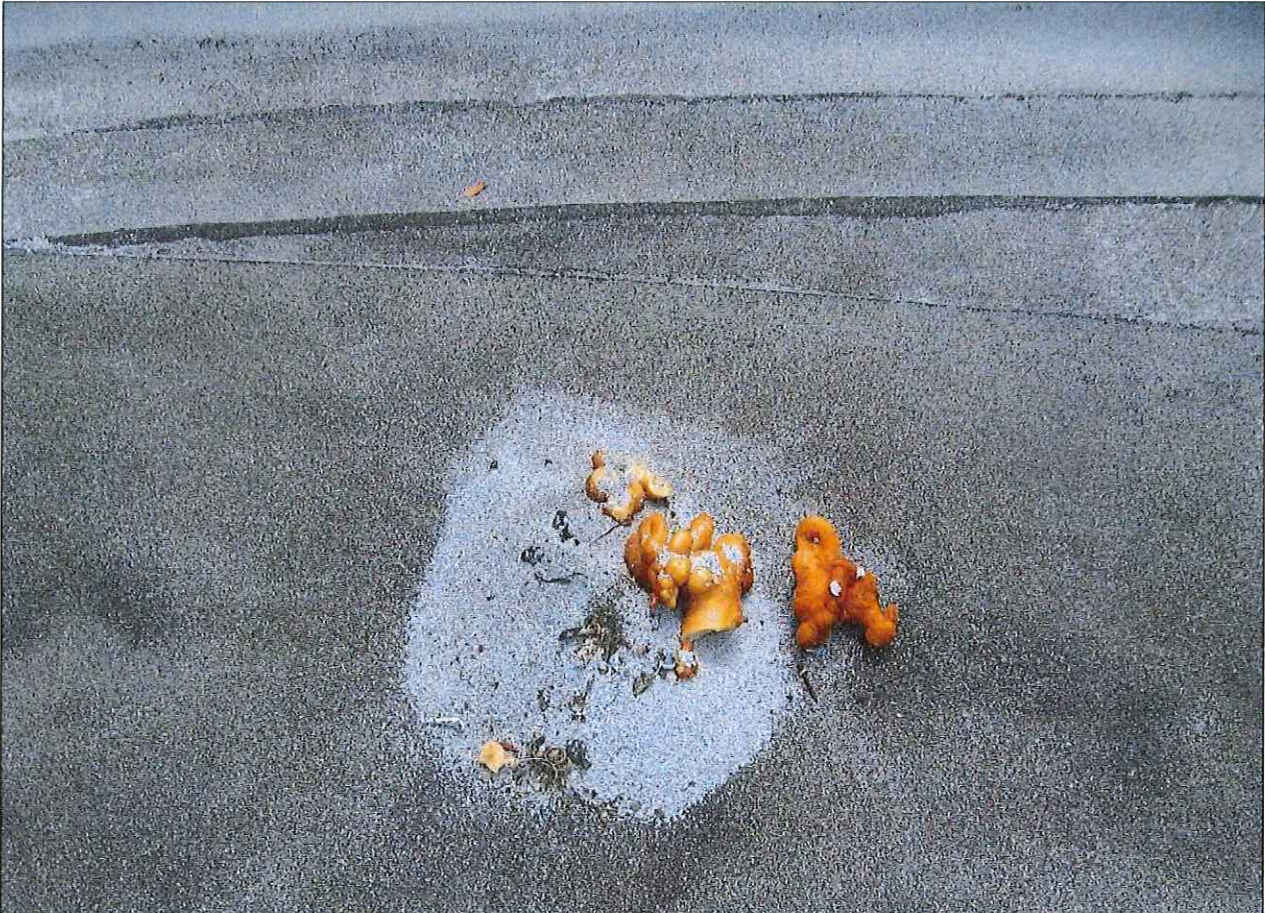
**EXHIBIT #: 6**

Identified debris on the roof surface

Cleaned the debris from the roof

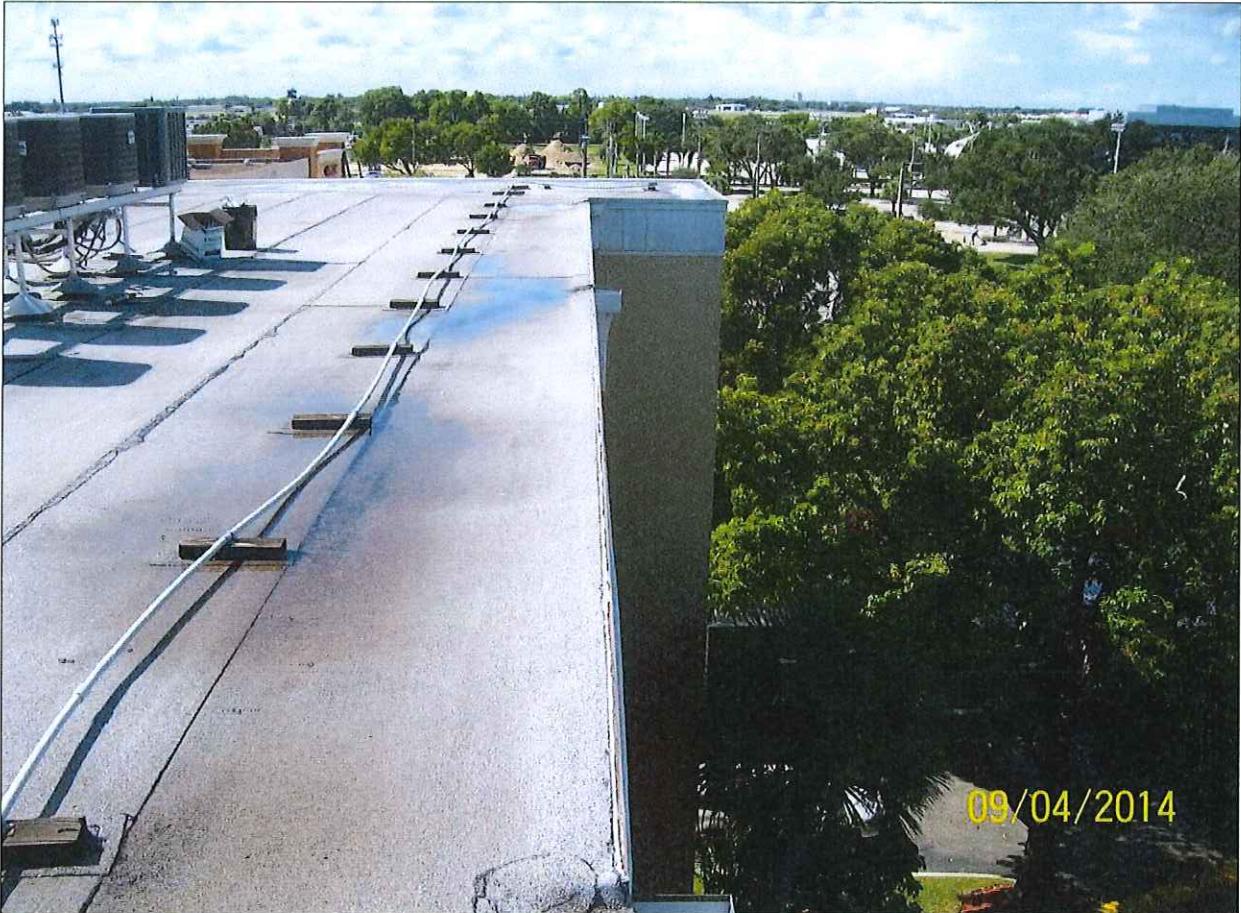
**EXHIBIT #: 7**

Found an area of open gravel stop metal

Will monitor the gravel stop metal

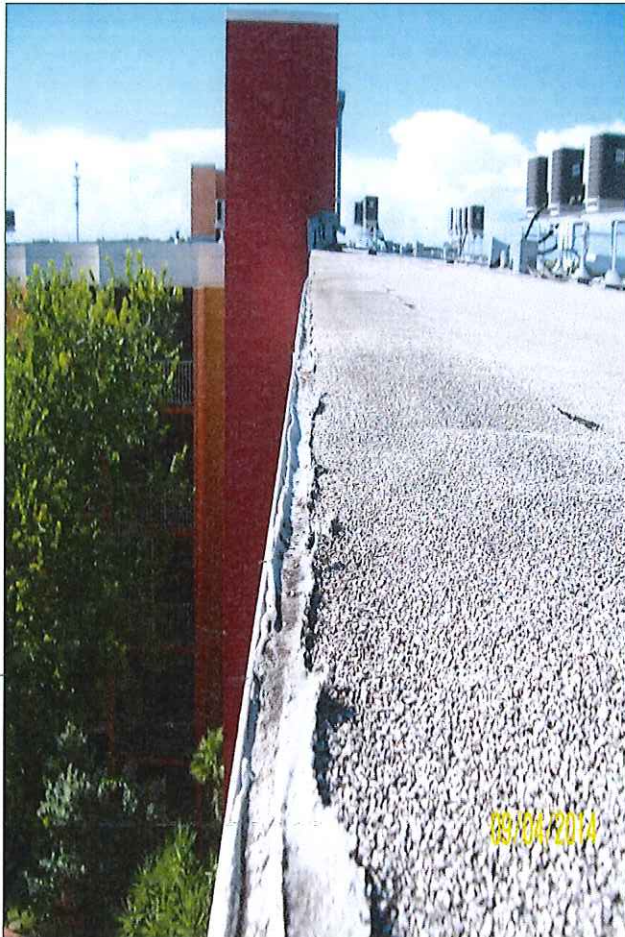
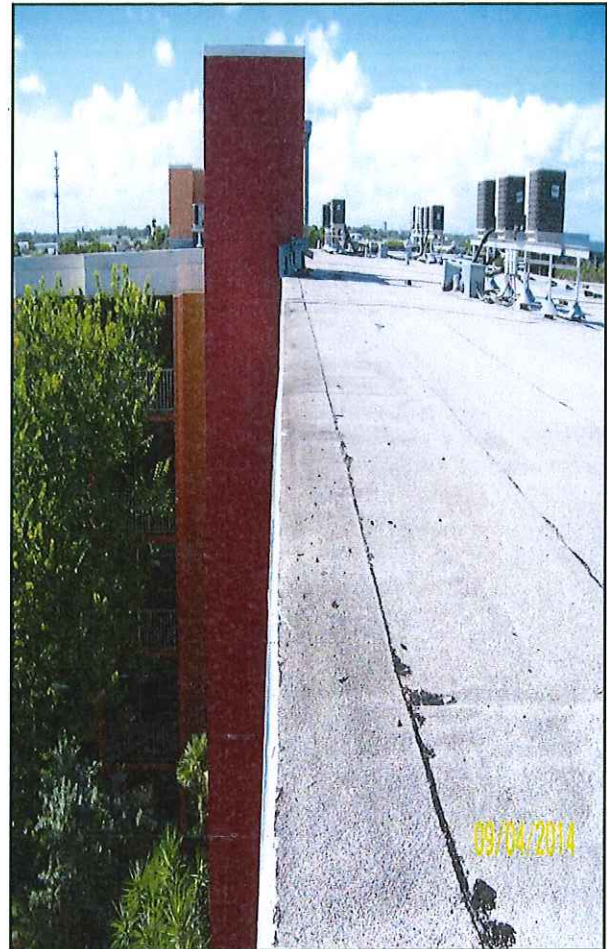
**EXHIBIT #: 8**

Found deteriorated sealant along  
the perimeter edge

Removed the deteriorated sealant and  
applied new at approximately 300'

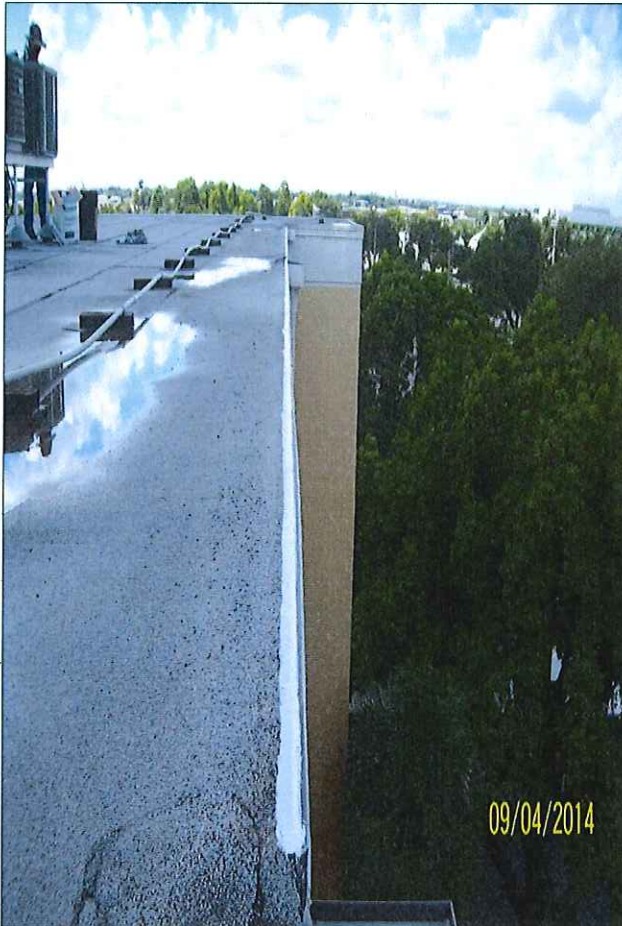
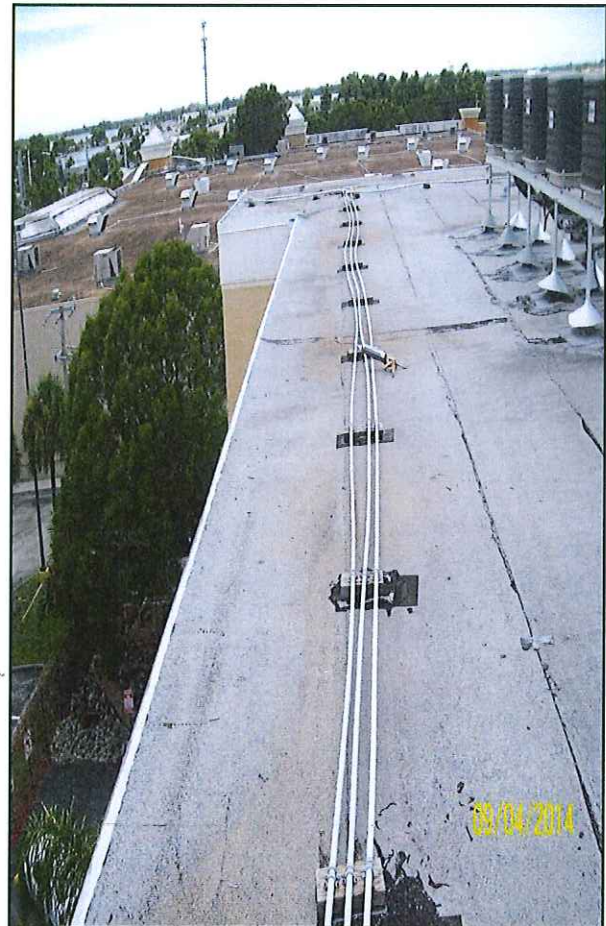
**EXHIBIT #: 9**

Found deteriorated sealant along the perimeter edge

Removed the deteriorated sealant and applied new at approximately 300'
