THE TOWERS
2366 EAST MALL DRIVE
FORT MYERS, FL 33912

ALLIANT ASSOCIATION MANAGEMENT

CROWTHER ROOFING AND SHEET METAL OF FLORIDA, INC.

Crowther Roof Check Maintenance Program-Inspection Report

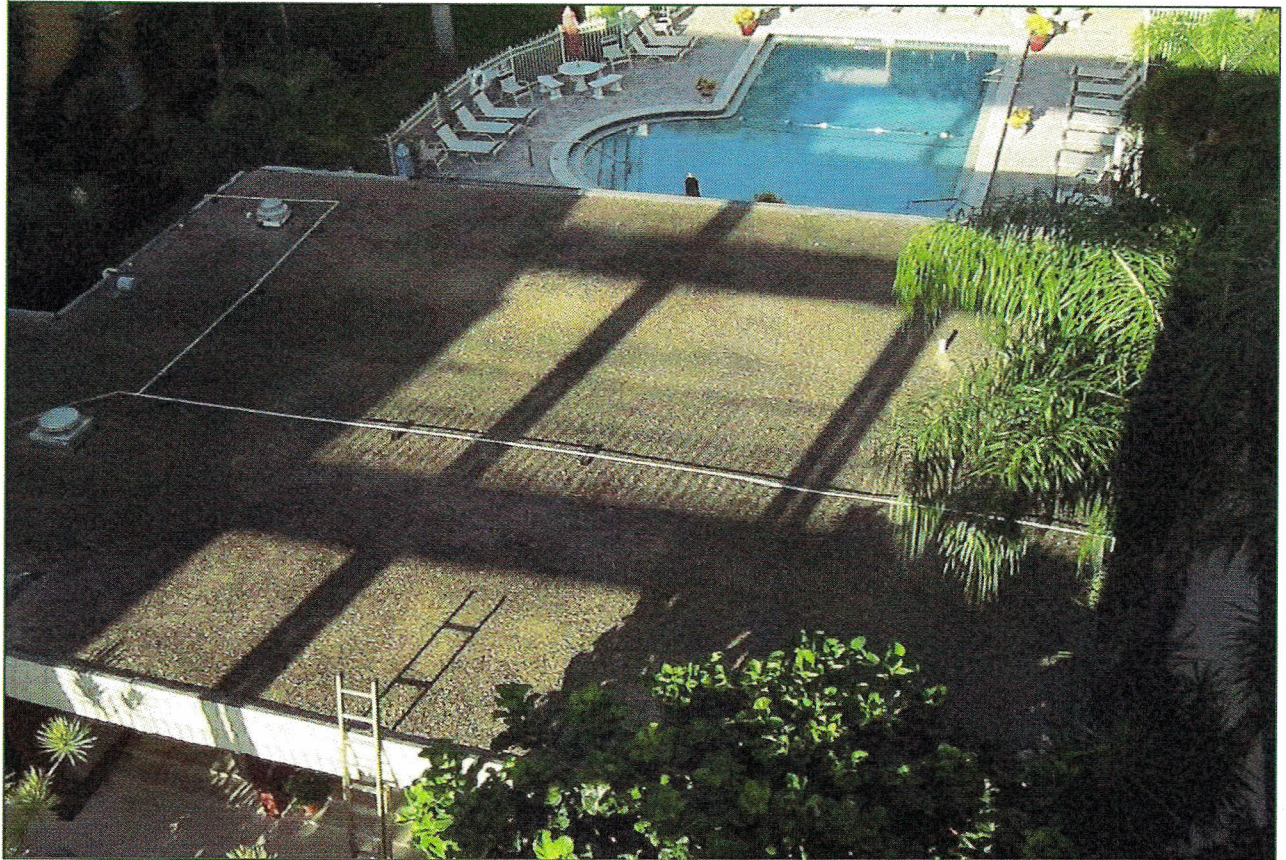
EXHIBIT #: 2

Main Roof Overview

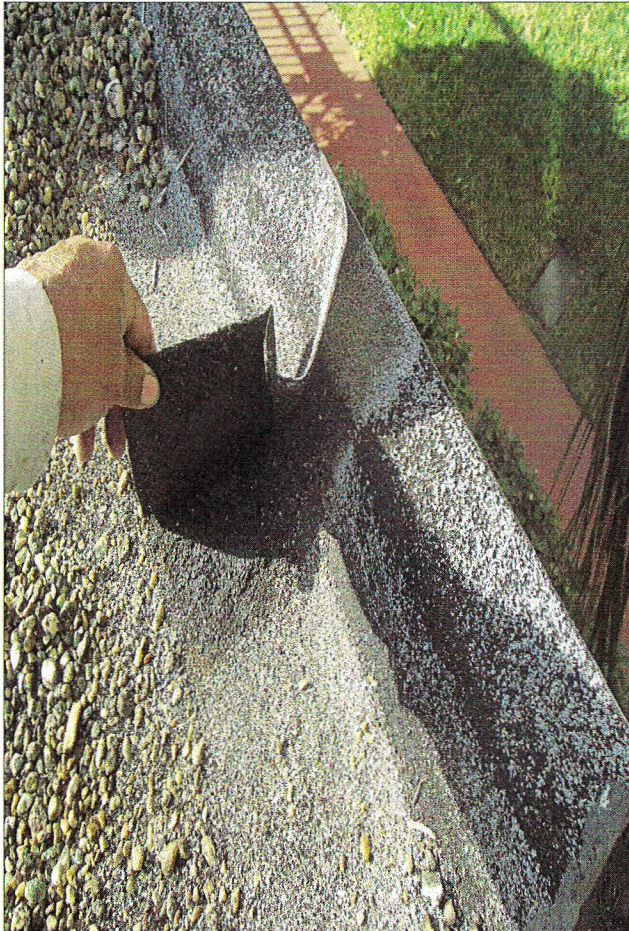
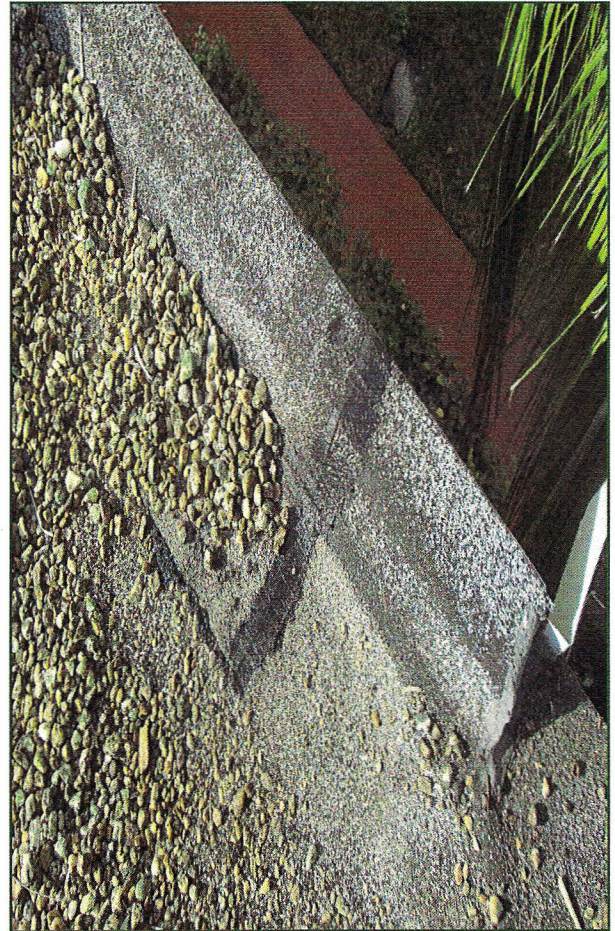
EXHIBIT #: 3

Identified loose base flashing laps

Sealed the base flashings with roofing
cement

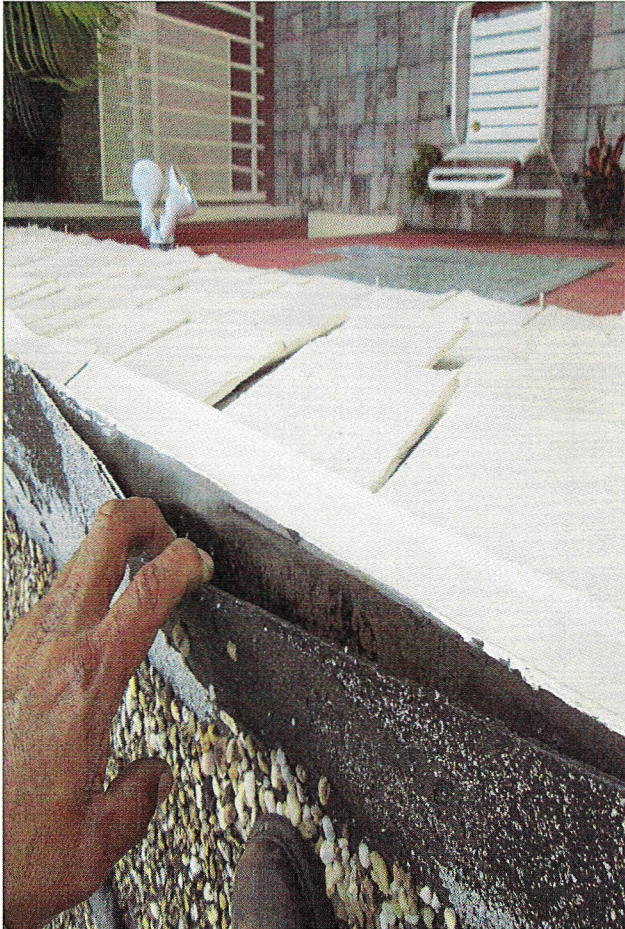
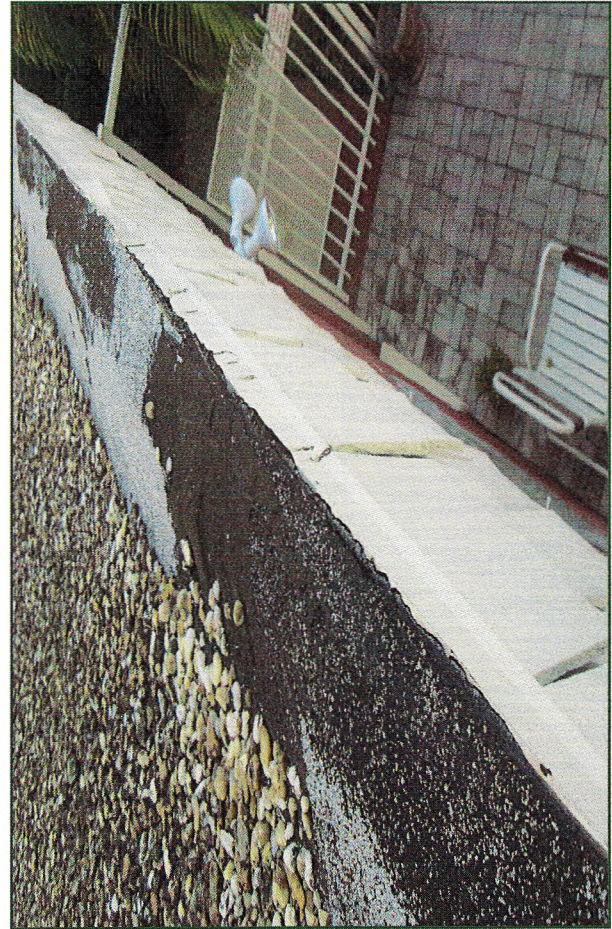
EXHIBIT #: 4

Identified loose cap sheet along the metal edge

Sealed the loose cap sheet lap on the metal edge

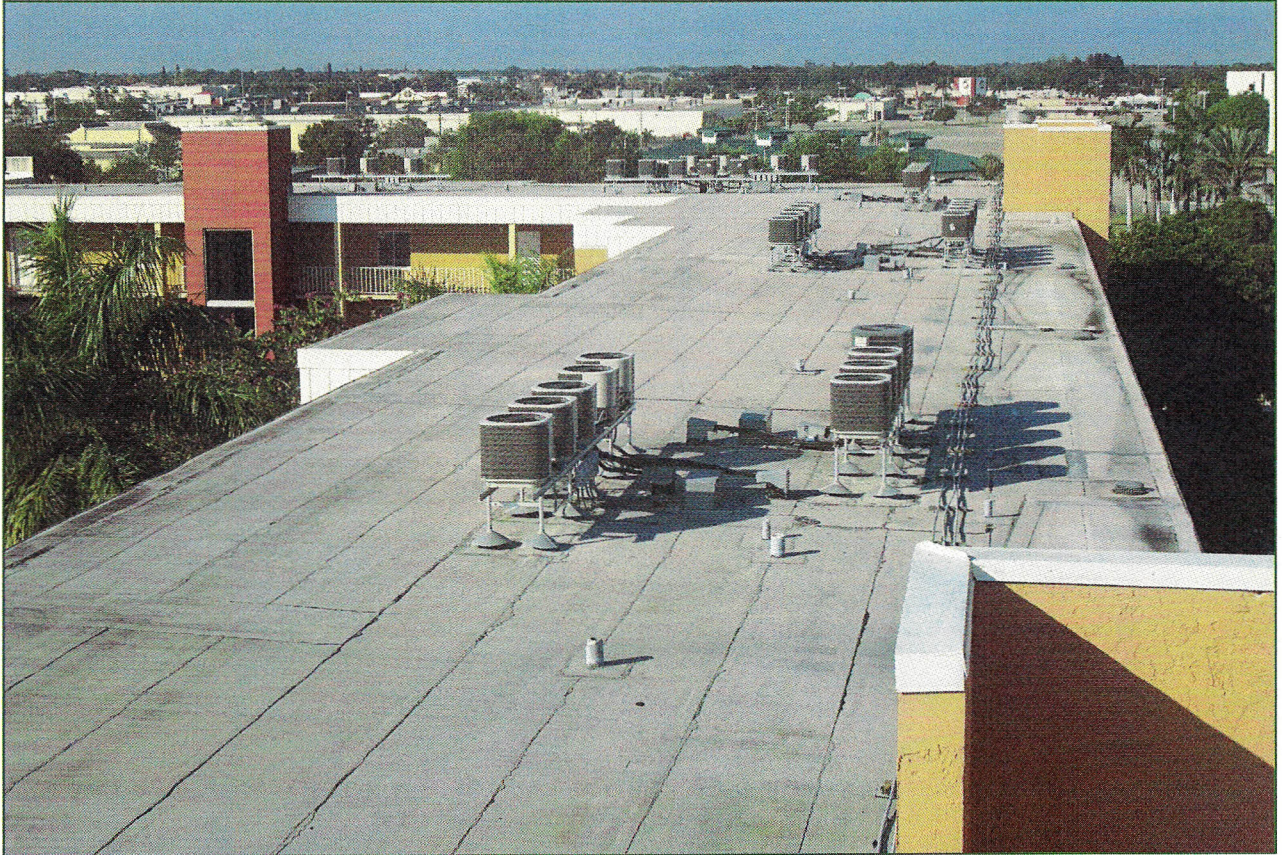
EXHIBIT #: 5

Main Roof Overview

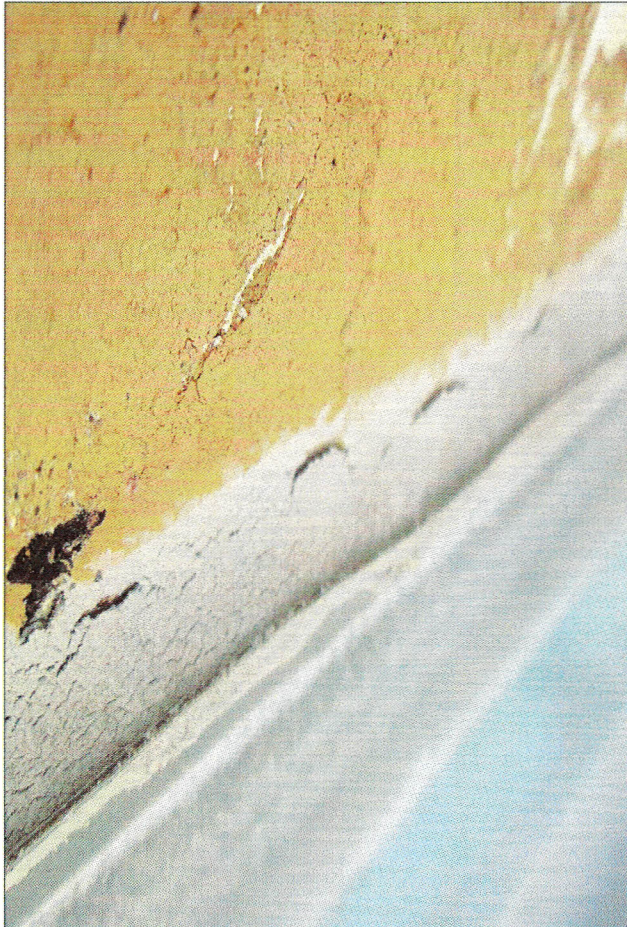
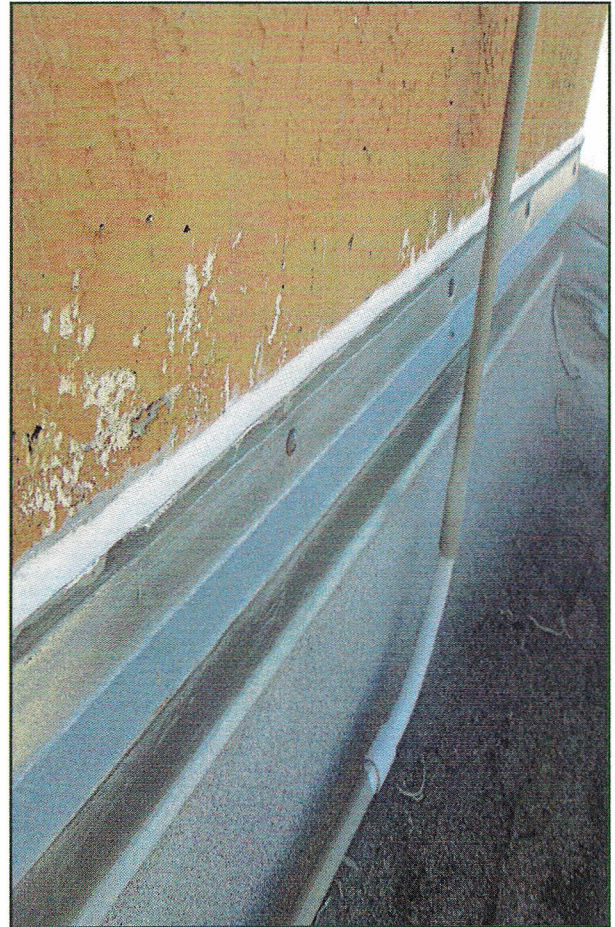
EXHIBIT #: 6

Identified voids along the top of the counter flashing

Sealed the counter flashings with sealant

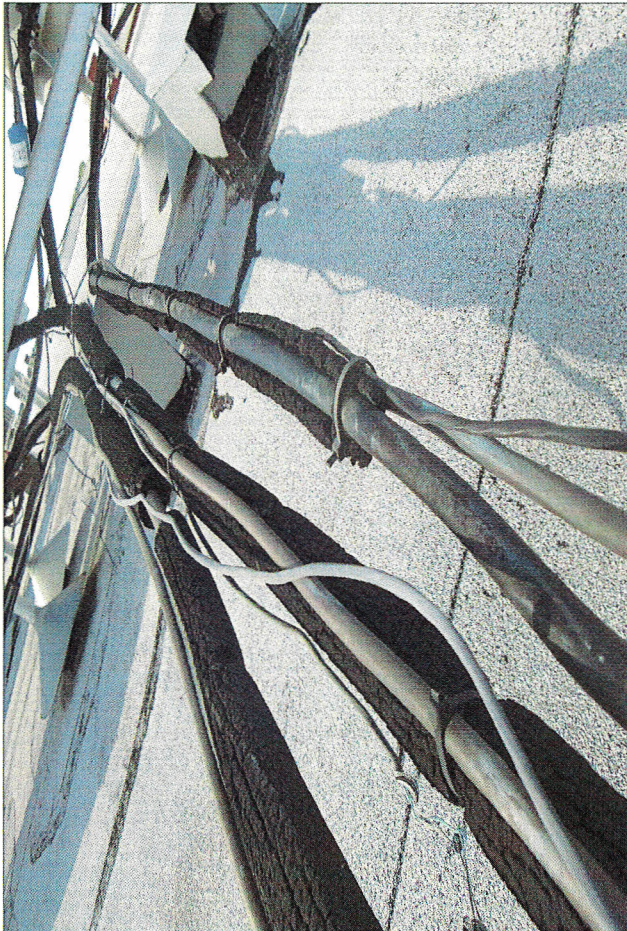
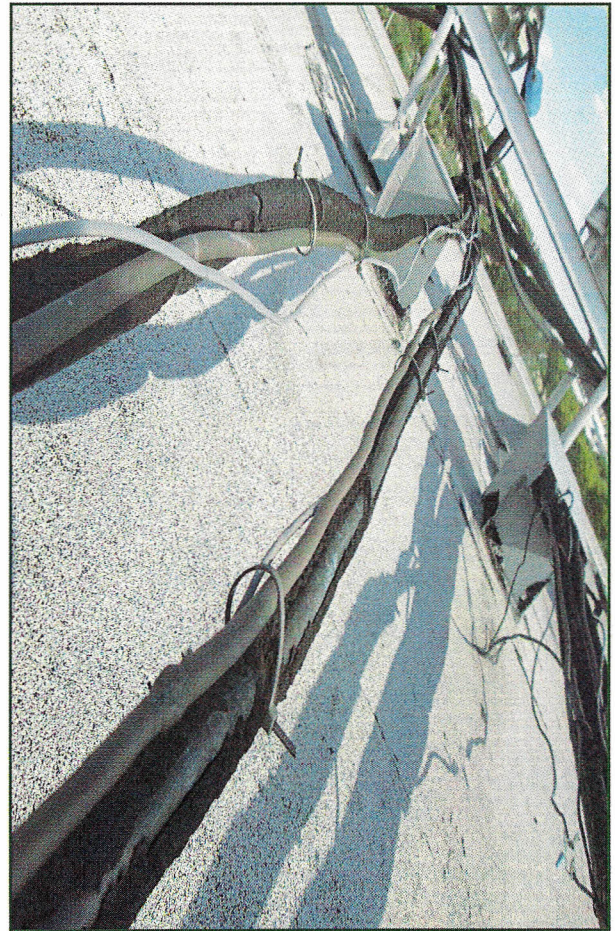
EXHIBIT #: 7

Identified deteriorated AC condensation lines

Suggest having arma-flex installed on the condensation lines

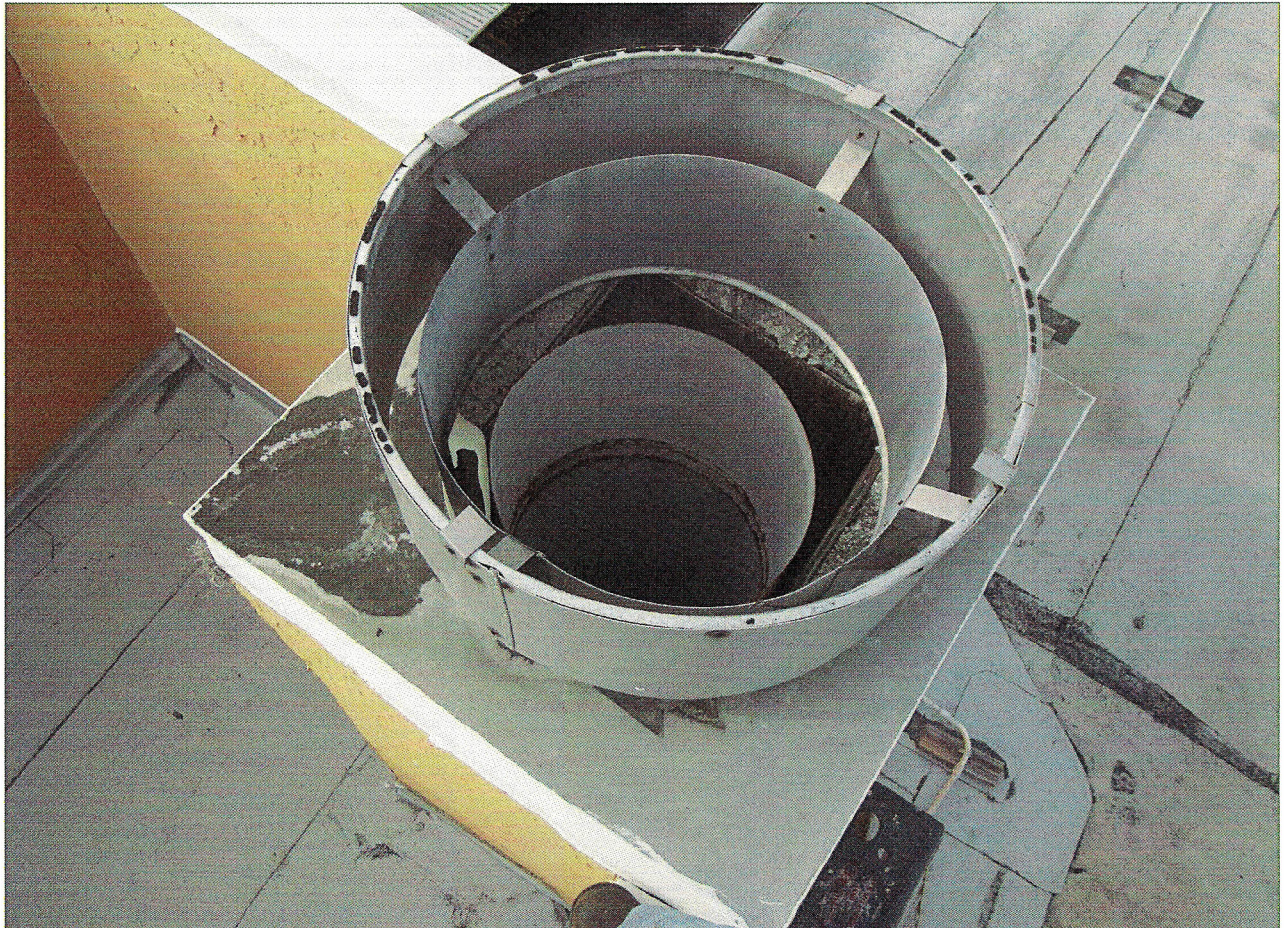
EXHIBIT #: 8

Identified a missing cover (cap) on the southeast trash chute

Suggest having the cap replaced

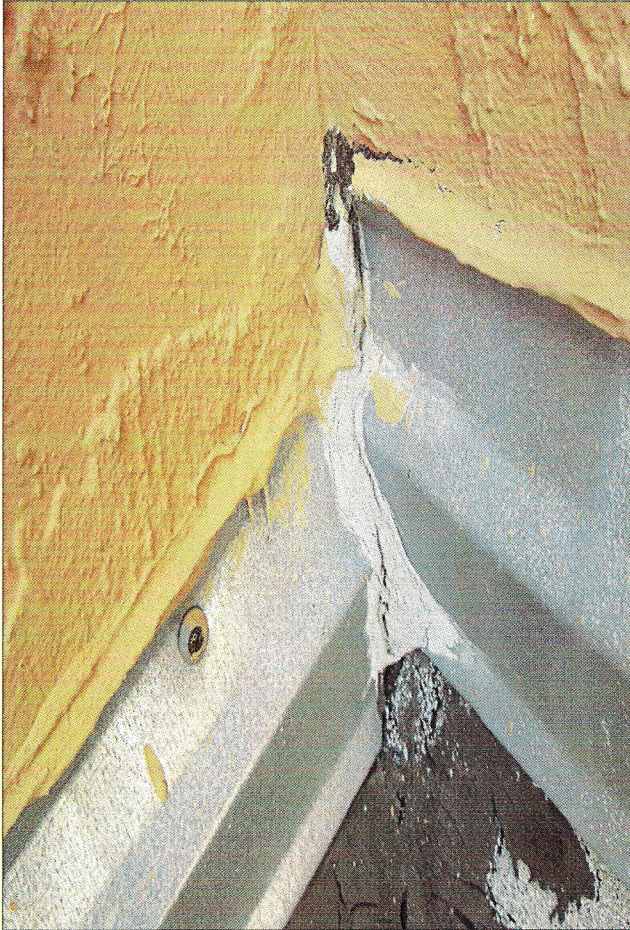
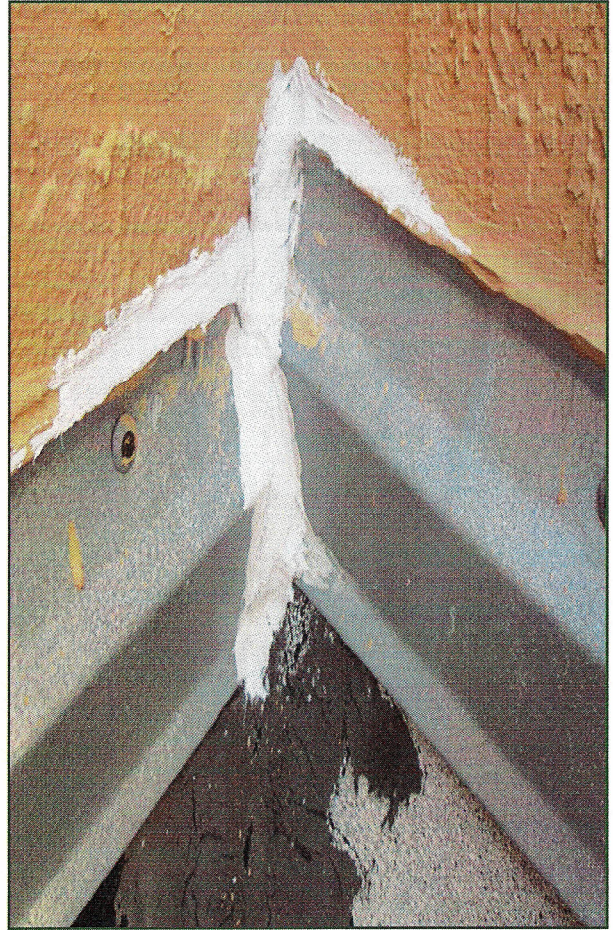
EXHIBIT #: 9

Identified voids at the counter flashing corners

Sealed the counter flashing corners
with urethane sealant

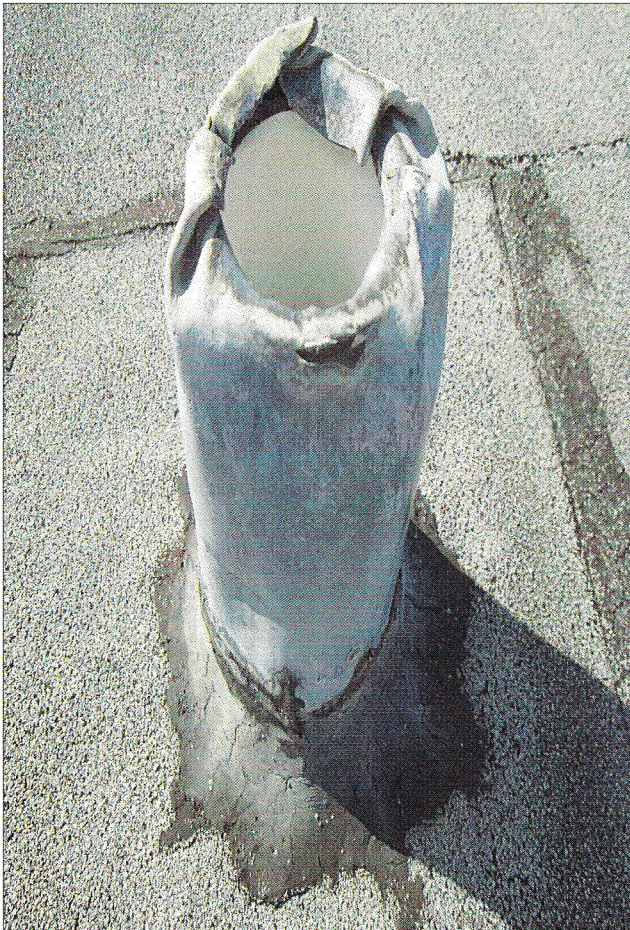
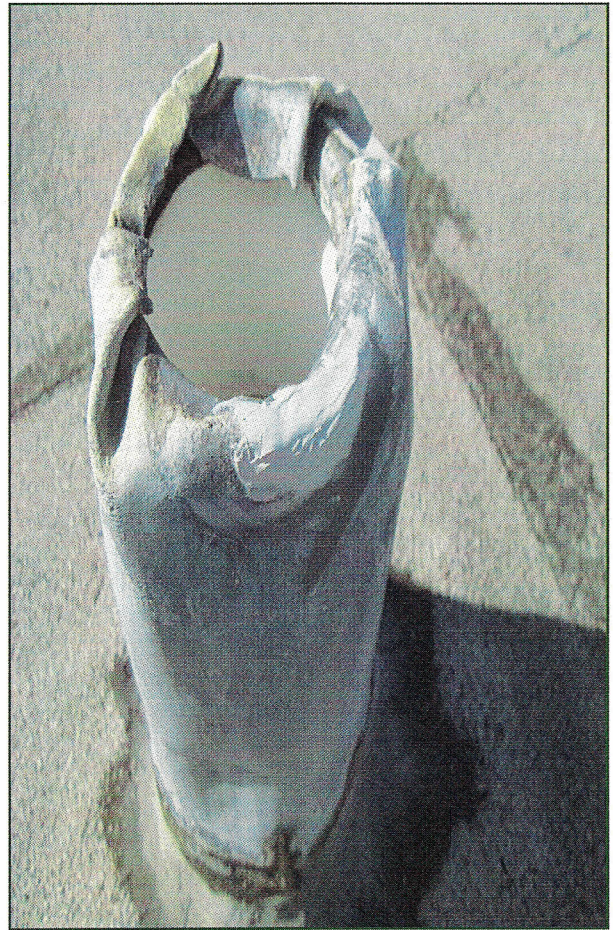
EXHIBIT #: 10

Identified voids at the top of the lead boots

Sealed the lead boots with urethane sealant

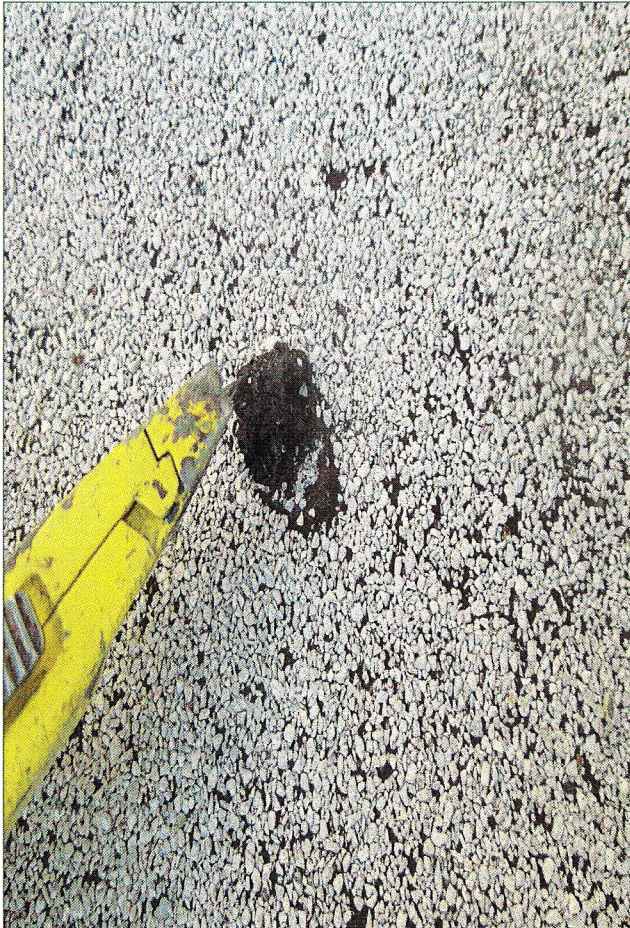
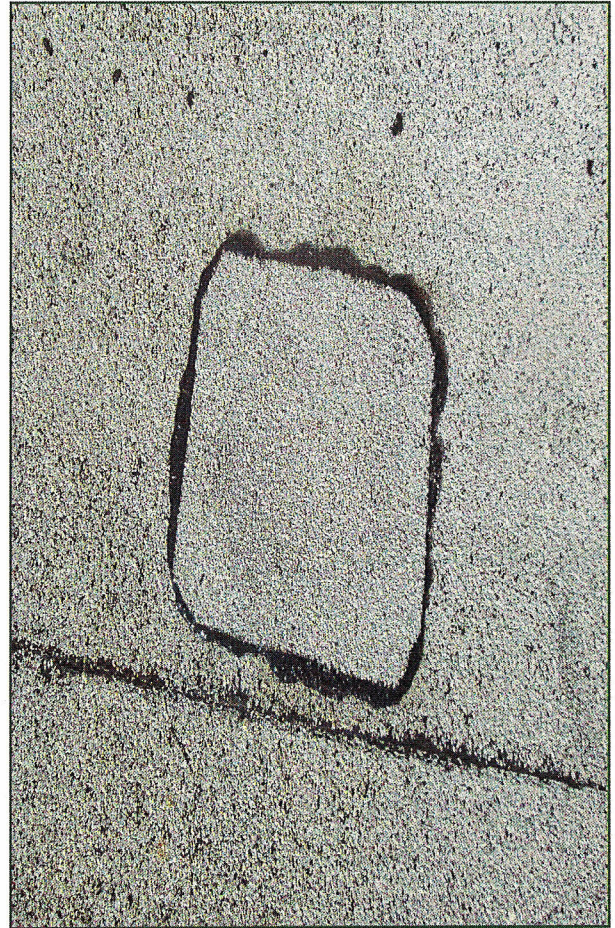
EXHIBIT #: 11

Identified three (3) punctures in the cap sheet

Sealed the punctures with cap sheet and roofing cement

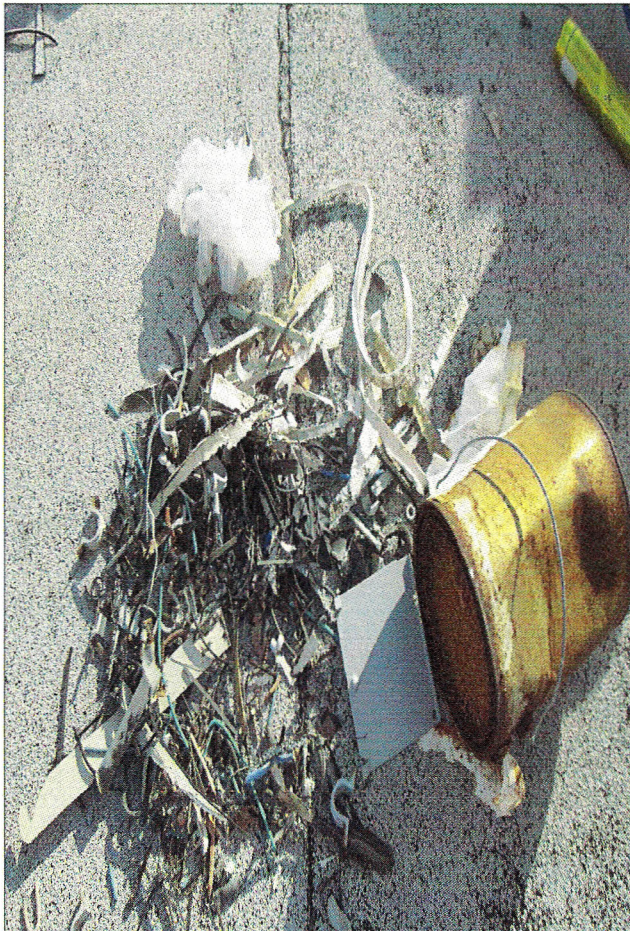
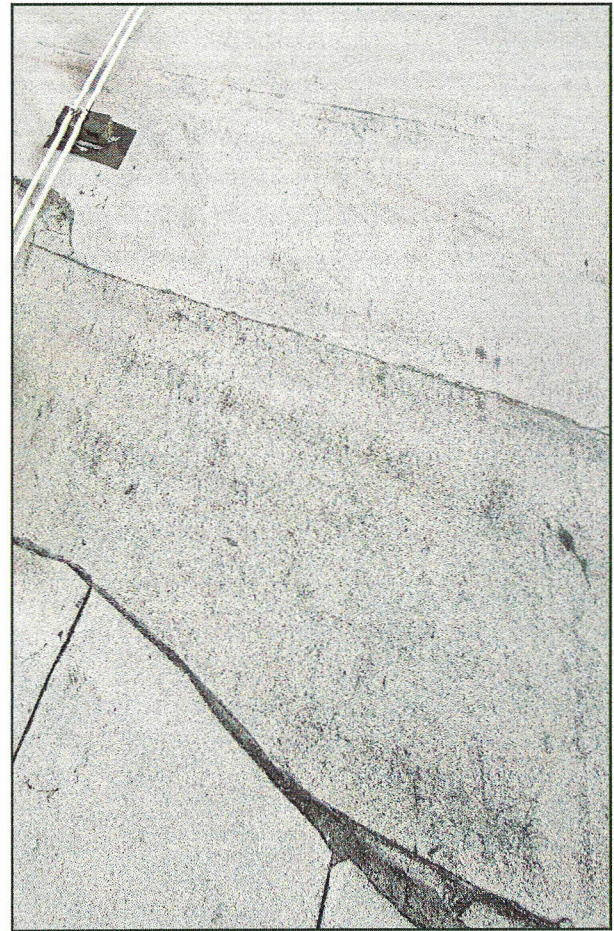
EXHIBIT #: 12

Identified debris on the roof surface

Cleaned the debris from the roof

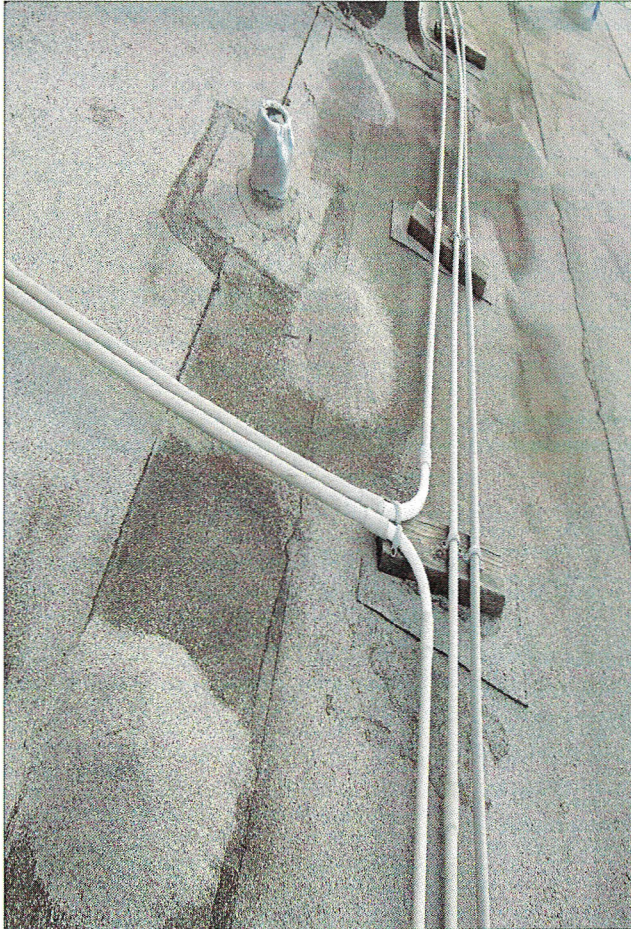
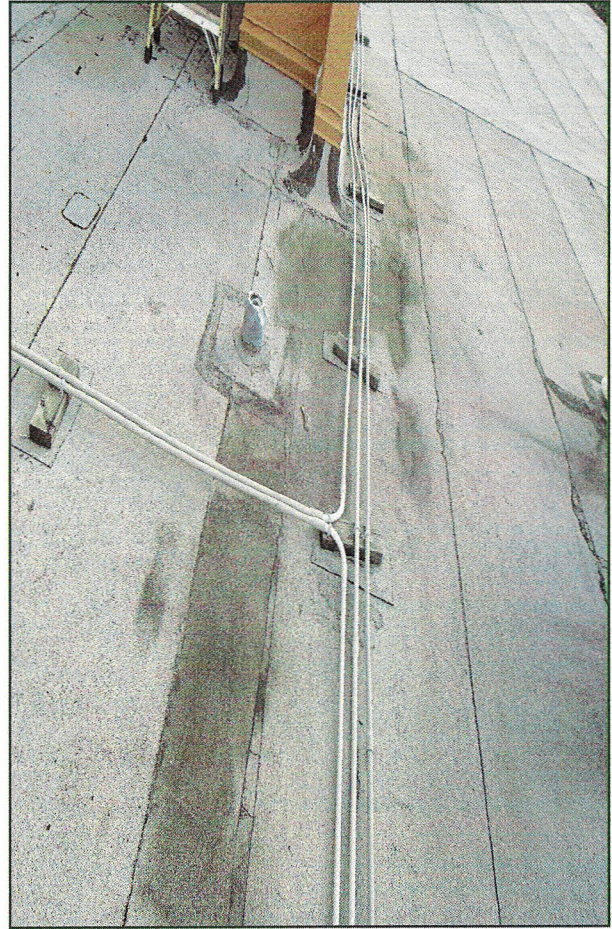
EXHIBIT #: 13

Identified loose granules on the roof surface

Removed the loose granules from the roof

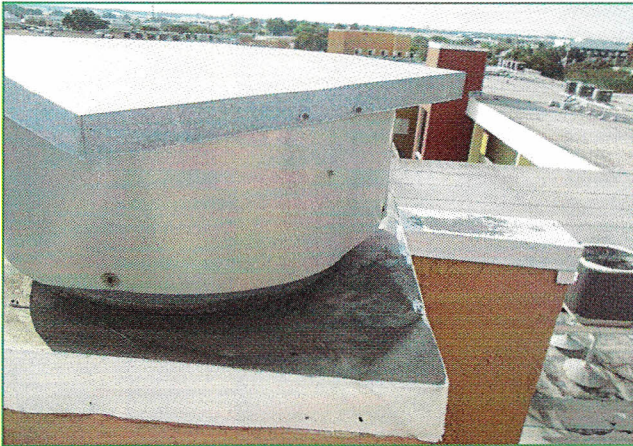
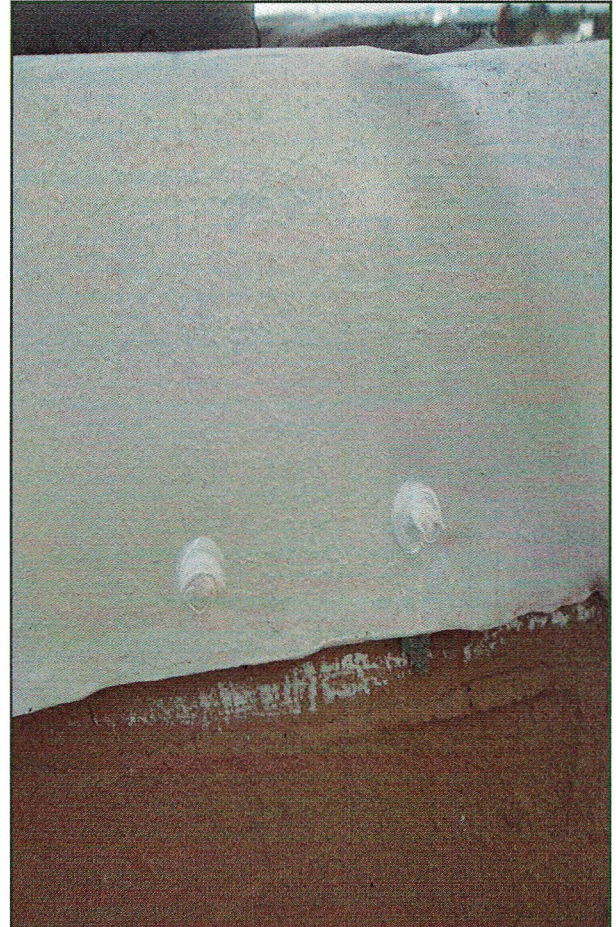
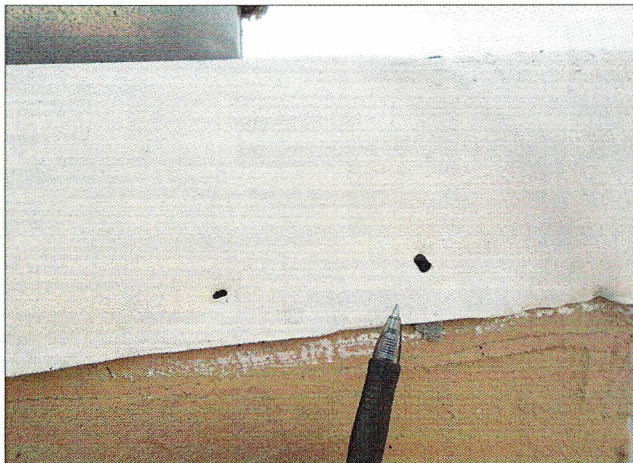
EXHIBIT #: 14

Identified several screw holes on the trash chute

Sealed the holes with urethane sealant

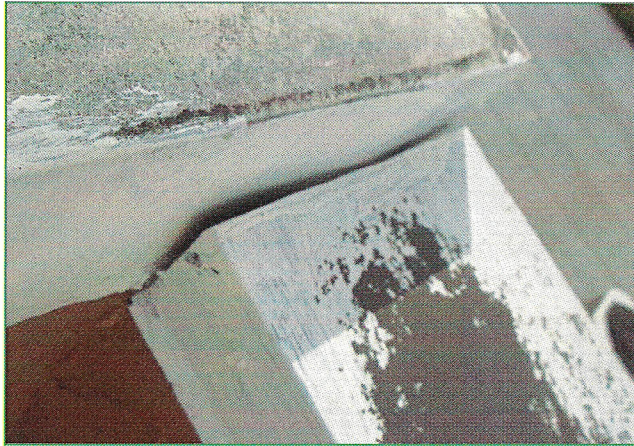
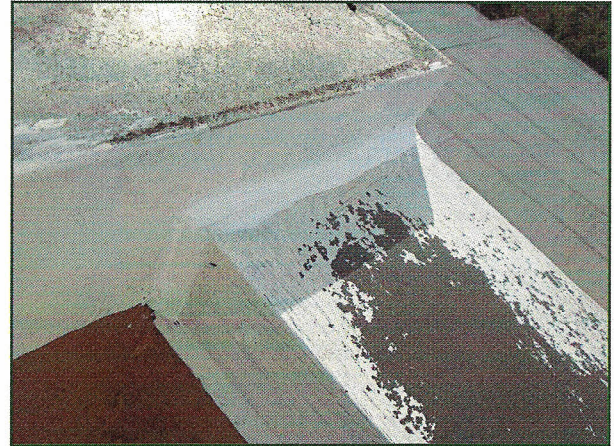
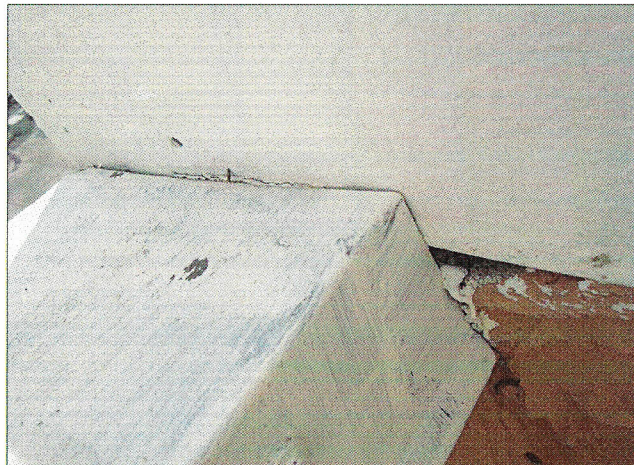
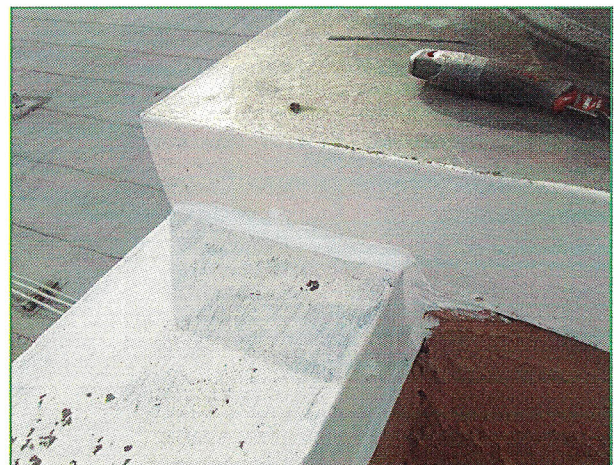
EXHIBIT #: 15

Identified voids at the coping and the trash chute caps

Sealed the voids with urethane sealant

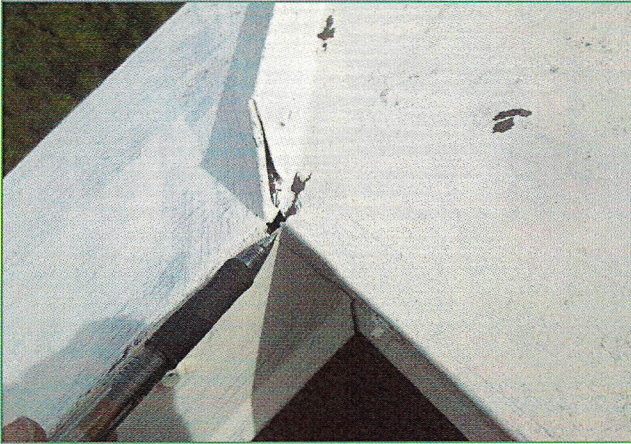
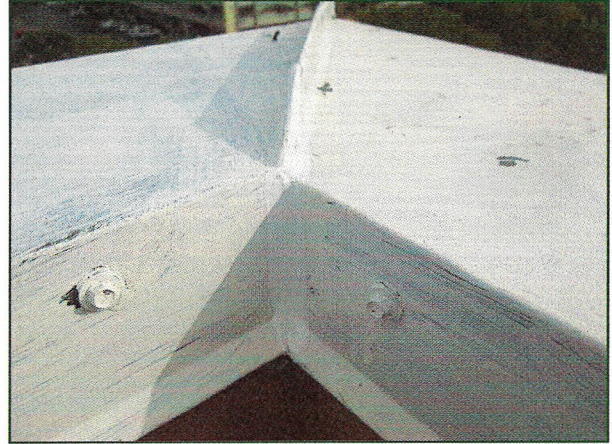
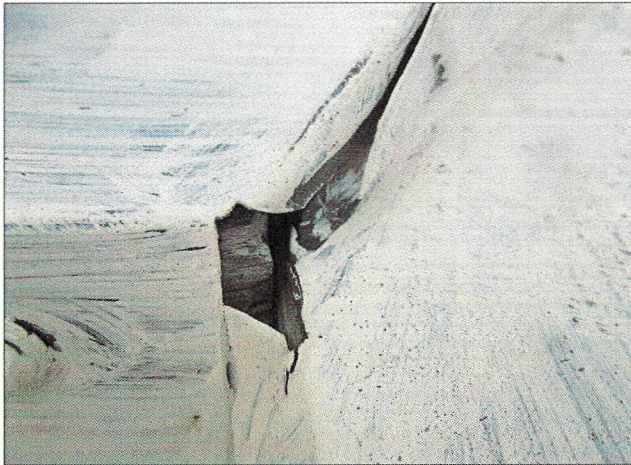
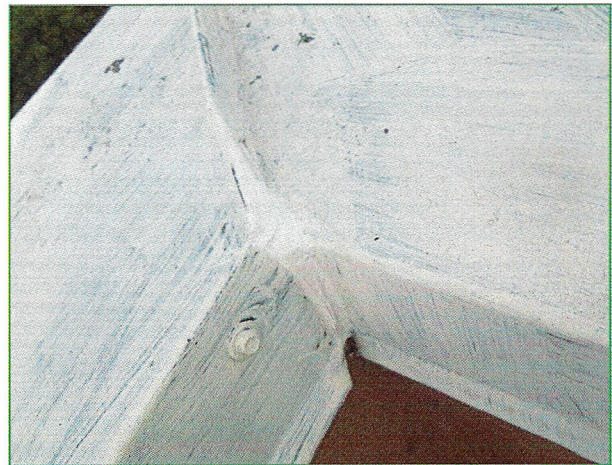
EXHIBIT #: 16

Identified two large holes in the coping corners

Sealed the holes with urethane sealant

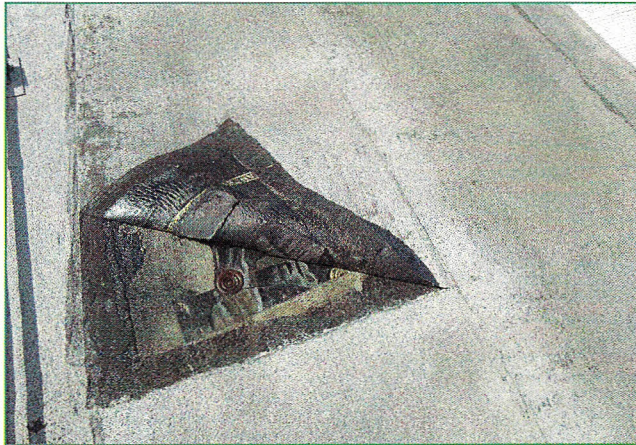
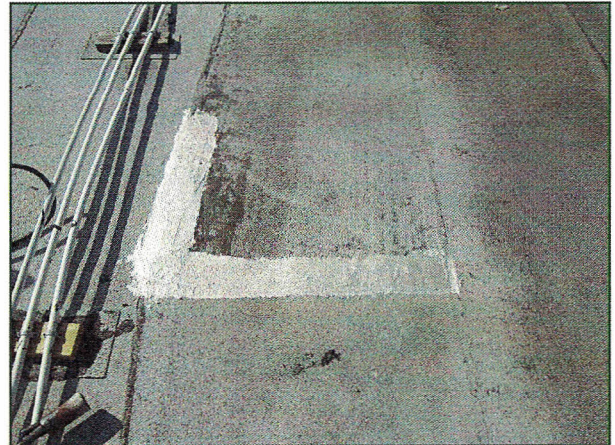
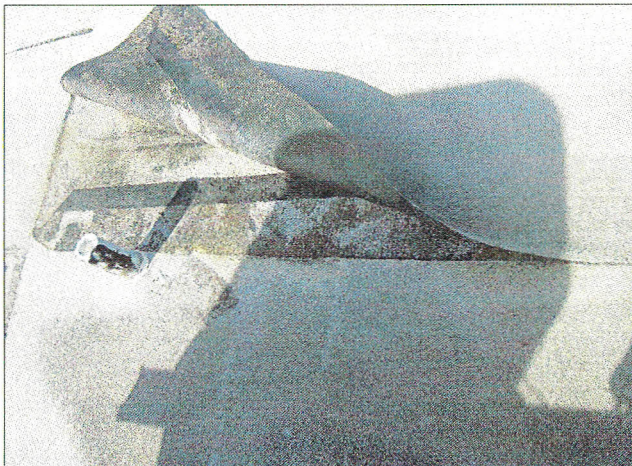
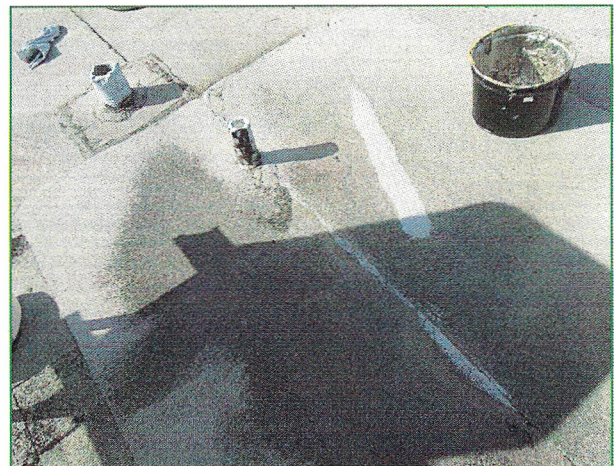
EXHIBIT #: 17

Identified two loose cap sheet laps

Repaired the loose cap sheet laps
