Inspection Report

Facility: Towers, The
Address: 2366 East Mall Dr,
Fort Myers, 33912

Work Order #: 3086

Re.: **Inspection Report (6 of 6) for The Towers**

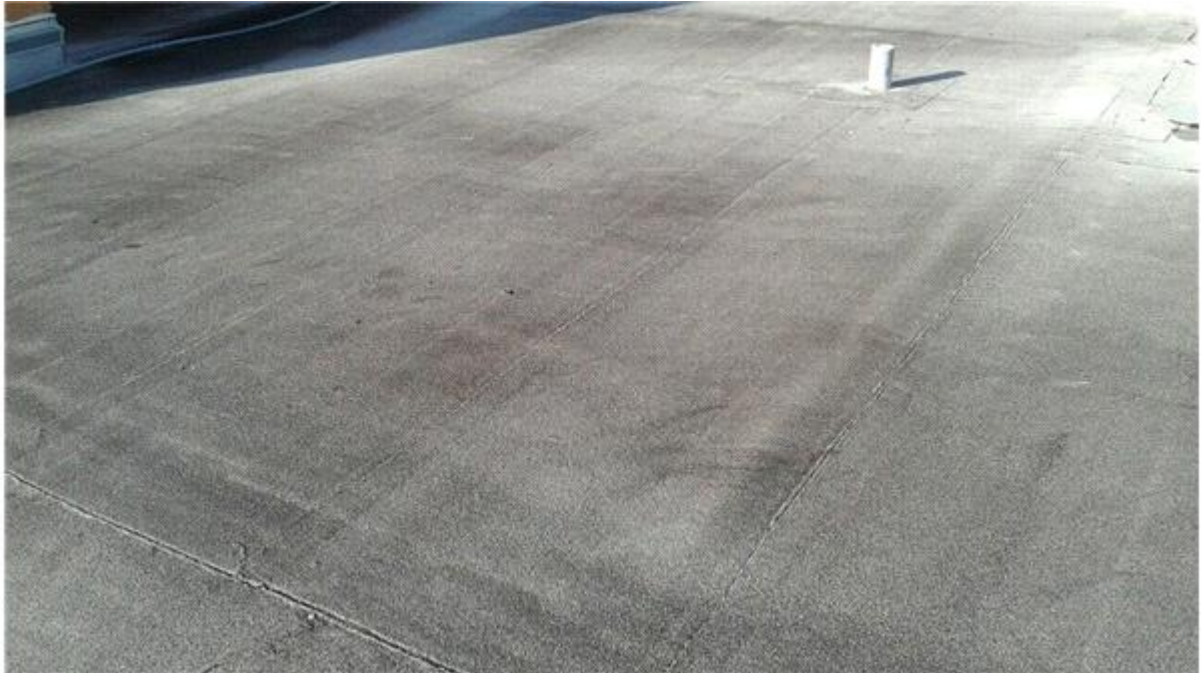
003F -Membrane Overview

The roof membrane appears to be in fair condition at this time.

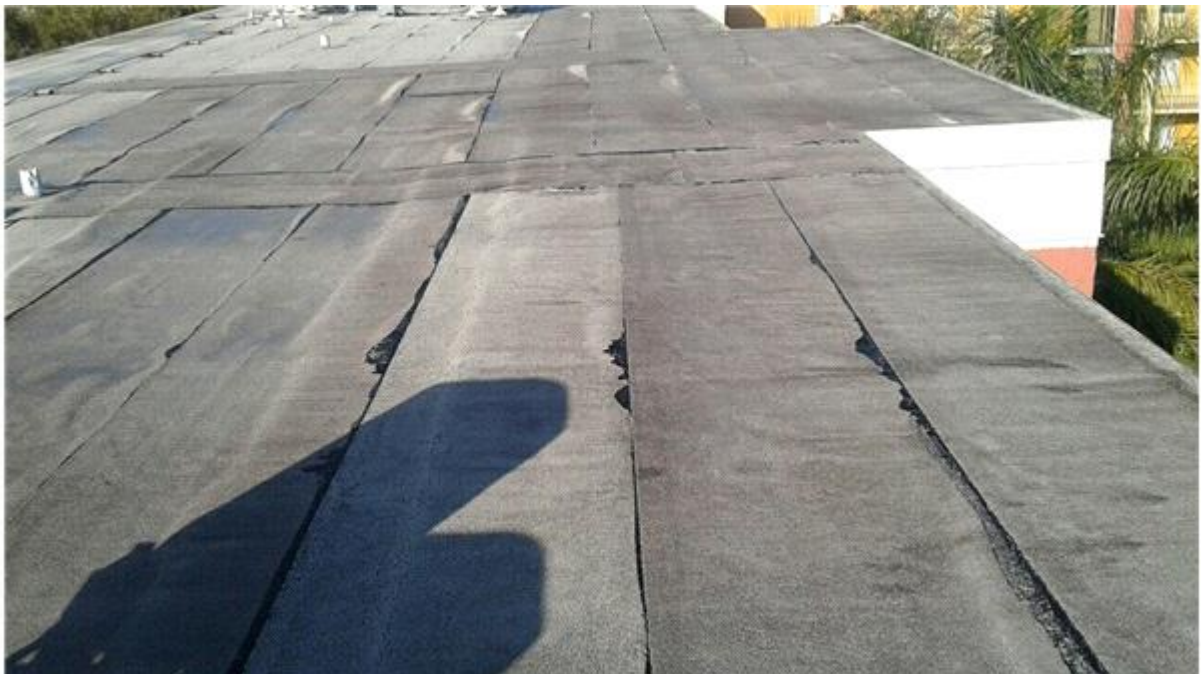
003F -Membrane Overview

The roof membrane appears to be in fair condition at this time.

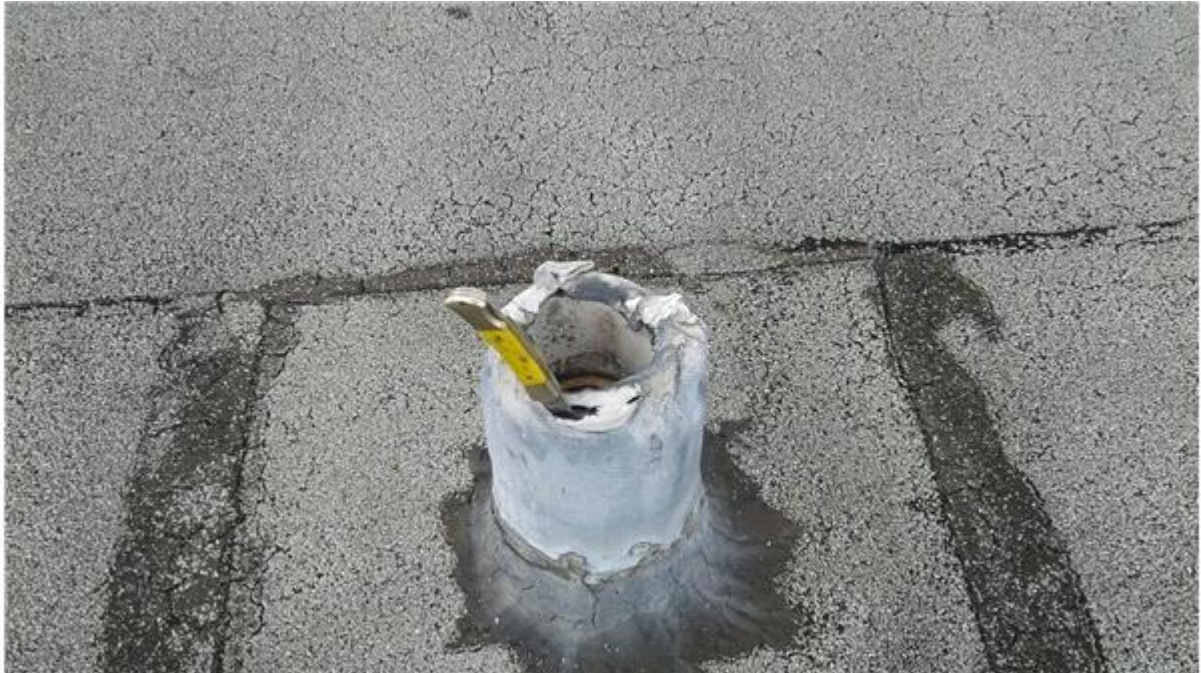
Lead Boot

Identified damaged sleeve.

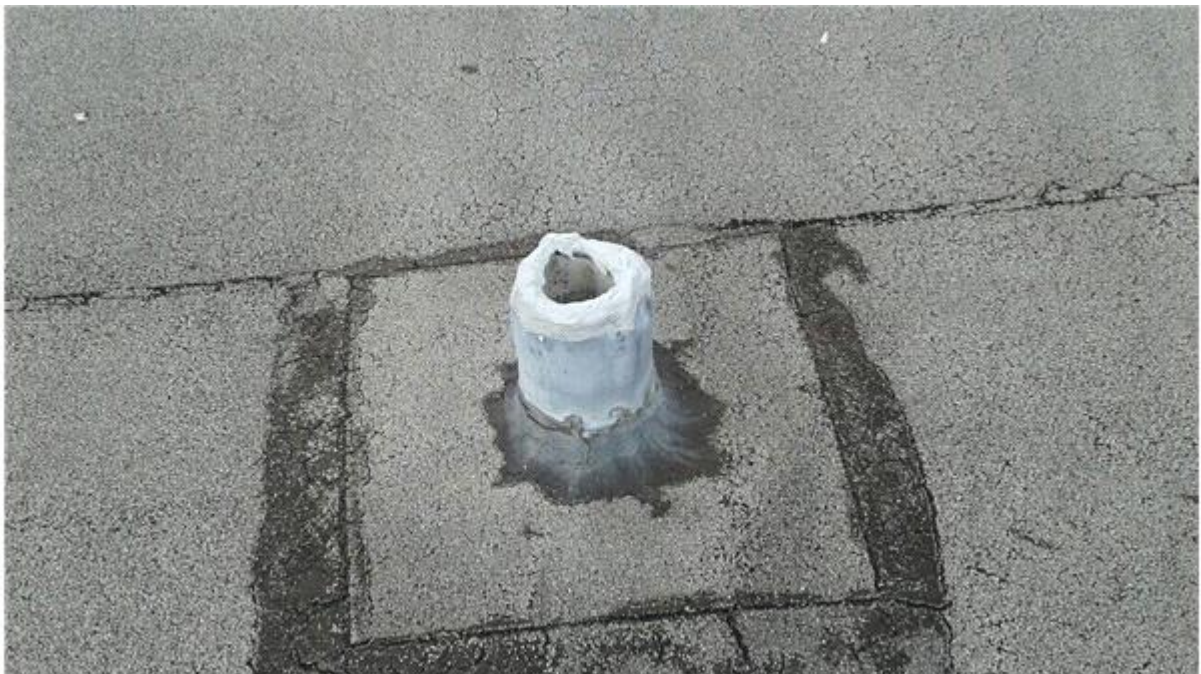
Temporary Repair

Temporary repair made with M1-sealant. Recommend installing new lead boot. 4"

TO BE REPAIRED AT NEXT SCHEDULED INSPECTION

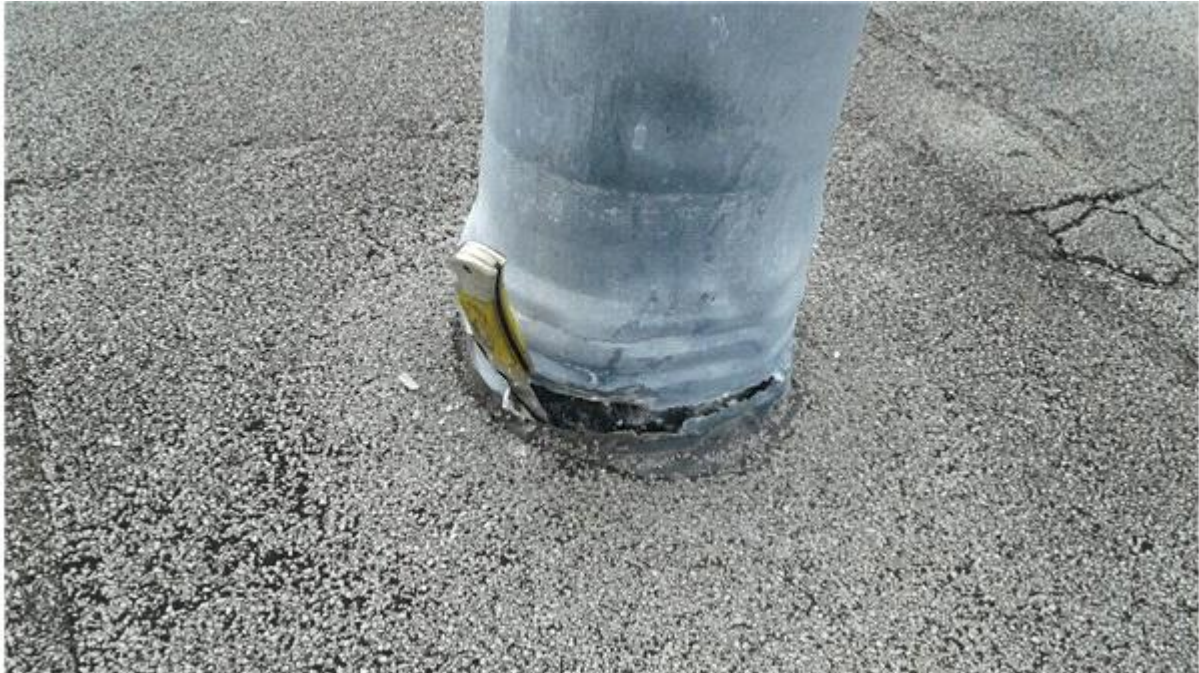
Lead Boot

Identified damaged sleeve

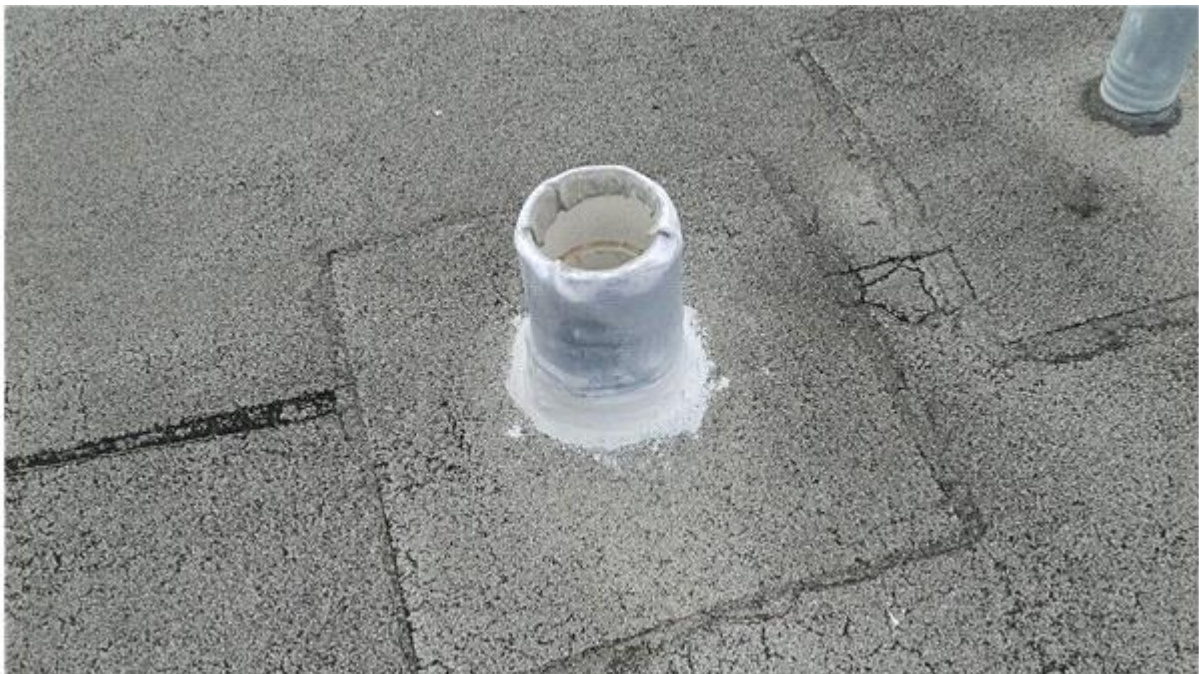
Lead Boot

Temporary repair made with M1-sealant. Recommend installing new lead boot. 4".

TO BE REPAIRED AT NEXT SCHEDULED INSPECTION

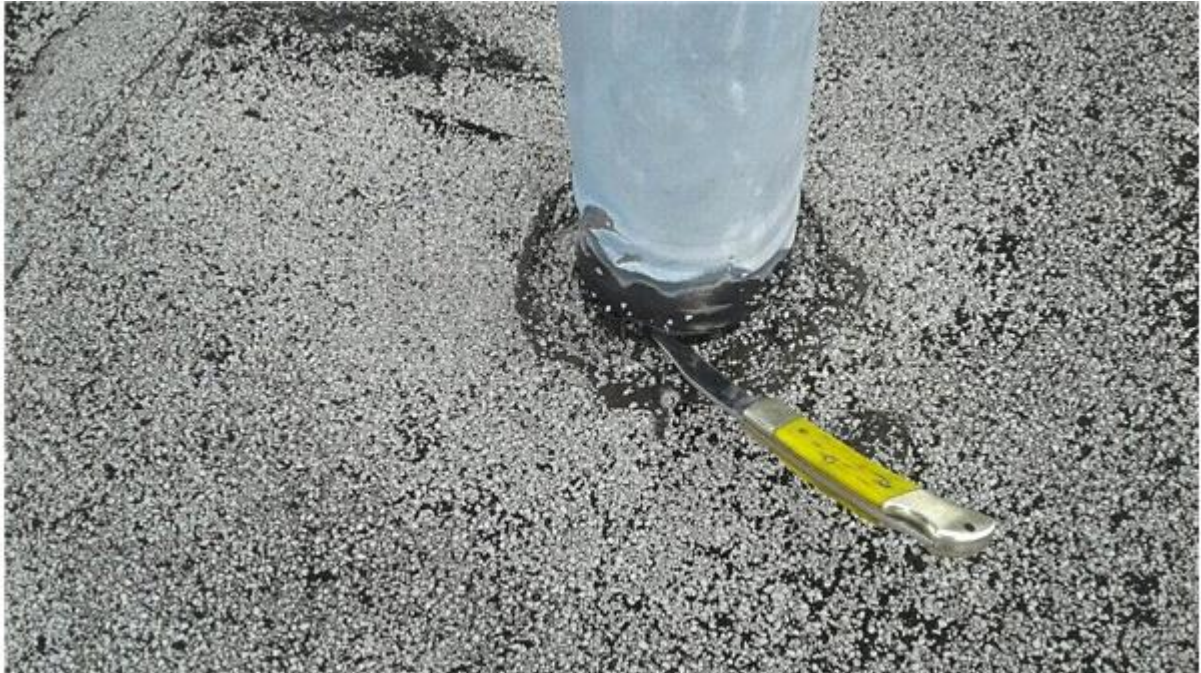
Lead Boot

Sleeve is damaged or deformed and needs to be replaced.

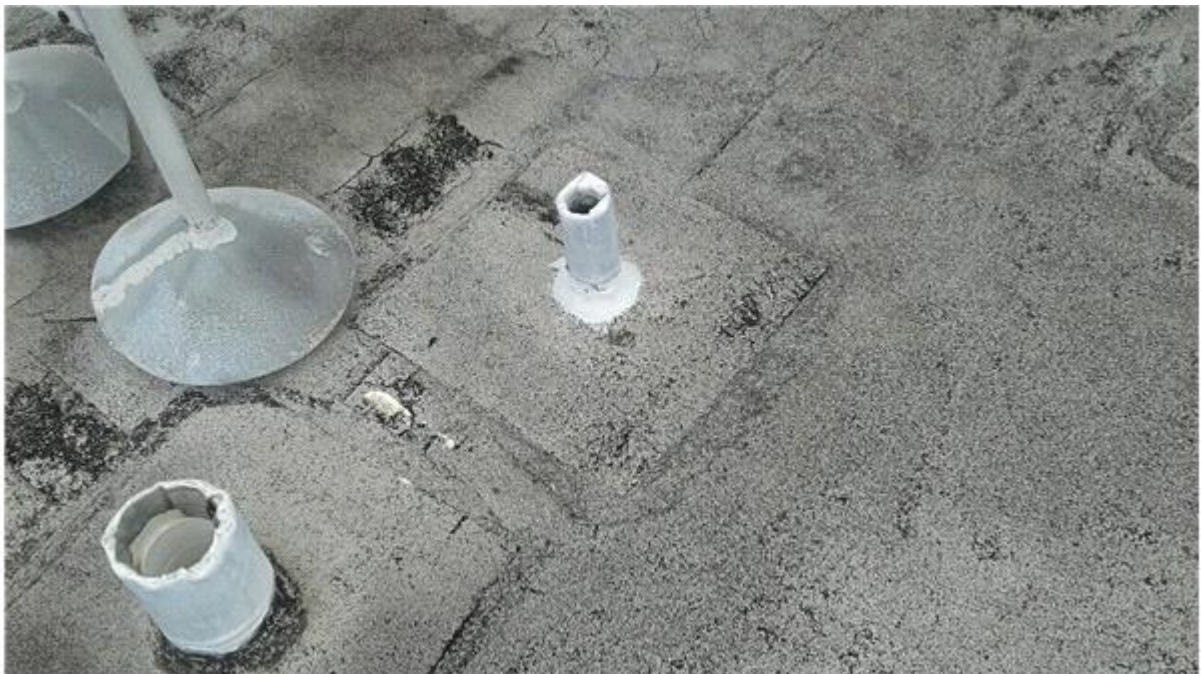
Lead Boot

Temporary repair made with M1-sealant. Recommend installing new lead boot. 2".

TO BE REPAIRED AT NEXT SCHEDULED INSPECTION

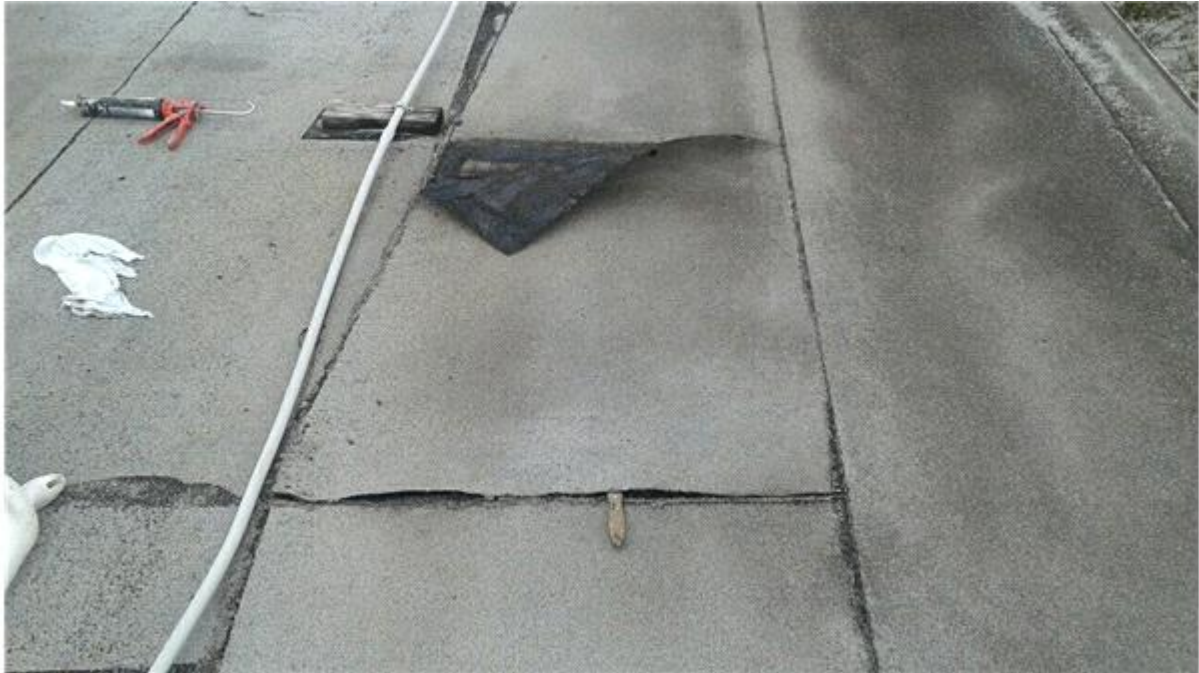
F-110 Field Membrane

An opening has formed at the edge of the felt that will allow water penetration.

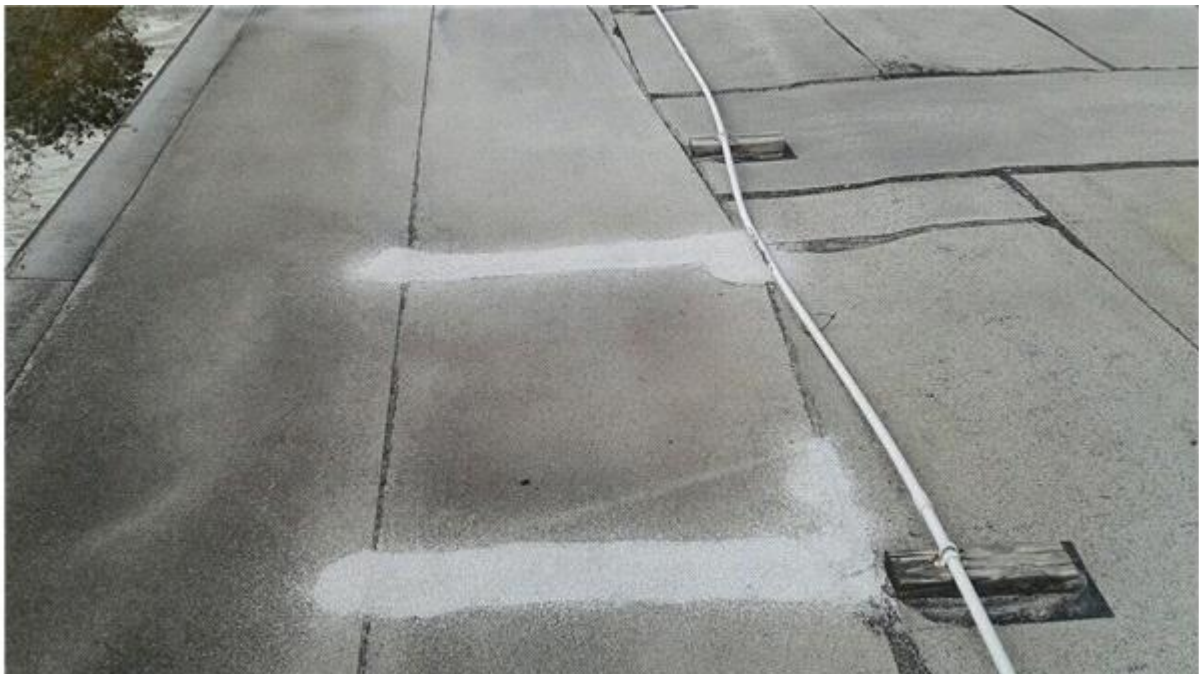
F-108 R Field Membrane

Repaired with high grade roofing cement and polyester membrane.

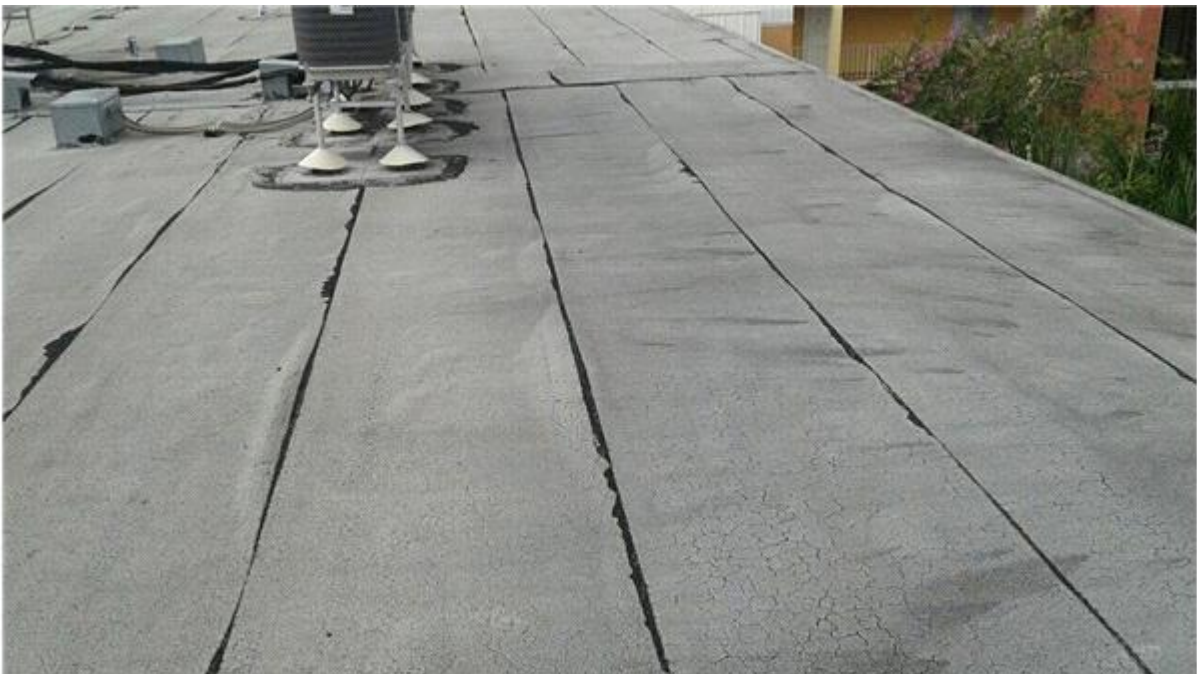
F-200 Field Membrane

Blisters are caused by gas trapped in the system and may be ruptured with foot traffic .Crowther Roofing will monitor.

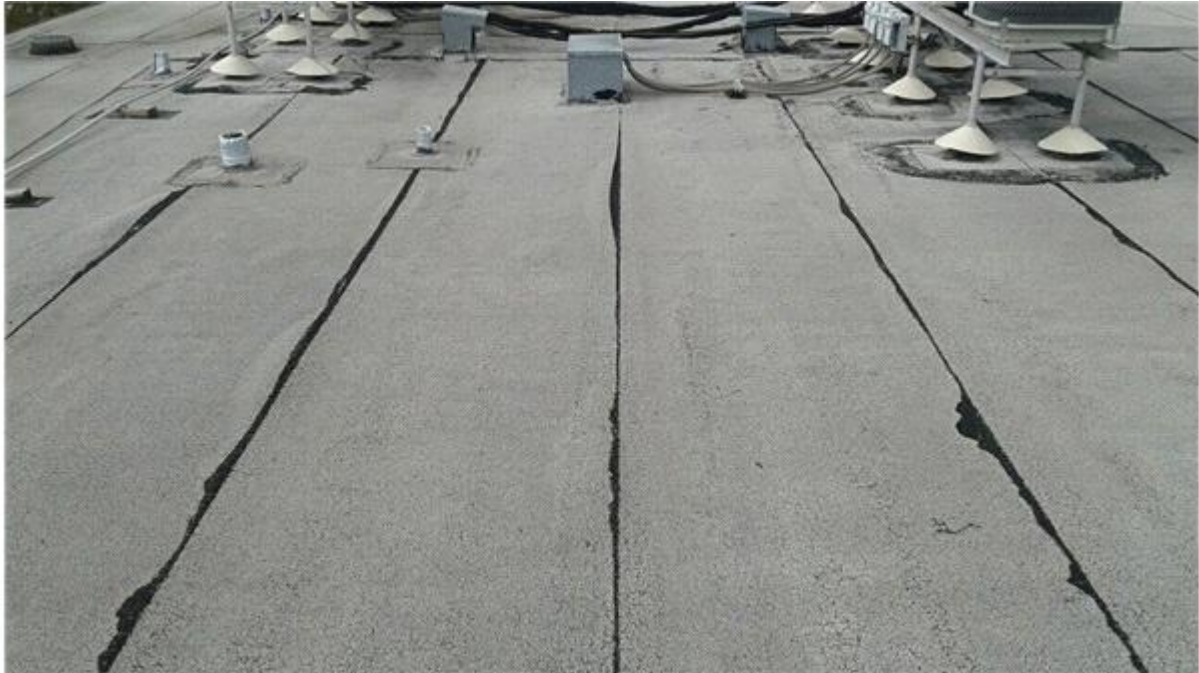
F-200 Field Membrane

Blisters are caused by gas trapped in the system and may be ruptured with foot traffic. Crowther Roofing will monitor.

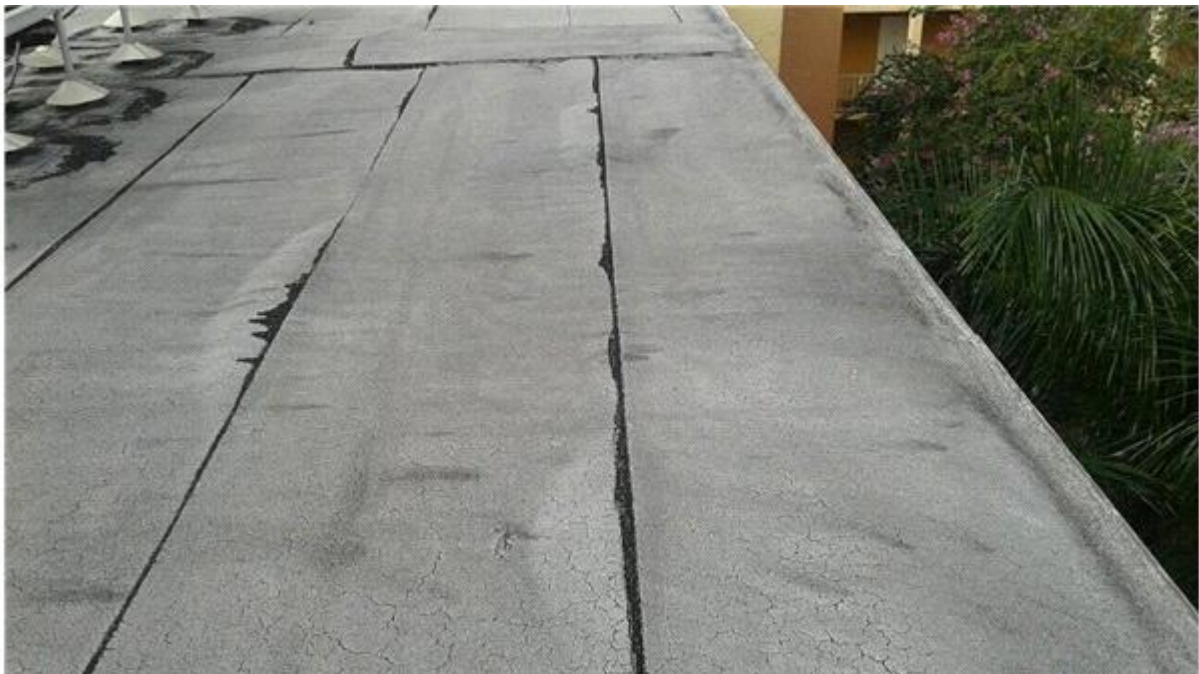
F-200 Field Membrane

Blisters are caused by gas trapped in the system and may be ruptured with foot traffic. Crowther Roofing will monitor.

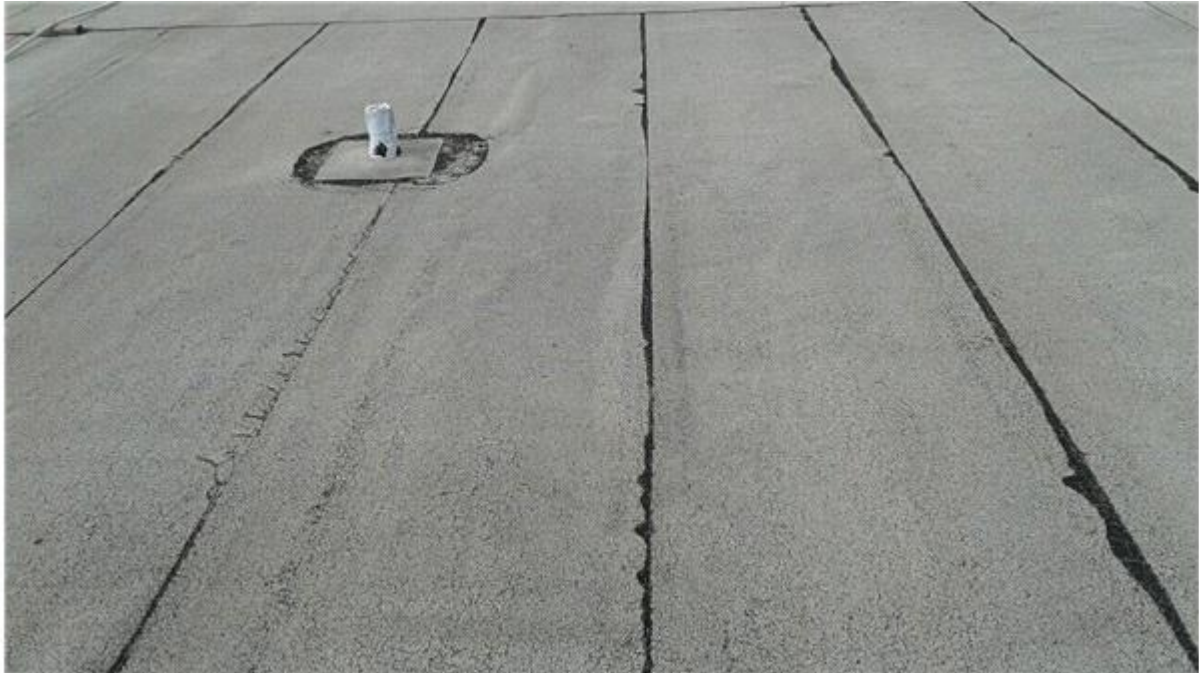
F-200 Field Membrane

Blisters are caused by gas trapped in the system and may be ruptured with foot traffic. Crowther Roofing will monitor.

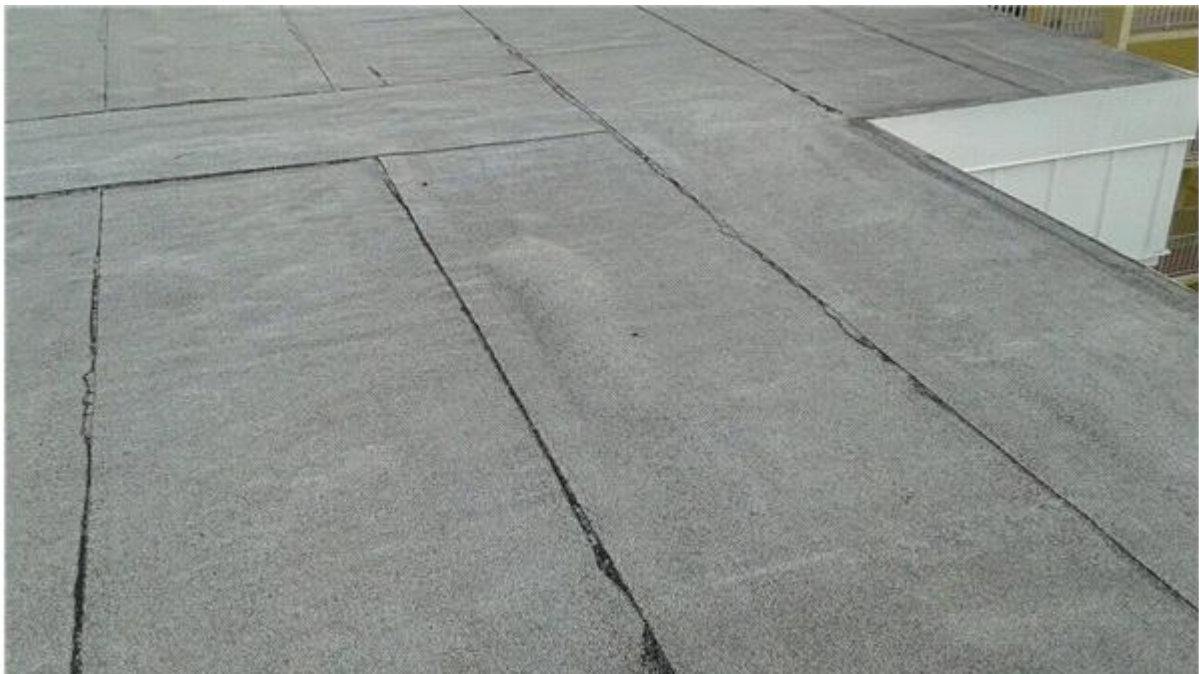
F-200 Field Membrane

Blisters are caused by gas trapped in the system and may be ruptured with foot traffic. Crowther Roofing will monitor.

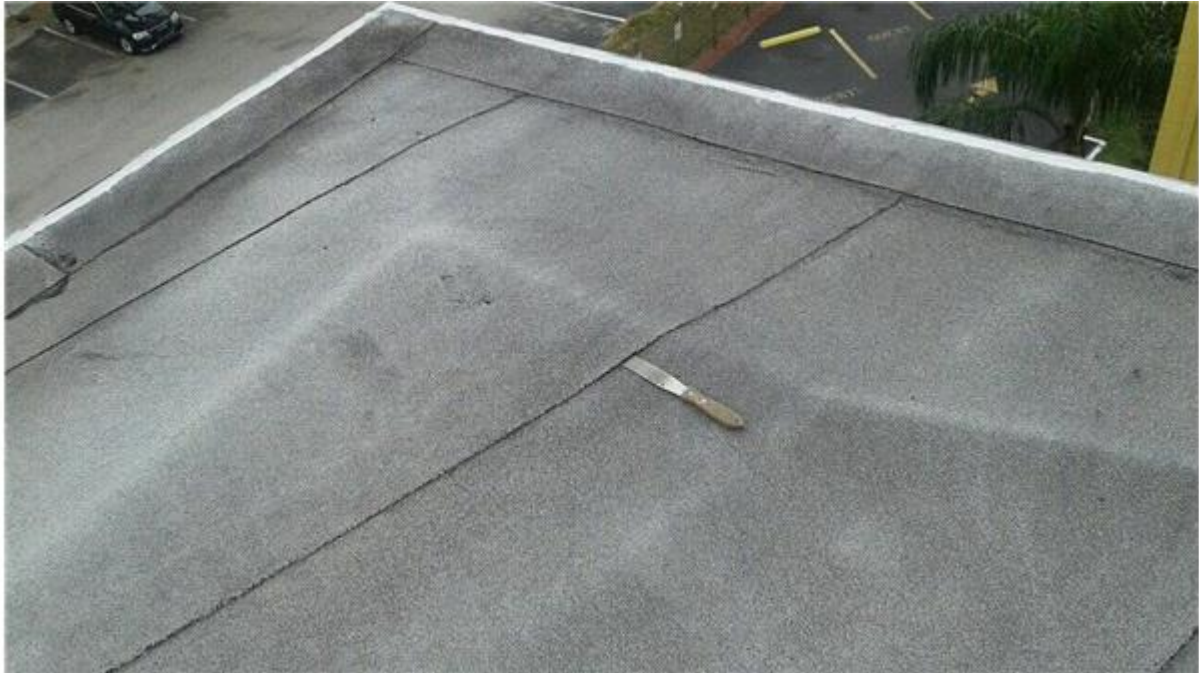
F-108 Field Membrane

An opening has formed at the edge of the felt. At this time water is not penetrating.

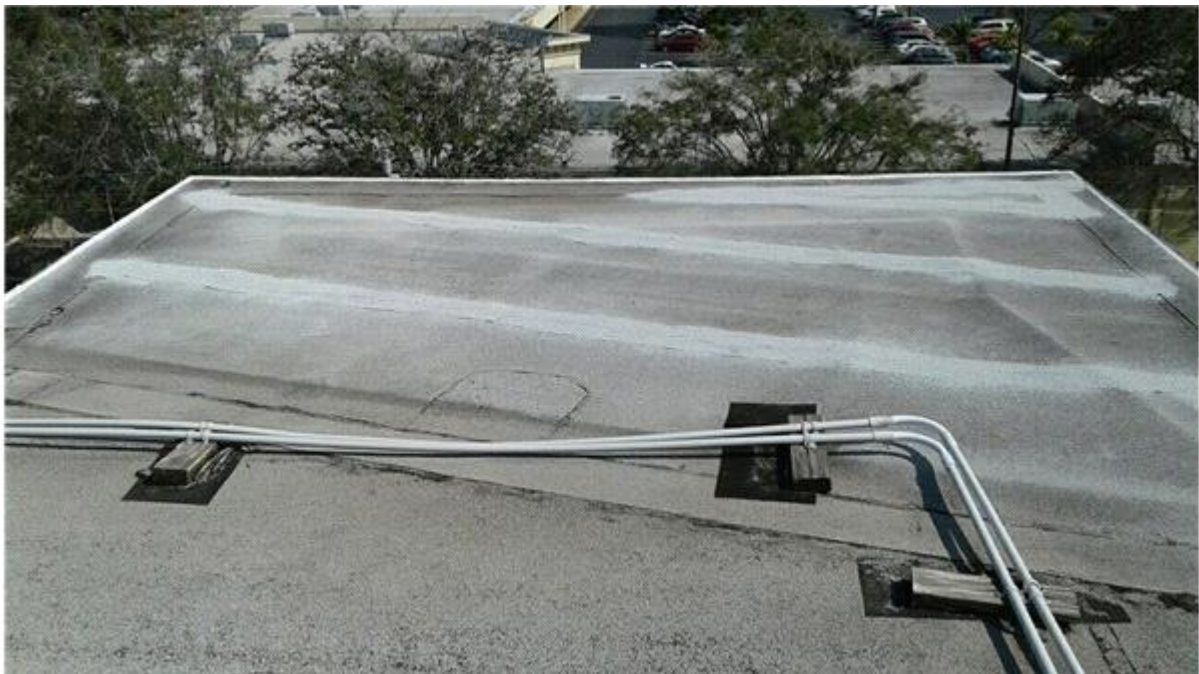
F-108 R Field Membrane

Repaired with high grade roofing cement and polyester membrane.

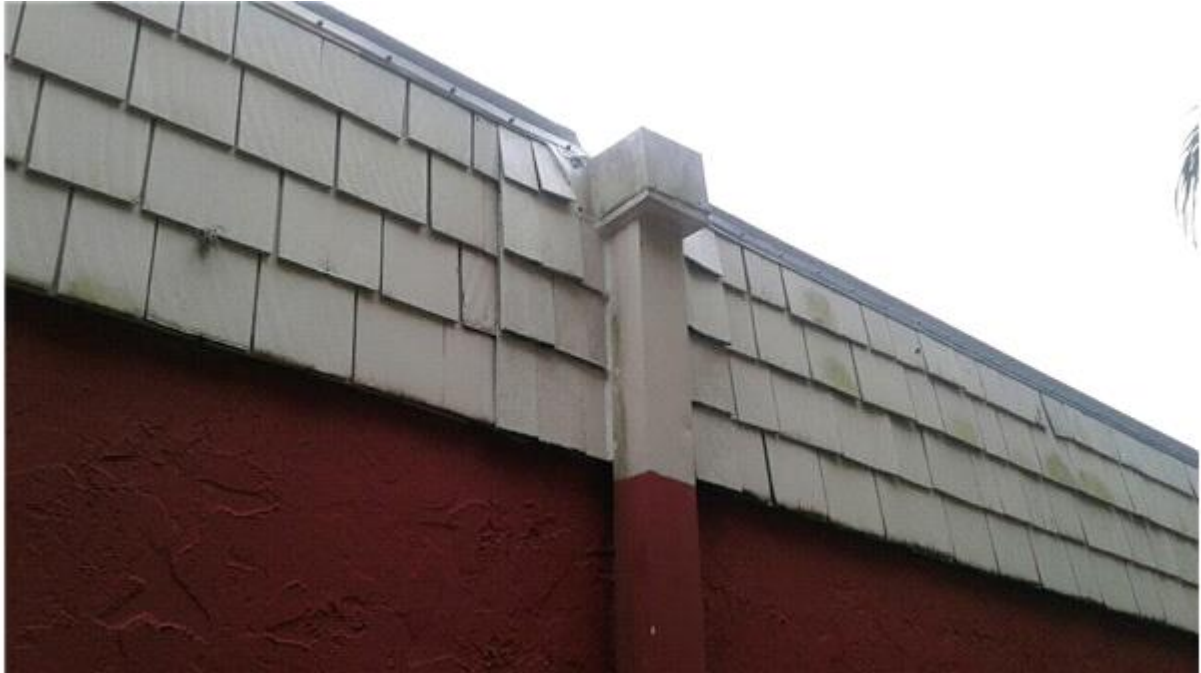
Downspout

Void between downspout and shake mansard sealed with M1-sealant.

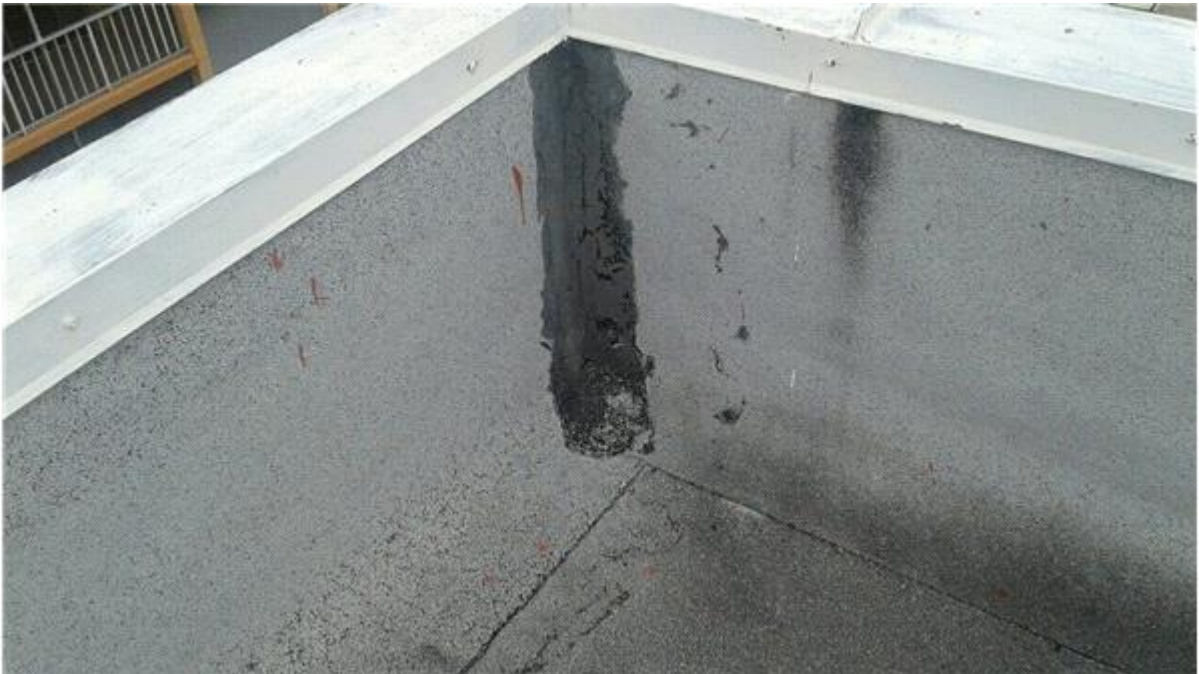
Base Flashings

Prolonged exposure to sun has compromised existing repair.

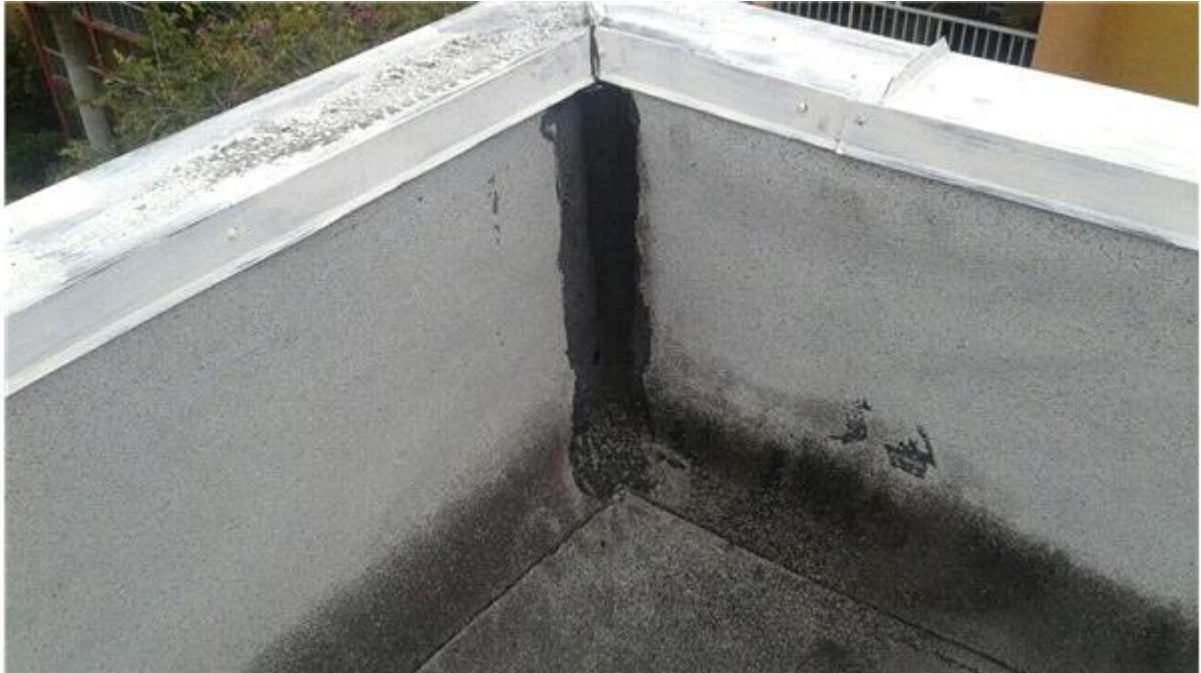
Base Flashings

Prolonged exposure to sun has compromised existing repair.
