Subject: **Inspection Report (2 of 3) at Towers, The**

THE TOWERS
2366 EAST MALL DRIVE
FORT MYERS, FL 33912

Crowther Roof Check Maintenance Program-Inspection Report

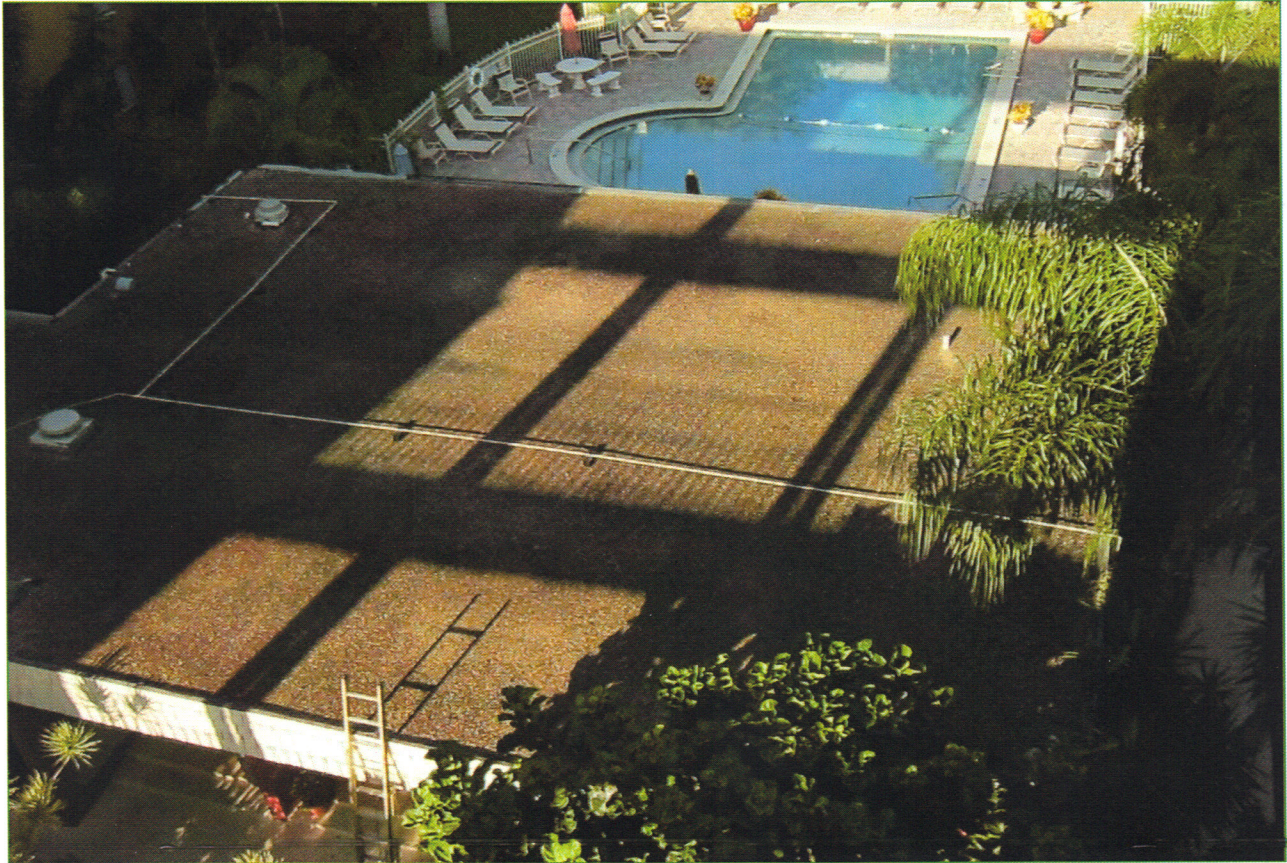
EXHIBIT #: 2

Main Roof Overview

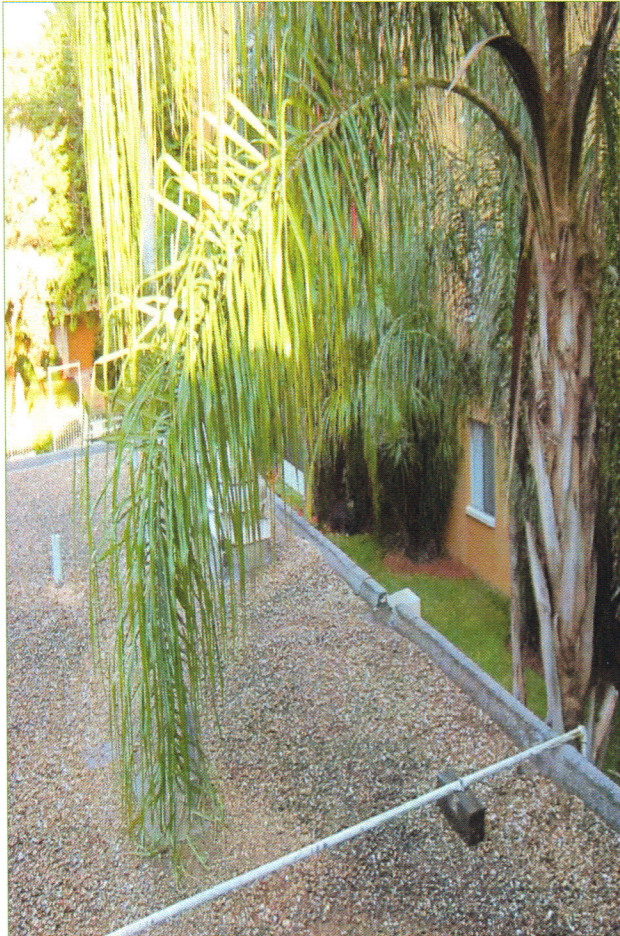
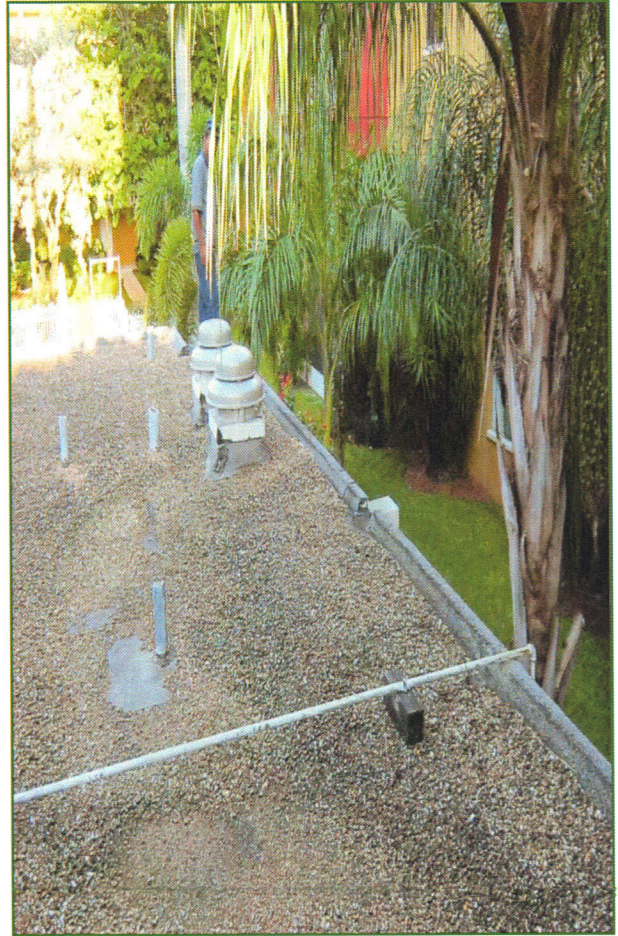
EXHIBIT #: 3

Identified tree branches hanging over the roof surface

Cut back the tree branches away from the roof system

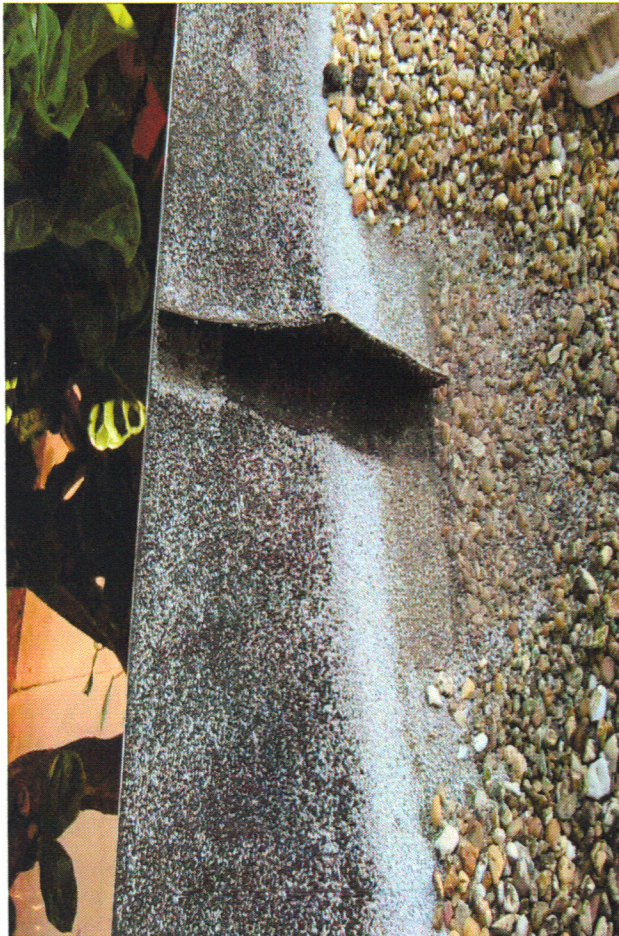
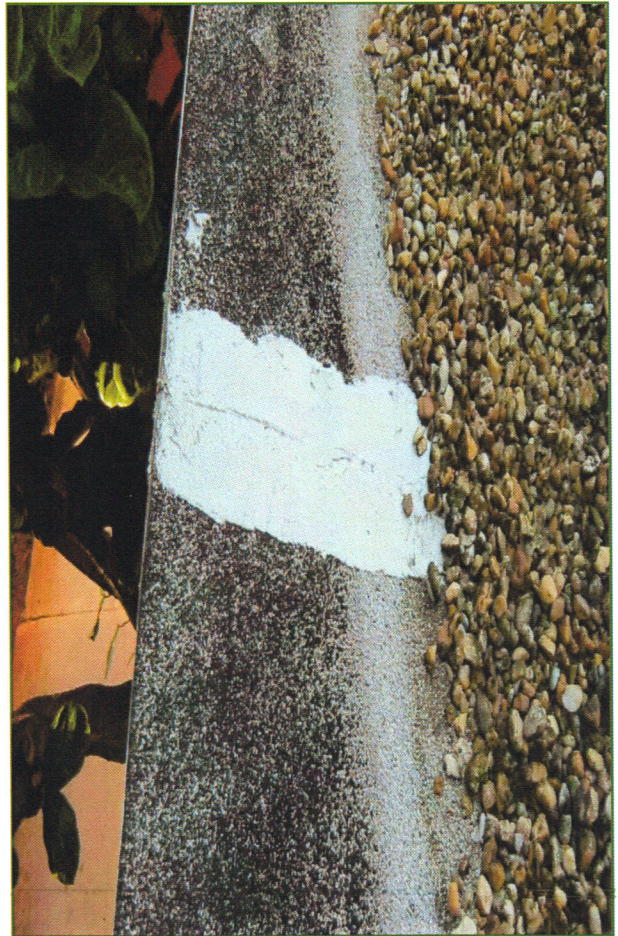
EXHIBIT #: 4

Identified loose base flashing

Sealed the base flashing with sealant

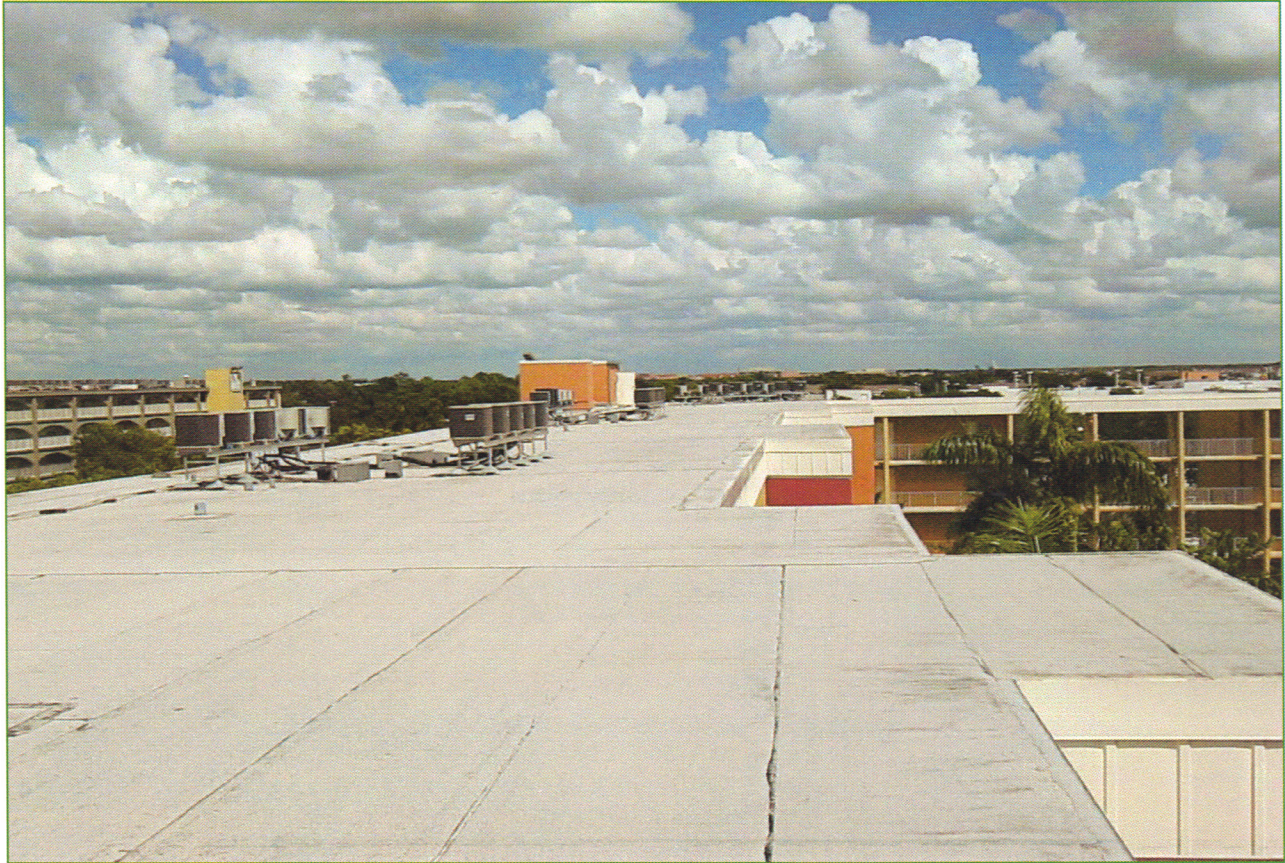
EXHIBIT #: 5

Main Roof Overview

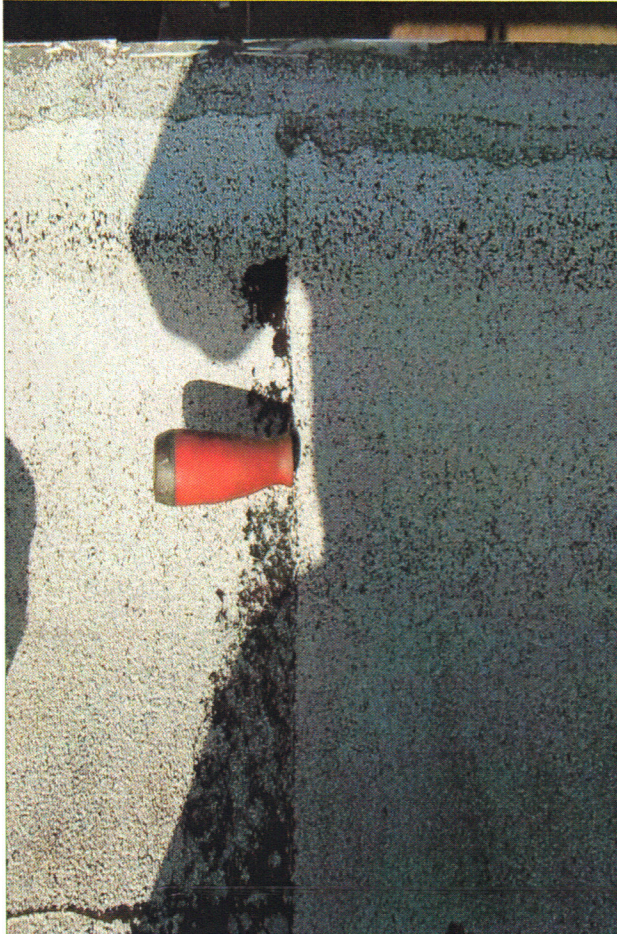
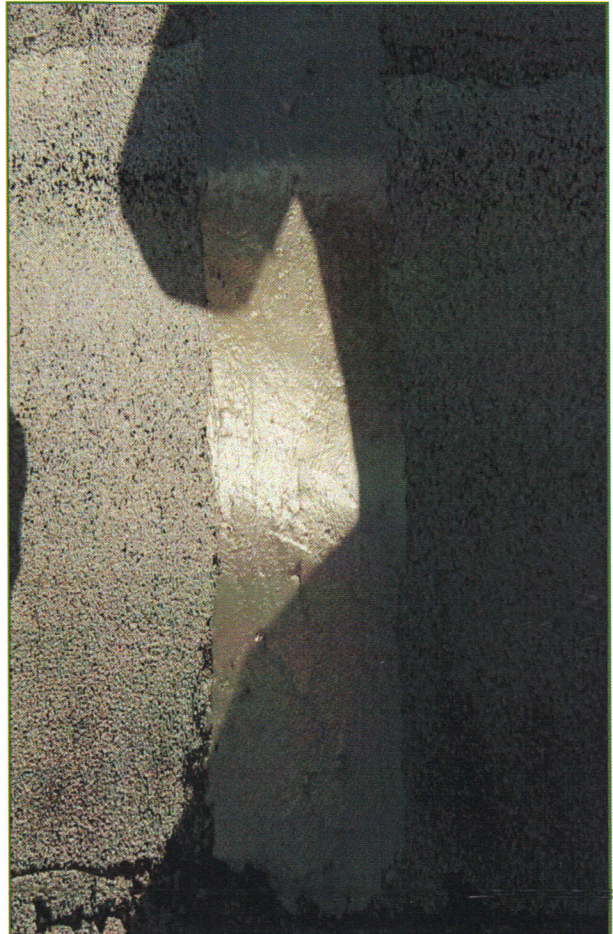
EXHIBIT #: 6

Identified a void in the base flashings

Sealed the base flashings with
modified roofing cement

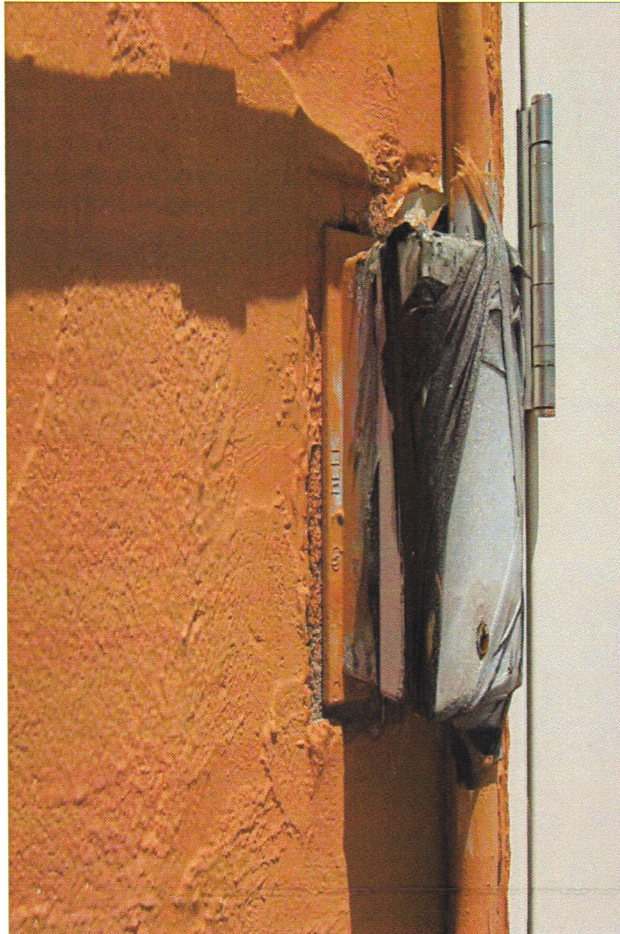
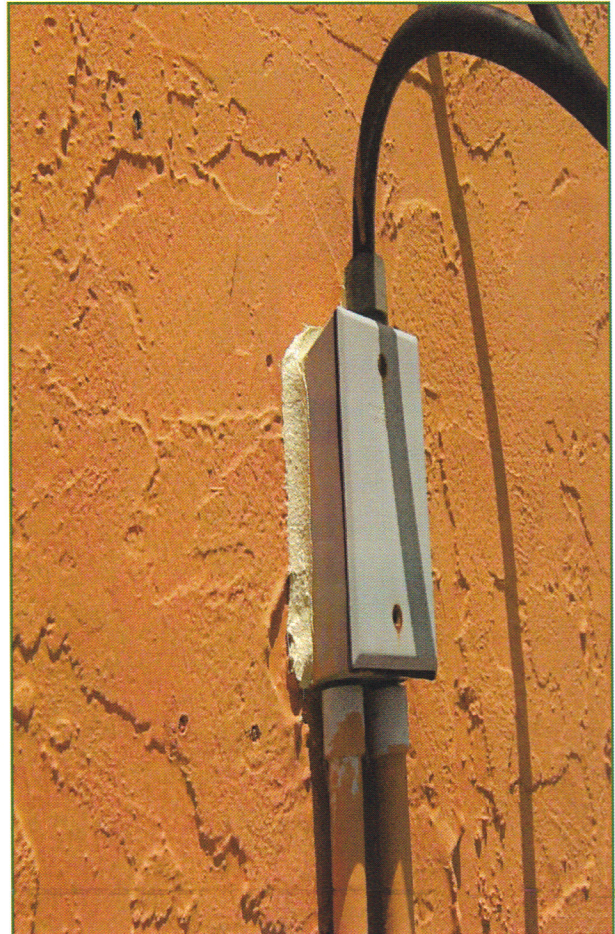
EXHIBIT #: 7

Identified open penetrations on the parapet wall

Sealed the penetrations with sealant where required

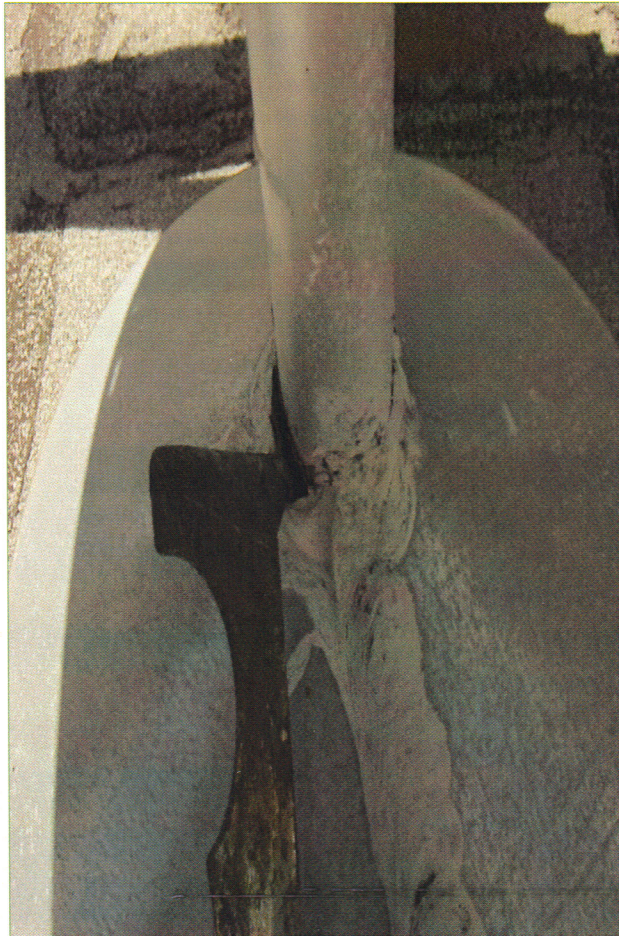
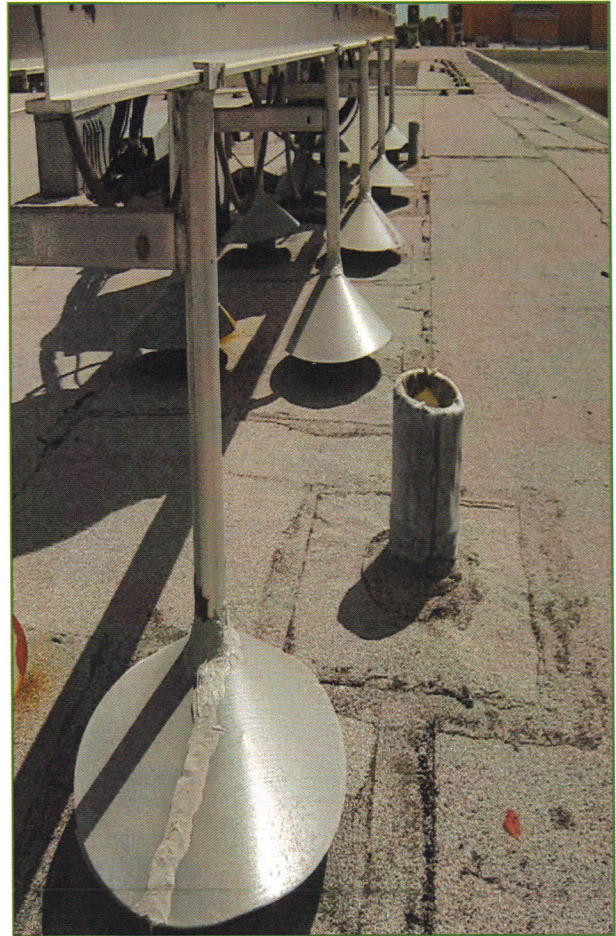
EXHIBIT #: 8

Identified voids at the top of the umbrellas on the stands (approximately 20 total)

Cleaned the stands and sealed with polyurethane sealant
