Inspection Report

Facility: Towers, The
Address: 2366 East Mall Dr,
Fort Myers, 33901

Work Order #: 4780

Re.: **Inspection Report (3 of 6) for The Towers**

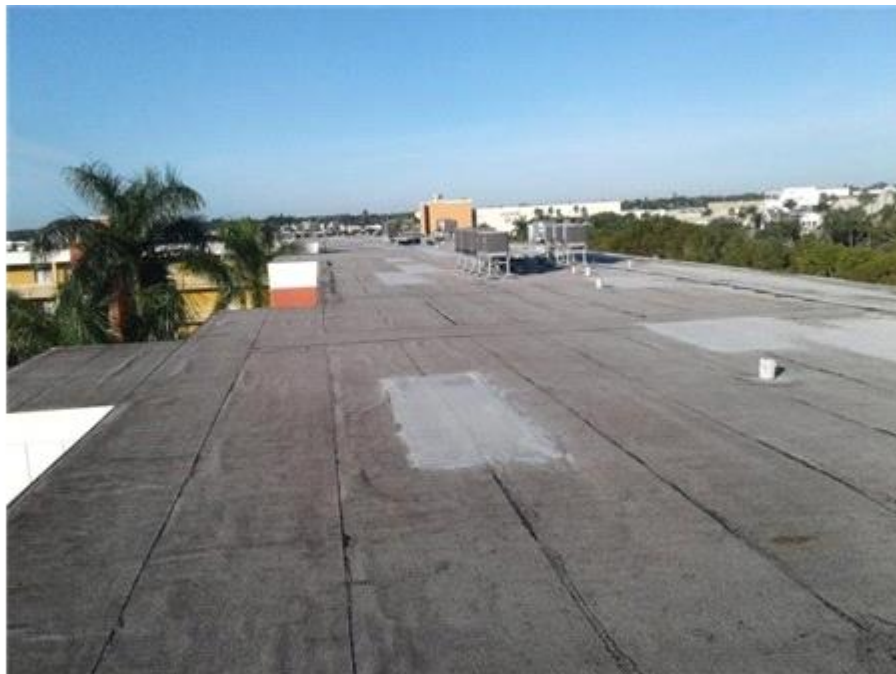
Main Roof: Roof Overview
General roof overview

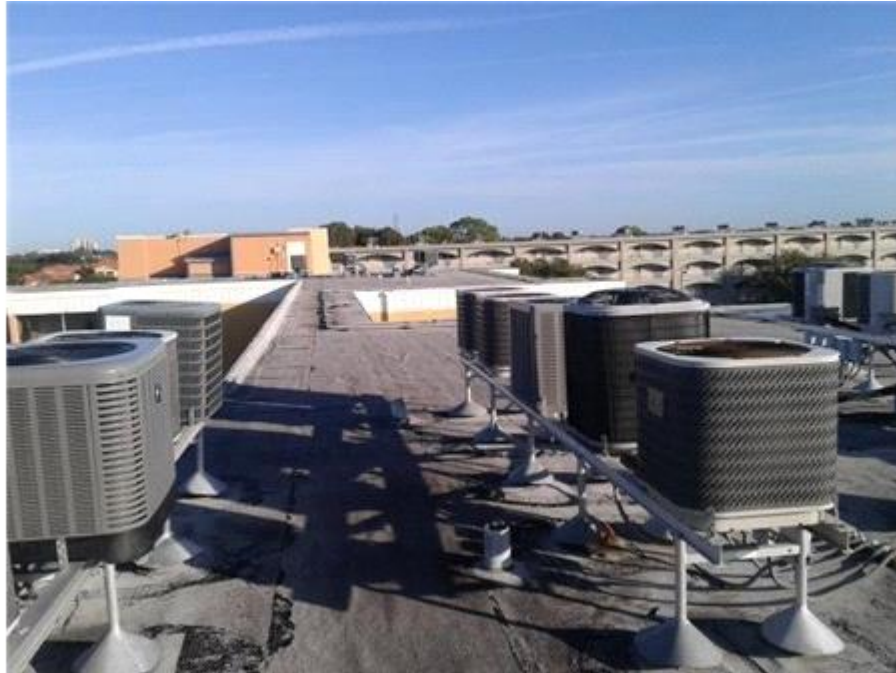
Main Roof: Roof Overview

General roof overview

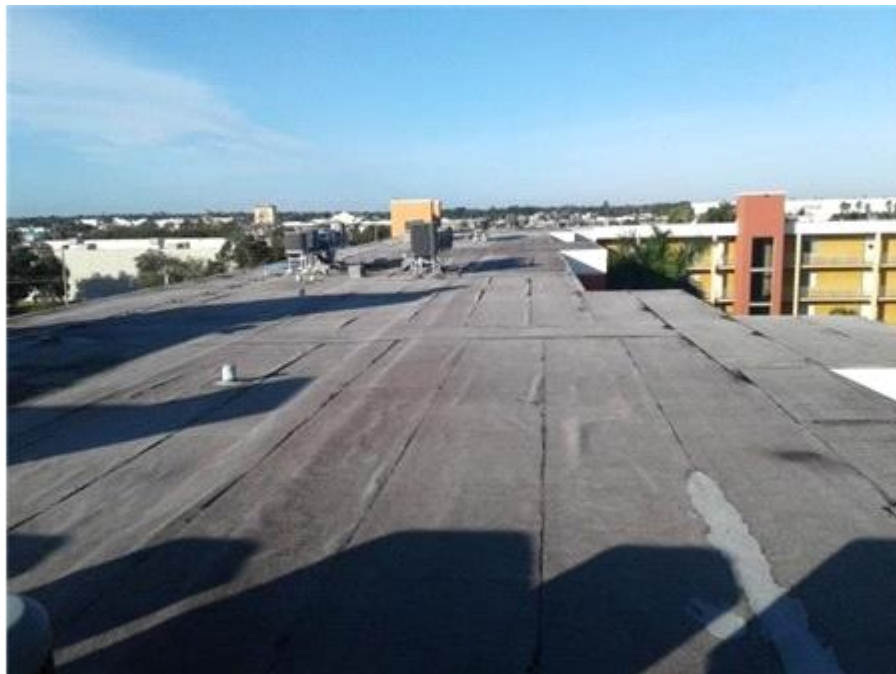
Main Roof: Roof Overview

General roof overview

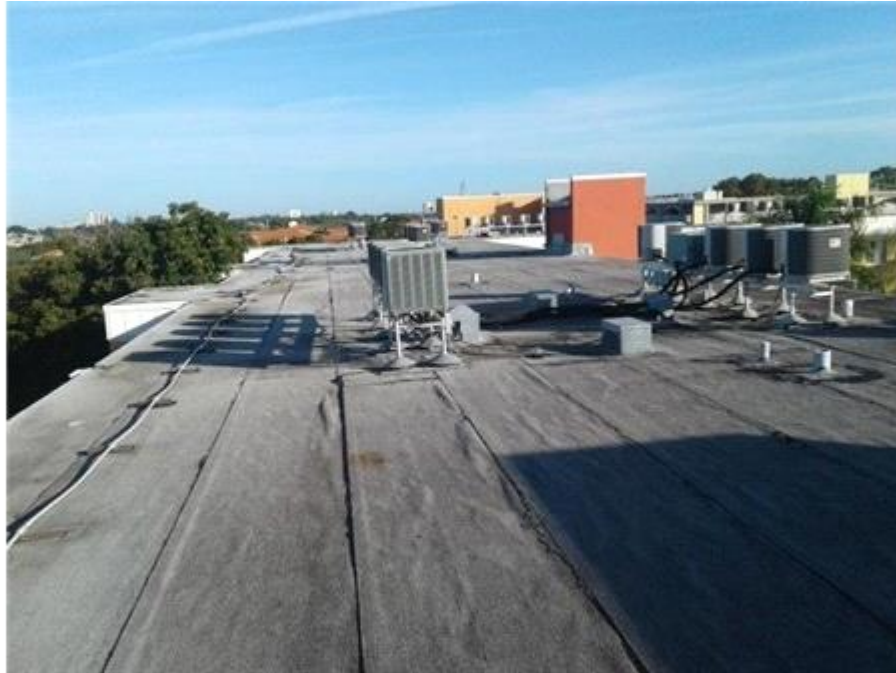
Main Roof: Roof Overview

General roof overview

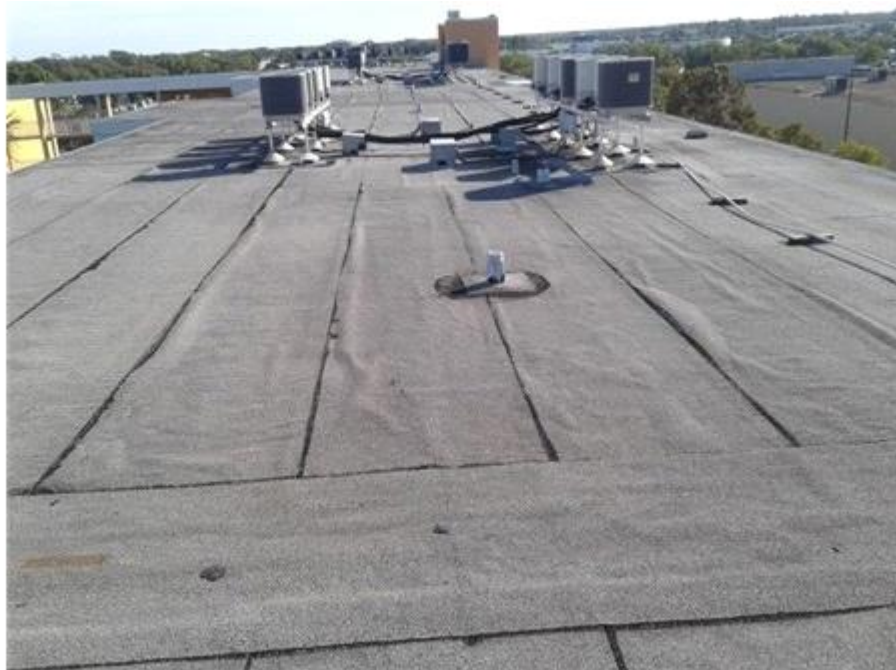
Main Roof: Roof Overview

General roof overview

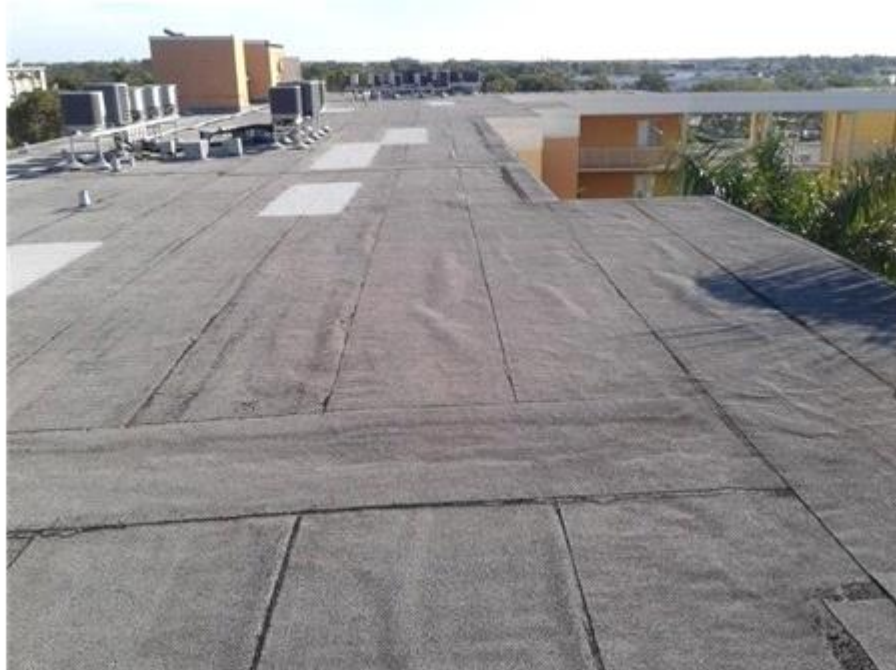
Main Roof: Roof Overview

General roof overview

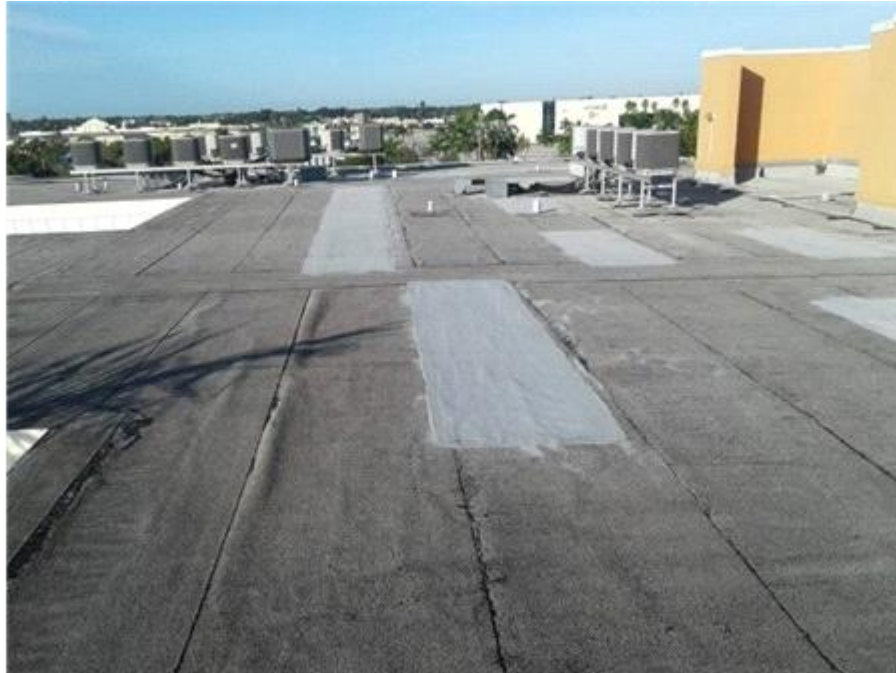
Main Roof: Surface Overview

The roof surface appears to be in fair condition at this time.

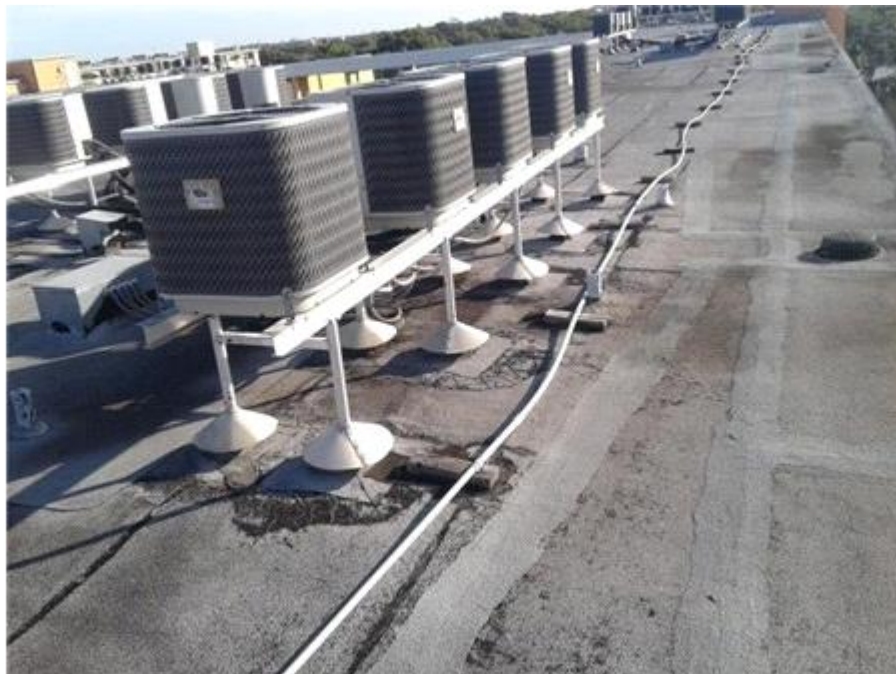
Main Roof: Appearance Overview

The appearance of the roof is in fair condition at this time.

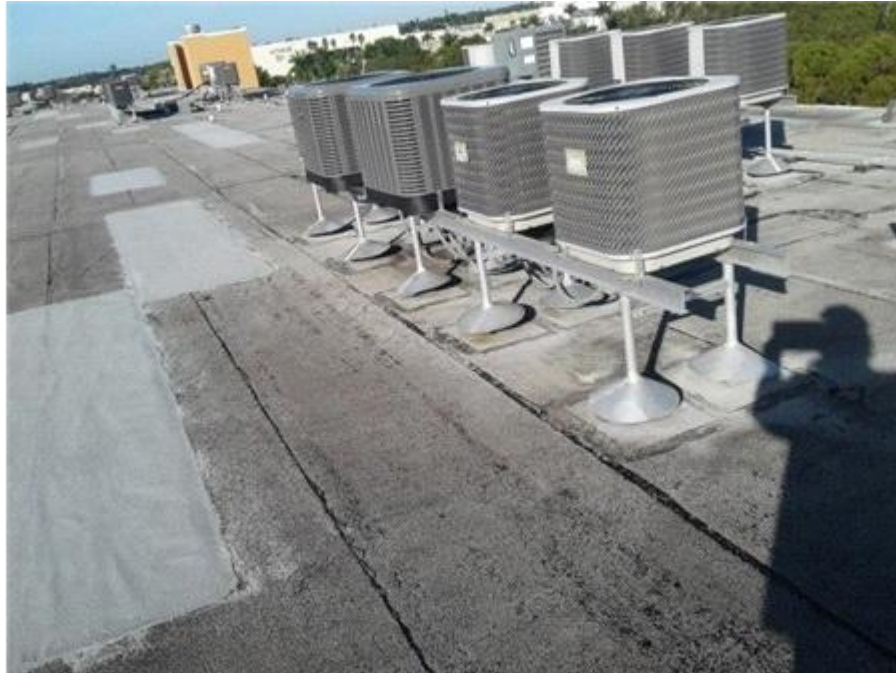
Main Roof: Appearance Overview

The appearance of the roof is in fair condition at this time.

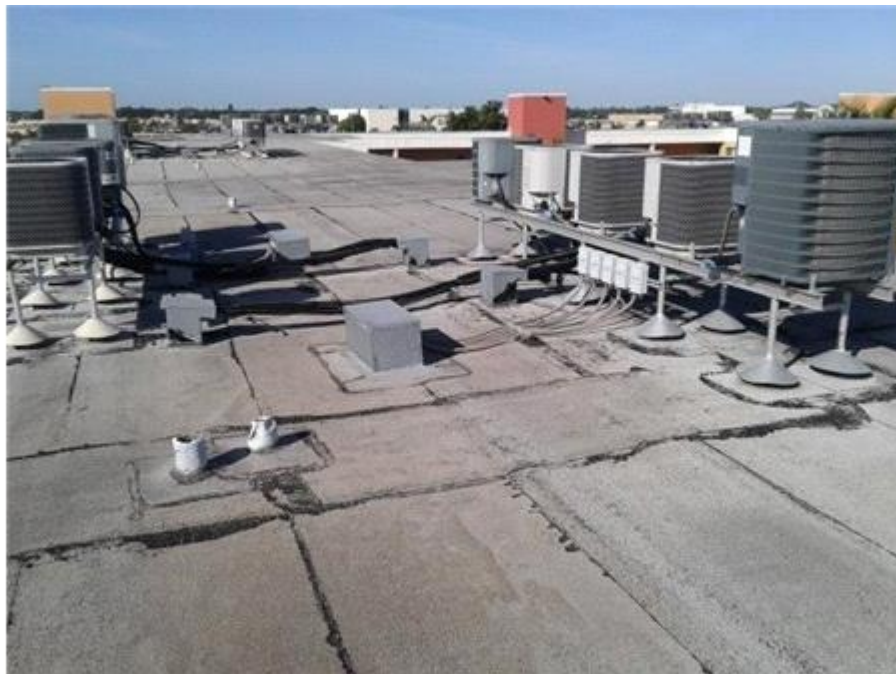
Main Roof: Appearance Overview

The appearance of the roof is in fair condition at this time.

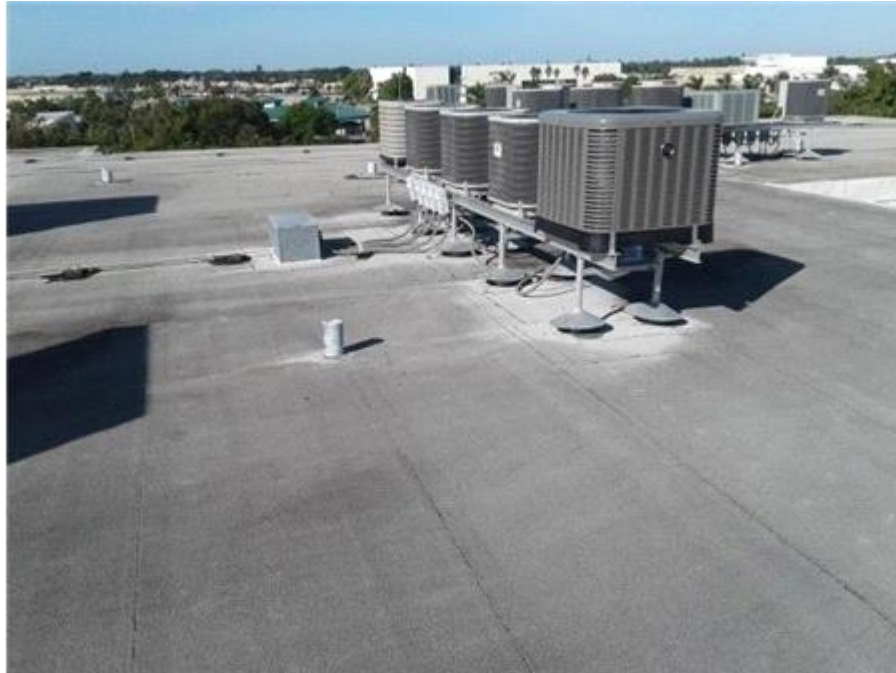
Main Roof: Appearance Overview

The appearance of the roof is in fair condition at this time.

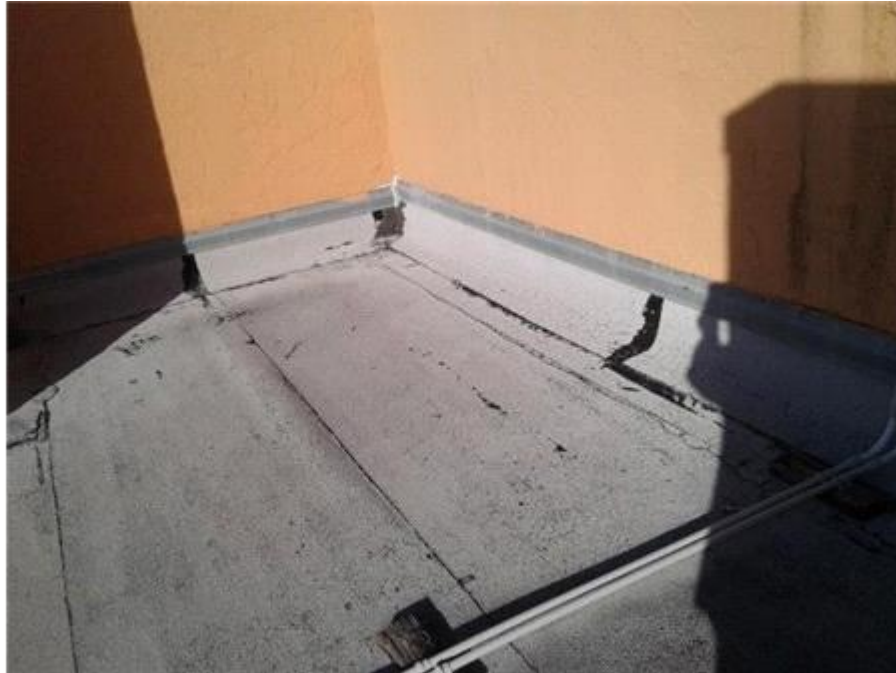
Main Roof: Base Flashings

The base flashings appear to be in fair condition at this time.

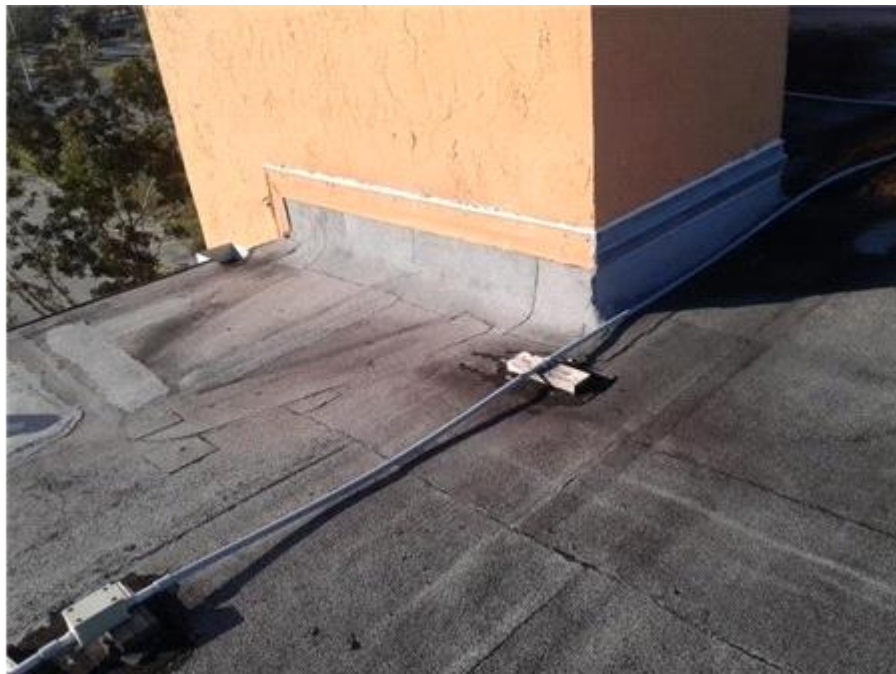
Main Roof: Base Flashings

The base flashings appear to be in fair condition at this time.

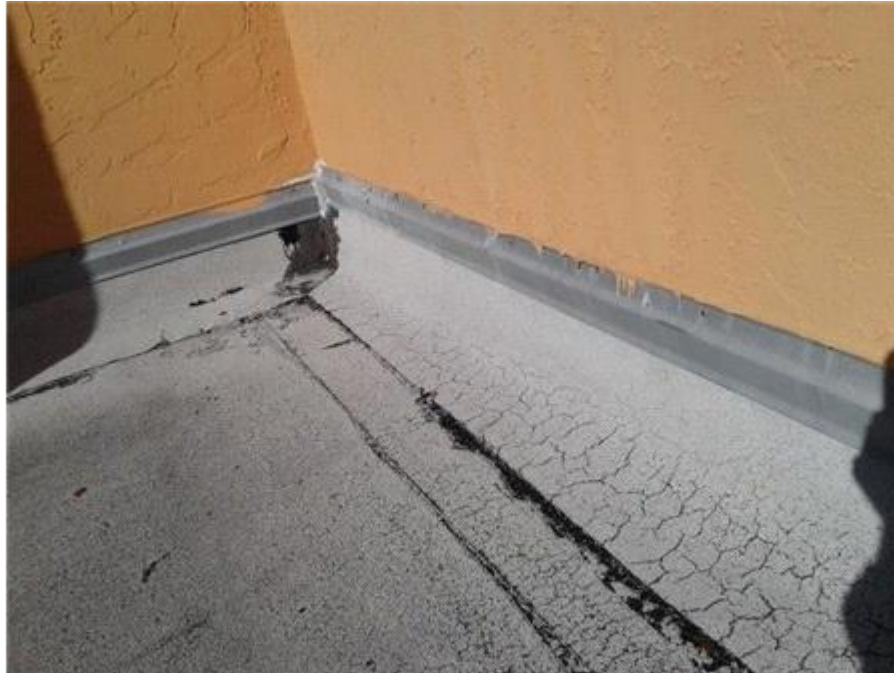
Main Roof: Counter Flashings

The counter flashing appear to be in fair condition at this time.

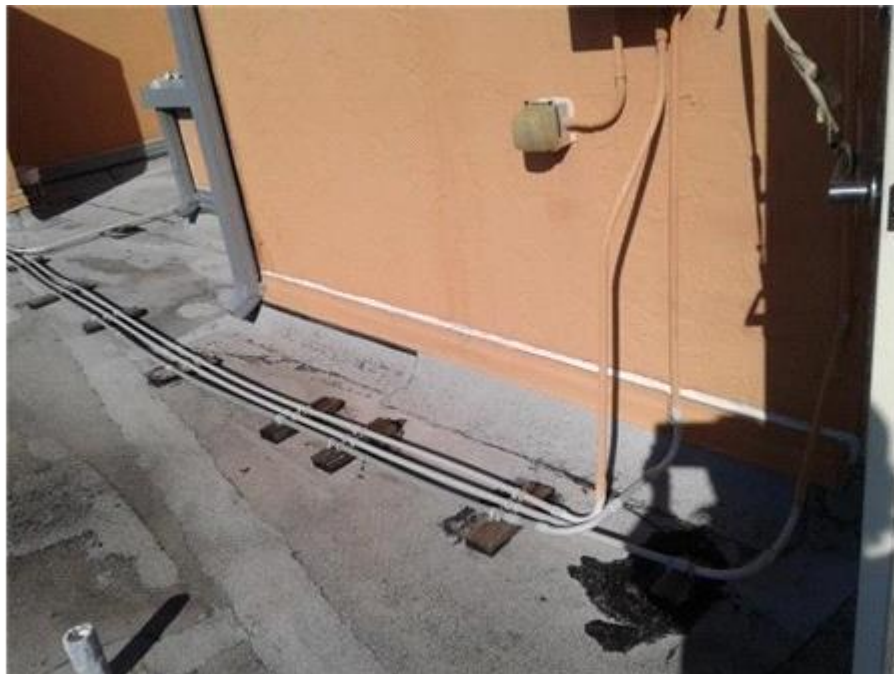
Main Roof: Counter Flashings

The counter flashing appear to be in fair condition at this time.

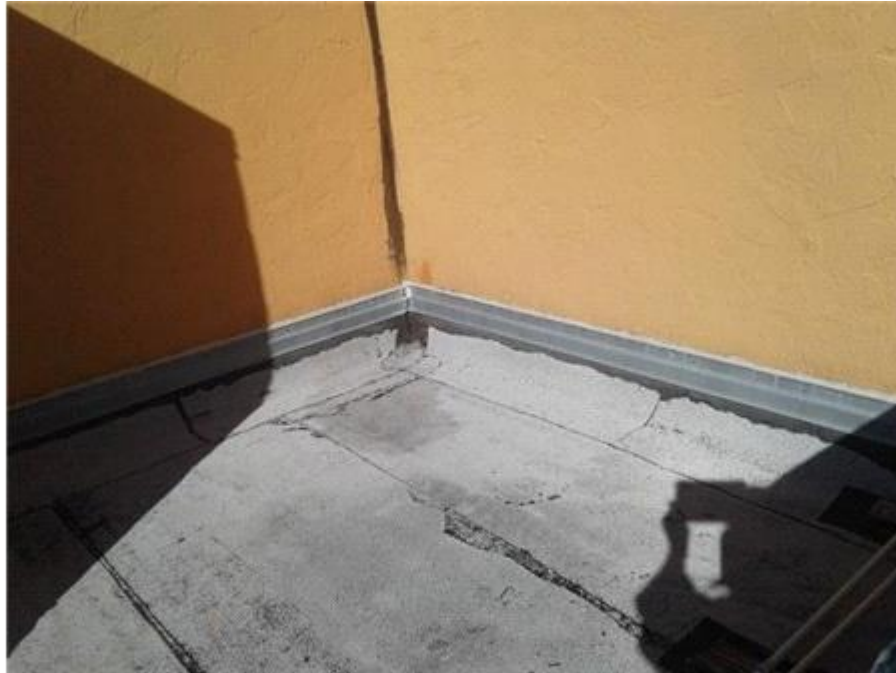
Main Roof: Counter Flashings

The counter flashing appear to be in fair condition at this time.

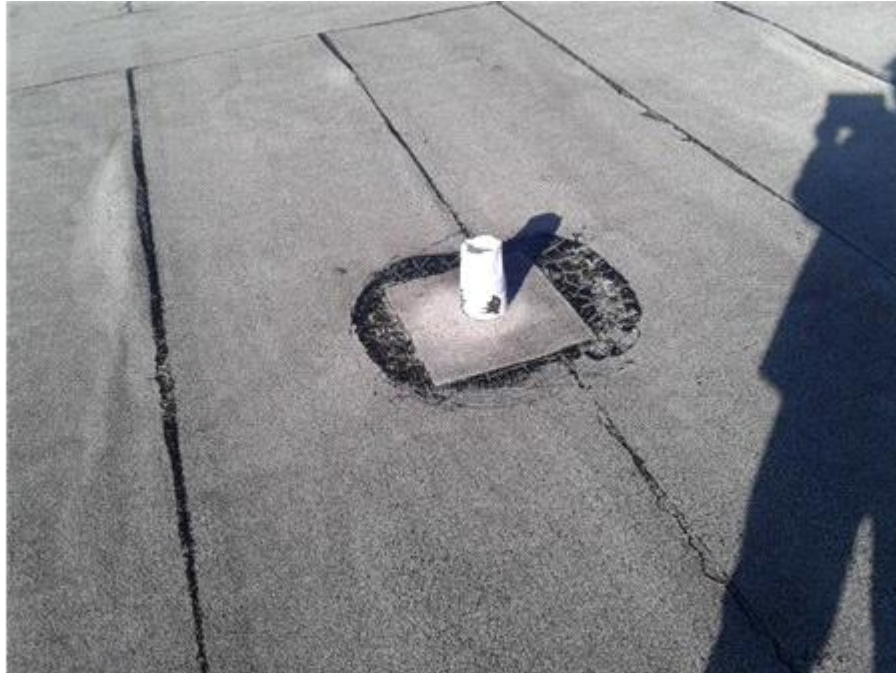
Main Roof: Lead Boots

The lead boots appear to be in fair condition at this time.

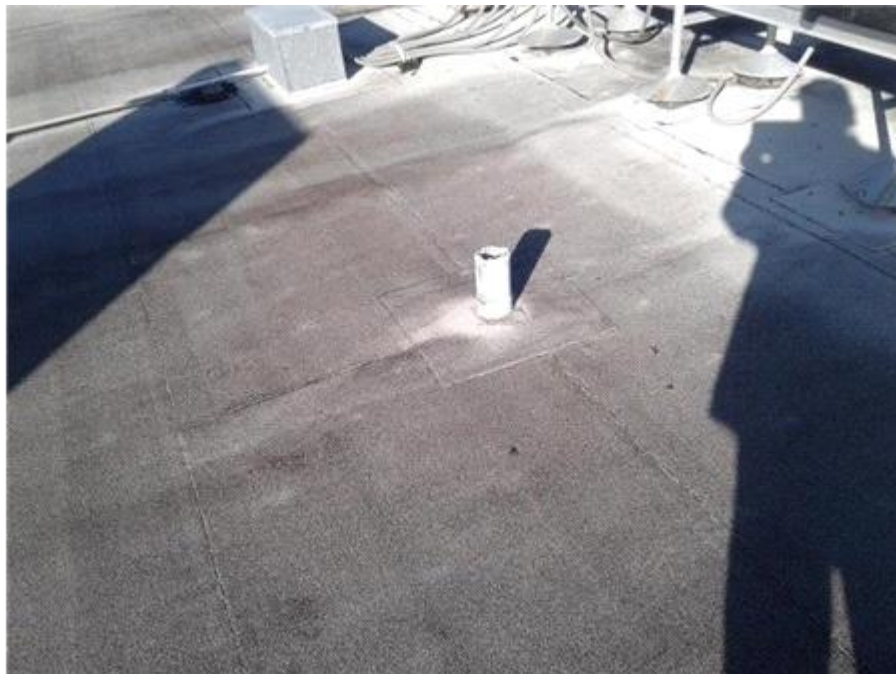
Main Roof: Lead Boots

The lead boots appear to be in fair condition at this time.

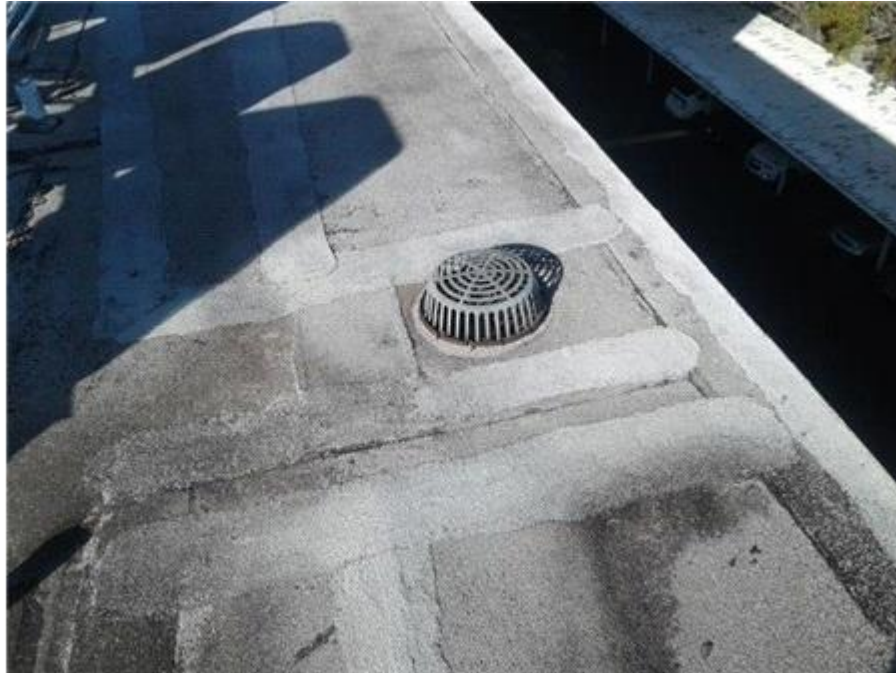
Main Roof: Roof Drains

The roof drains appear to be in fair condition at this time.

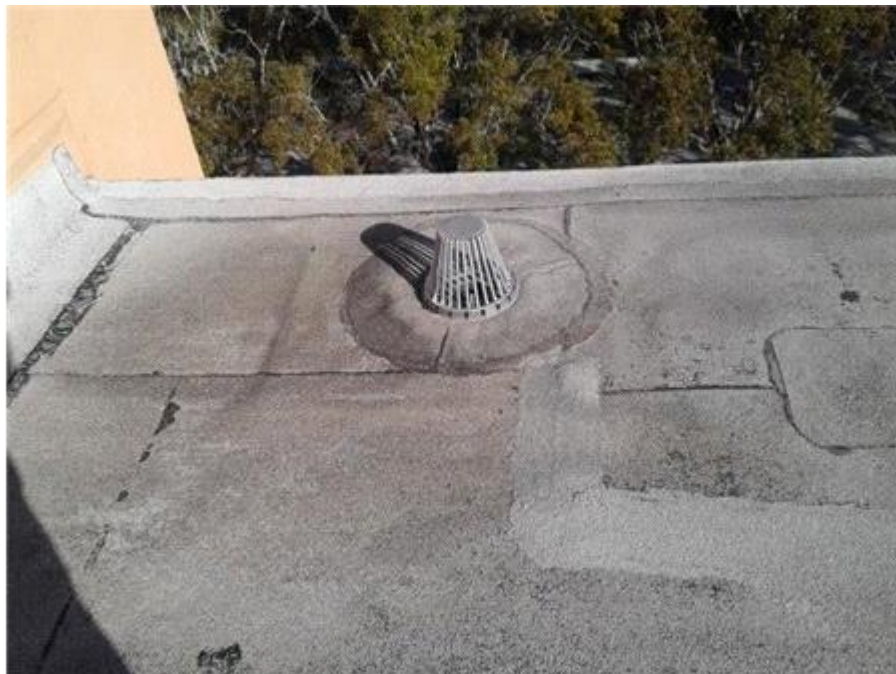
Main Roof: Roof Drains

The roof drains appear to be in fair condition at this time.

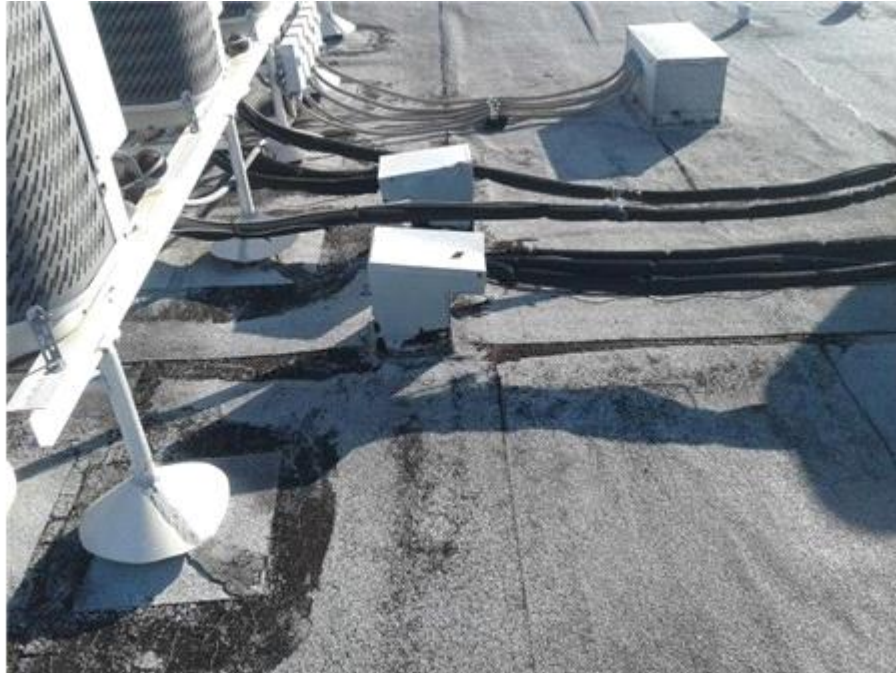
Main Roof: Equipment Housing

The equipment housing appears to be in fair condition at this time.

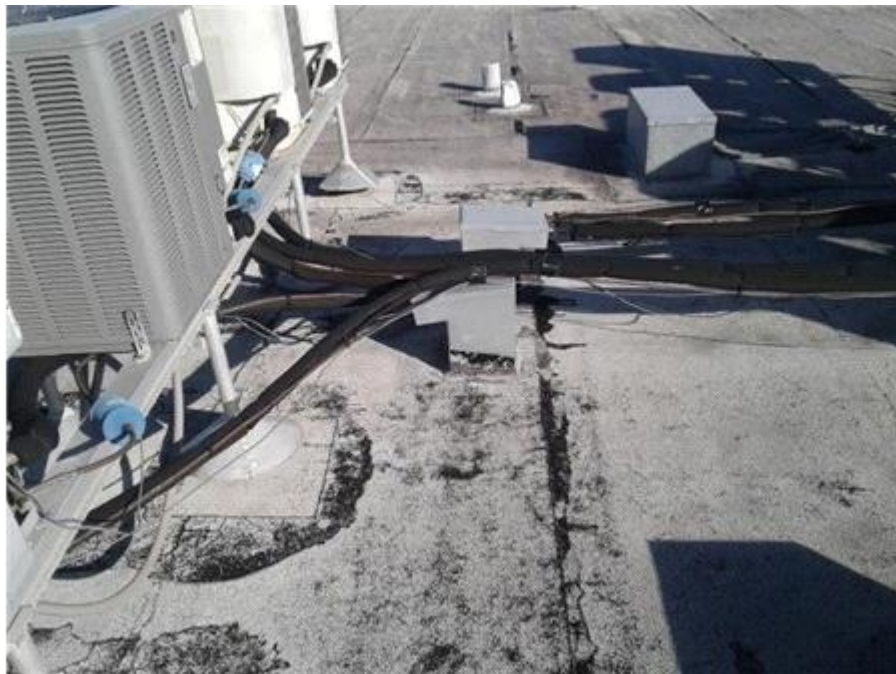
Main Roof: Equipment Housing

The equipment housing appears to be in fair condition at this time.

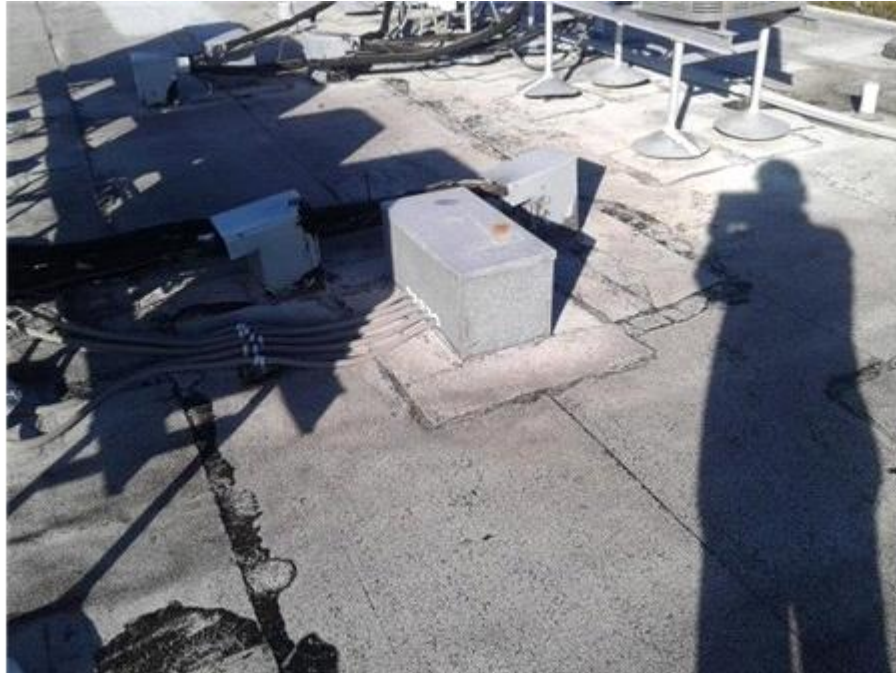
Main Roof: Equipment Housing

The equipment housing appears to be in fair condition at this time.

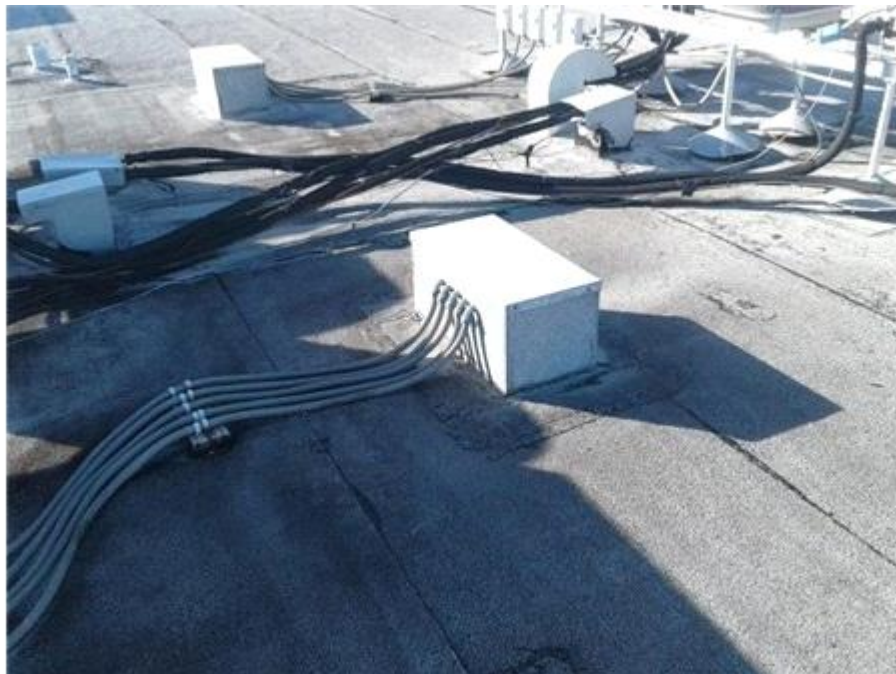
Main Roof: Equipment Housing

The equipment housing appears to be in fair condition at this time.

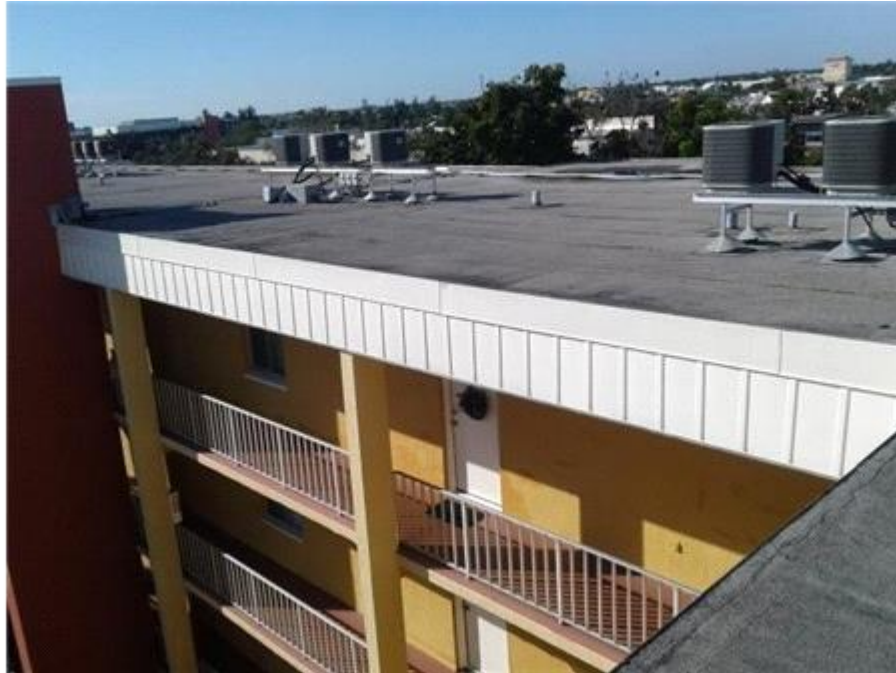
Main Roof: Edge Metal

The edge metal appears to be in good condition at this time.

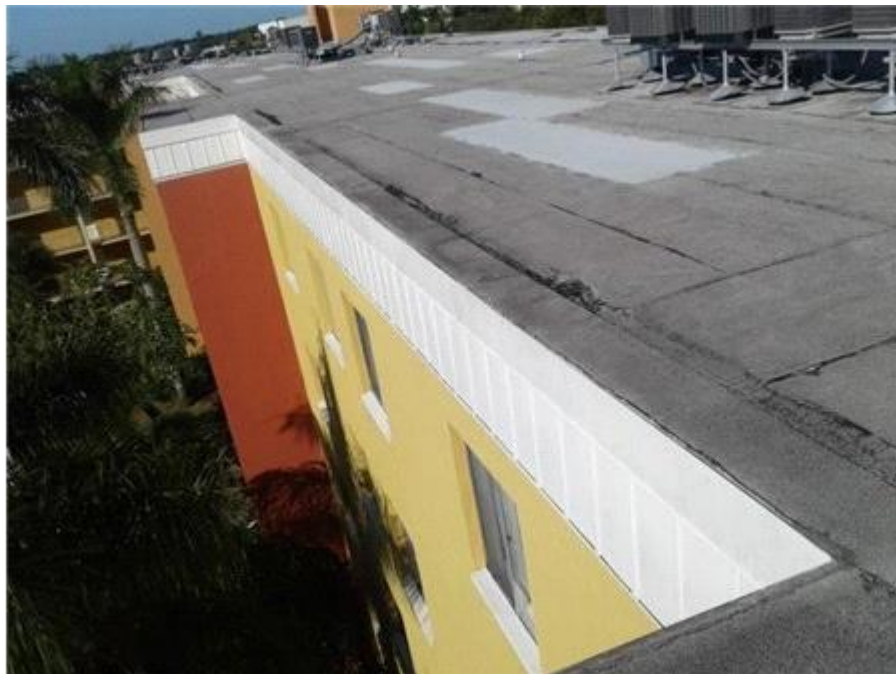
Main Roof: Edge Metal

The edge metal appears to be in good condition at this time.

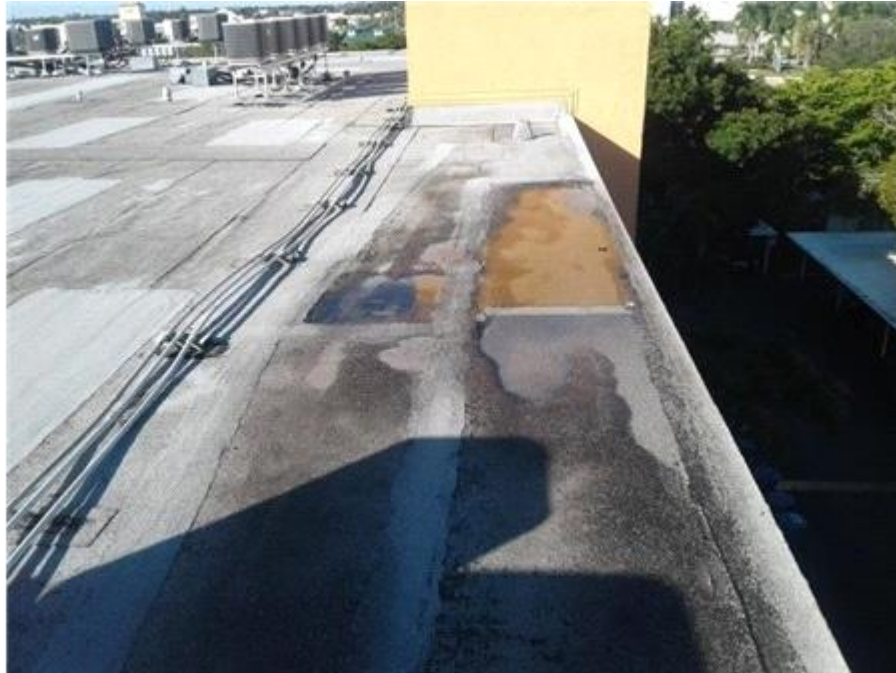
Main Roof: Roof Edge

The roof edge appears to be in fair condition at this time.

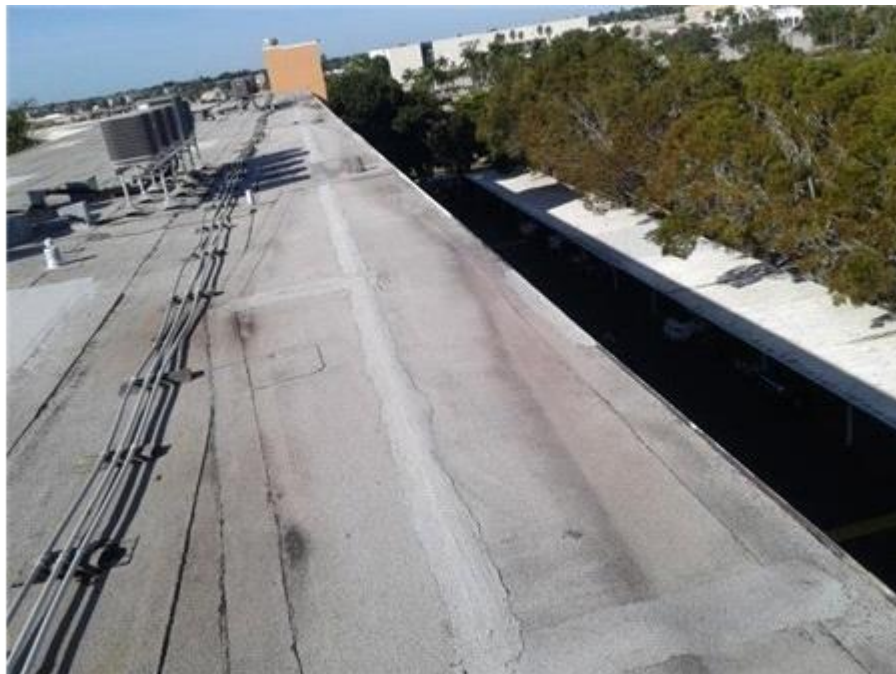
Main Roof: Roof Edge

The roof edge appears to be in fair condition at this time.

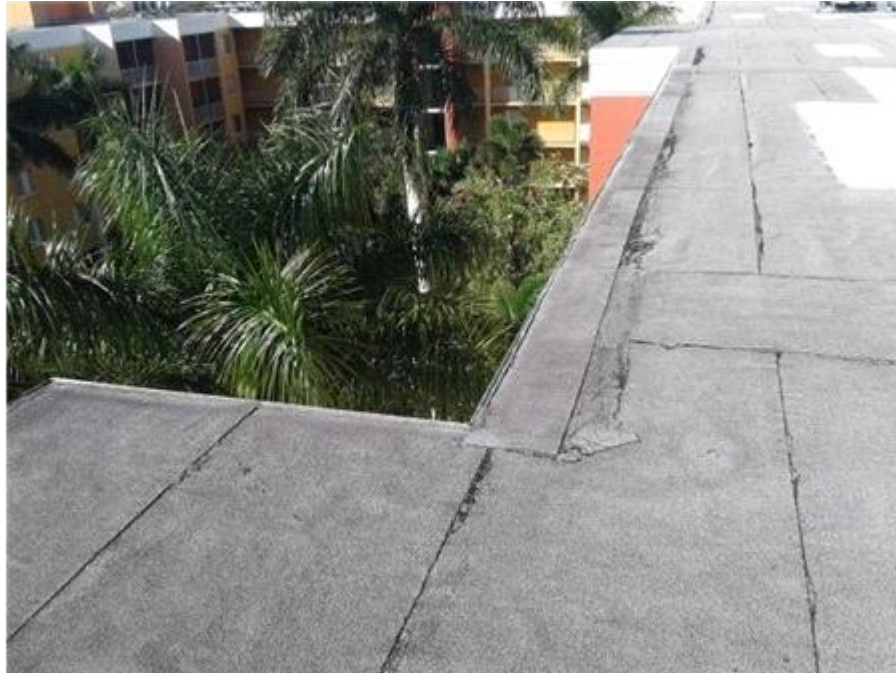
Main Roof: Roof Edge

The roof edge appears to be in fair condition at this time.

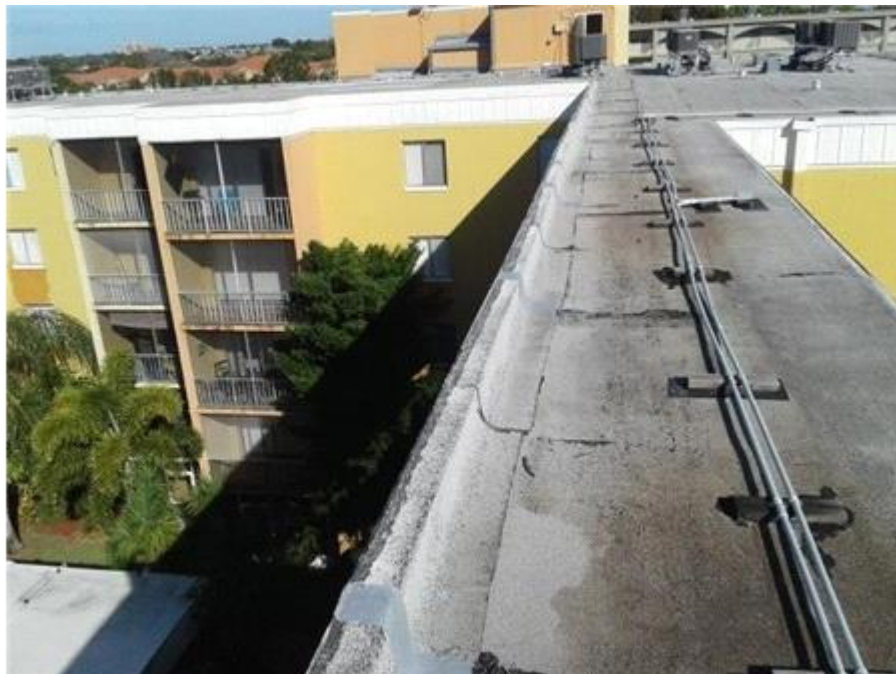
Main Roof: Roof Edge

The roof edge appears to be in fair condition at this time.

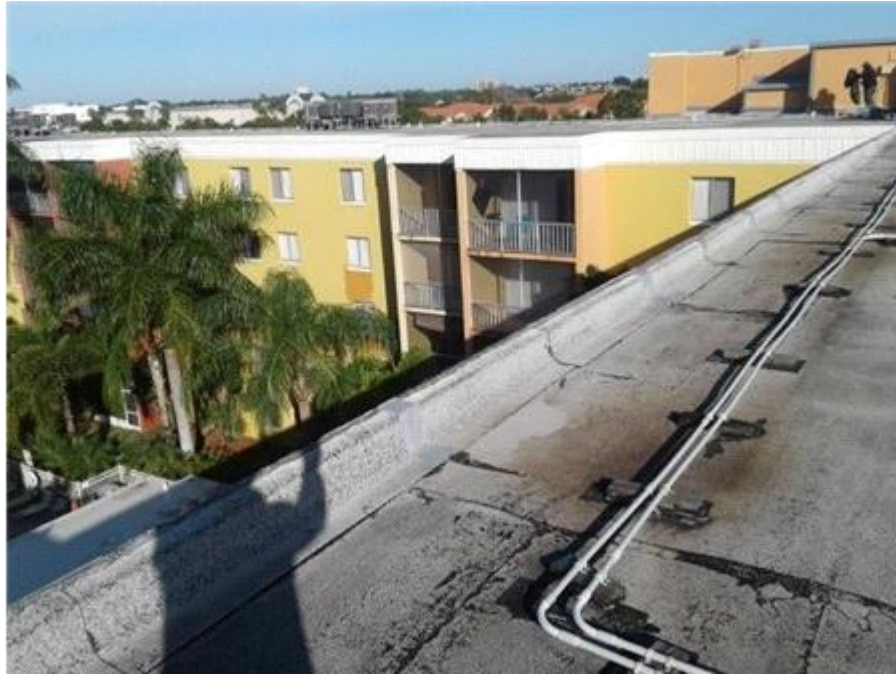
Main Roof: Wall Flashing

The wall flashing appears to be in fair condition at this time.

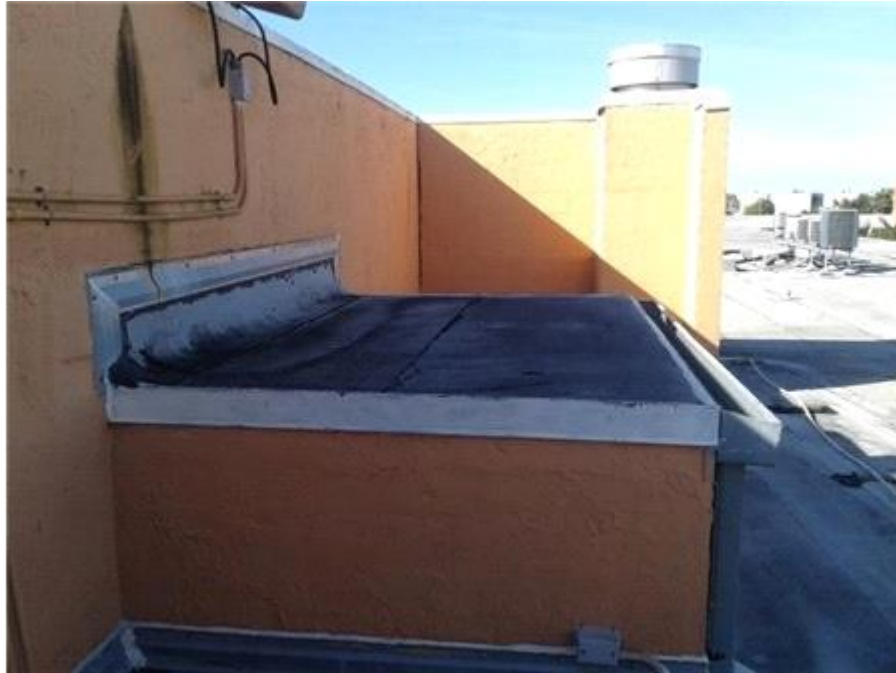
Stairwell Roof: Membrane Overview

The roof membrane appears to be in fair condition at this time.

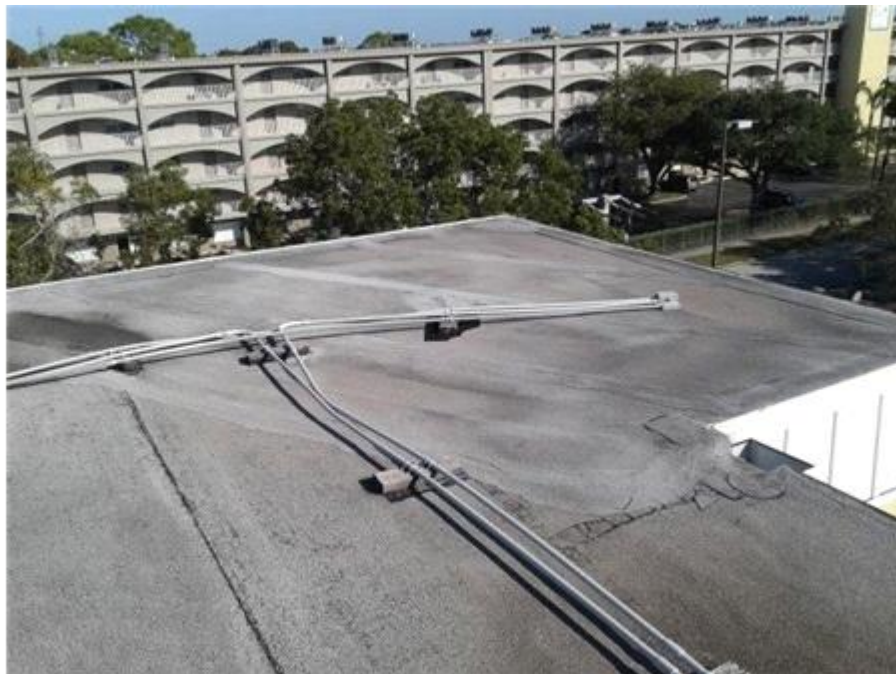
Stairwell Roof: Surface Overview

The roof surface appears to be in fair condition at this time.

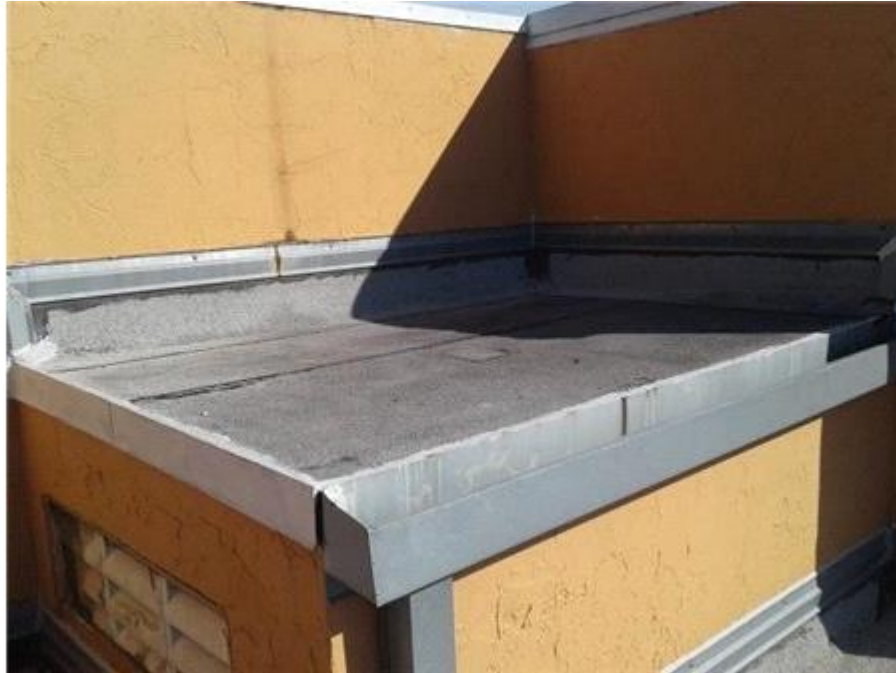
Stairwell Roof: Appearance Overview

The appearance of the roof is in fair condition at this time.

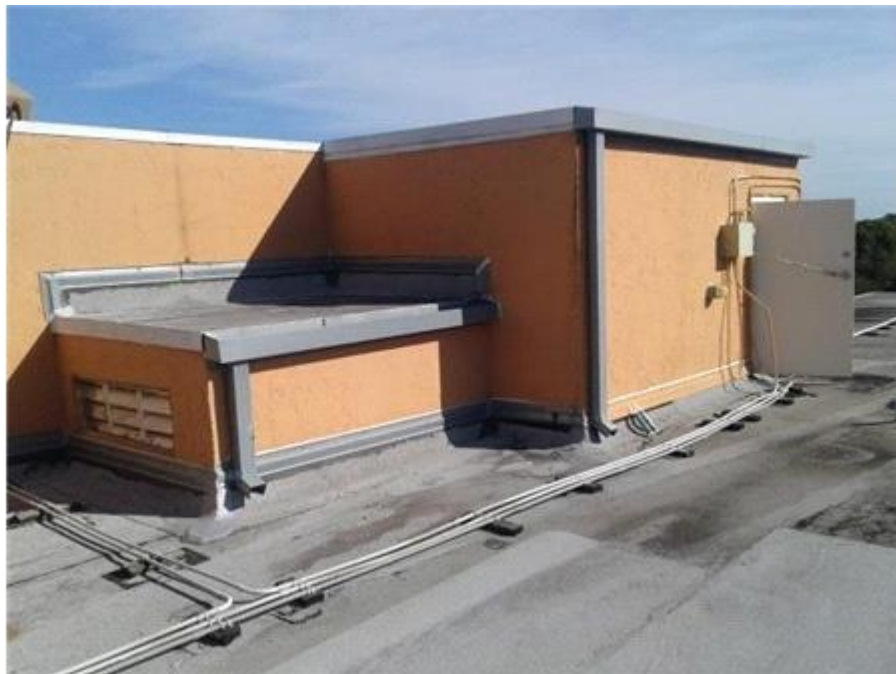
Stairwell Roof: Appearance Overview

The appearance of the roof is in fair condition at this time.

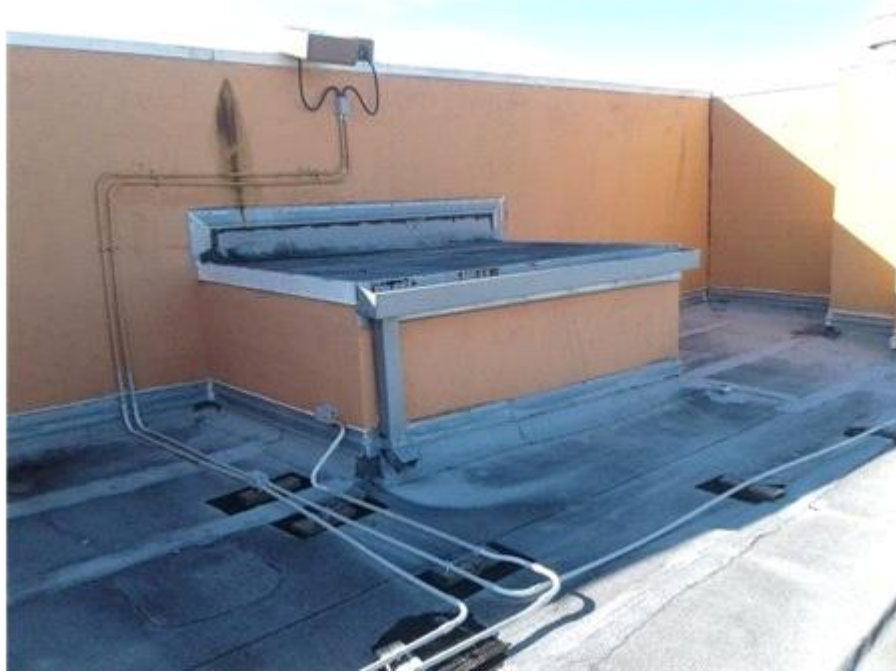
Stairwell Roof: Appearance Overview

The appearance of the roof is in fair condition at this time.

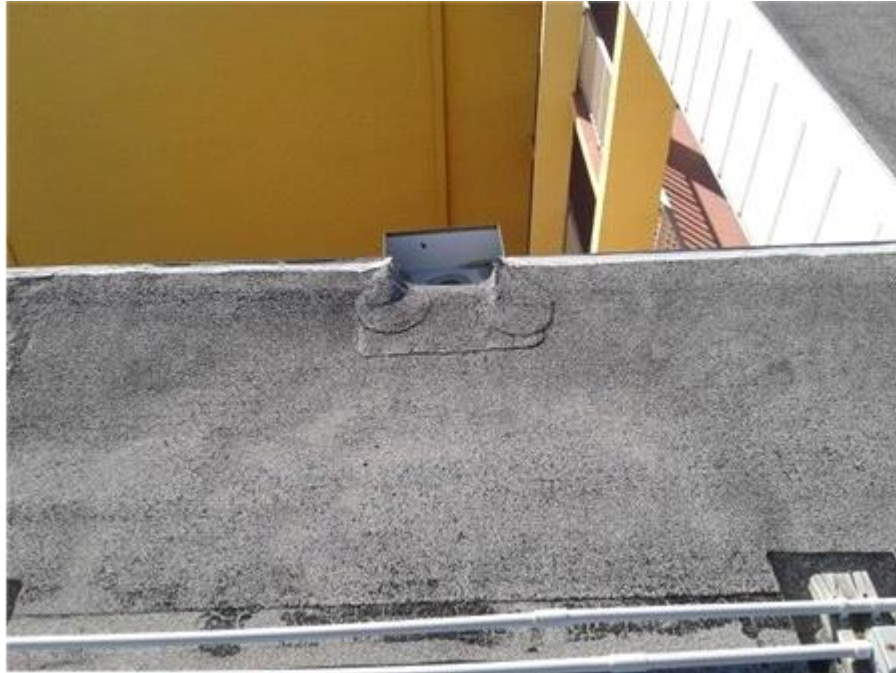
Stairwell Roof: Scuppers

The scuppers appear to be in fair condition at this time.
