Inspection Report

Facility: Towers, The
Address: 2366 East Mall Dr,
Fort Myers, 33901

Work Order #: 4780

Re.: **Inspection Report (3 of 6) for The Towers**

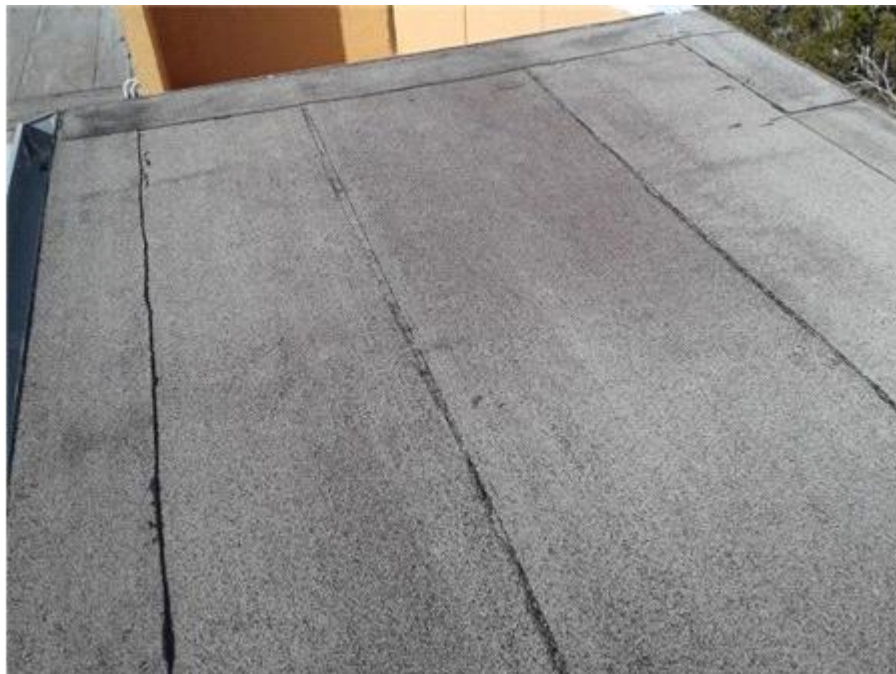
Stairwell Roof: Base Flashings

The base flashings appear to be in fair condition at this time.

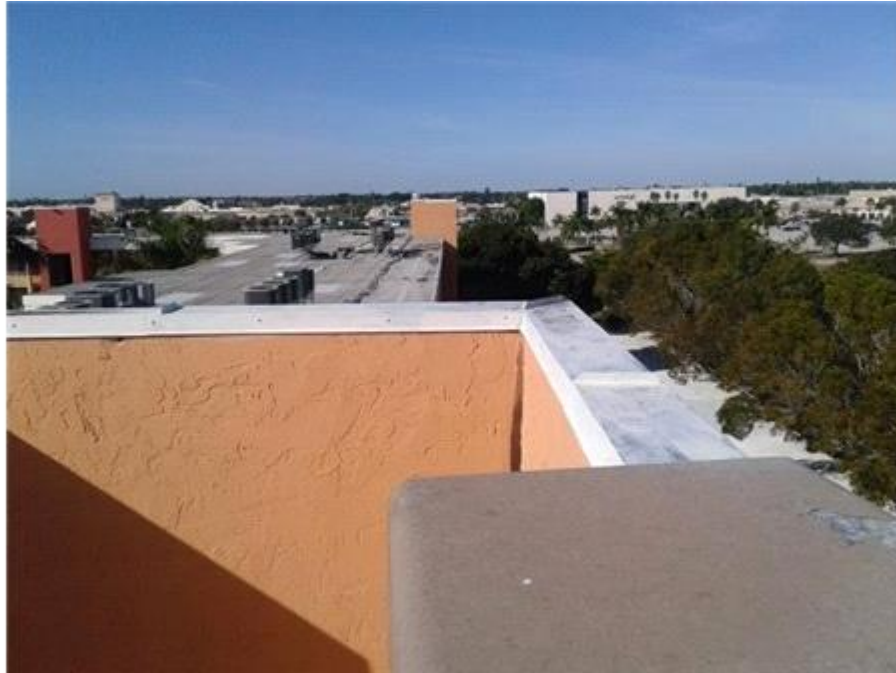
Stairwell Roof: Coping

The coping appears to be in fair condition at this time.

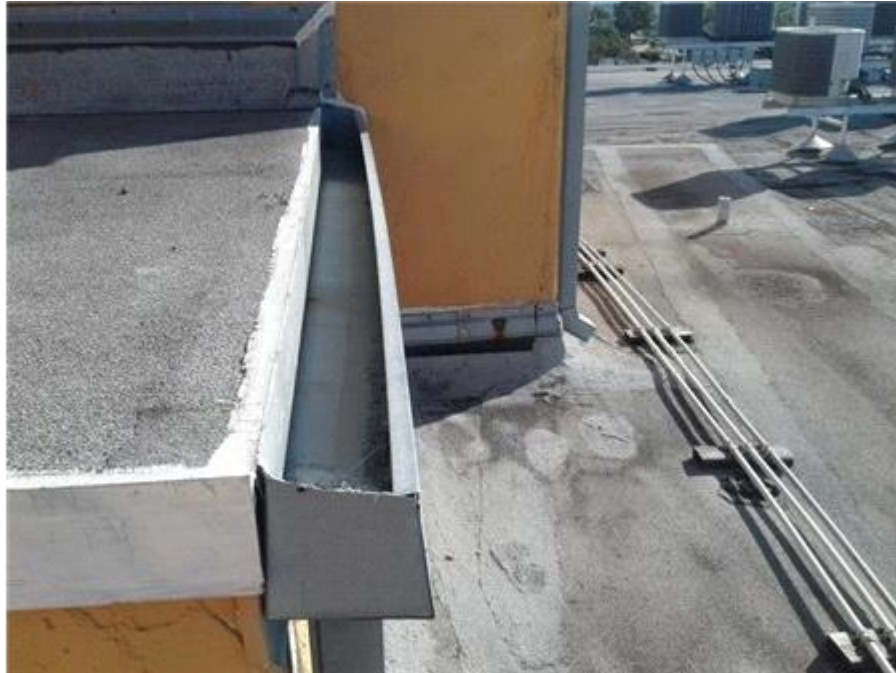
Stairwell Roof: Gutters

The gutters appear to be in fair condition at this time.

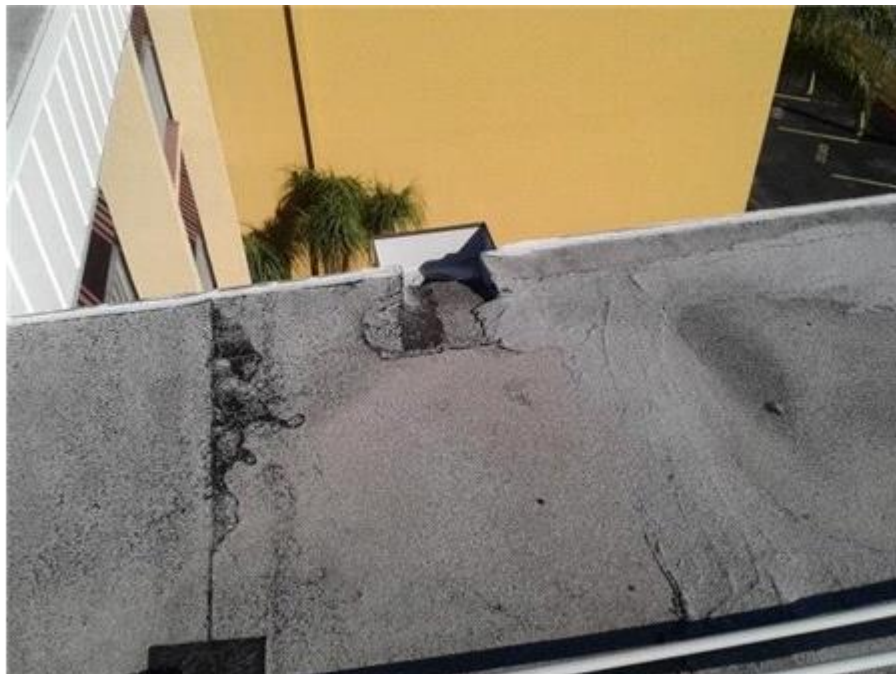
Stairwell Roof: Scuppers

The scuppers appear to be in fair condition at this time.

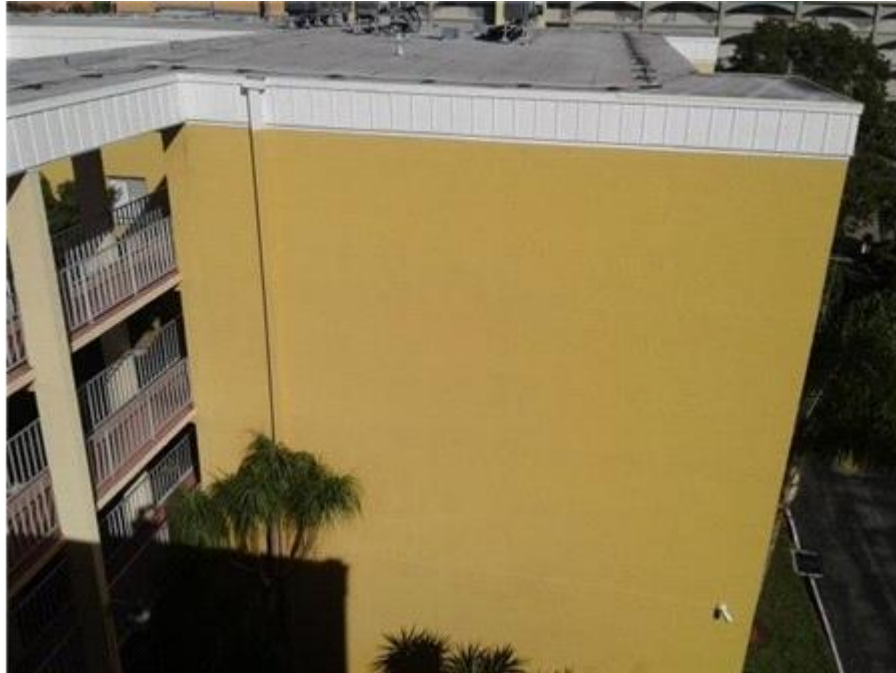
Stairwell Roof: Downspouts

The downspouts appear to be in good condition at this time.

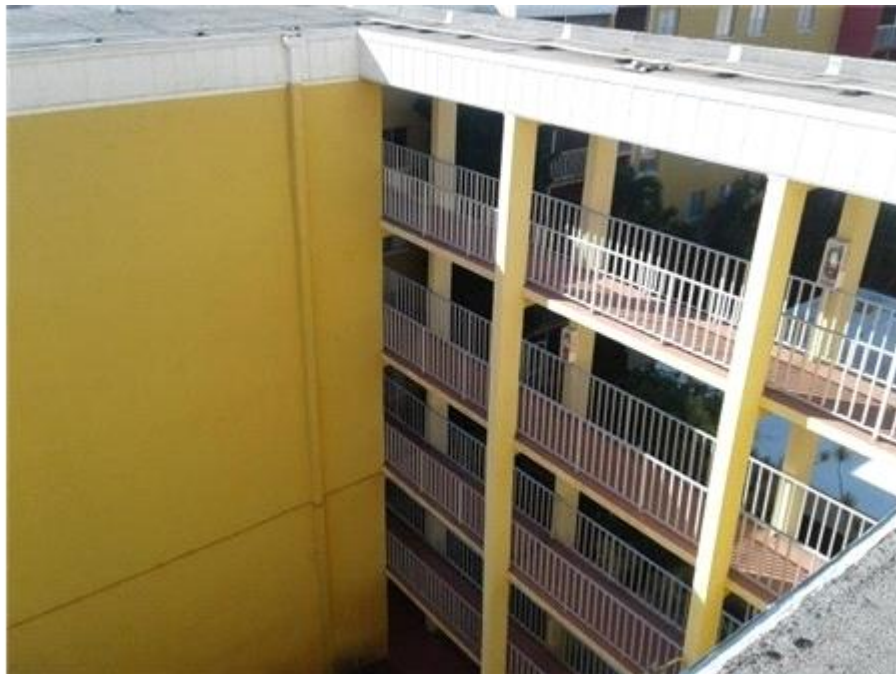
Stairwell Roof: Downspouts

The downspouts appear to be in good condition at this time.

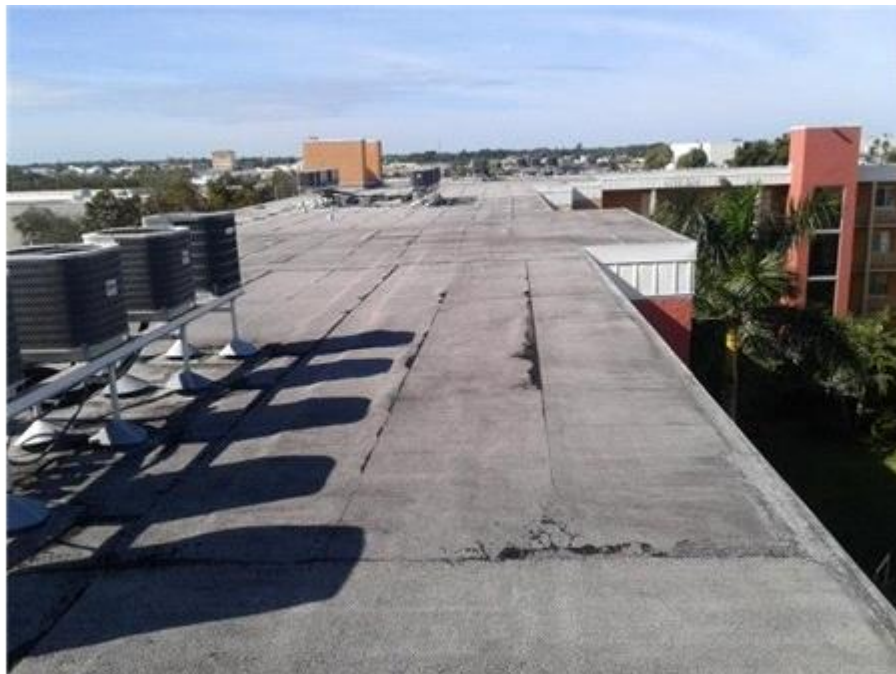
Elevator Shaft Roof: Surface Overview

The roof surface appears to be in fair condition at this time.

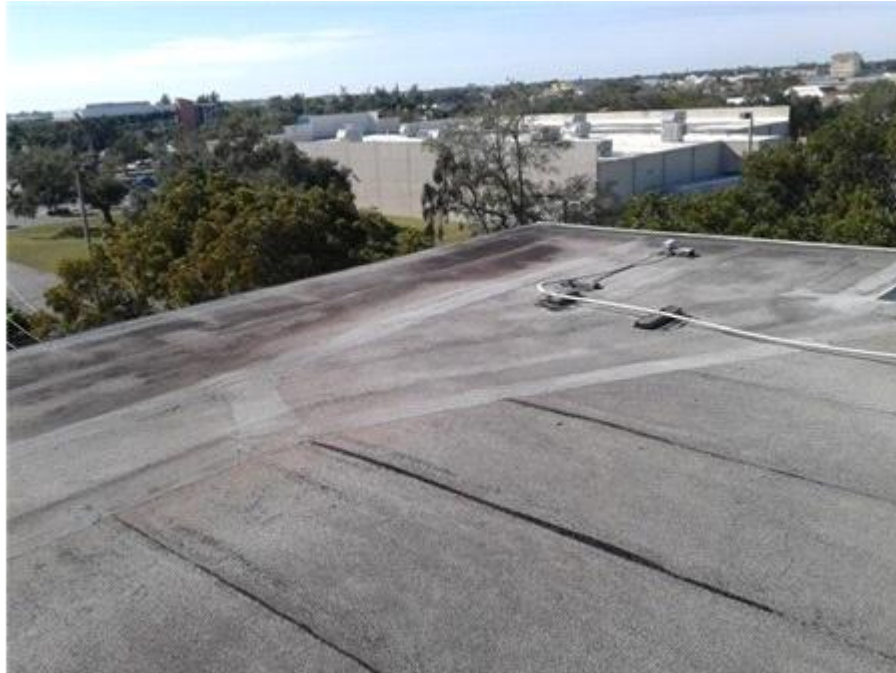
Elevator Shaft Roof: Surface Overview

The roof surface appears to be in fair condition at this time.

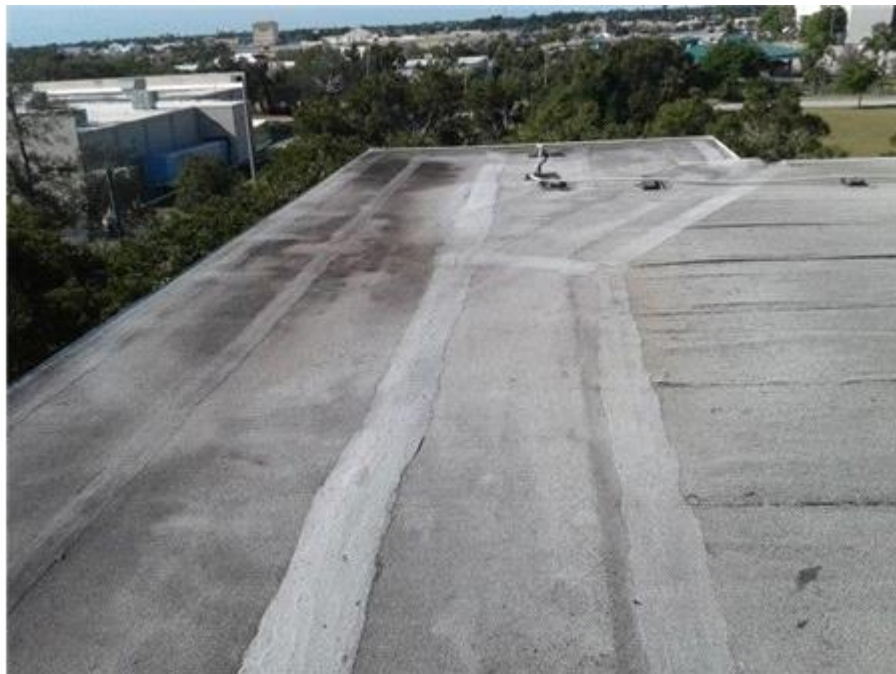
Elevator Shaft Roof: Surface Overview

The roof surface appears to be in fair condition at this time.

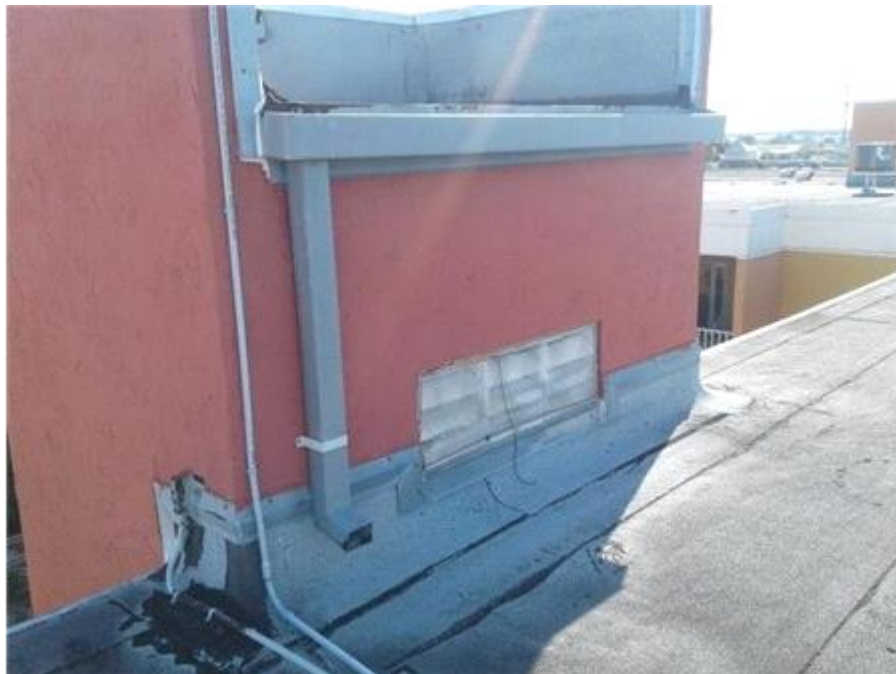
Elevator Shaft Roof: Appearance Overview
The appearance of the roof is in fair condition at this time.

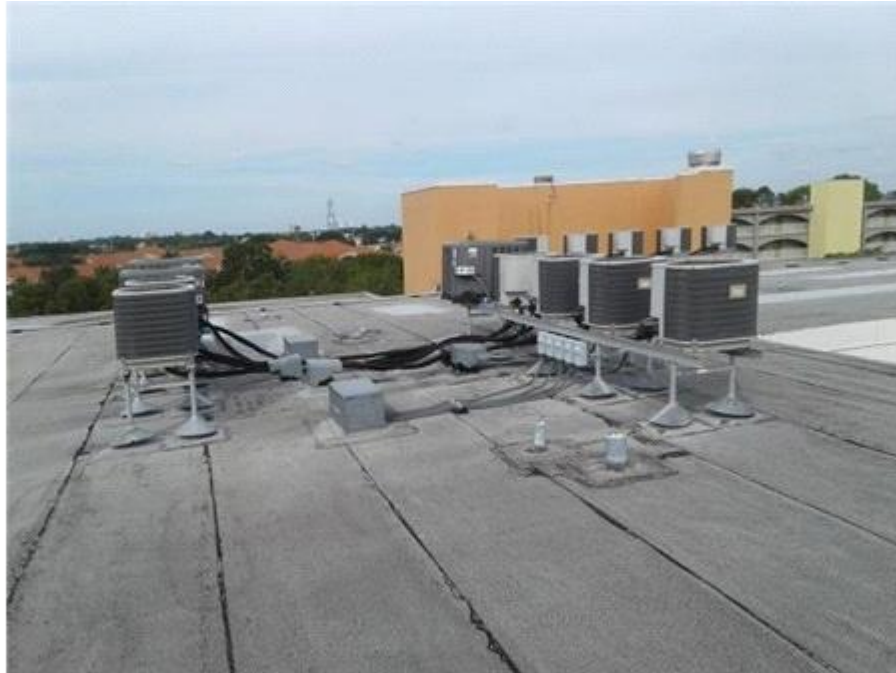
Elevator Shaft Roof: Appearance Overview

The appearance of the roof is in fair condition at this time.

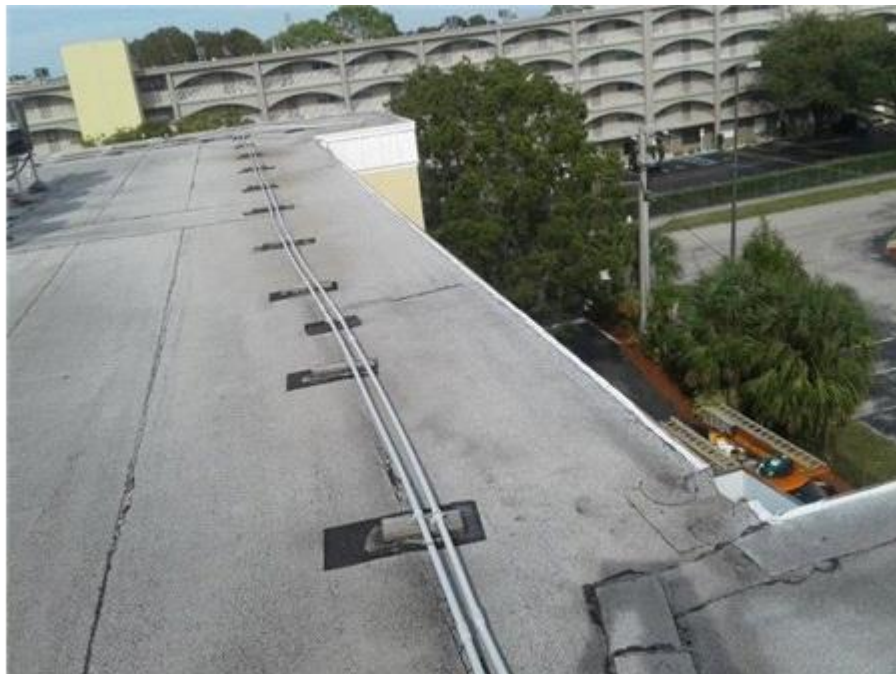
Elevator Shaft Roof: Roof Edge

The roof edge appears to be in fair condition at this time.

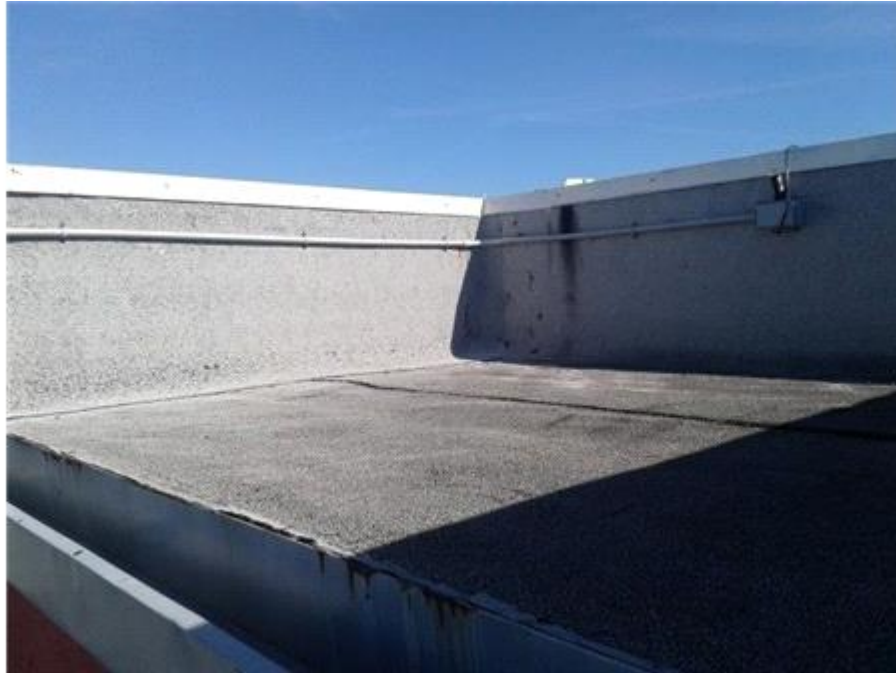
Elevator Shaft Roof: Appearance Overview

The appearance of the roof is in fair condition at this time.

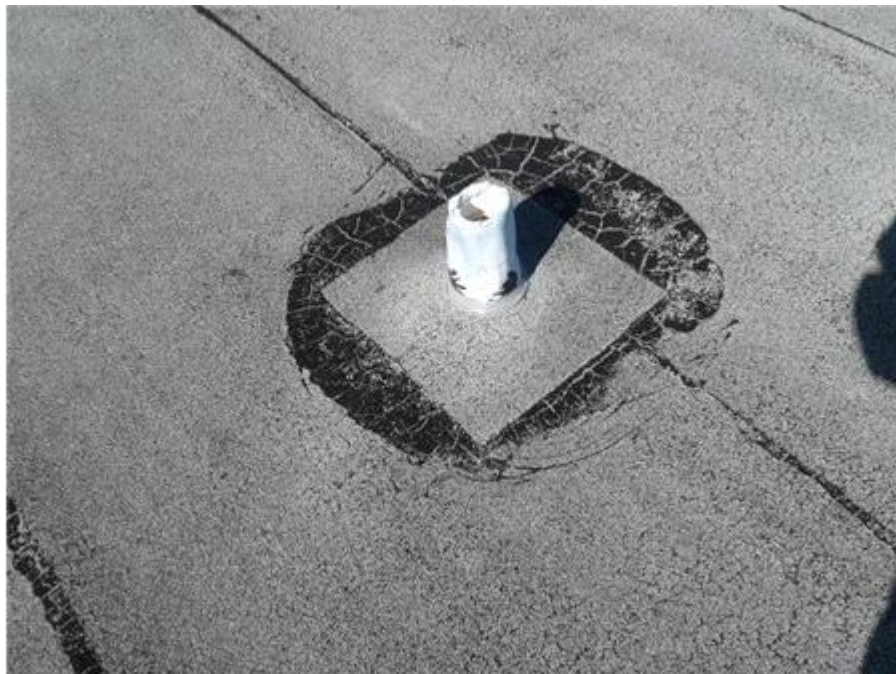
Elevator Shaft Roof: Lead Boots

The lead boots appear to be in fair condition at this time.

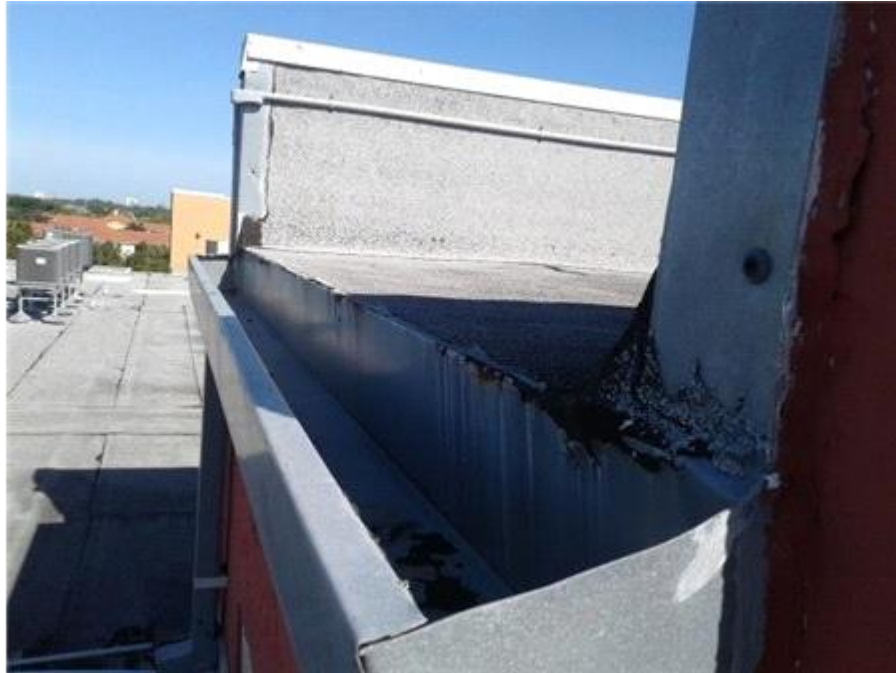
Elevator Shaft Roof: Gutters

The gutters appear to be in fair condition at this time.

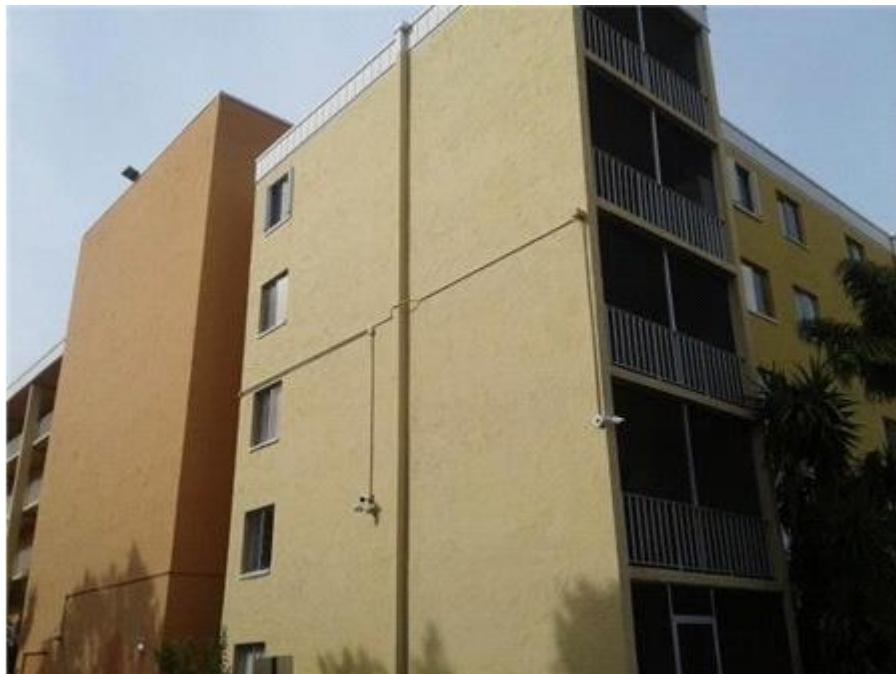
Elevator Shaft Roof: Downspouts

The downspouts appear to be in good condition at this time.

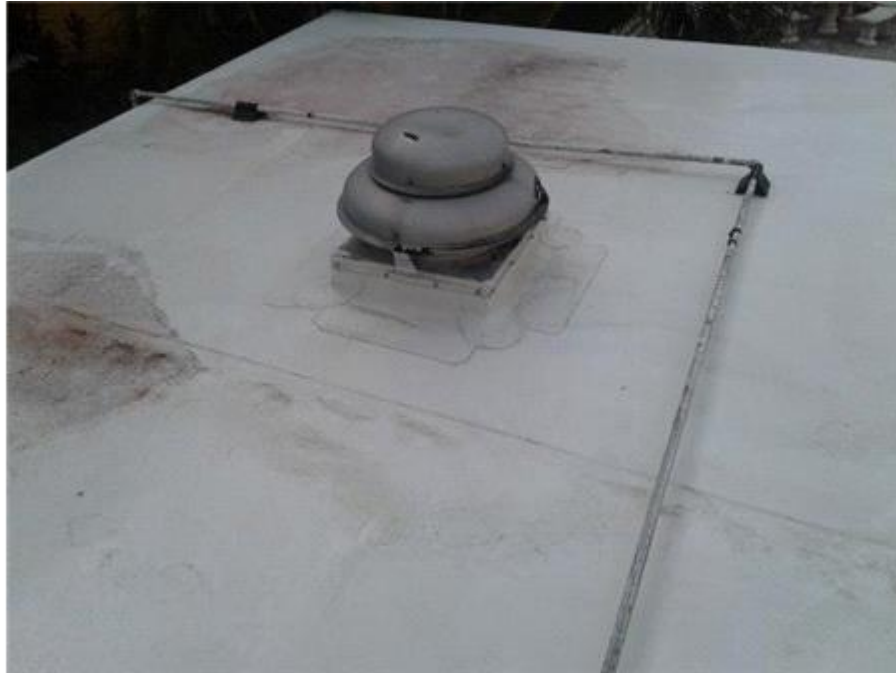
Clubhouse: Roof Vents

The roof vents appear to be in good condition at this time.

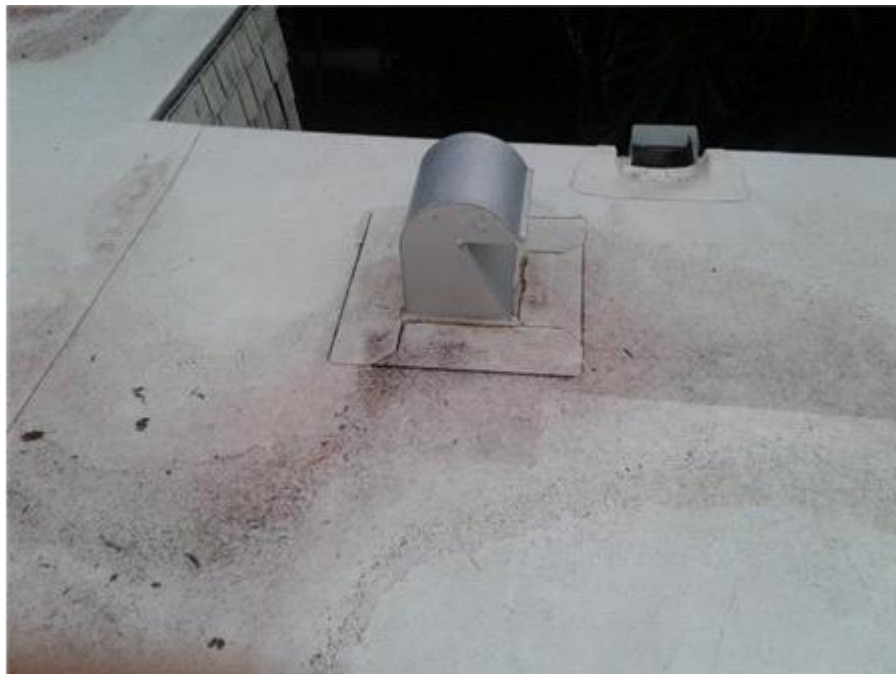
Clubhouse: Roof Vents

The roof vents appear to be in good condition at this time.

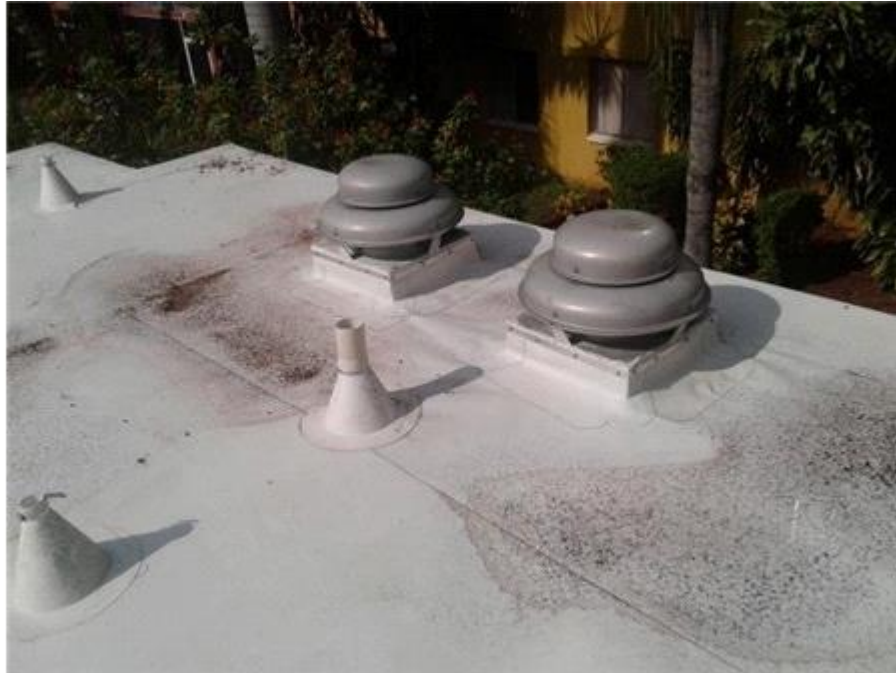
Clubhouse: Base Flashings

The base flashings appear to be in good condition at this time.

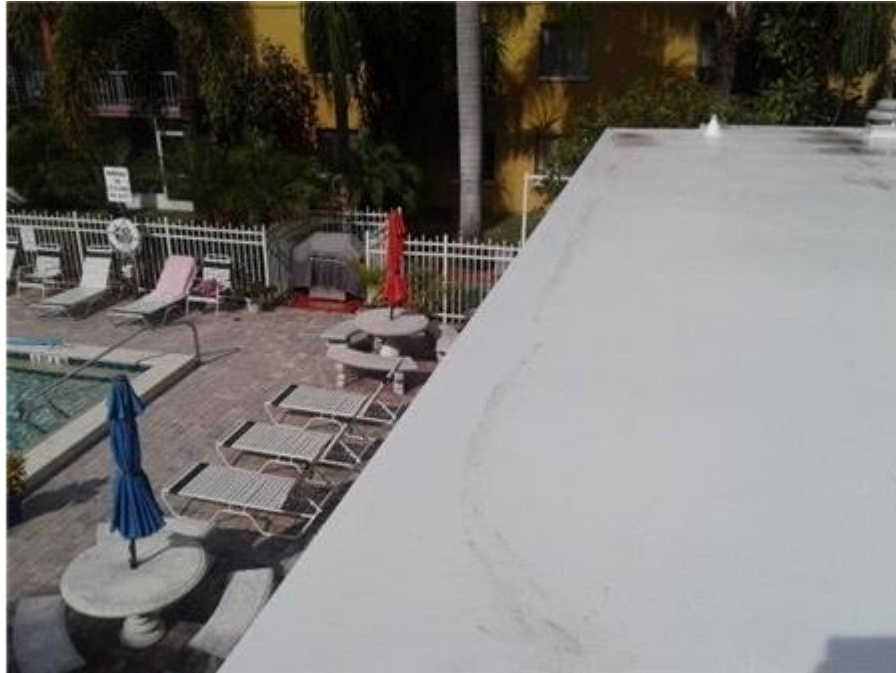
Clubhouse: Roof Edge

The roof edge appears to be in good condition at this time.

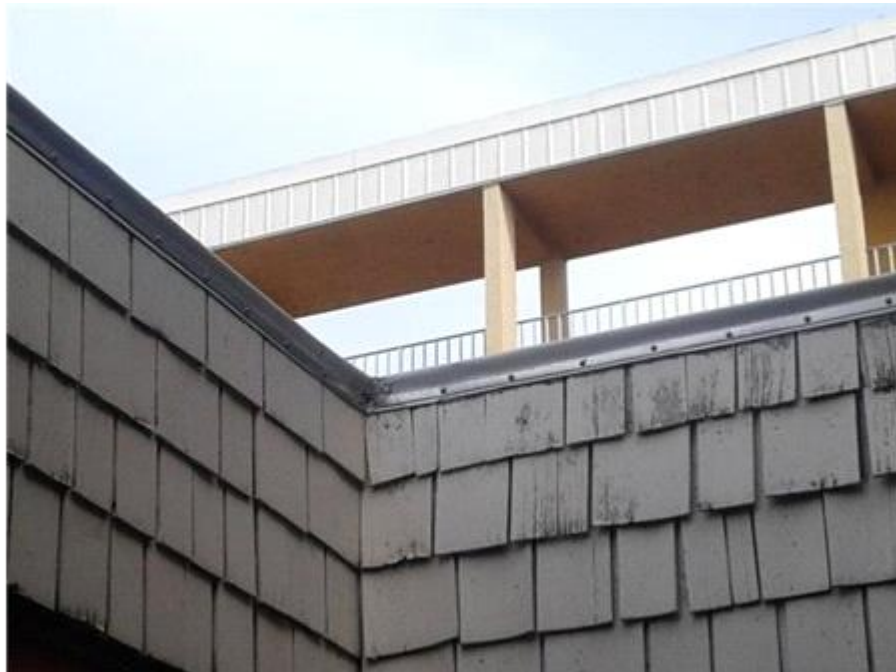
Clubhouse: Roof Edge

The roof edge appears to be in good condition at this time.

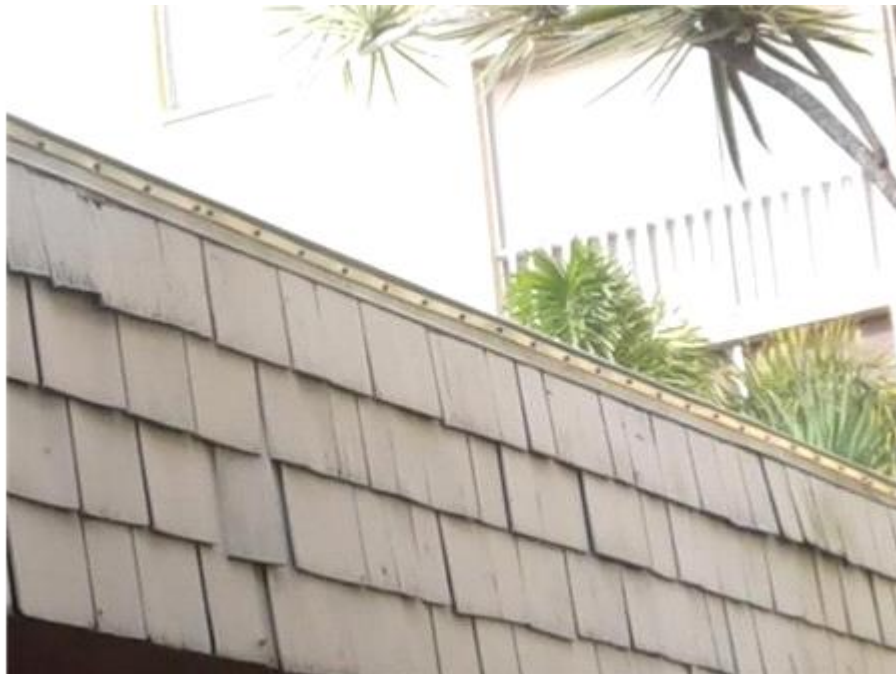
Clubhouse: Roof Edge

The roof edge appears to be in good condition at this time.
