Inspection Report

Facility: Towers, The
Address: 2366 East Mall Dr,
Fort Myers, 33901

Work Order #: 7558

Re.: **Inspection Report (2 of 6) for The Towers**

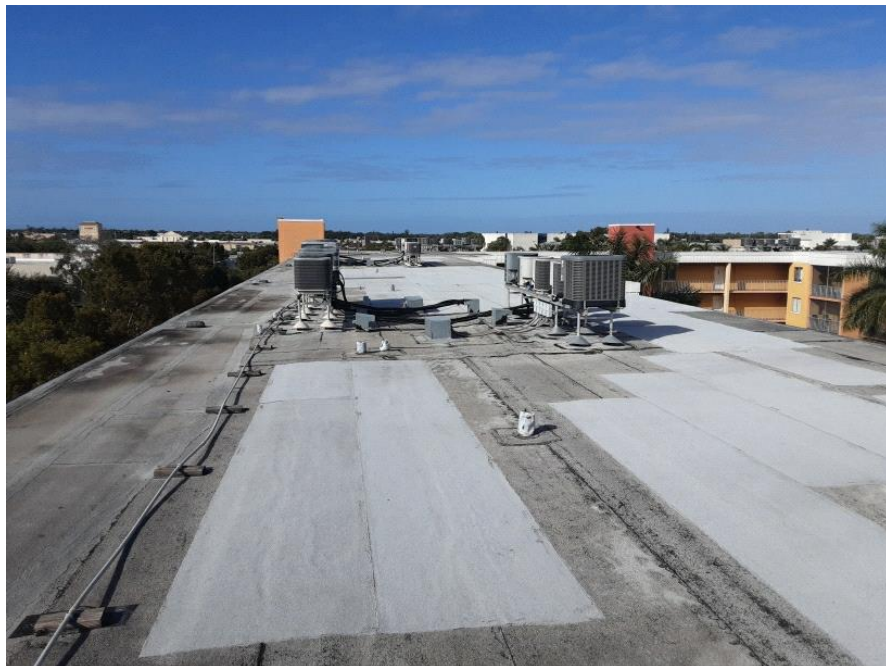
Roof Overview
General roof overview.

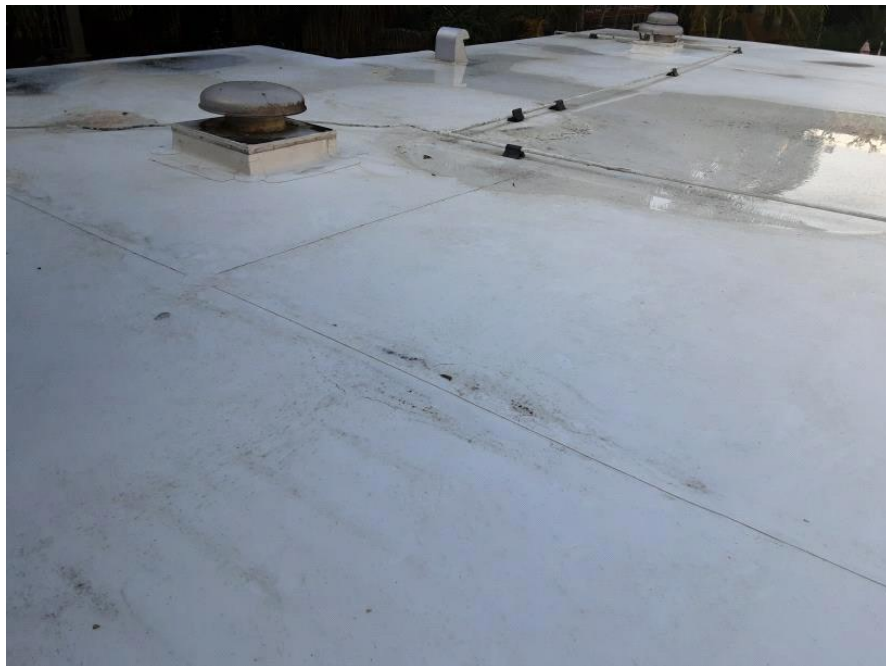
Membrane Overview
The membrane appears to be in good, maintainable condition.

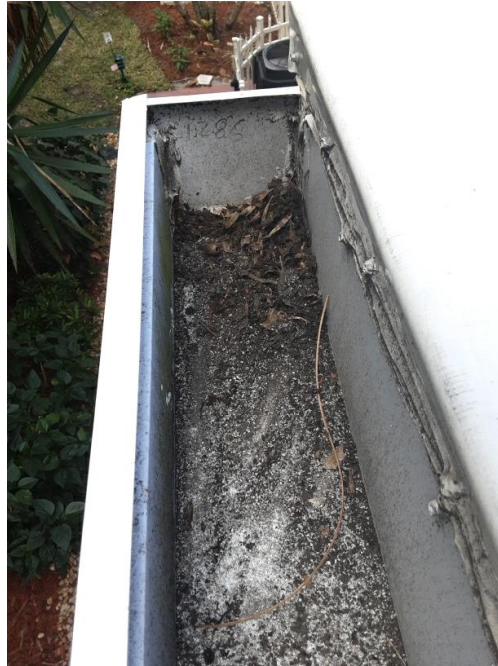
Roof Edge

The roof edge appears to be in good condition.

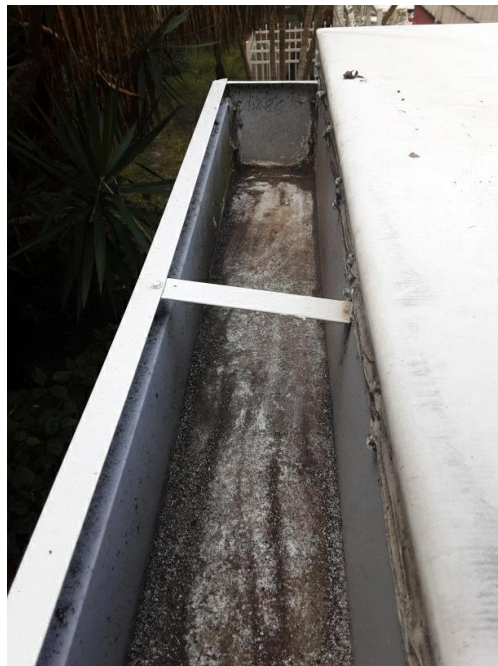
Debris in Gutter

Identified debris in the gutter system which can prevent proper drainage.
