Inspection Report

Facility: Towers, The
Address: 2366 East Mall Dr,
Fort Myers, 33912

Work Order #: 3086

Re.: **Inspection Report (6 of 6) for The Towers**

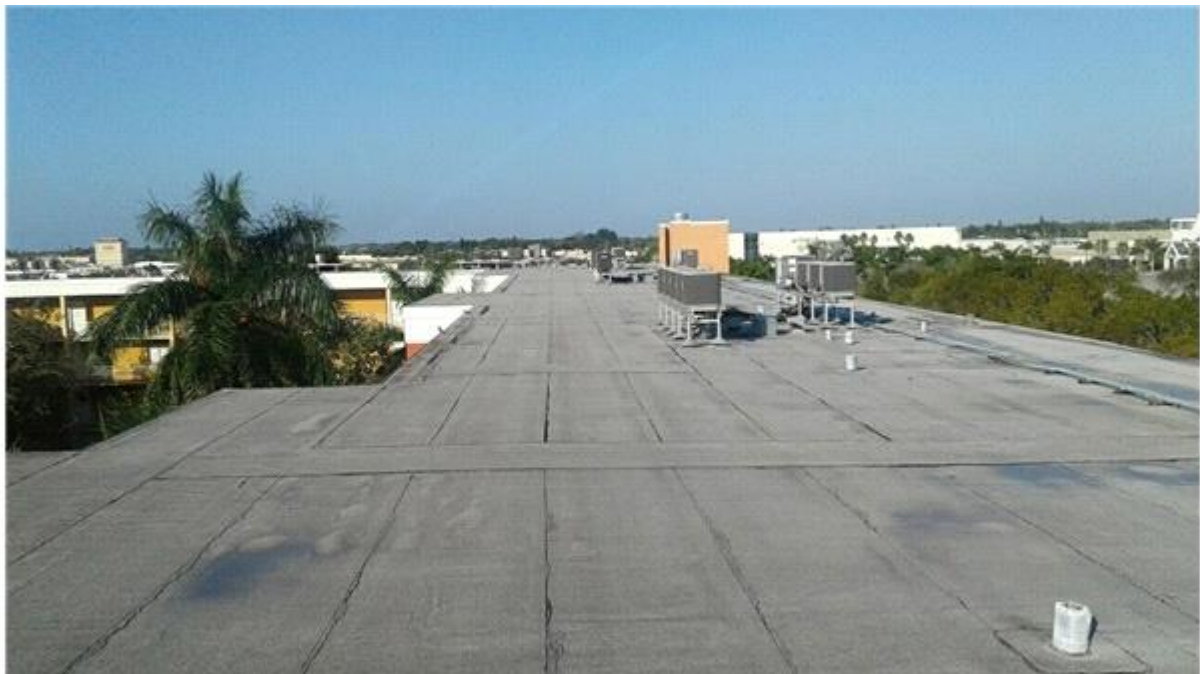
029- Roof overview
General roof overview

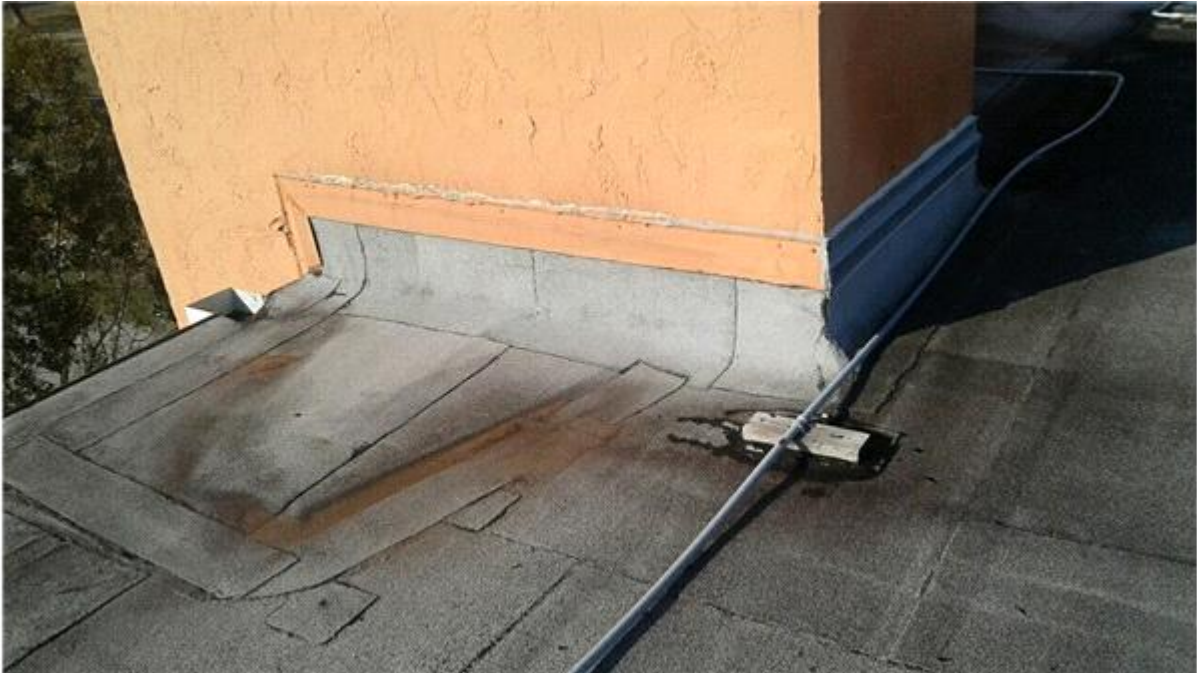
004F - Base Flashings

The base flashings appear to be in fair condition.

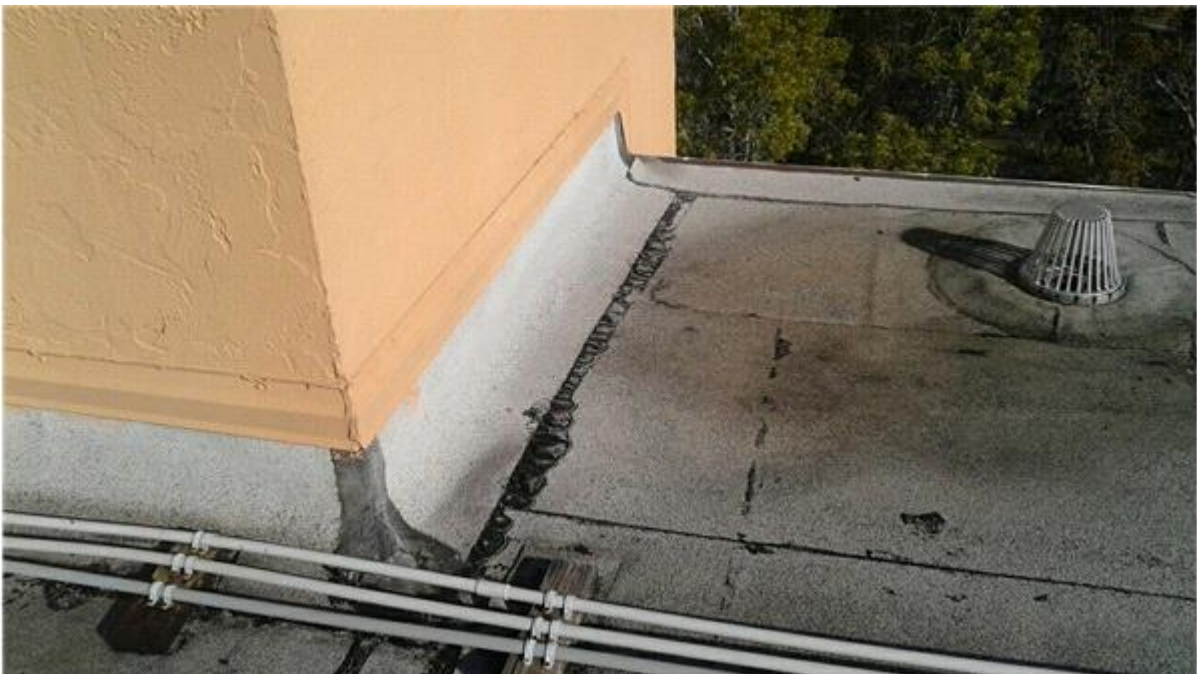
004F - Base Flashings

The base flashings appear to be in fair condition.

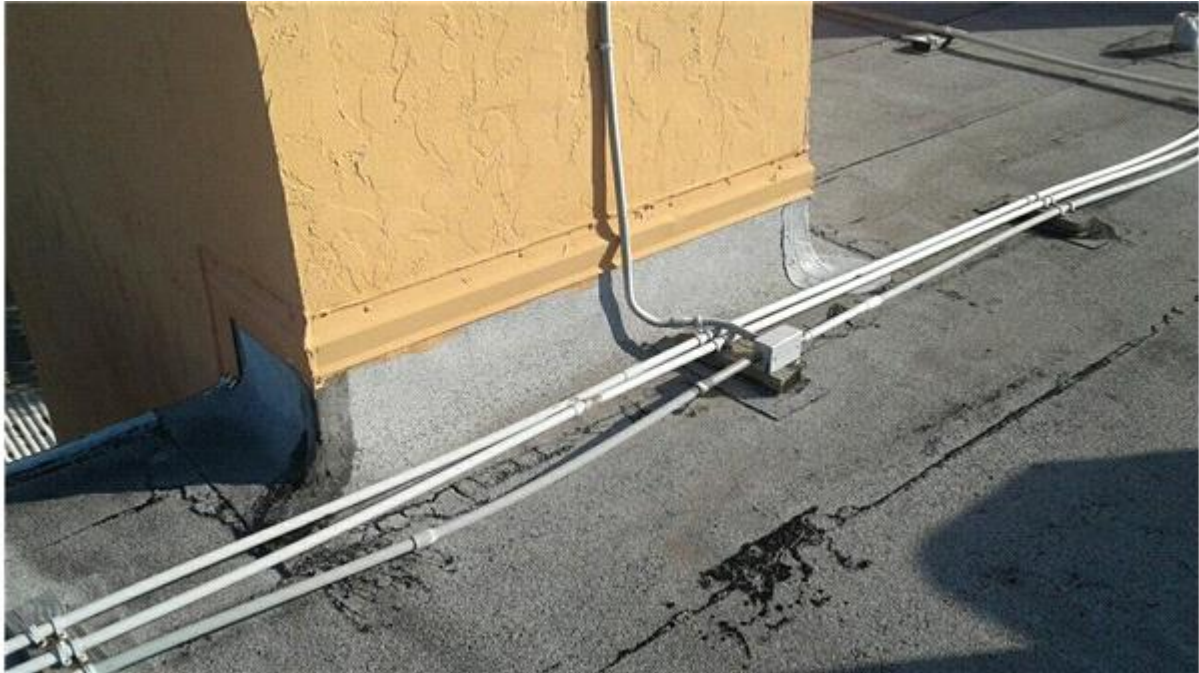
004F - Base Flashings

The base flashings appear to be in fair condition.

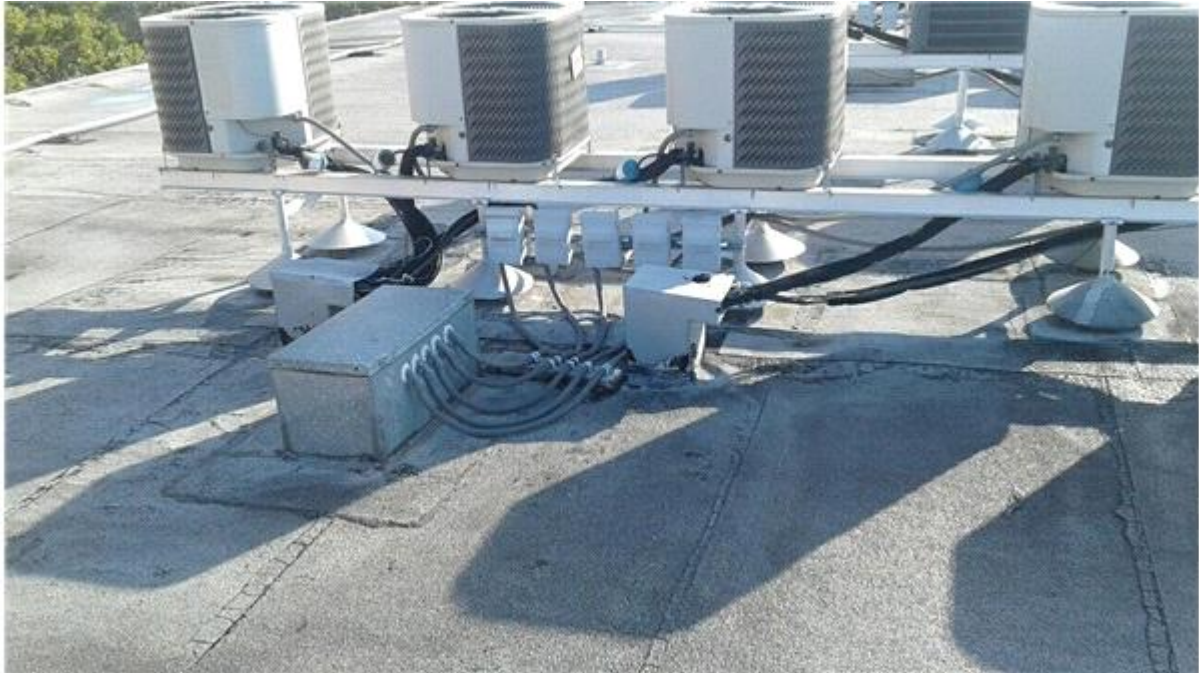
010F- Equipment Housing

The equipment housing appears to be in fair condition.

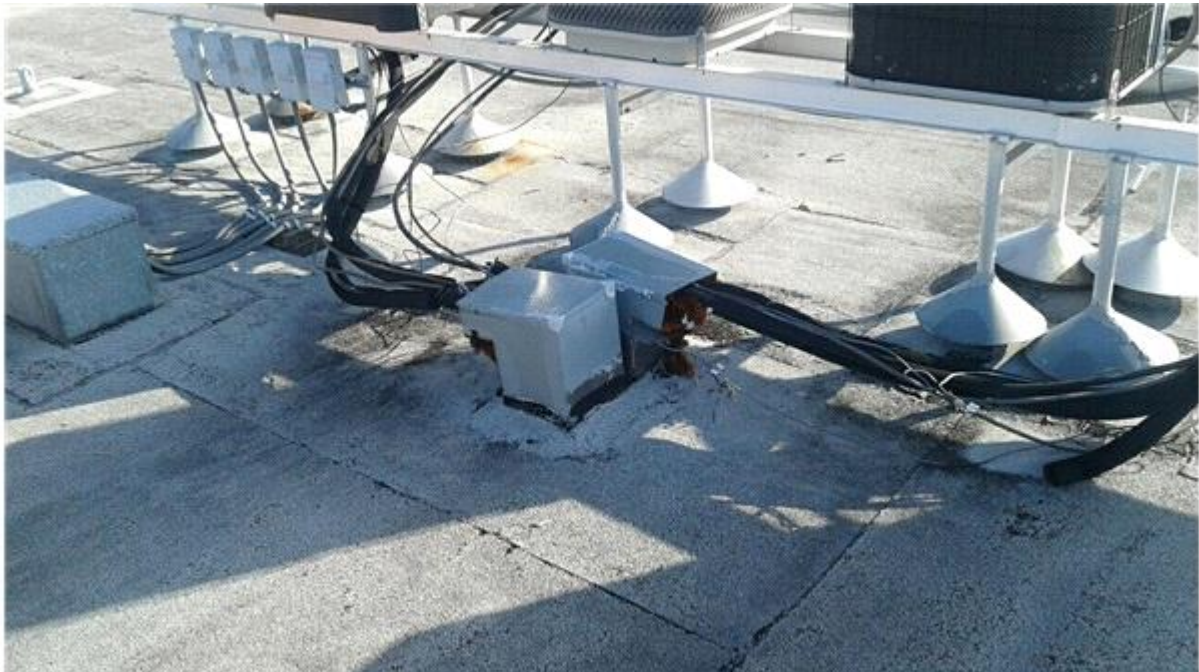
010F- Equipment Housing

The equipment housing appears to be in fair condition.

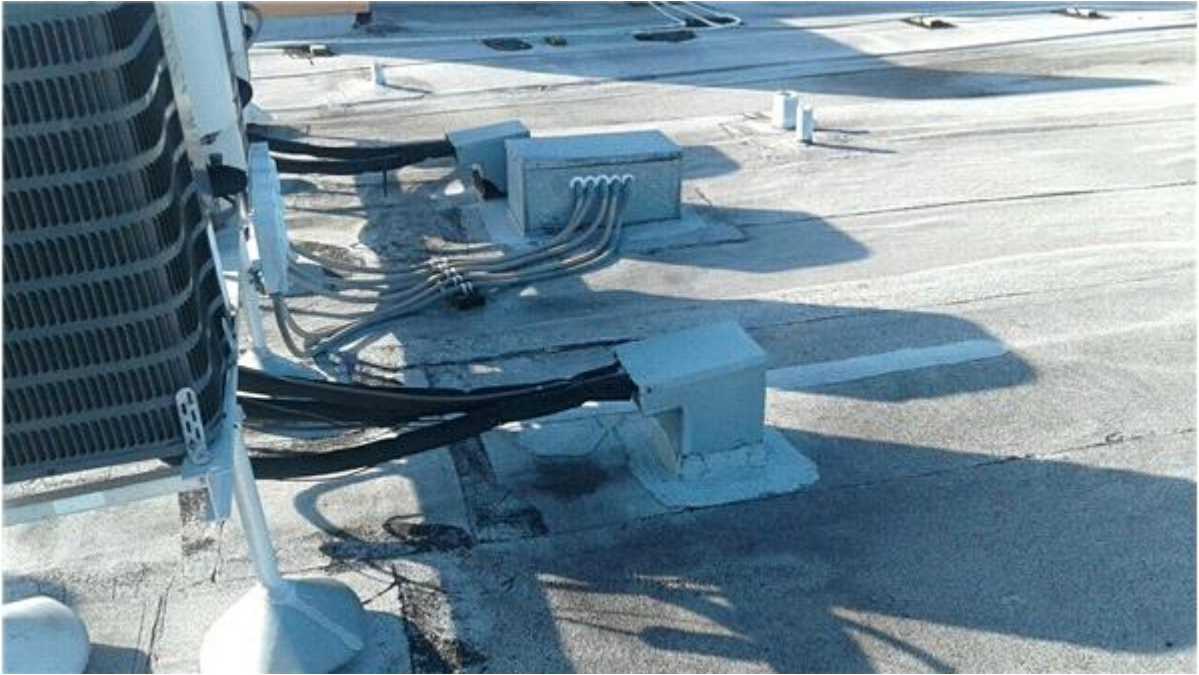
010F- Equipment Housing

The equipment housing appears to be in fair condition.

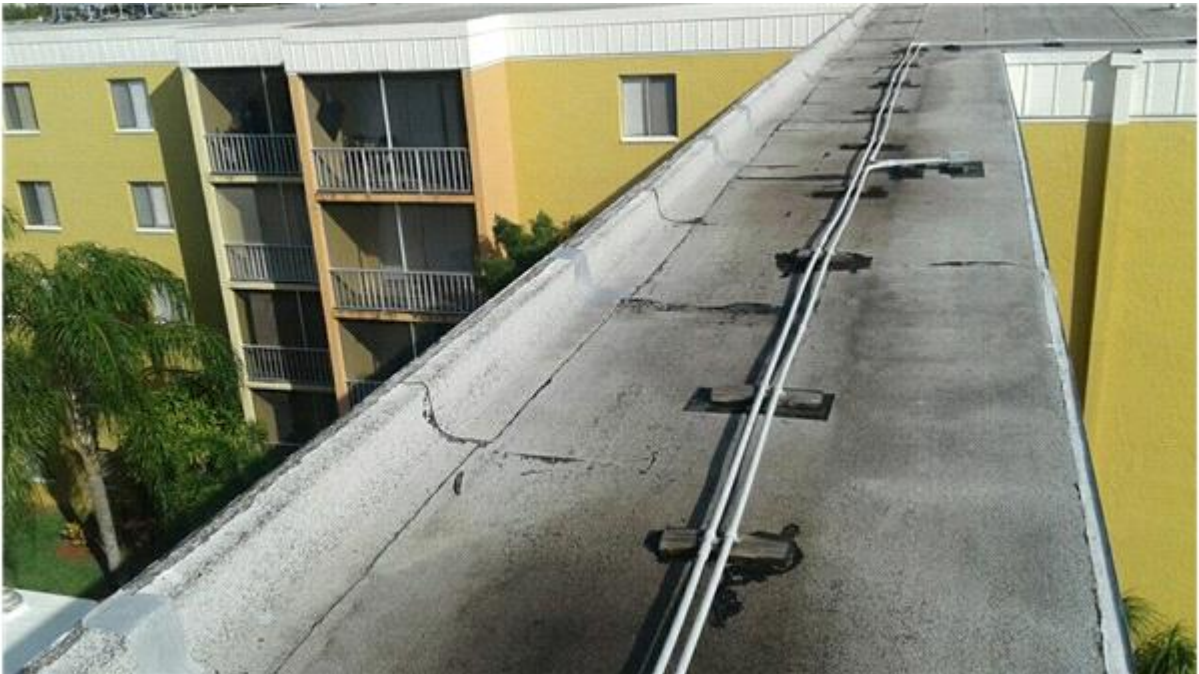
004F - Base Flashings

The base flashings appear to be in fair condition.

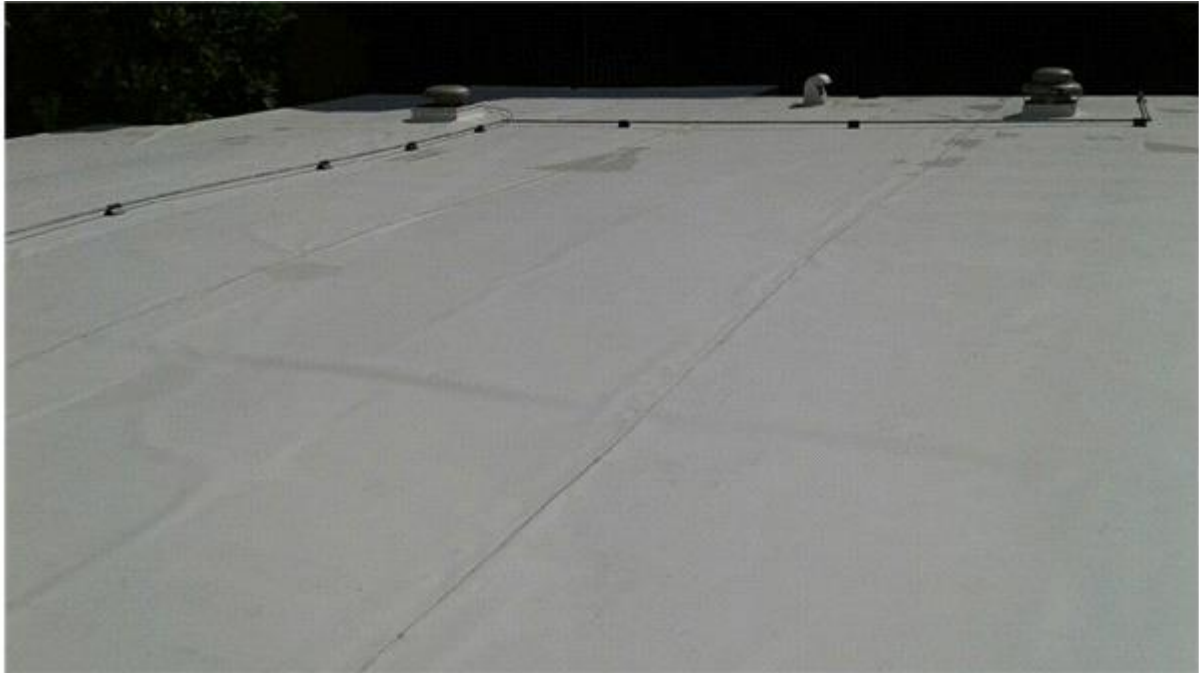
003G - Membrane Overview

The membrane appears to be in good, maintainable condition at this time.

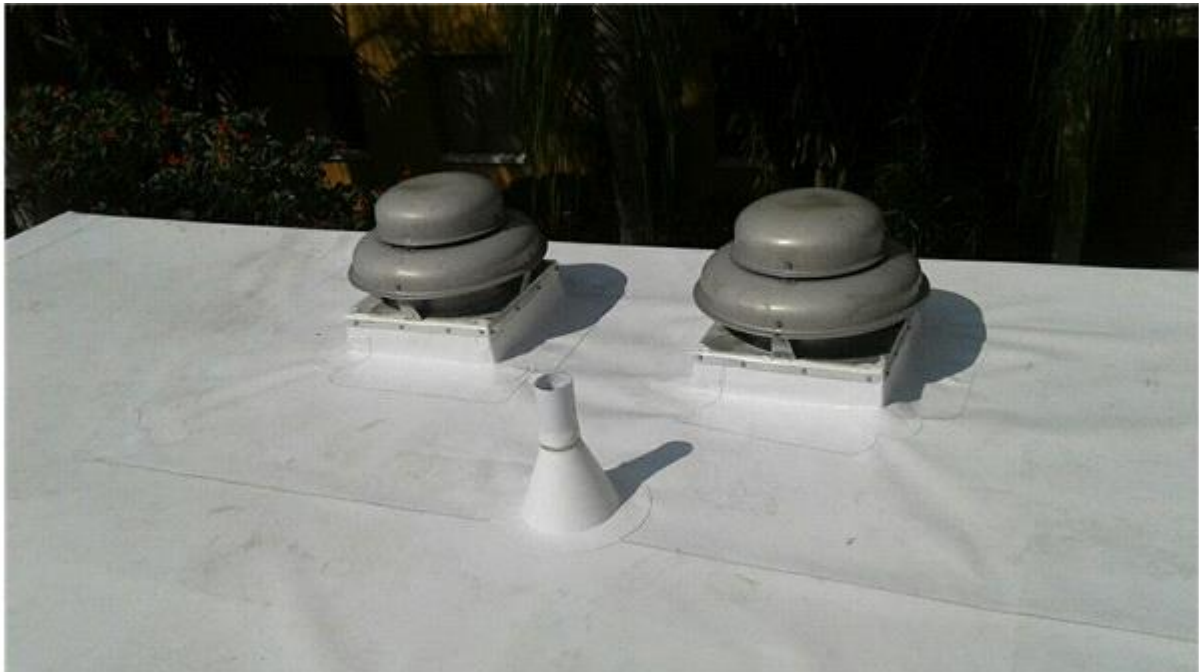
029- Roof overview
General roof overview
