Inspection Report

Facility: Towers, The
Address: 2366 East Mall Dr,
Fort Myers, 33901

Work Order #: 5326

Re.: **Inspection Report (4 of 6) for The Towers**

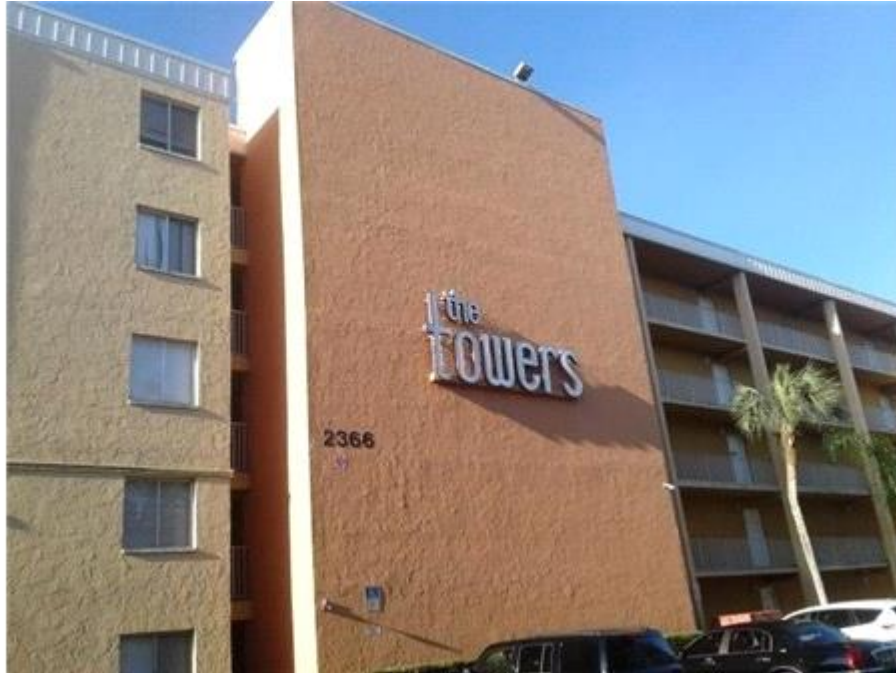
The Towers - BUR - Front of Building
Building Identification

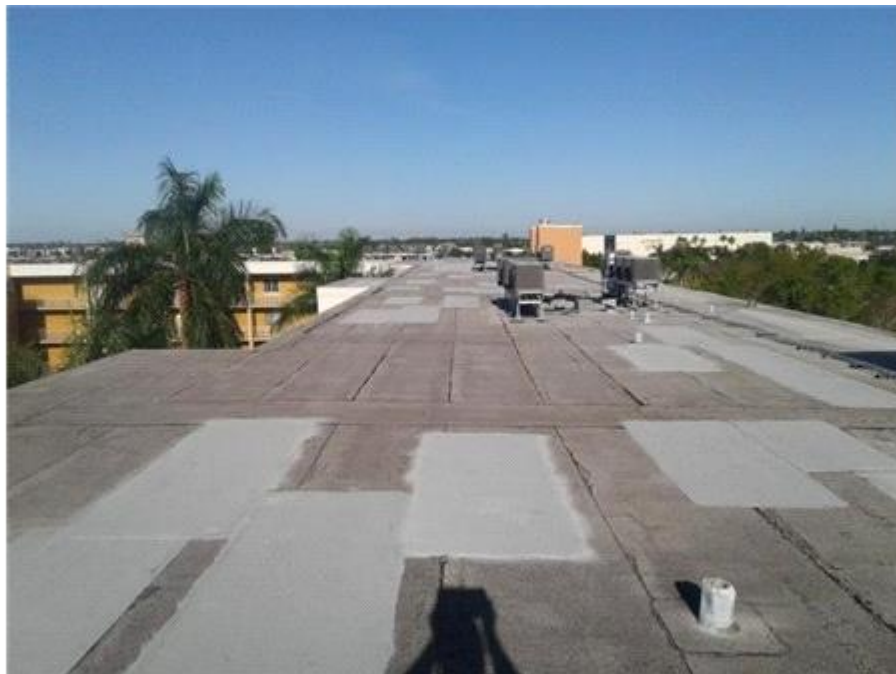
029- The Towers - BUR Roof Overview
General roof overview.

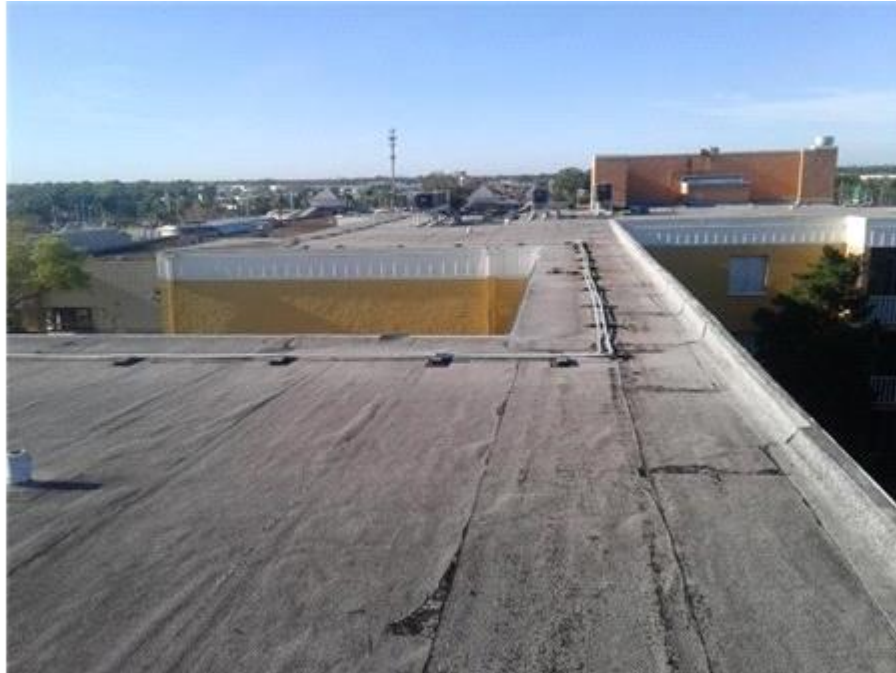
029- The Towers - BUR Roof Overview

General roof overview.

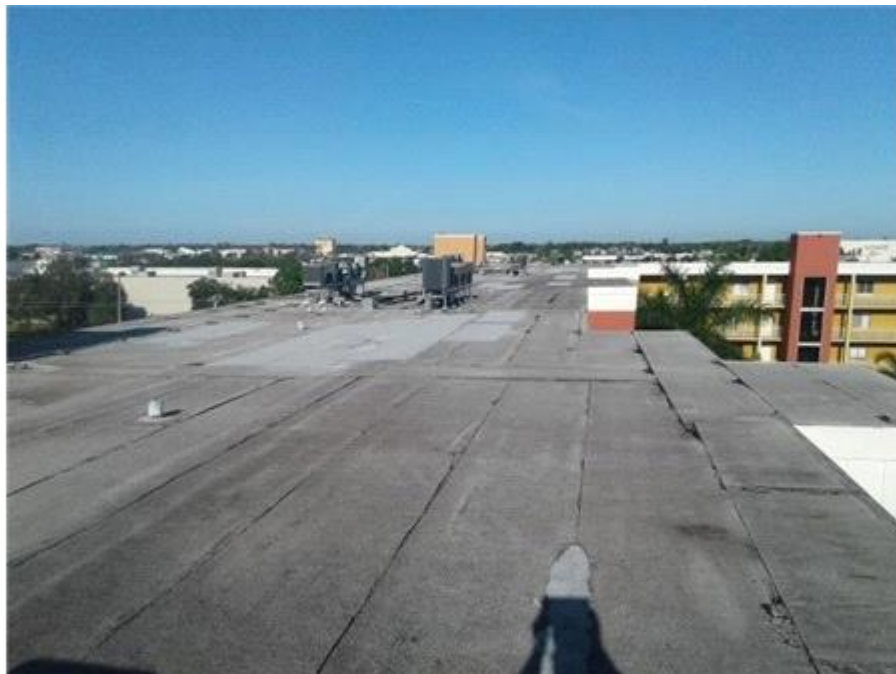
029- The Towers - BUR Roof Overview

General roof overview.

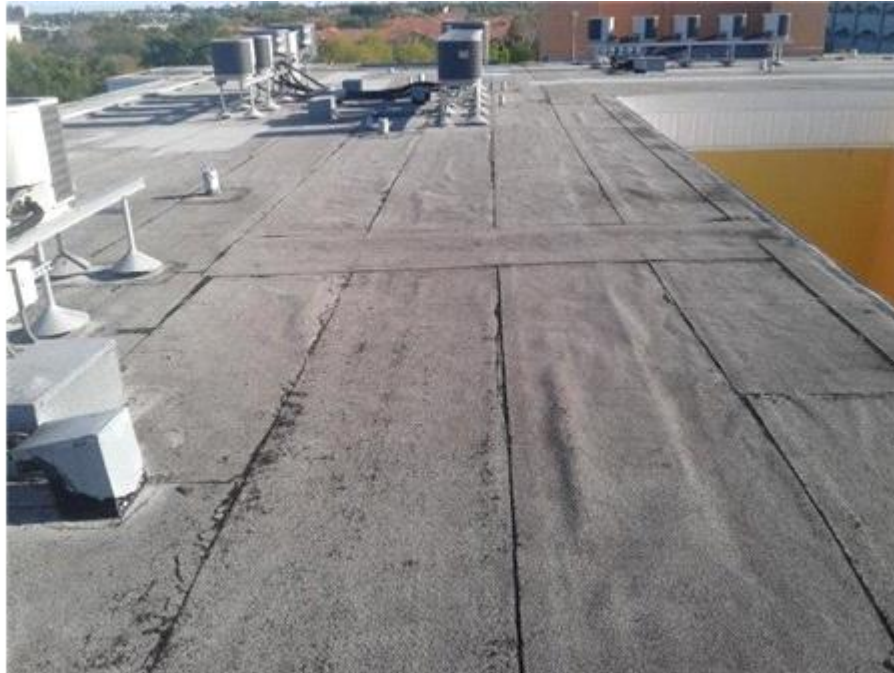
001F - The Towers - BUR Surface Overview

The roof surface appears to be in fair condition at this time.

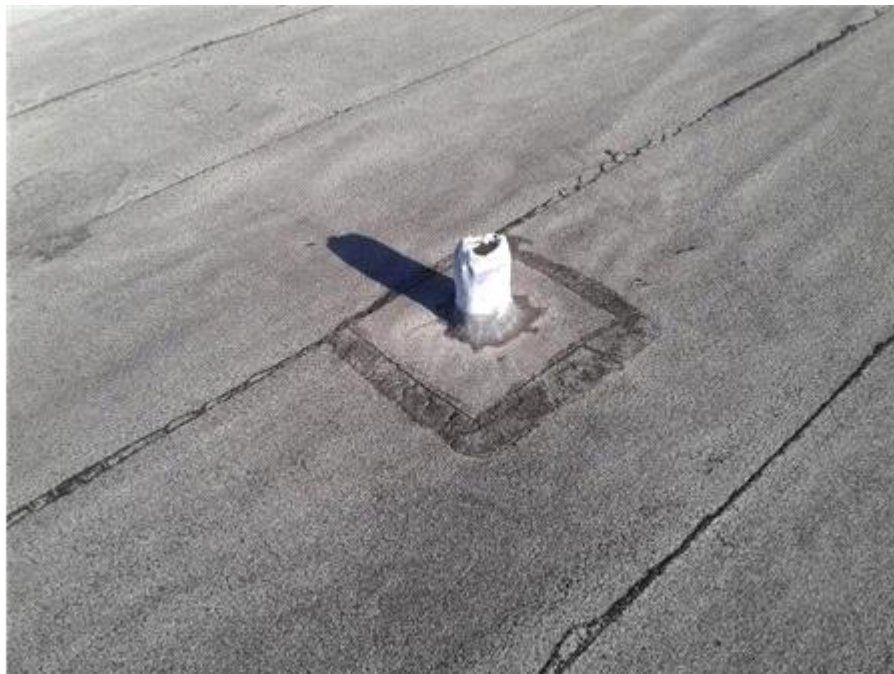
019F- The Towers - BUR Lead Boots

Lead boots appear to be in fair condition

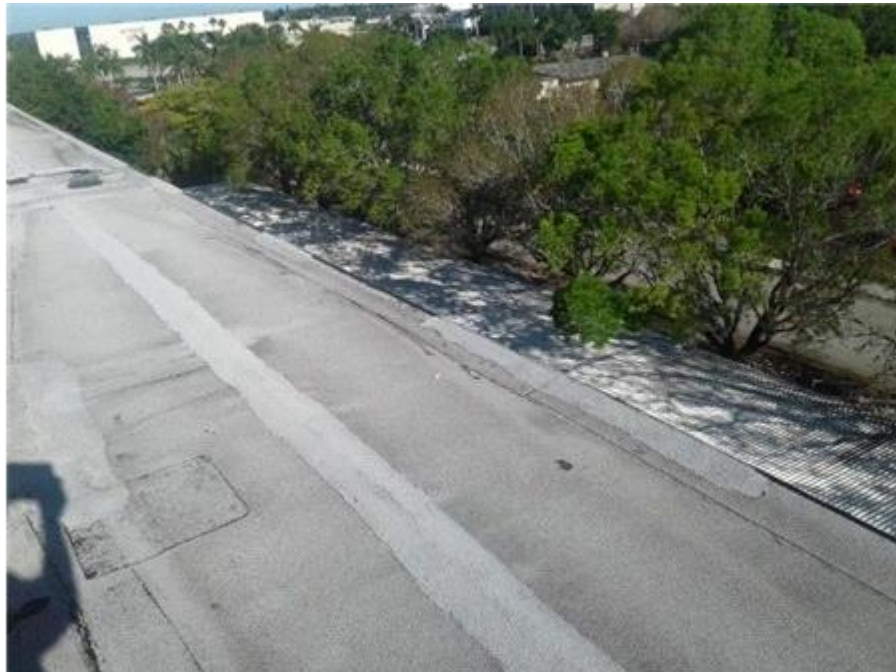
016F- The Towers - BUR Roof Edge

Roof edge appears to be in fair condition.

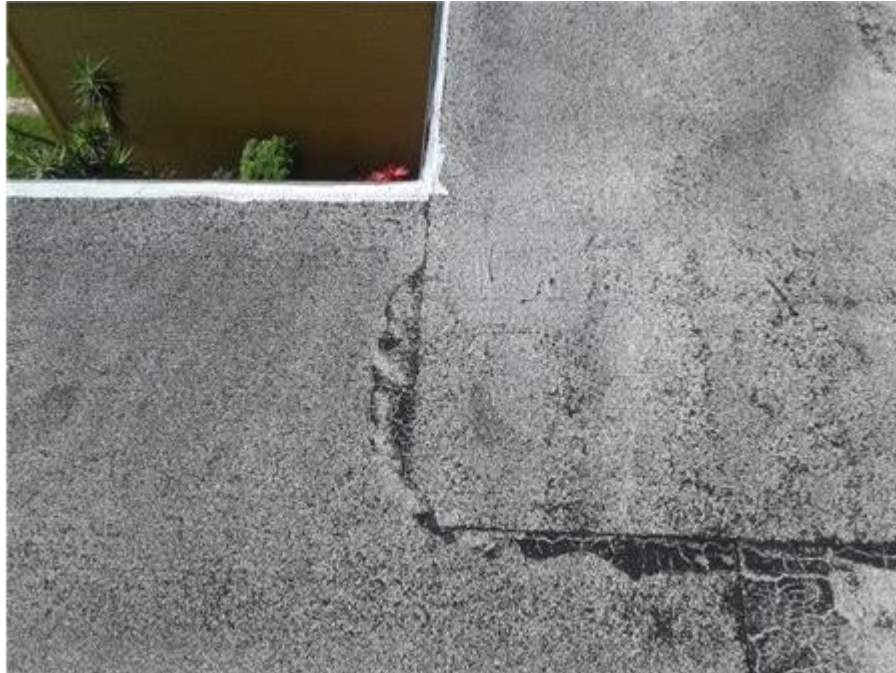
The Towers - BUR Field Membrane - Puncture

Three coursed and granulated puncture.

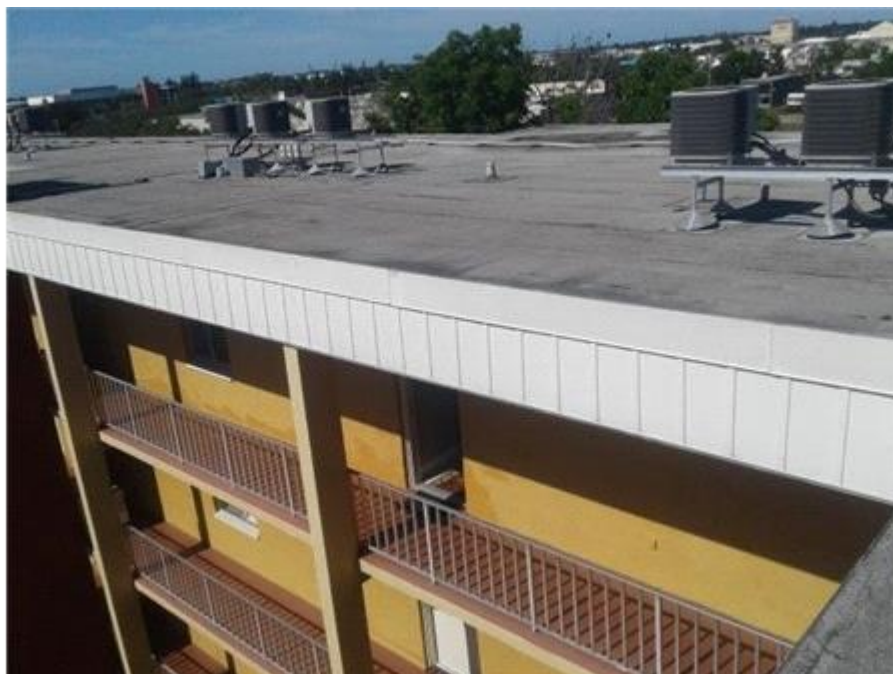
The Towers - BUR Edge Metal/Fascia

Edge metal/fascia appears to be in good condition at this time.

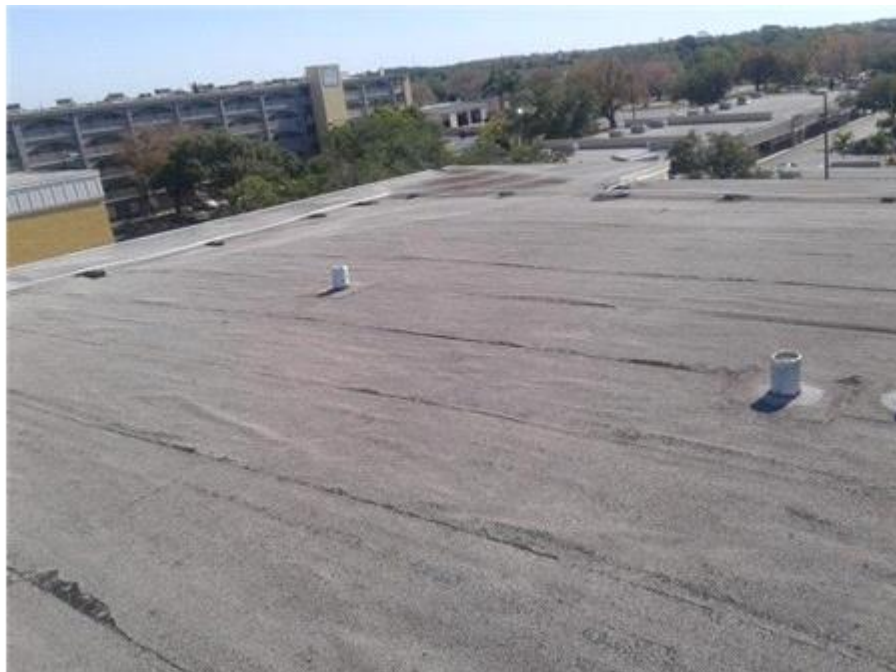
003F - The Towers - BUR Membrane Overview
The roof membrane appears to be in fair condition at this time.

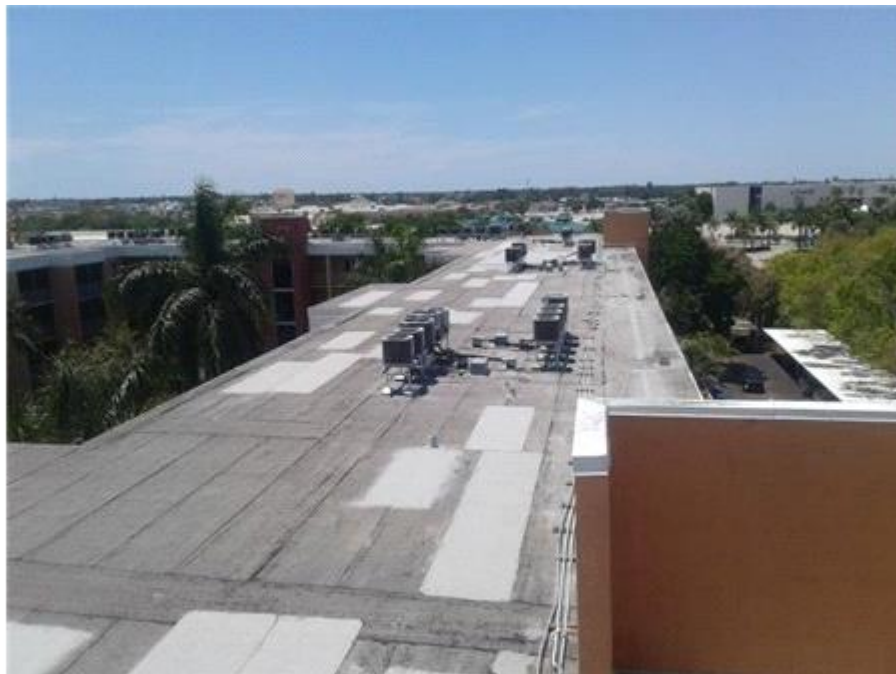
029- The Towers - BUR Roof Overview

General roof overview.

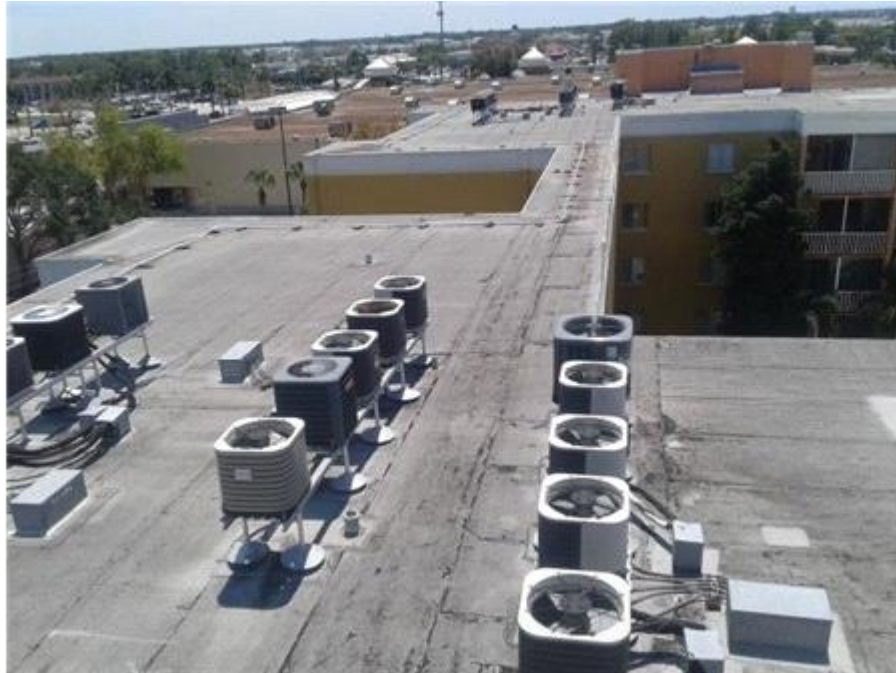
029- The Towers - BUR Roof Overview

General roof overview.

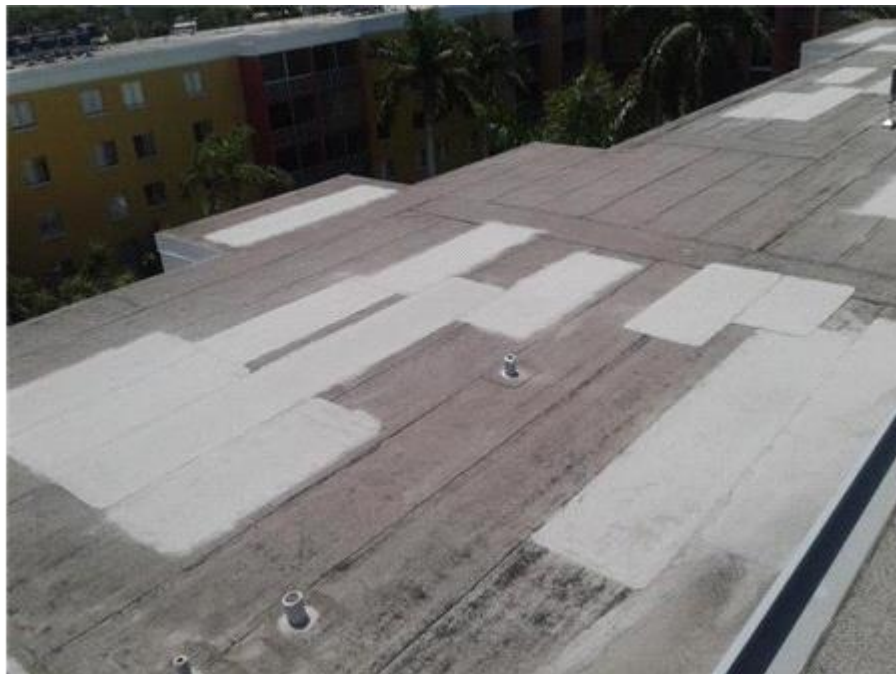
029- The Towers - BUR Roof Overview

General roof overview.

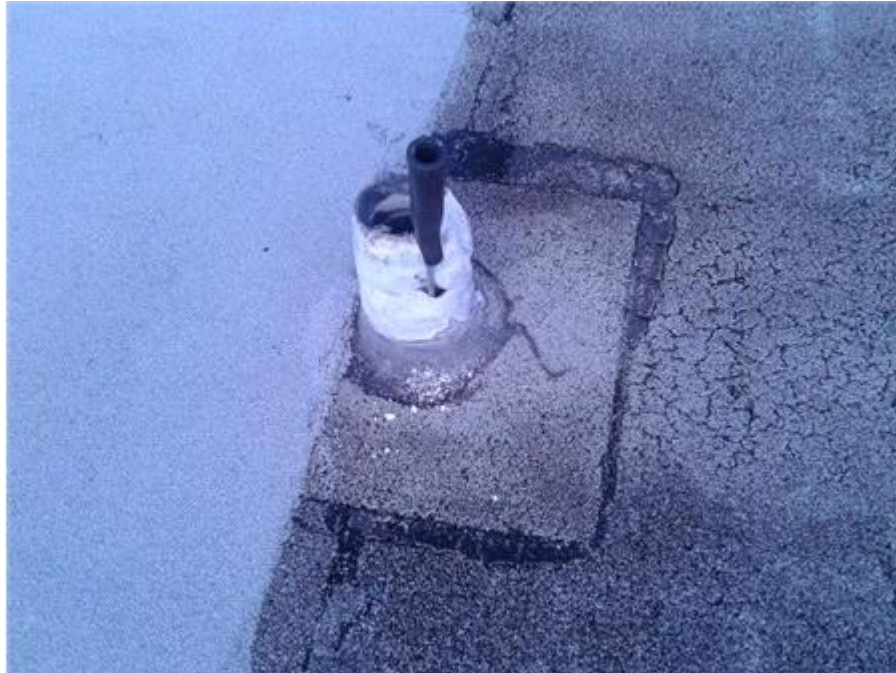
The Towers - BUR Lead Boot

Hole in lead boot.

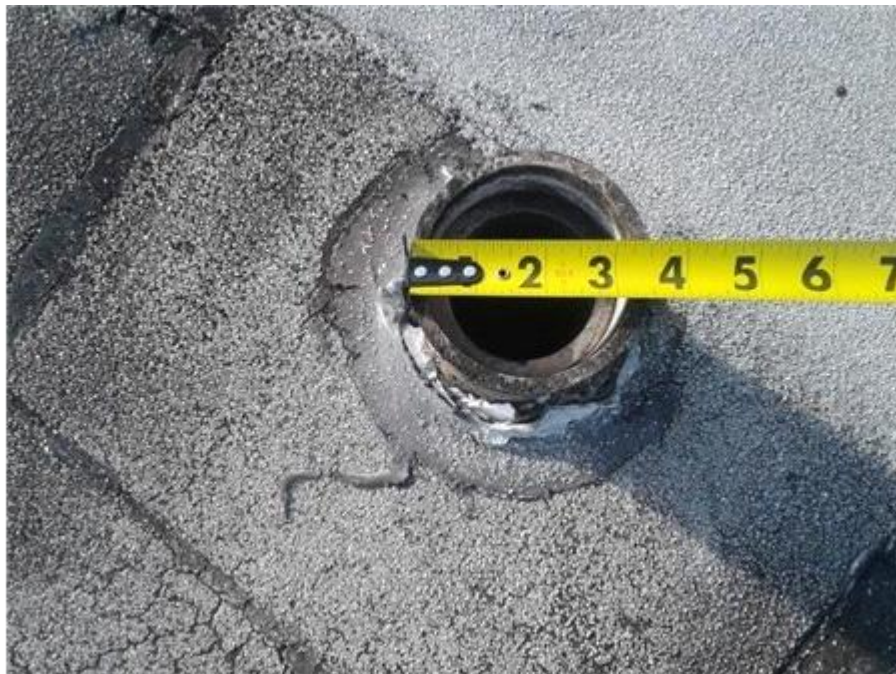
The Towers - BUR Lead Boot

Lead boot measurements - 4".

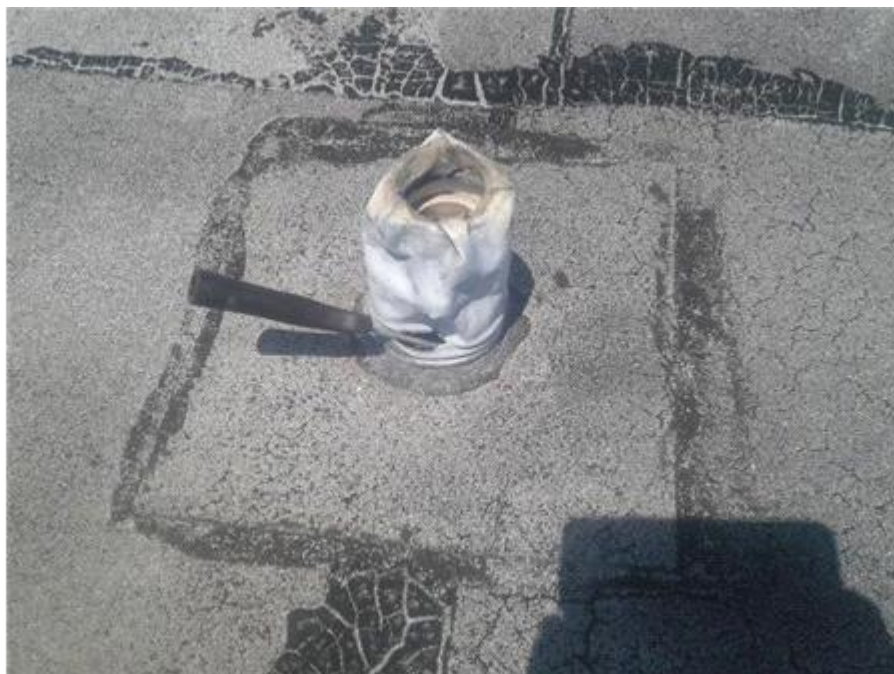
The Towers - BUR Lead Boot

Hole in base of lead boot.

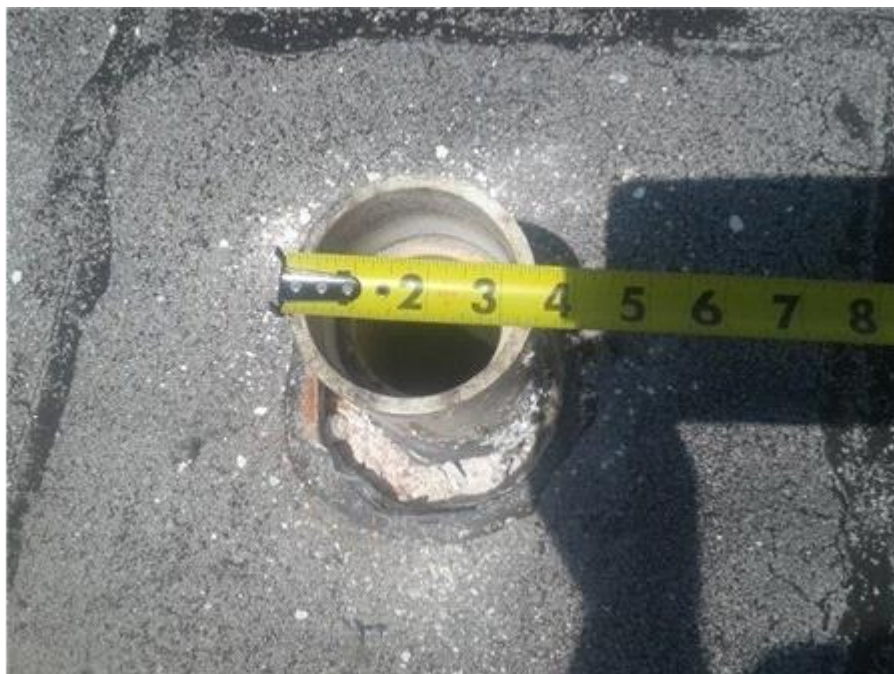
The Towers - BUR Lead Boot

Measurements for lead boot - 4".

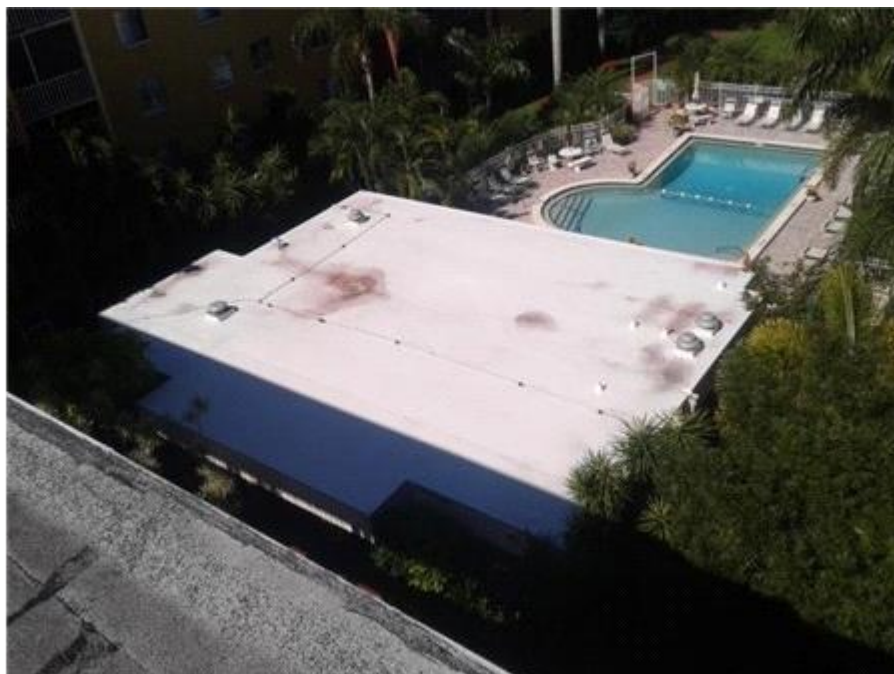
029- The Towers - TPO Roof - Roof Overview

General roof overview.

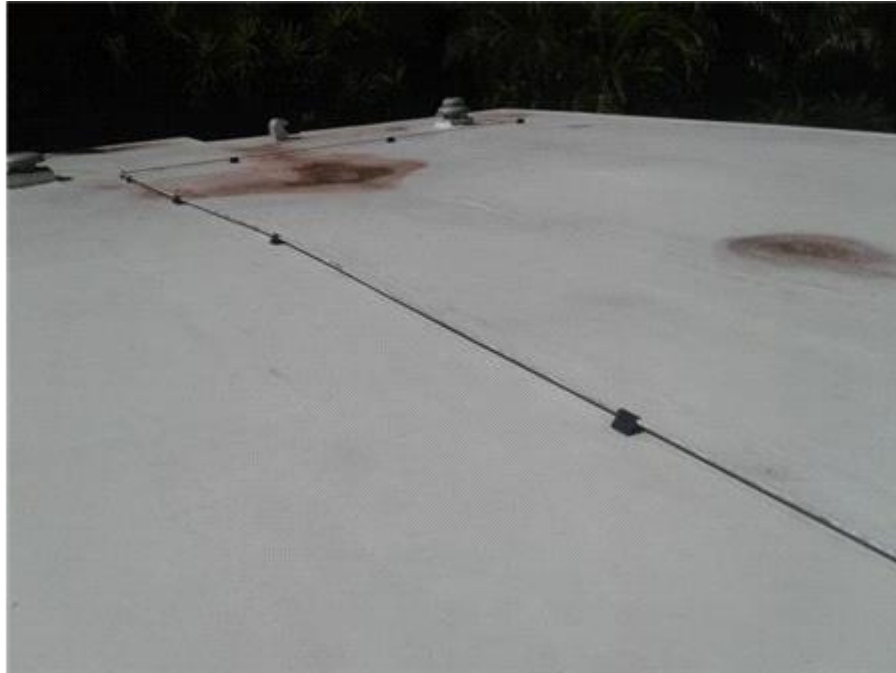
003G - The Towers - TPO Roof Membrane Overview

The membrane appears to be in good, maintainable condition at this time.

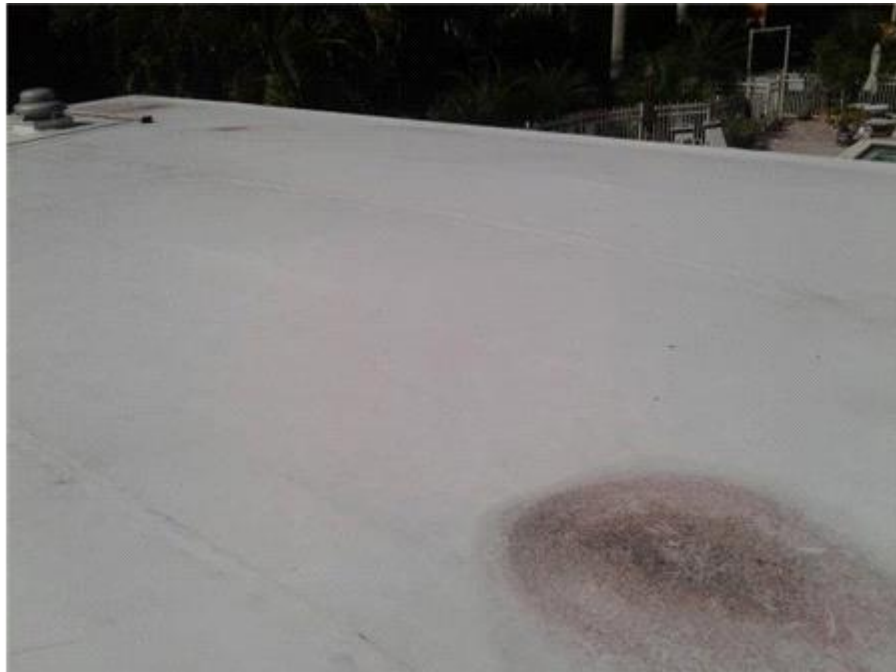
001G- The Towers - TPO Roof Surface Overview

The roof surface appears to be in good, maintainable condition at this time.

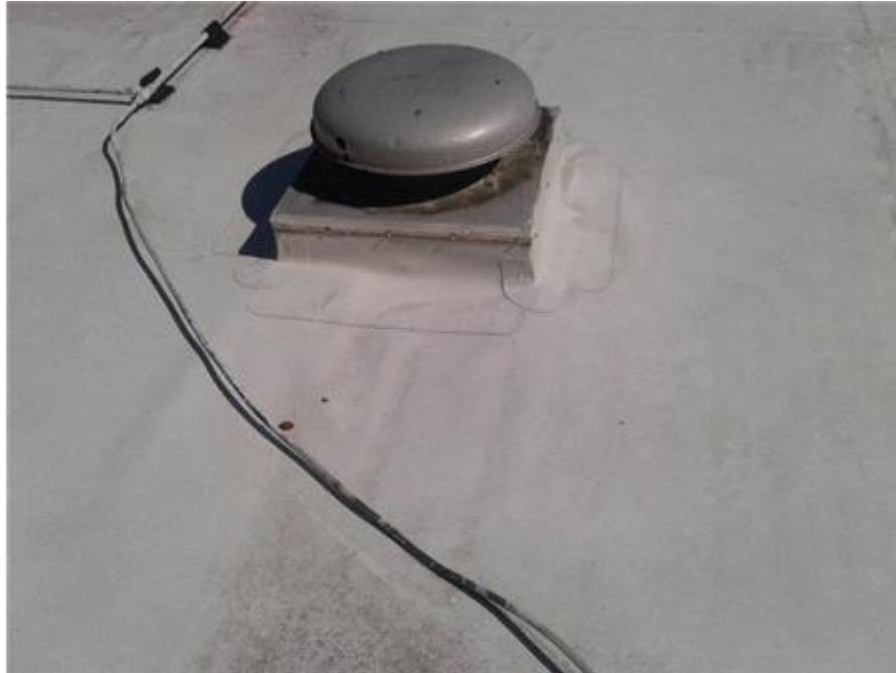
004G - The Towers - TPO Roof Base Flashings

The base flashings appear to be in good condition.

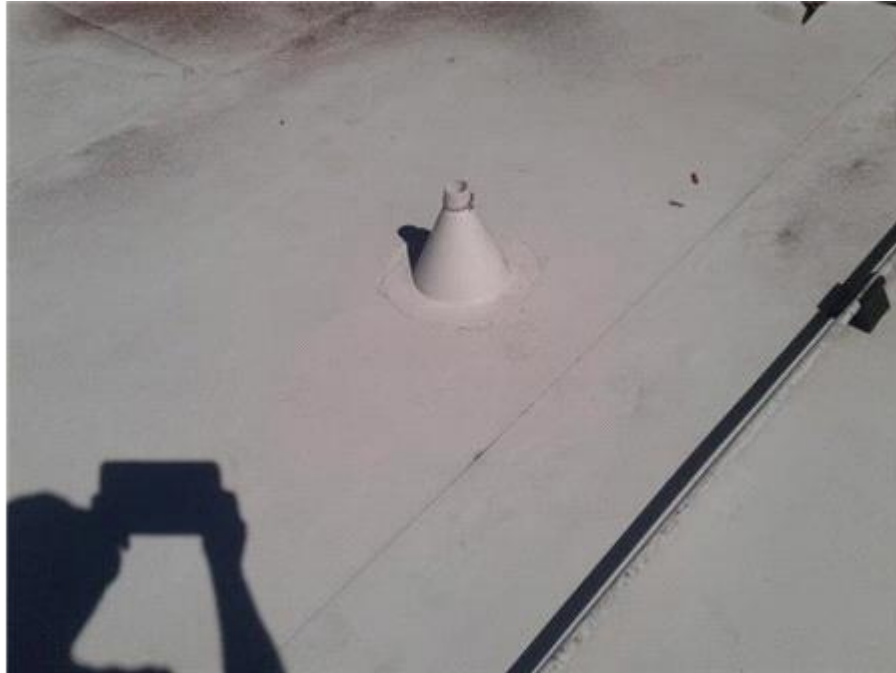
The Towers - TPO Roof Soil Stacks

Soil stack boots appear to be in good condition at this time.

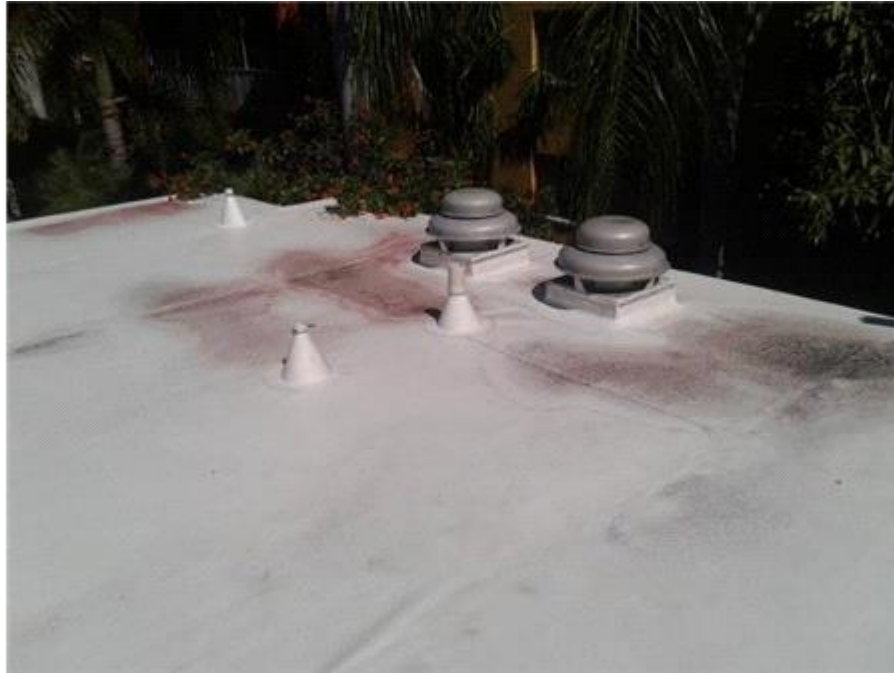
002G- The Towers - TPO Roof Appearance Overview

The roof appearance is in good, maintainable condition at this time.

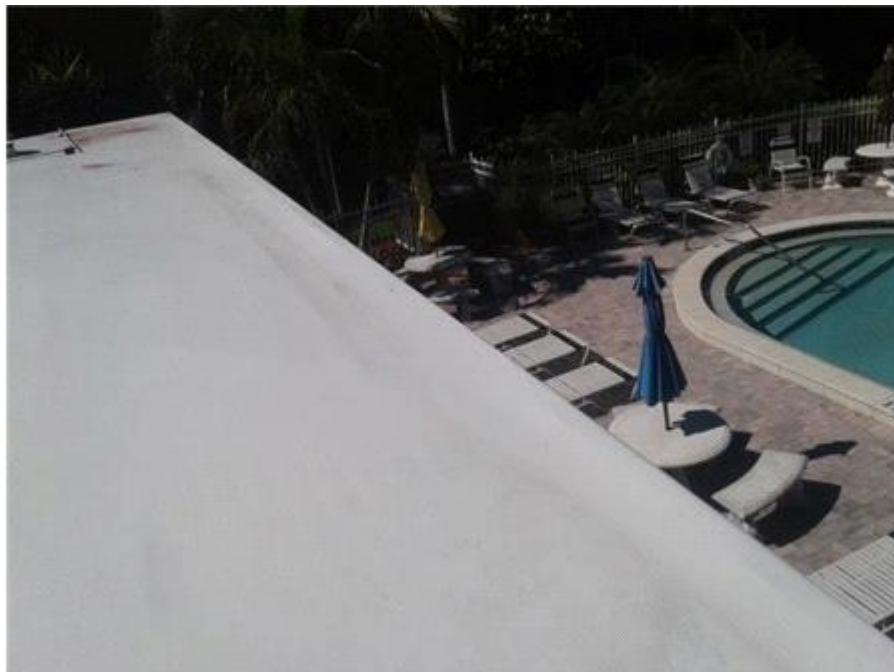
016G- The Towers - TPO Roof Roof Edge

Roof edge appears to be in good condition.

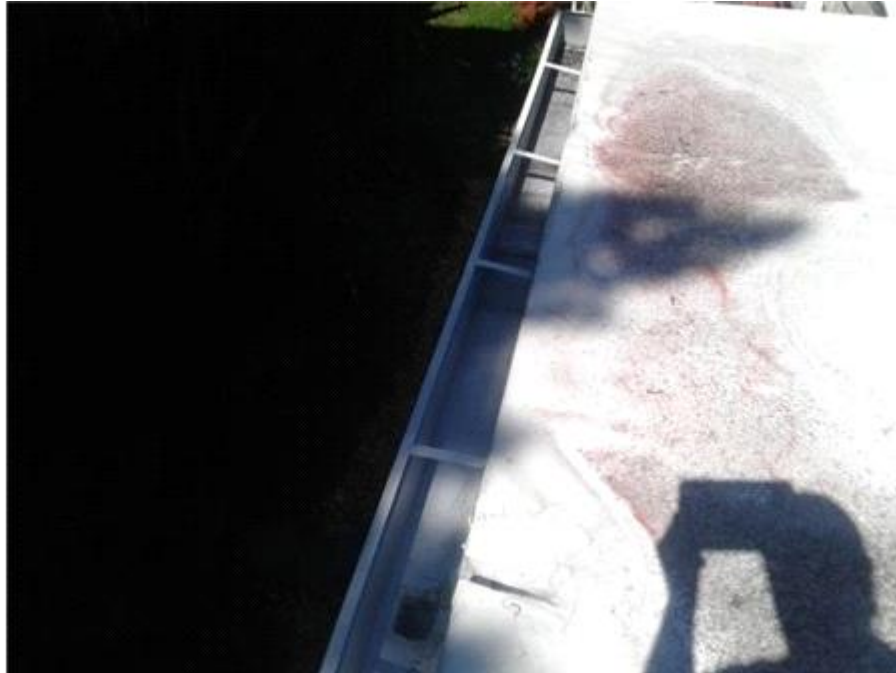
008G- The Towers - TPO Roof Gutters

The gutters appear to be in good condition.

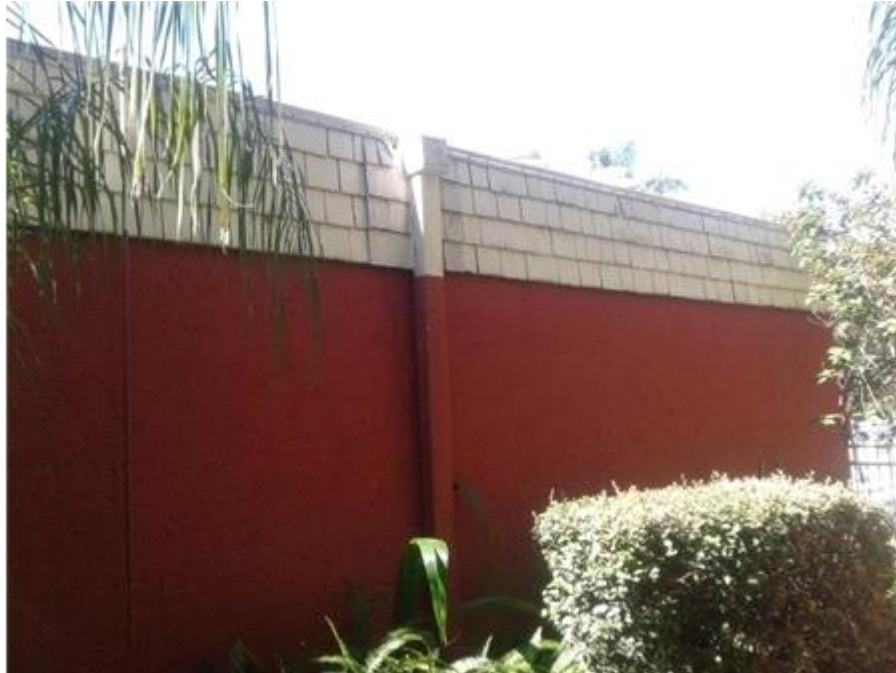
009G- The Towers - TPO Roof Downspouts
The downspouts appear to be in good condition.
