Inspection Report

Facility: Towers, The
Address: 2366 East Mall Dr,
Fort Myers, 33901

Work Order #: 4780

Re.: **Inspection Report (3 of 6) for The Towers**

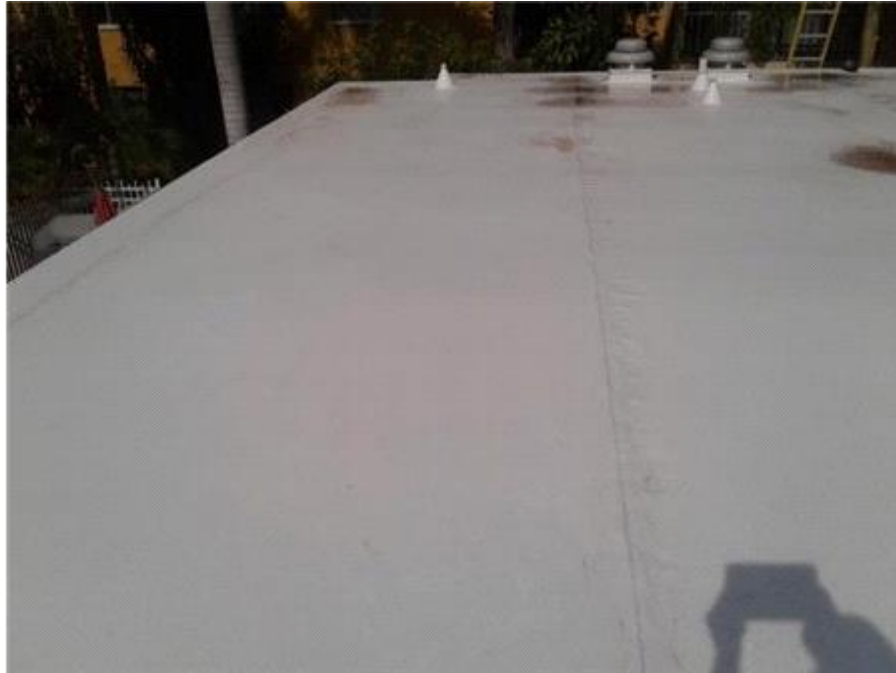
Clubhouse: Membrane Overview

The membrane appears to be in good, maintainable condition at this time.

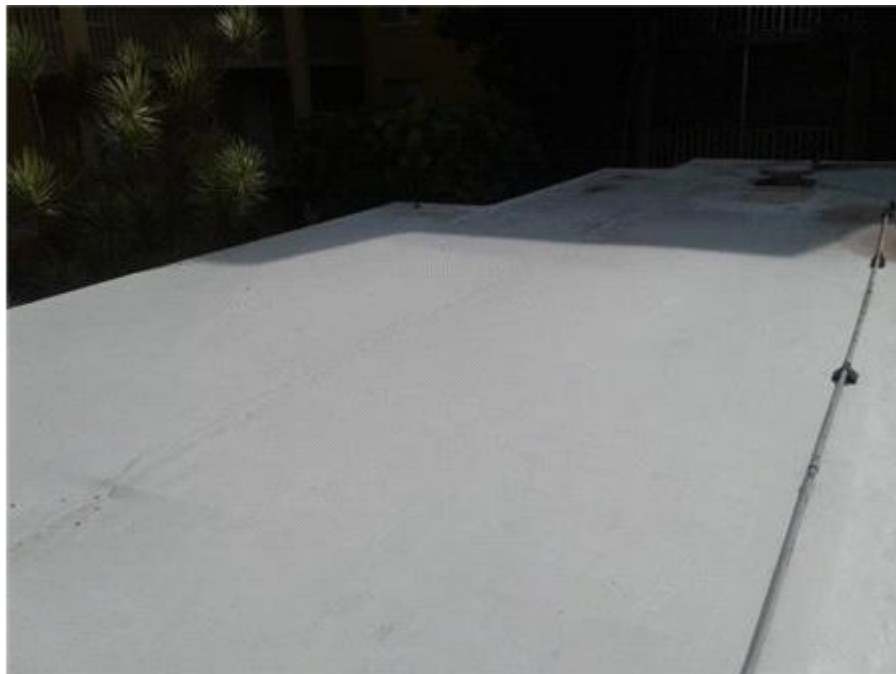
Clubhouse: Surface Overview

The roof surface appears to be in good, maintainable condition at this time.

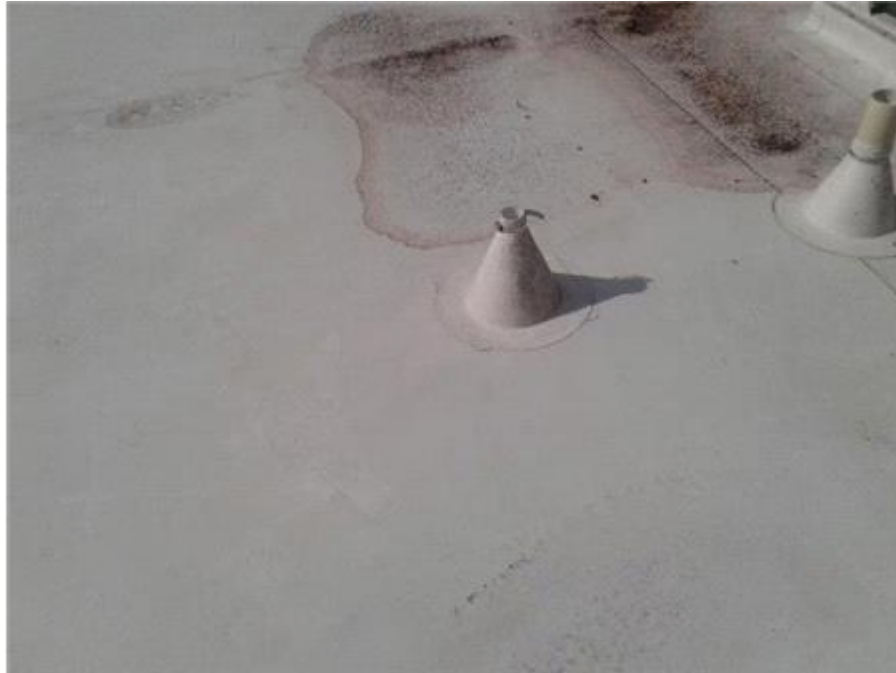
Clubhouse: Soil Stacks

The soil stack boots appear to be in good condition at this time.

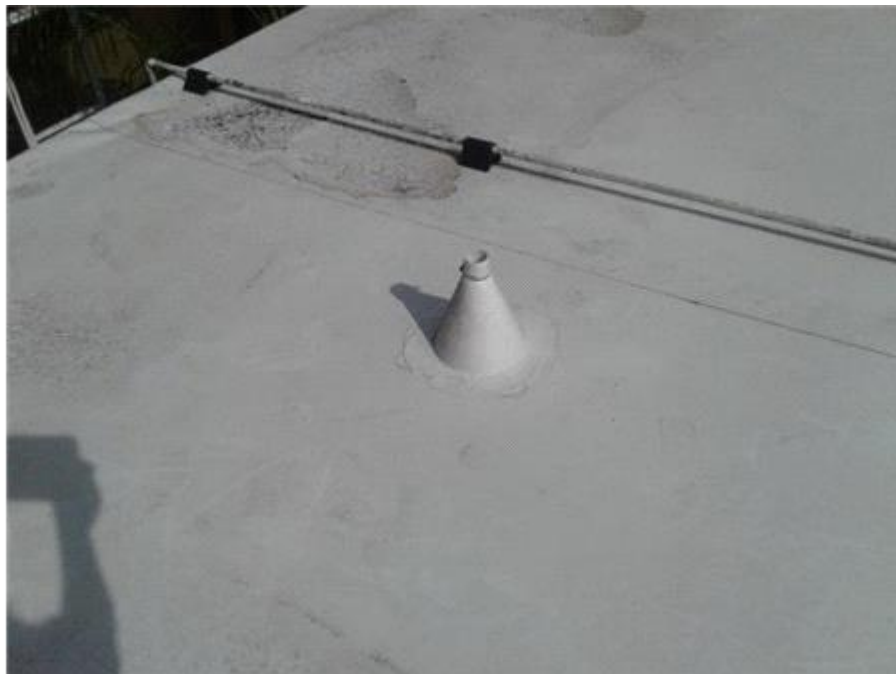
Clubhouse: Soil Stacks

The soil stack boots appear to be in good condition at this time.

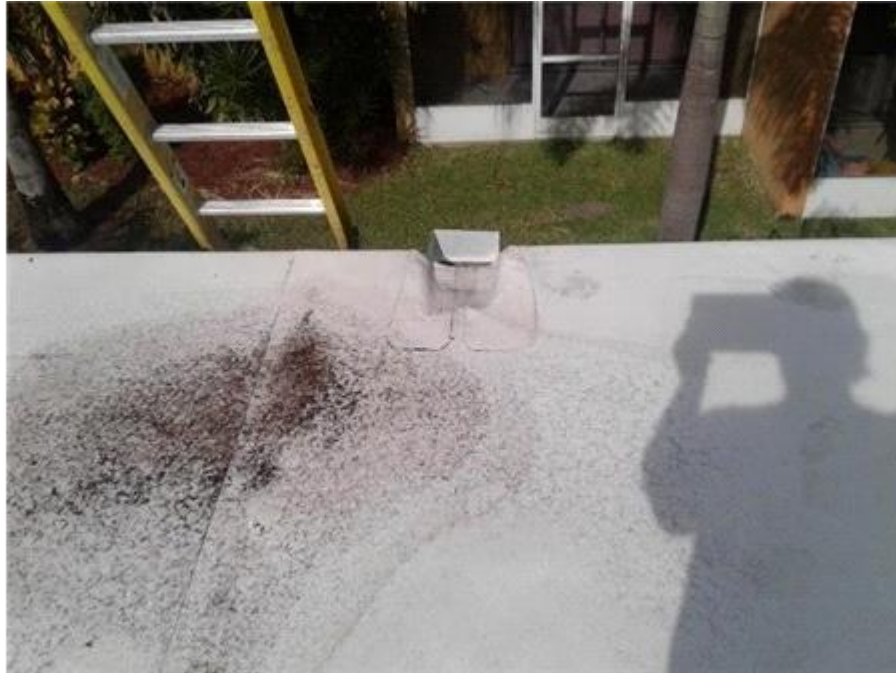
Clubhouse: Scuppers

The scuppers appear to be in good condition at this time.

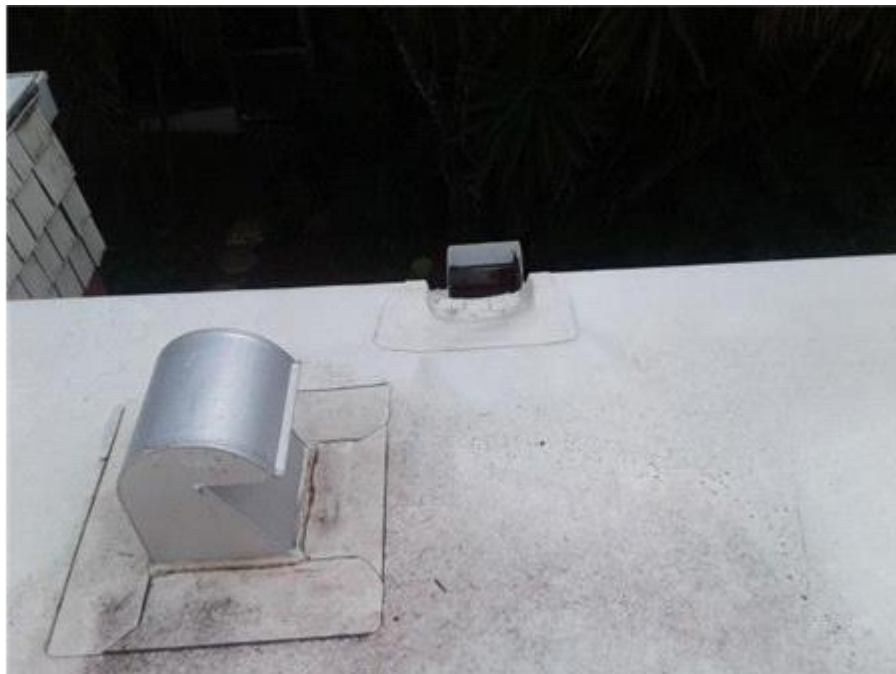
Clubhouse: Scuppers

The scuppers appear to be in good condition at this time.

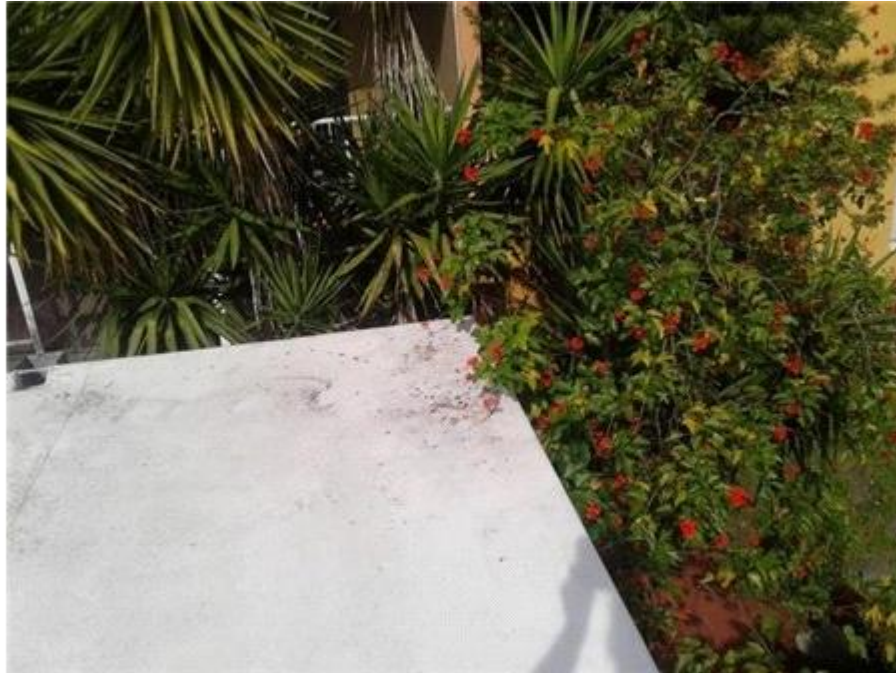
Clubhouse: Tree Branches

Identified tree branches hanging over the roof surface. Branches on the roof surface can cause deterioration of membrane, and act as an access for rodents and unwanted bugs/pests.

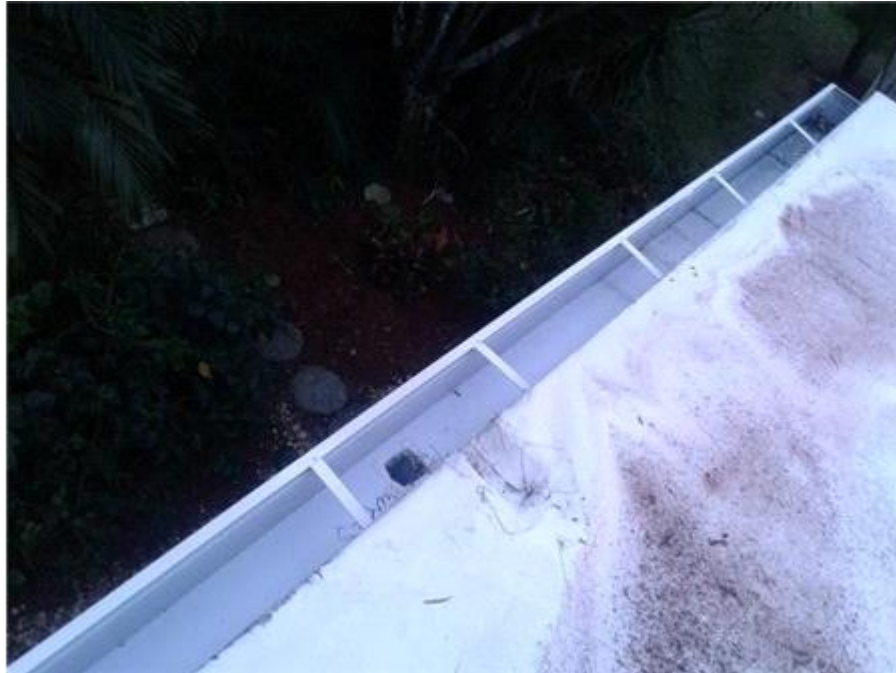
Clubhouse: Gutters

The gutters appear to be in good condition at this time.

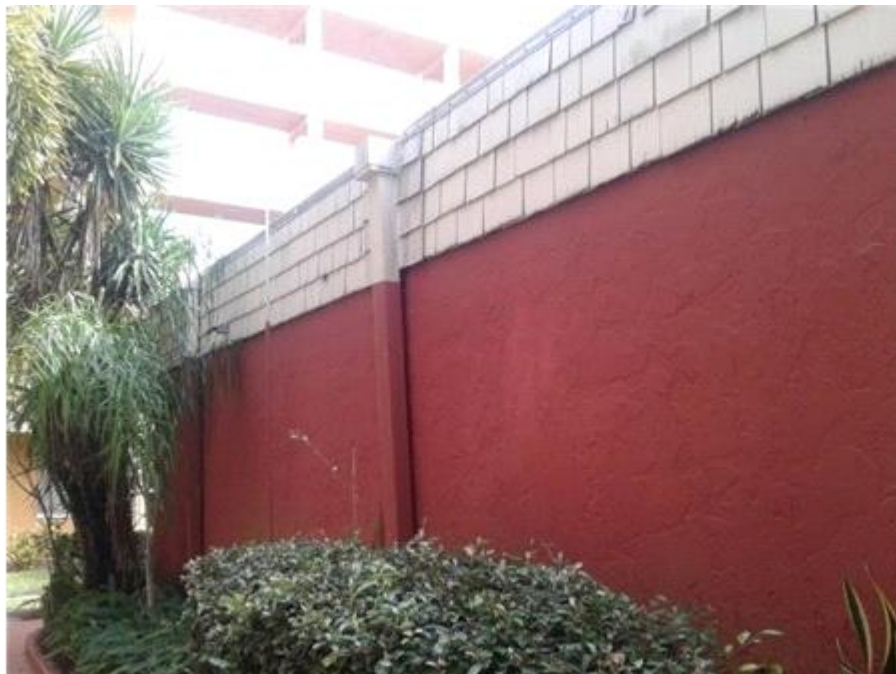
Clubhouse: Downspouts

The downspouts appear to be in good condition at this time.

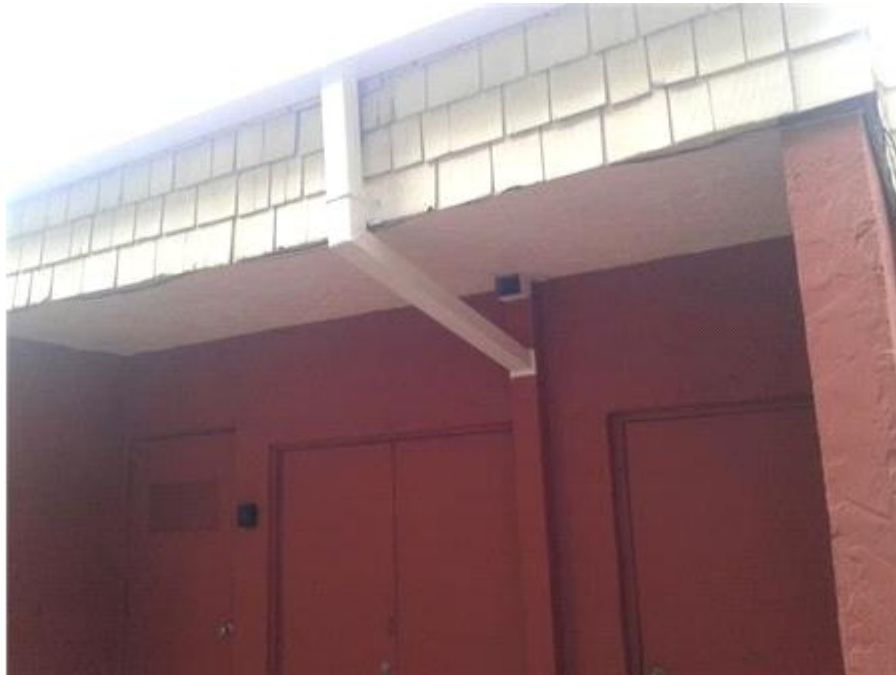
Clubhouse: Downspouts

The downspouts appear to be in good condition at this time.
