Inspection Report

Facility: Towers, The
Address: 2366 East Mall Dr,
Fort Myers, 33901

Work Order #: 7558

Re.: **Inspection Report (2 of 6) for The Towers**

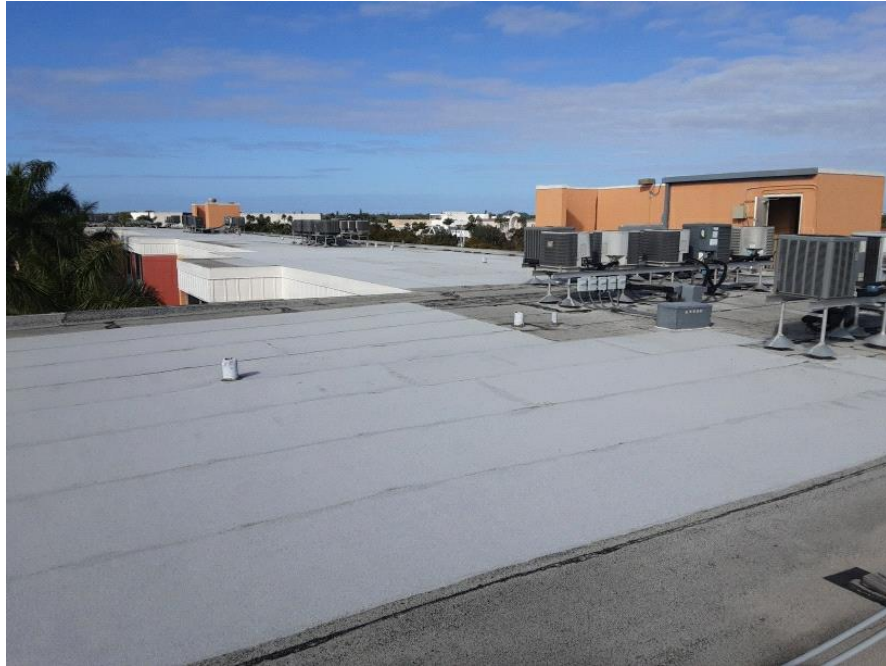
Roof Overview

General roof overview.

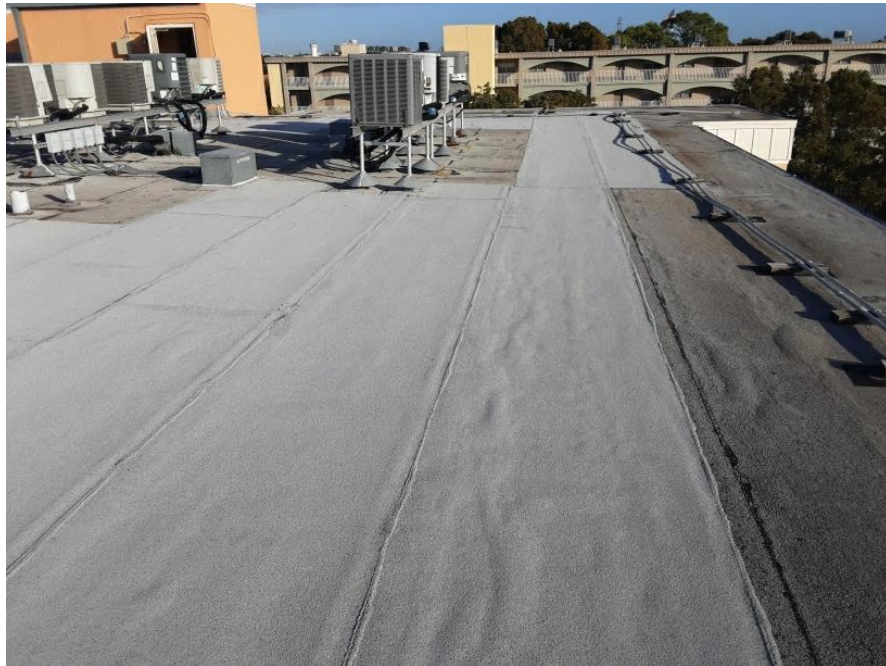
Surface Overview

The roof surface appears to be in fair condition.

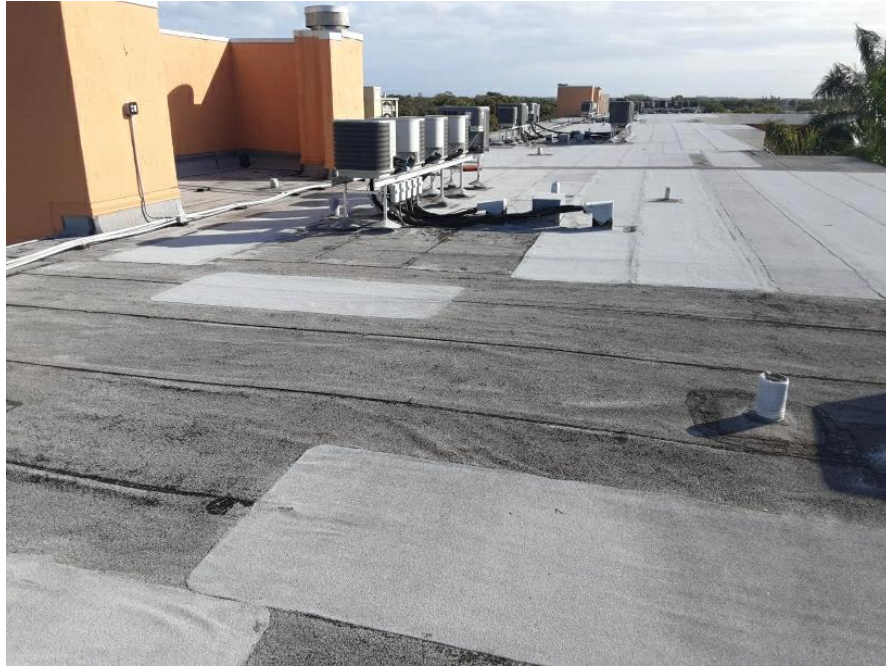
Surface Overview

The roof surface appears to be in fair condition.

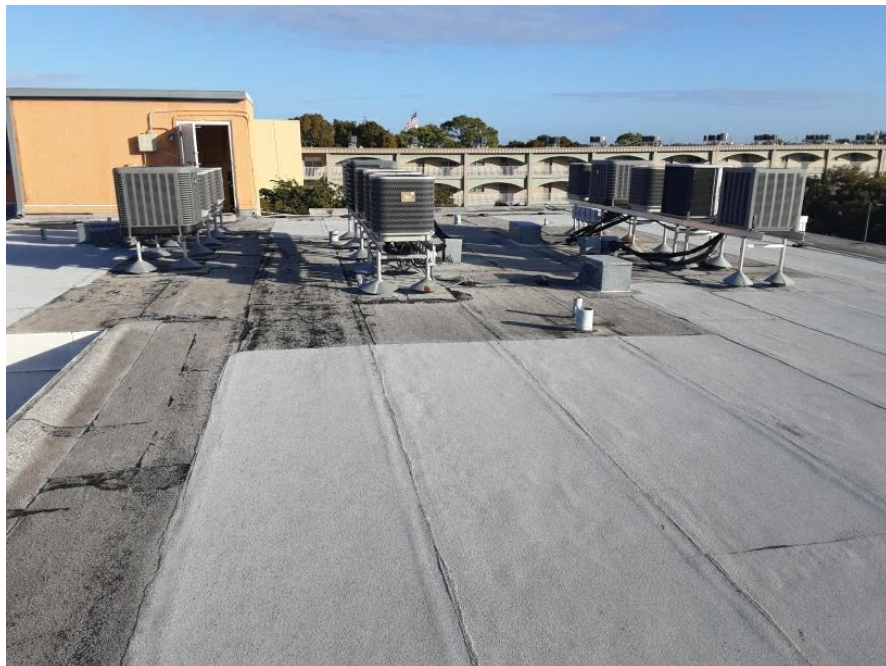
Appearance Overview

The appearance of the roof is in fair condition.

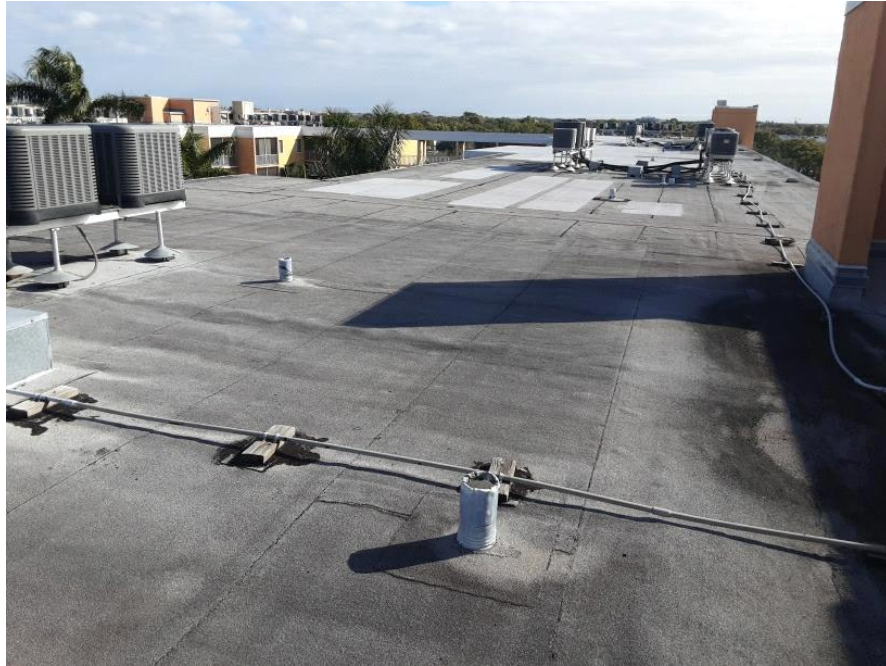
Appearance Overview

The appearance of the roof is in fair condition.

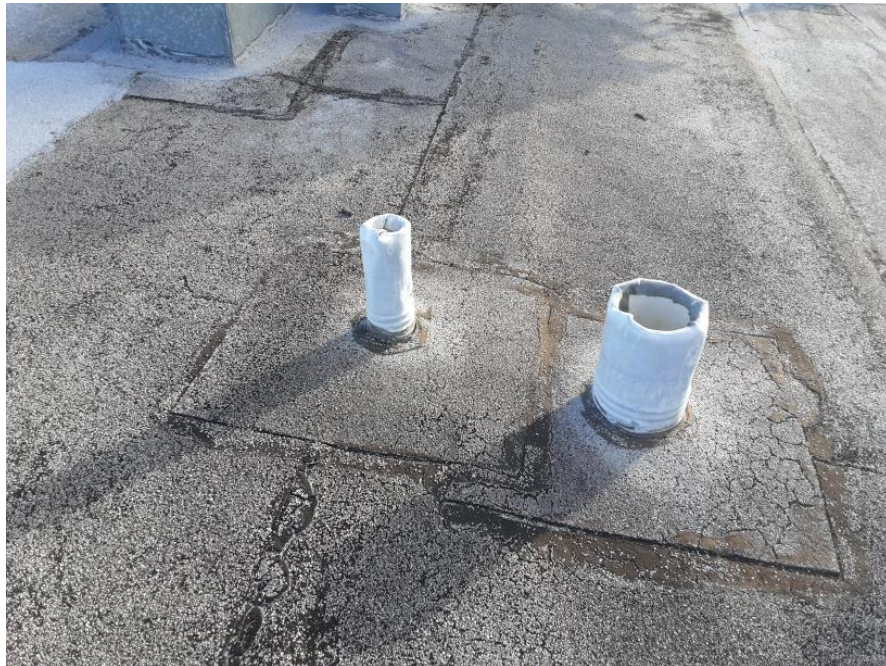
Lead Boots

The lead boots appear to be in fair condition.

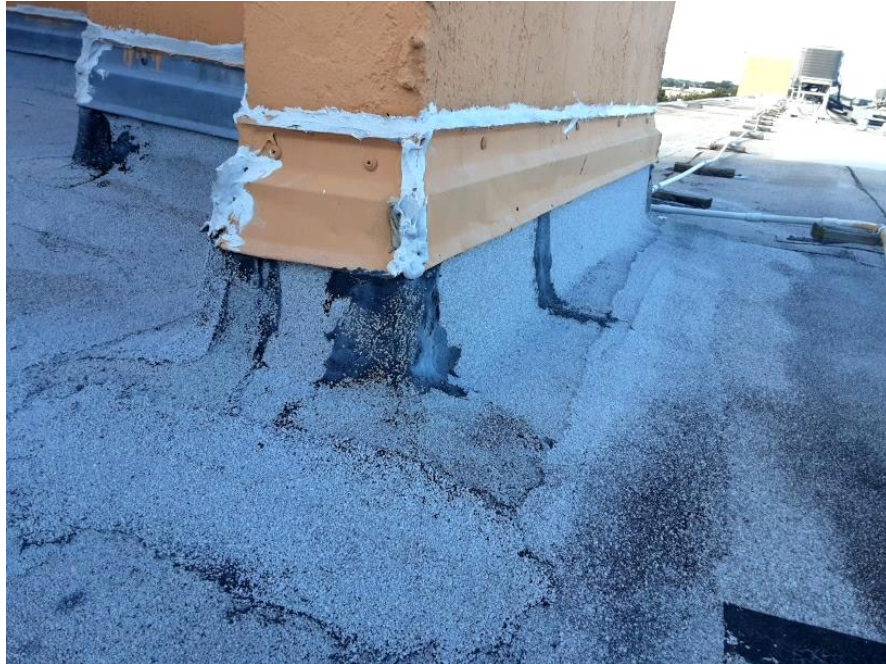
Base Flashings

The base flashings appear to be in fair condition.

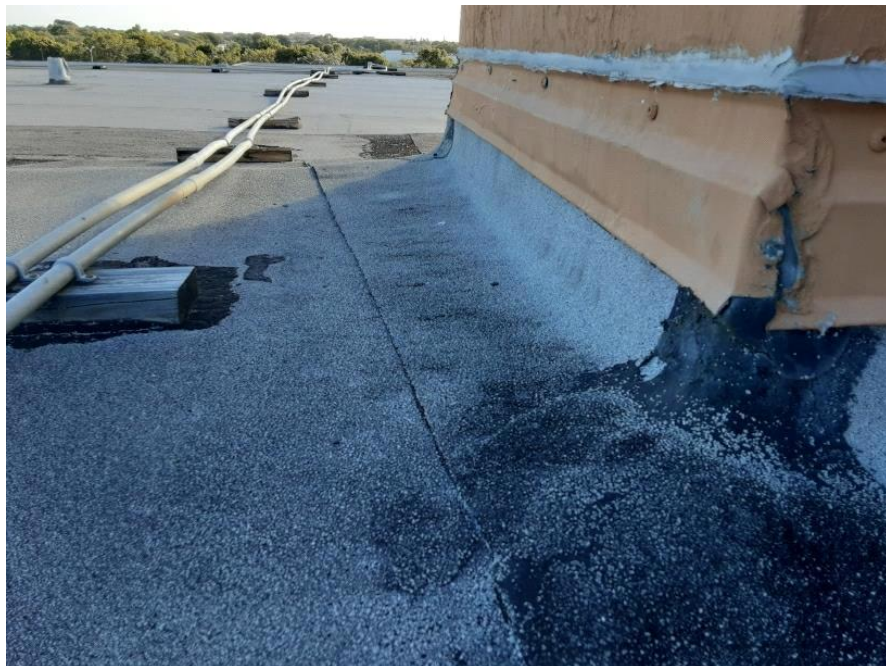
Base Flashings

The base flashings appear to be in fair condition.

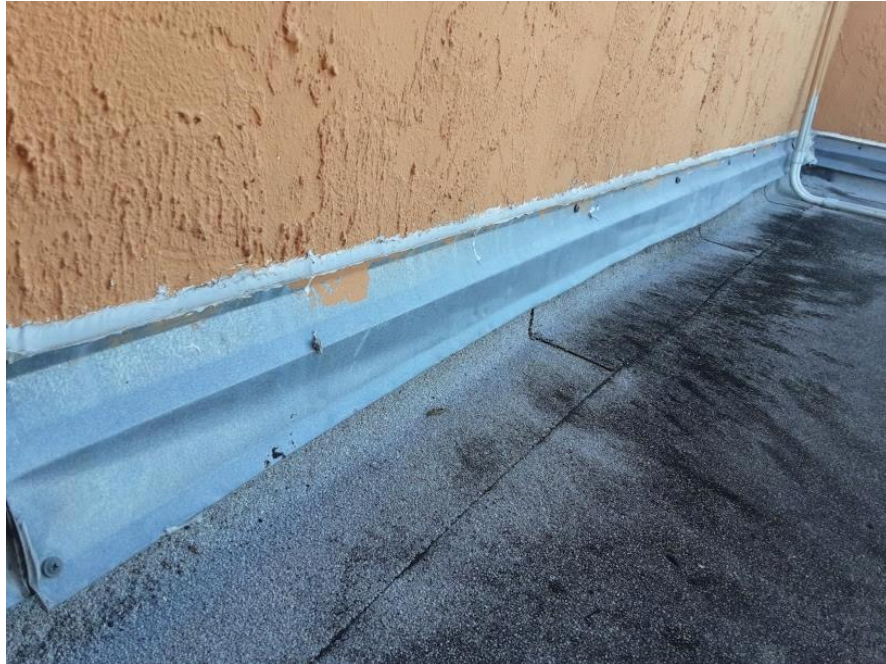
Counter Flashings

The counter flashing appears to be in fair condition.

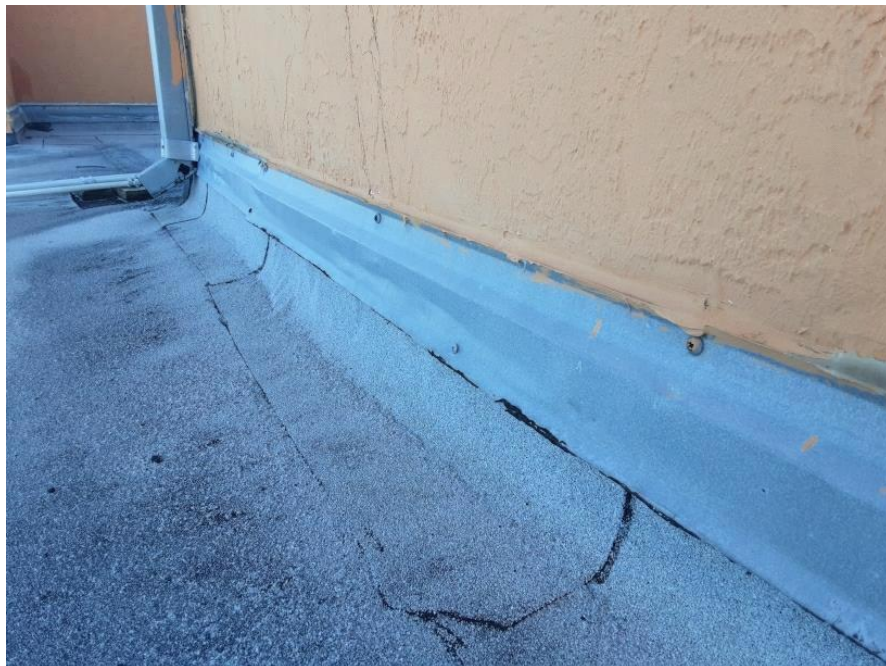
Counter Flashings

The counter flashing appears to be in fair condition.

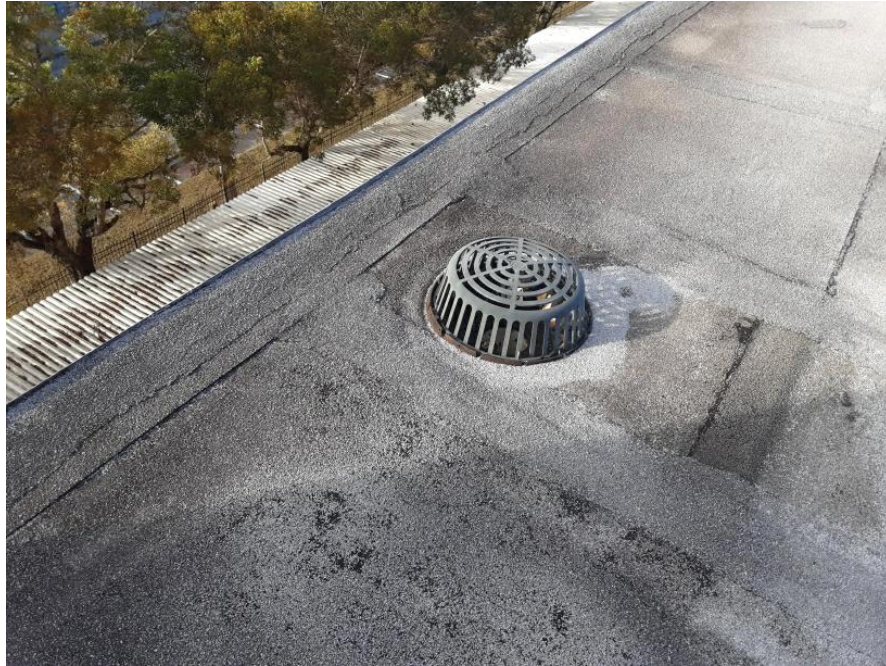
Roof Drains

Roof drains appear to be in fair condition.

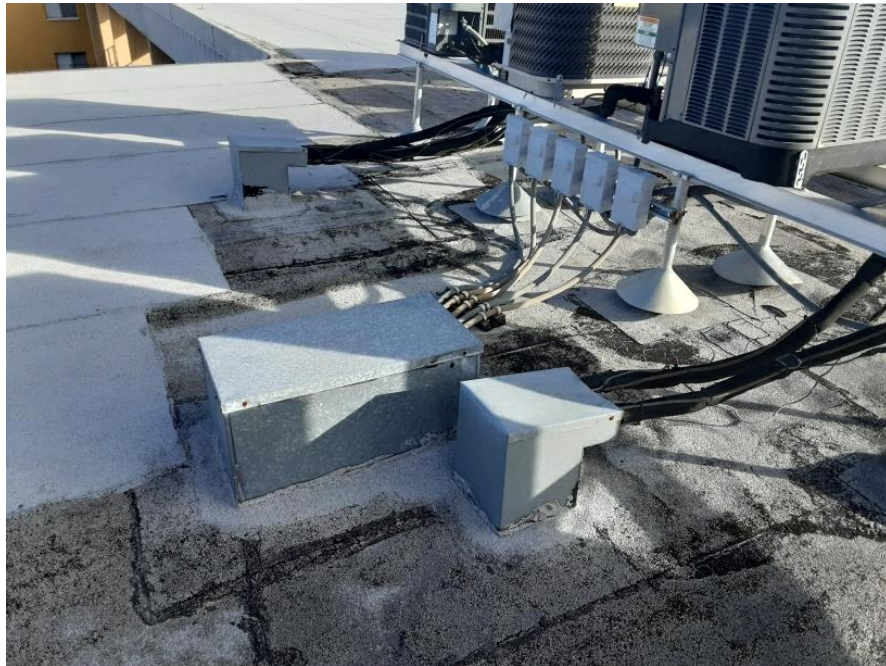
Equipment Housing

The equipment housing appears to be in fair condition.

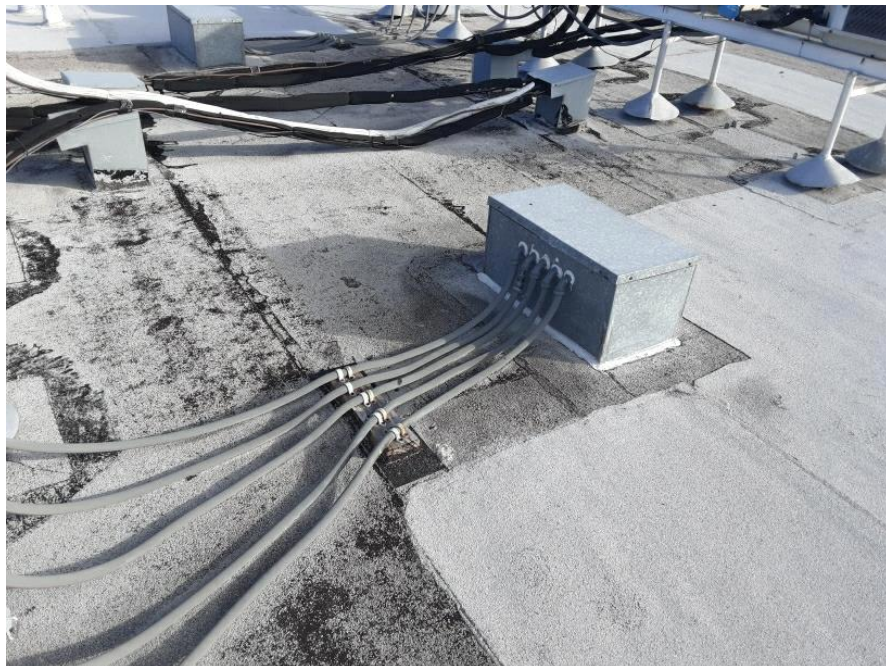
Equipment Housing

The equipment housing appears to be in fair condition.

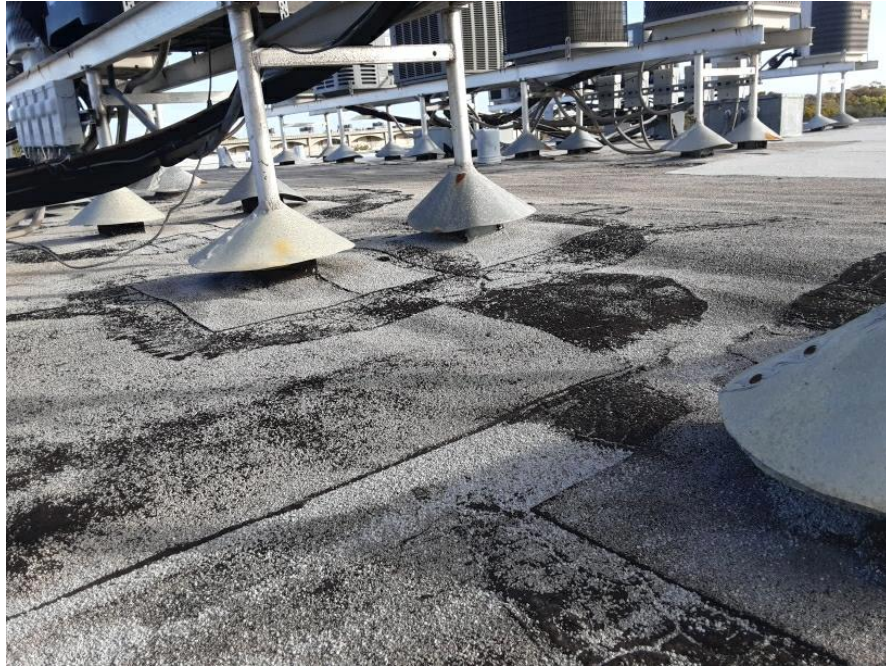
Pitch Pans

The pitch pans appear to be in fair condition.

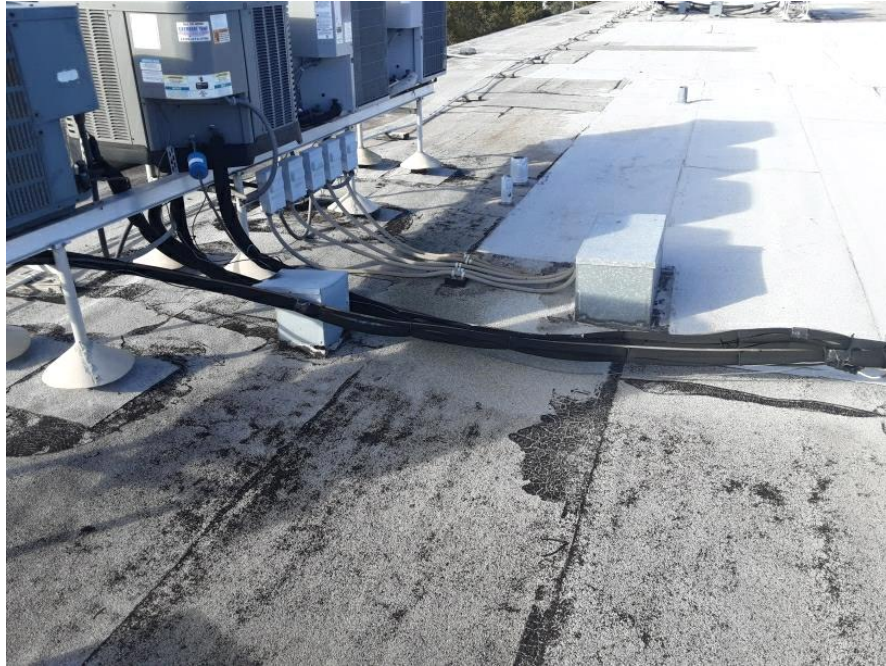
Armaflex Foam

The armaflex foam appears to be in poor condition. Crowther Roofing suggests having Crowther Mechanical replace approximately 1500 feet of ArmaFlex.

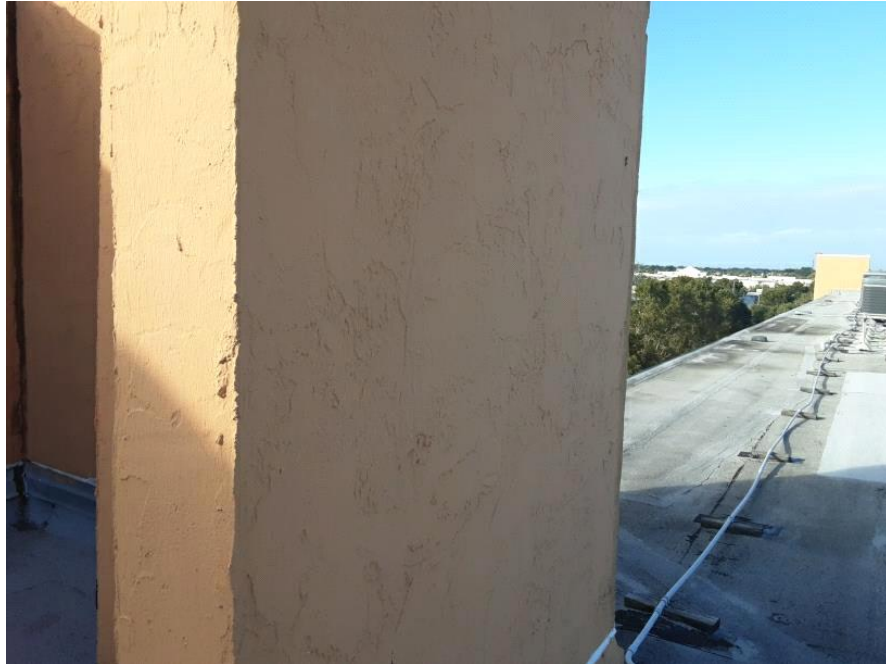
Wall

The walls appear to be in fair condition.

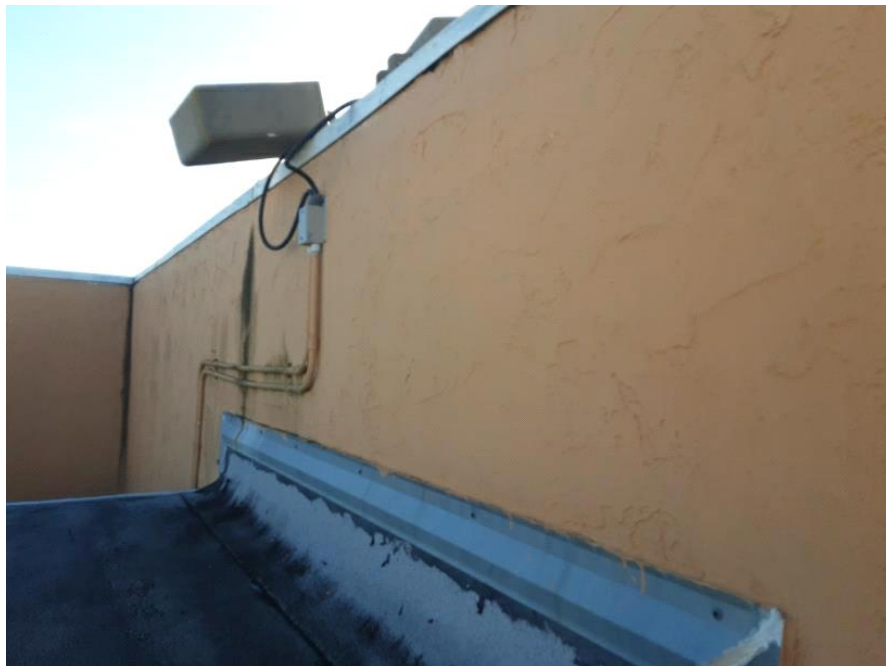
Wall

The walls appear to be in fair condition.

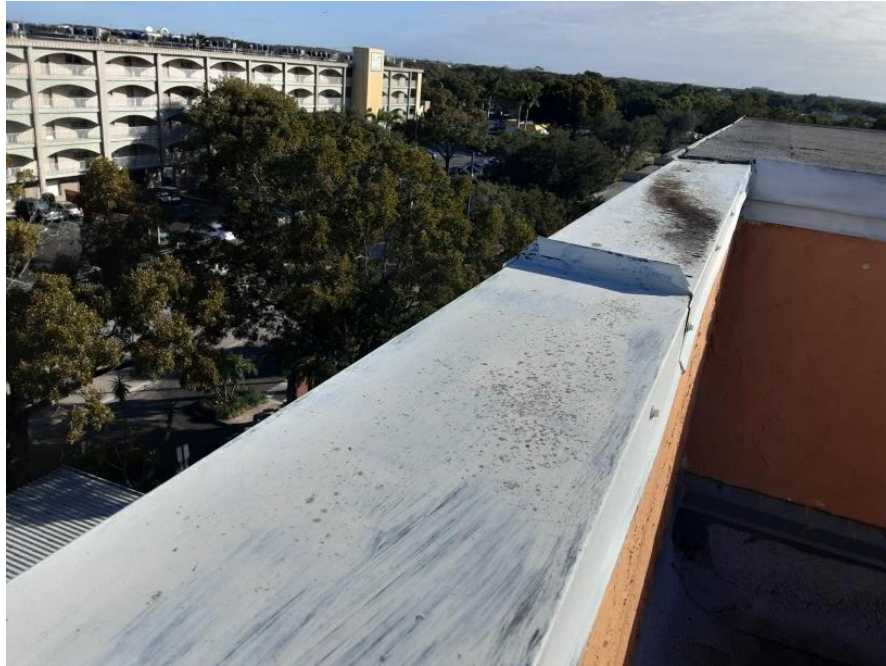
Coping

The coping appears to be in fair condition.

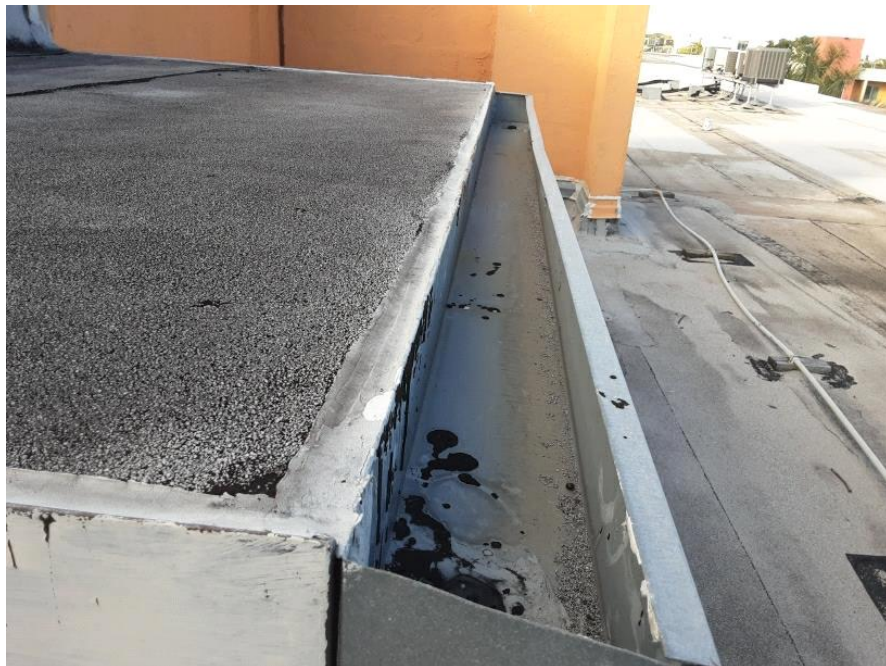
Gutters

The gutters appear to be in fair condition.

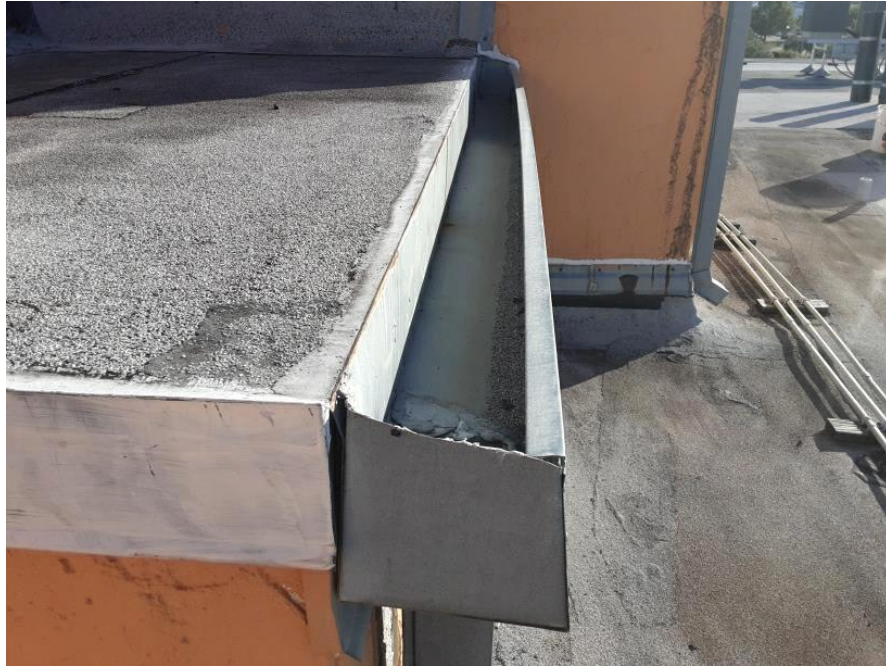
Gutters

The gutters appear to be in fair condition.

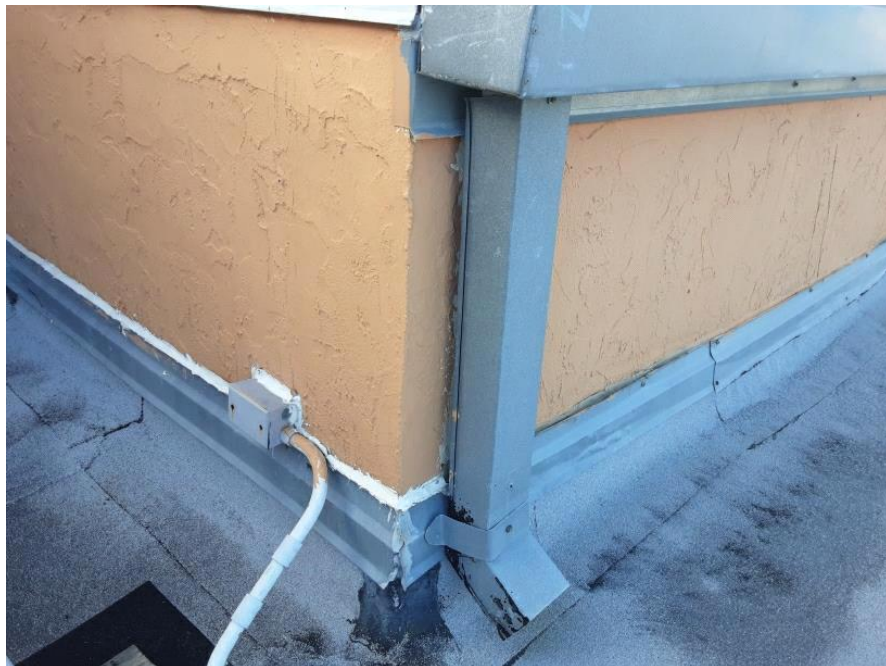
Downspouts

The downspouts appear to be in fair condition.

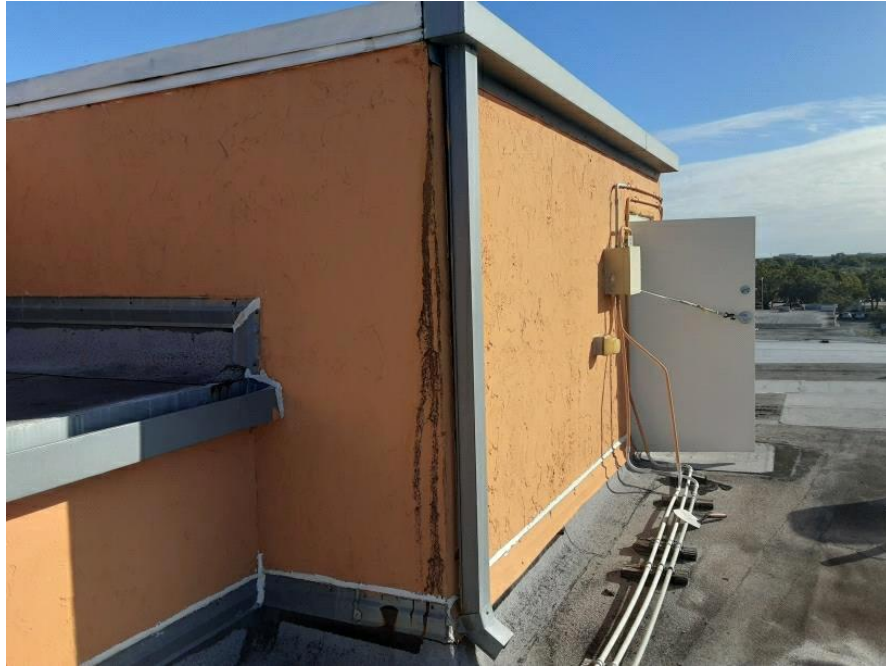
Downspouts

The downspouts appear to be in fair condition.

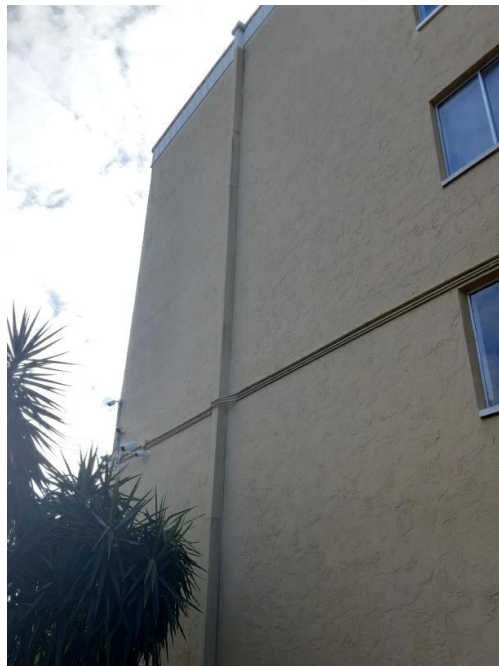
Downspouts

The downspouts appear to be in good condition.

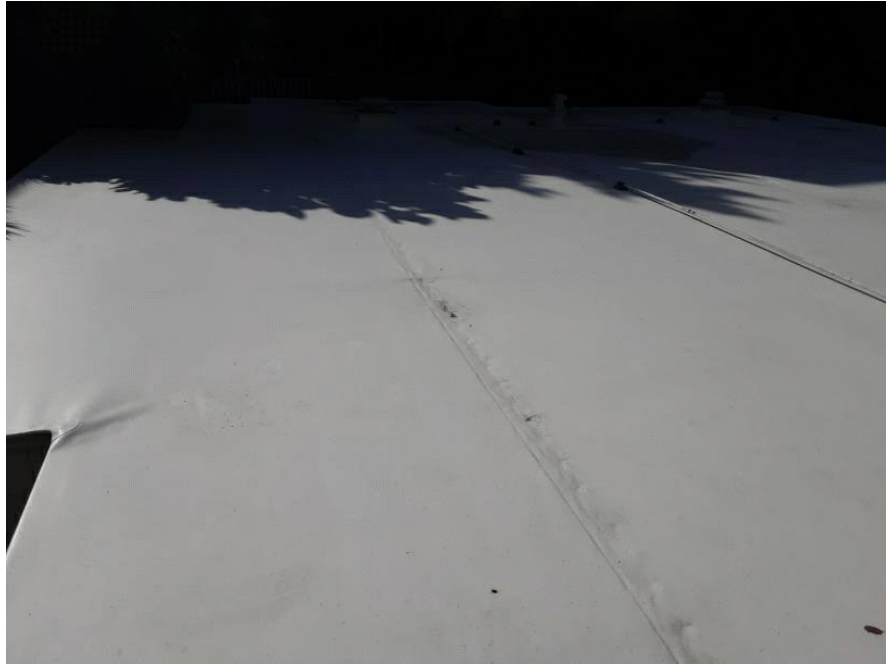
Surface Overview

The roof surface appears to be in good, maintainable condition.

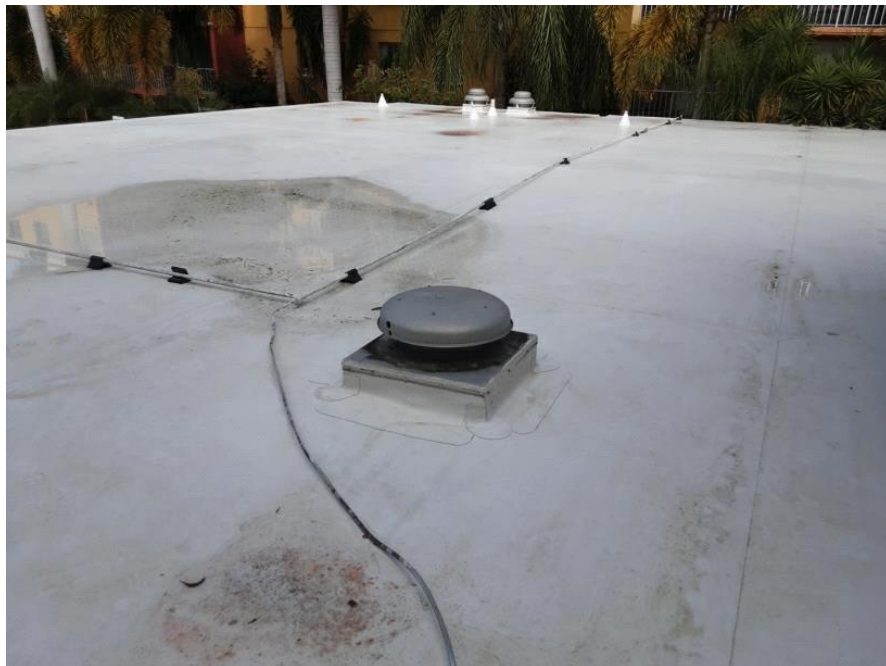
Surface Overview

The roof surface appears to be in good, maintainable condition.

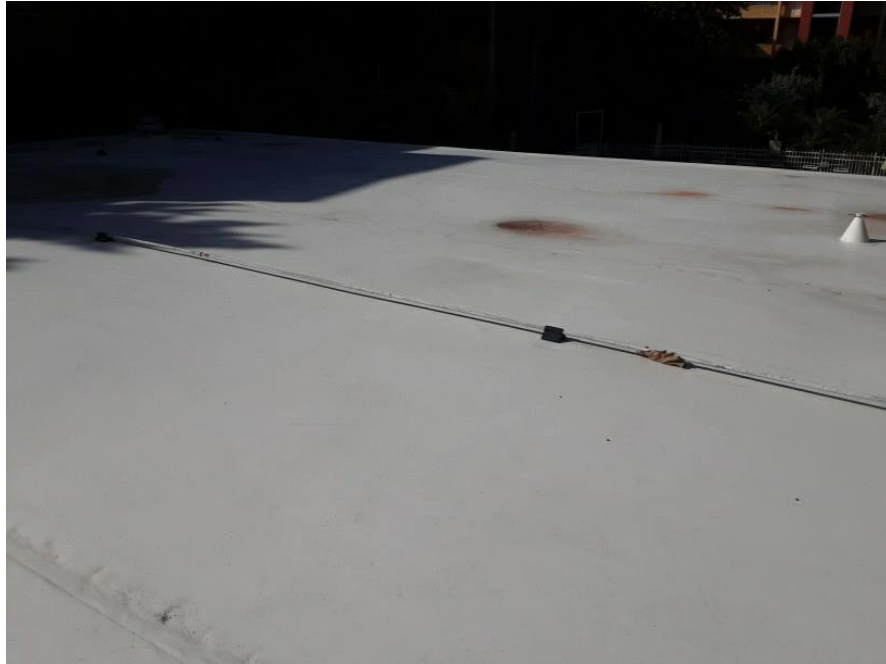
Appearance Overview

The roof appearance is in good, maintainable condition.

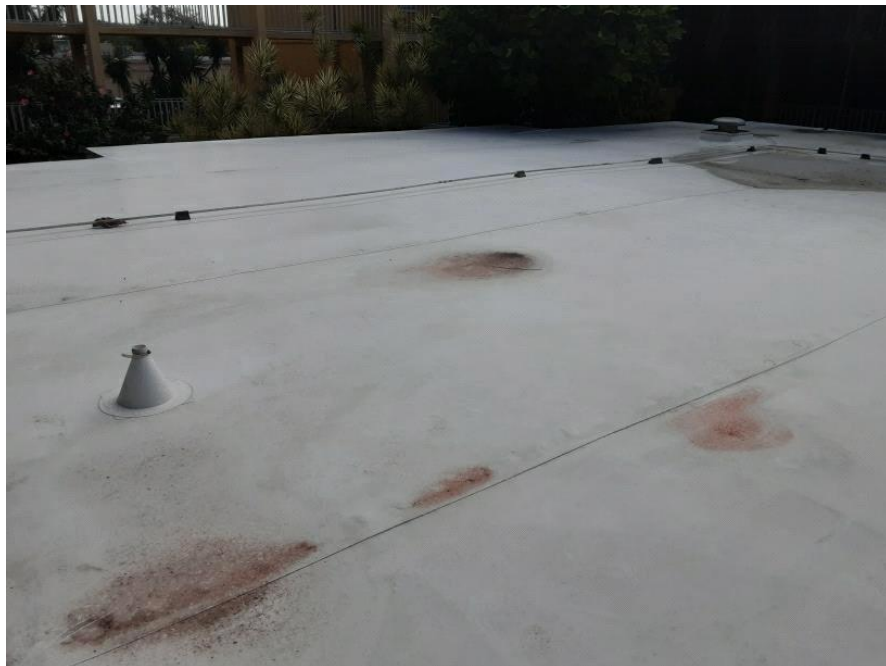
Appearance Overview

The roof appearance is in good, maintainable condition.

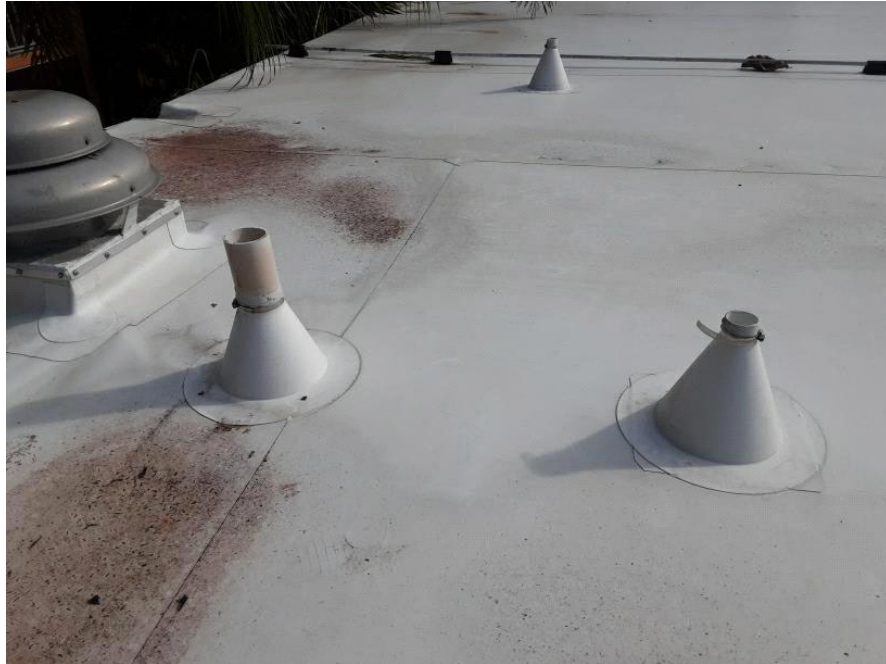
Boots

The boots appear to be in good condition.

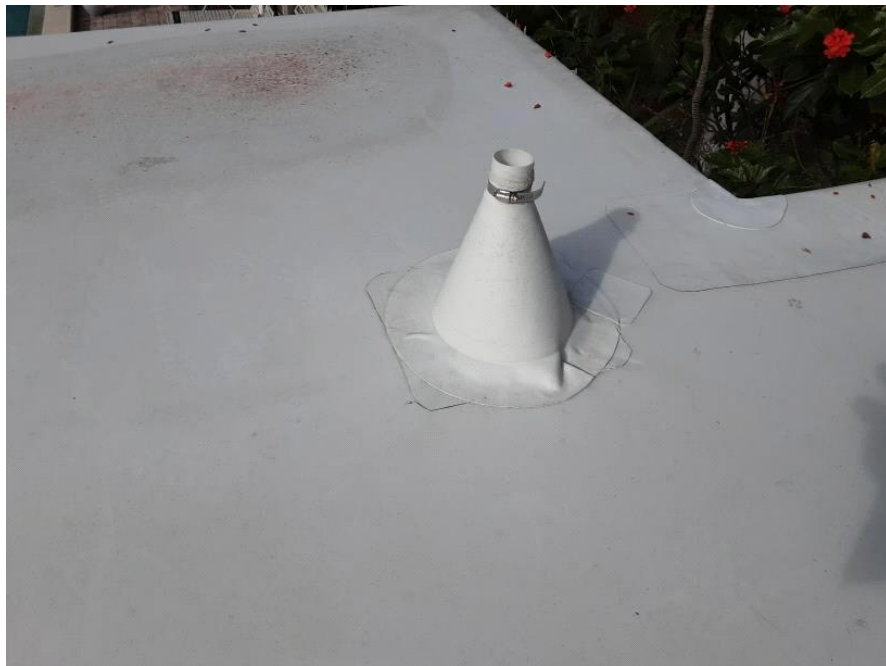
Boots

The boots appear to be in good condition.

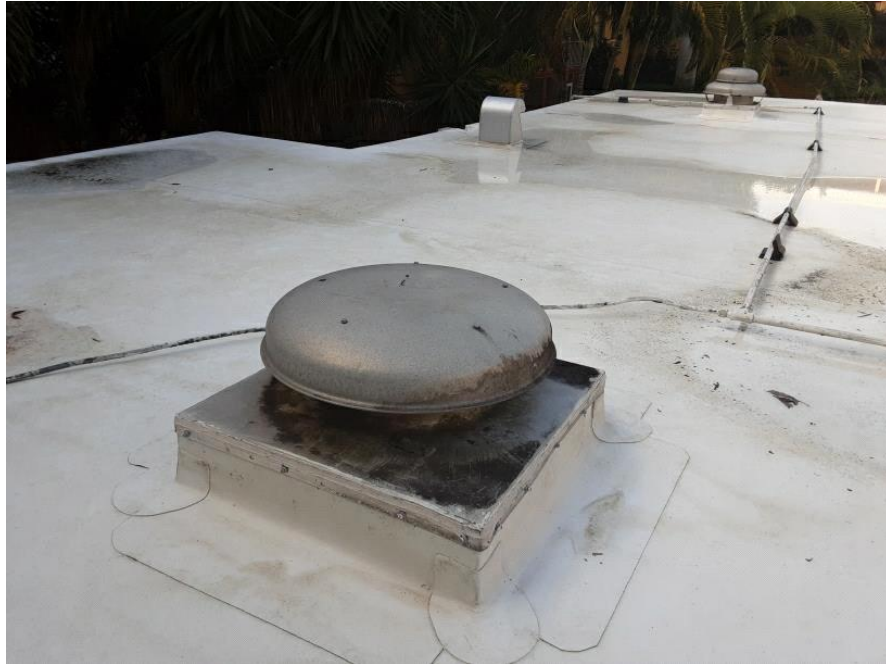
Roof Vents

The roof vents appear to be in good condition.

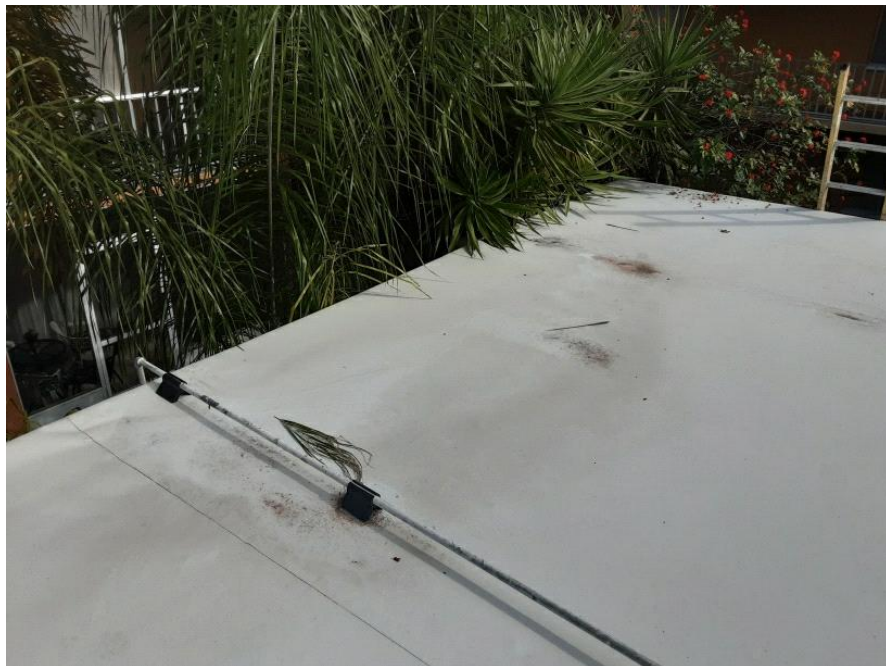
Tree Branches

Identified tree branches hanging over the roof surface. Branches on the roof surface can cause deterioration of membrane, and act as an access for rodents and unwanted bugs/pests.

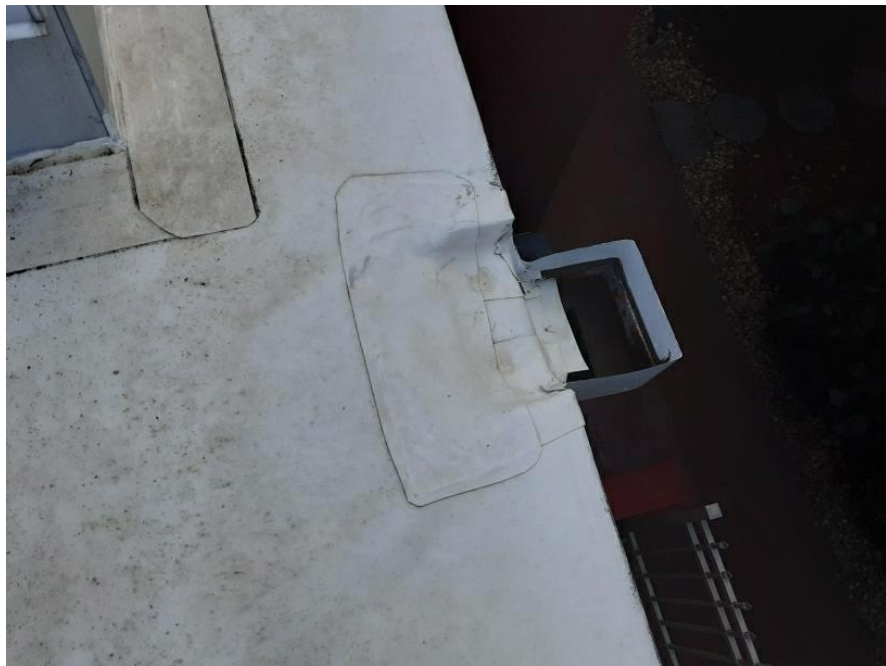
Scuppers

The scuppers appear to be in good condition at this time.

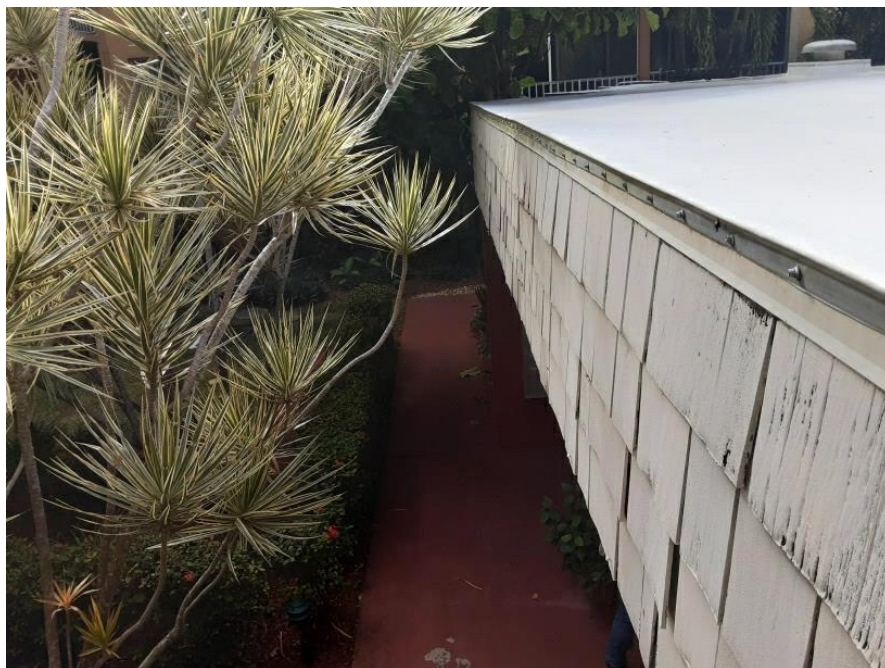
Base Flashings

The base flashings appear to be in good condition.

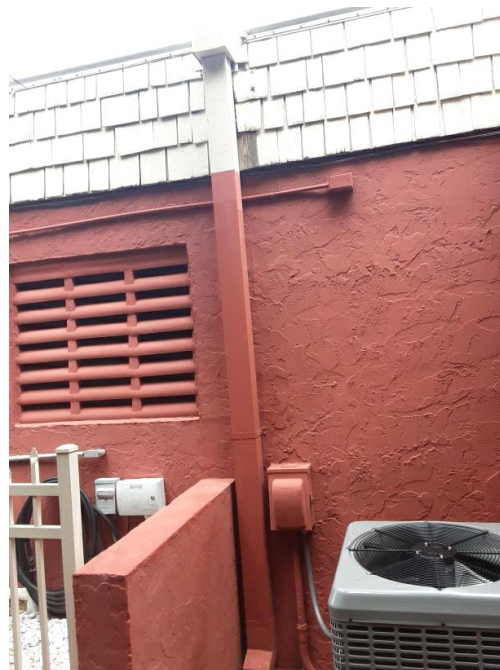
Gutters

The gutters appear to be in good condition.
