# Inspection Report

**Facility:** Towers, The  
**Address:** 2366 East Mall Dr,  
Fort Myers, 33901

Work Order #: 6220

Re.: **Inspection Report (6 of 6) for The Towers**

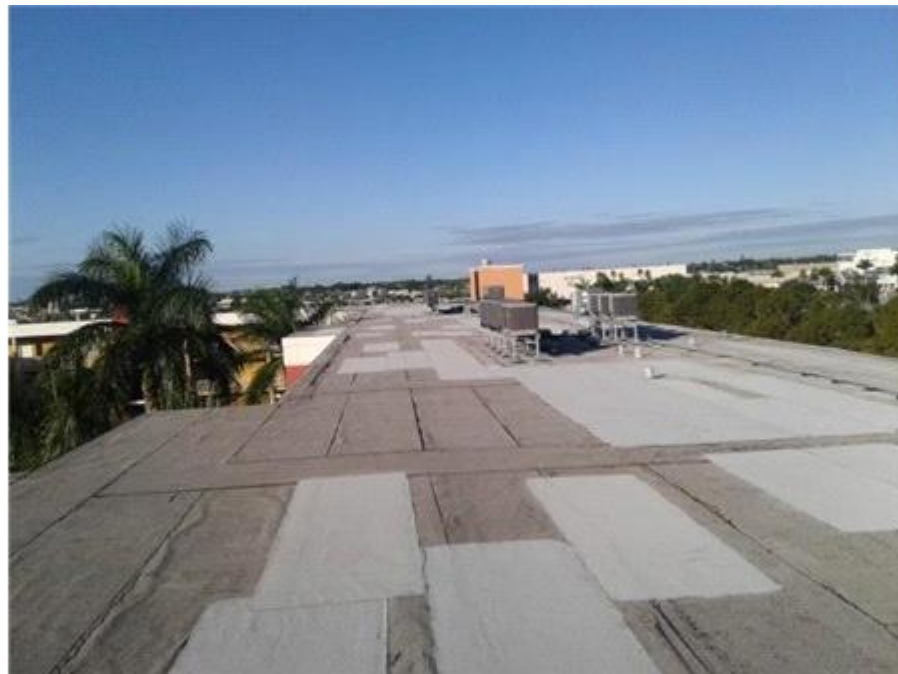
029- The Towers - BUR - Roof Overview  
General roof overview.

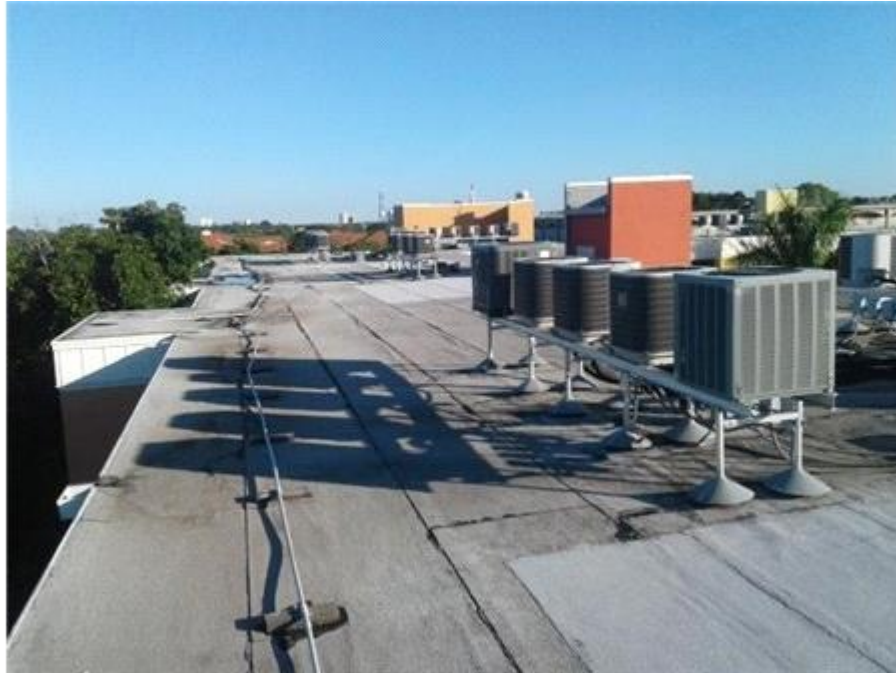
029- The Towers - BUR - Roof Overview

General roof overview.

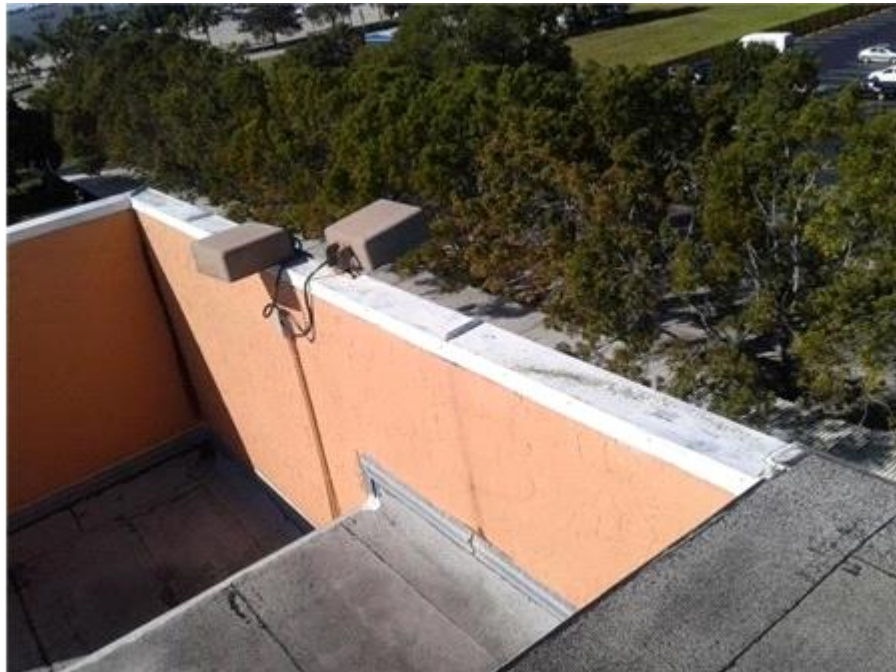
006F- The Towers - BUR - Coping

The coping appears to be in fair condition.

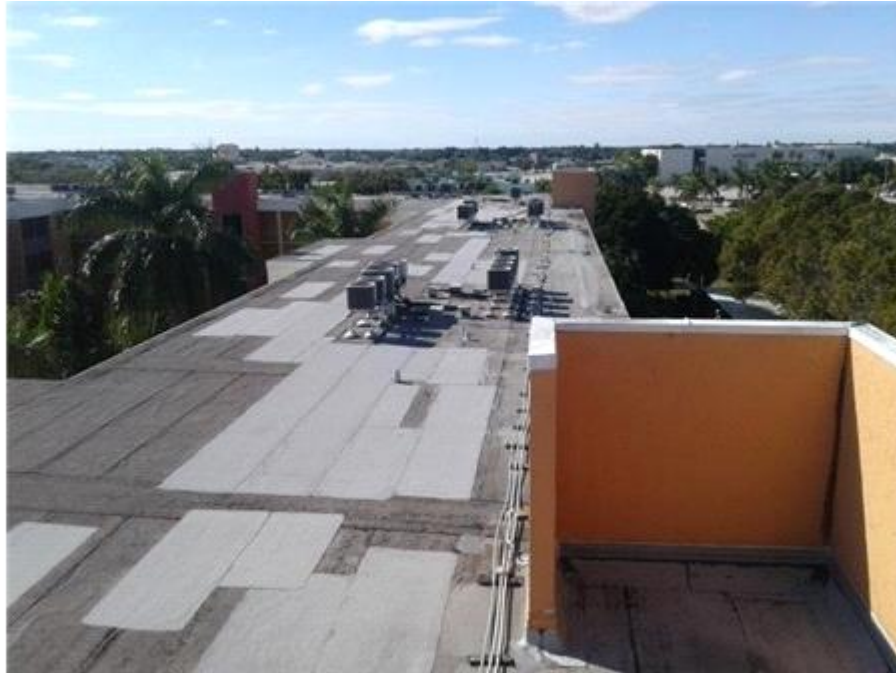
029- The Towers - BUR - Roof overview

General roof overview.

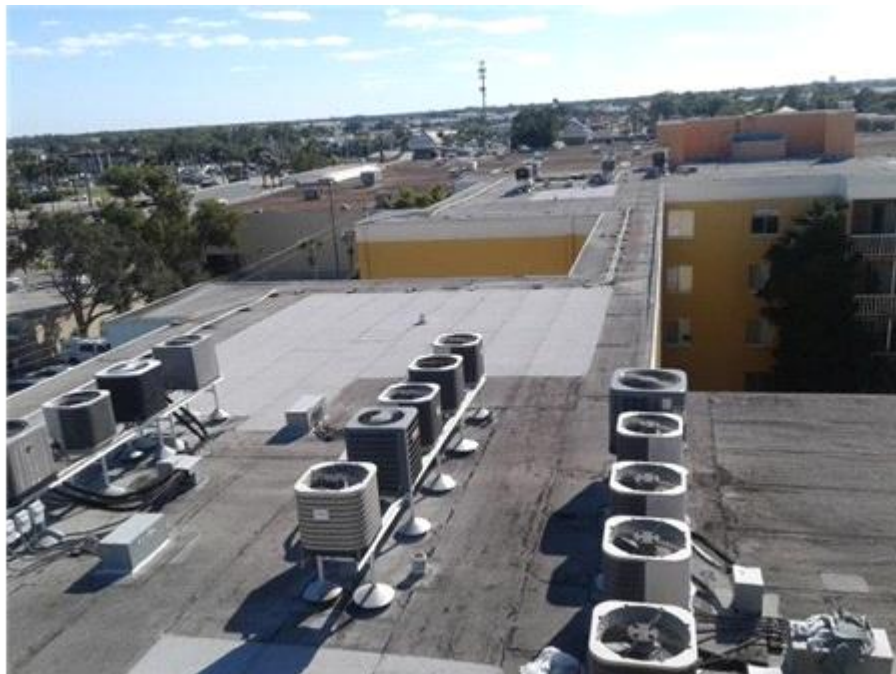
029- The Towers - BUR - Roof Overview

General roof overview.

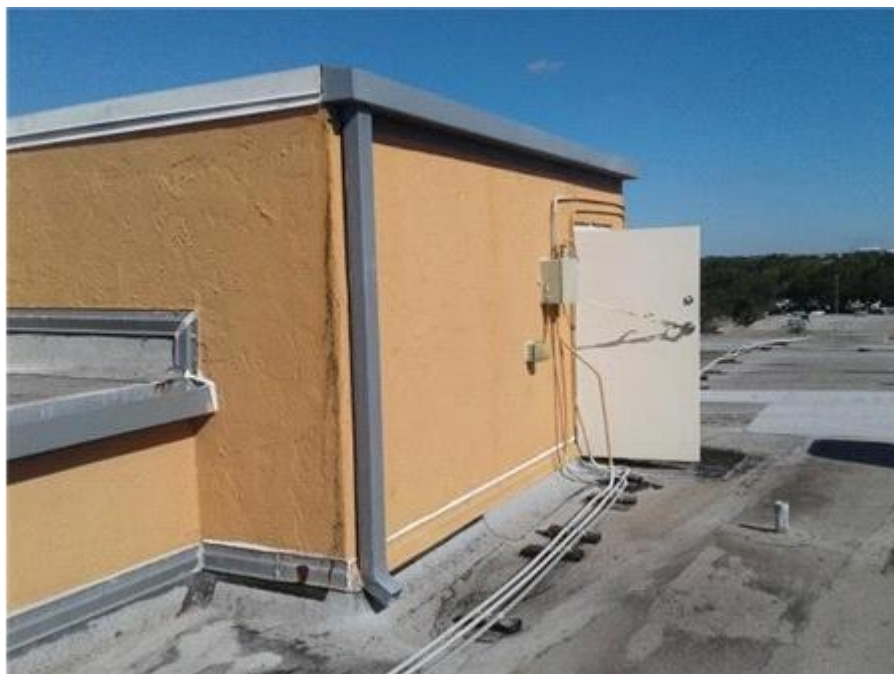
009G- The Towers - BUR - Downspouts

The downspouts appear to be in good condition.

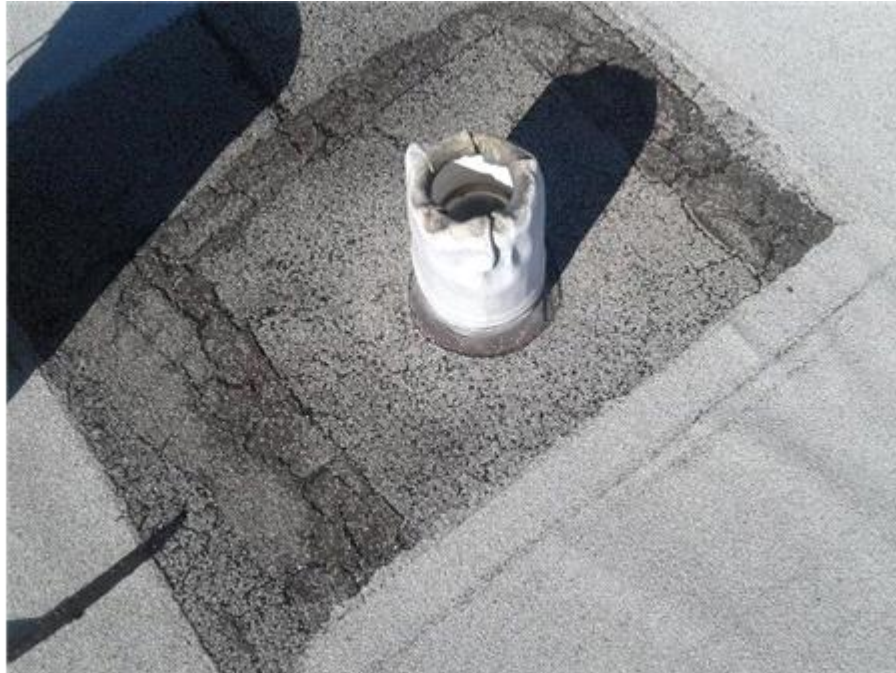
028- The Towers - BUR - Sealant Deterioration/Failure

Sealant should be removed and replaced to prevent water entry.

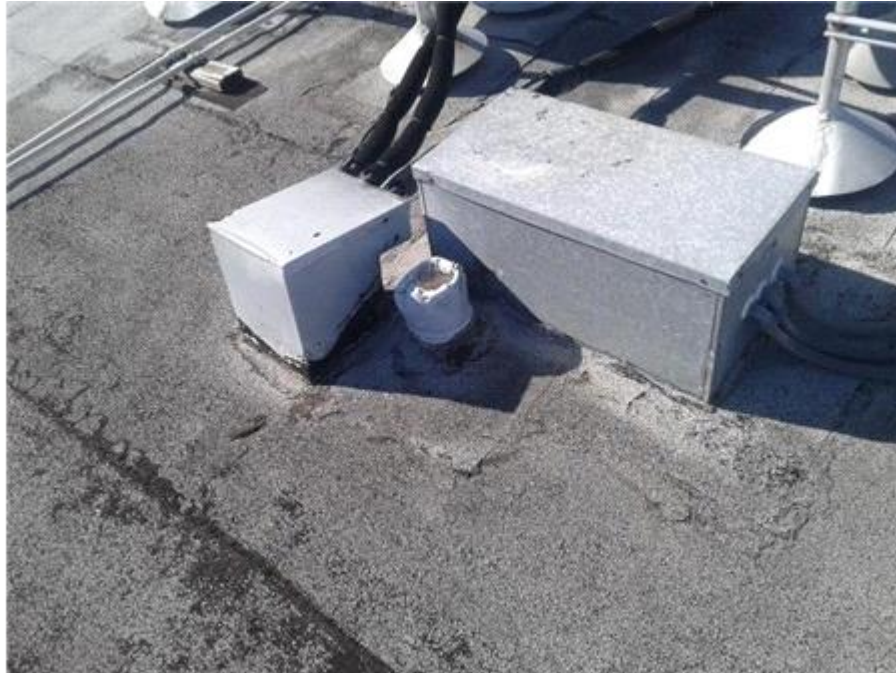
028- The Towers - BUR - Sealant Deterioration/Failure

Sealant should be removed and replaced to prevent water entry.

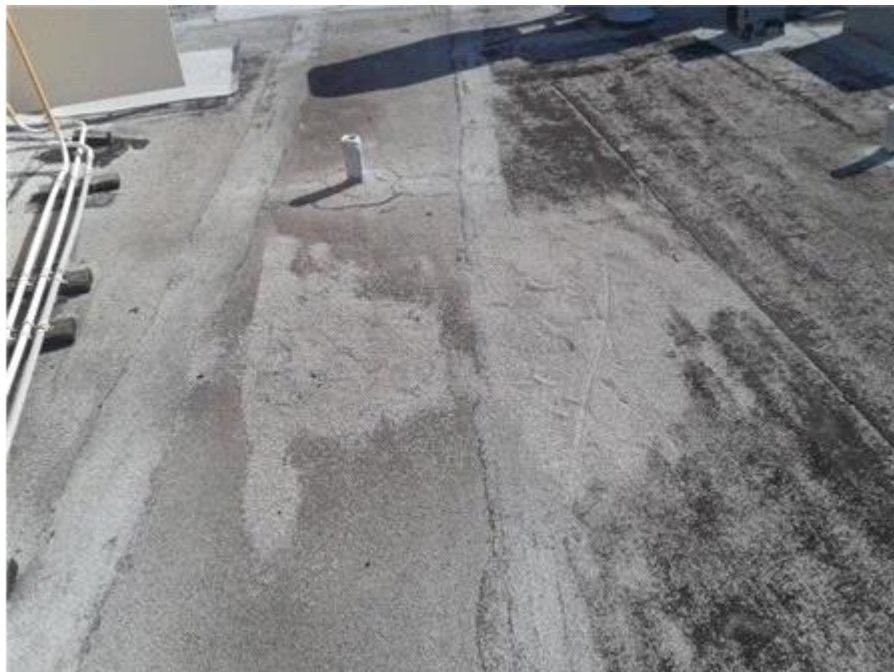
F-247- The Towers - BUR - Loose Granules

Identified loose granules on the roof surface.

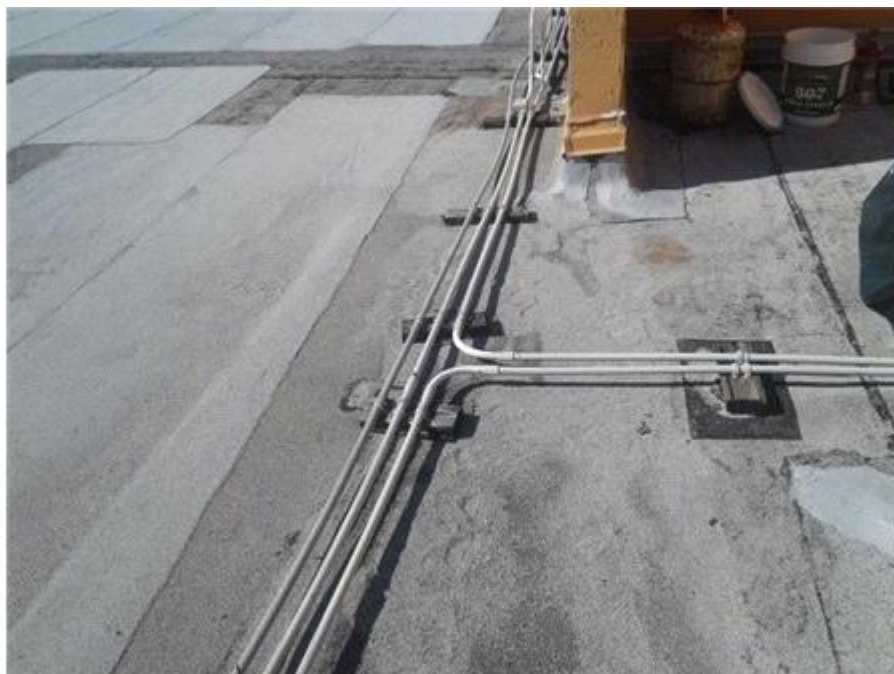
F-247- The Towers - BUR - Loose Granules

Identified loose granules on the roof surface.

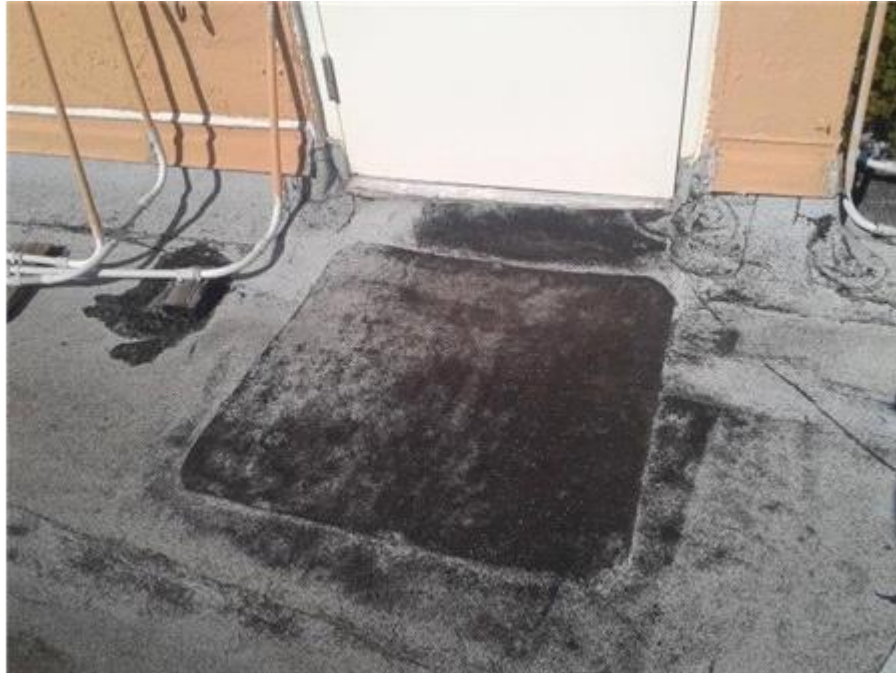
F-236 The Towers - BUR - Field Walkway

Walkway is needed to prevent roof system damage from foot traffic.

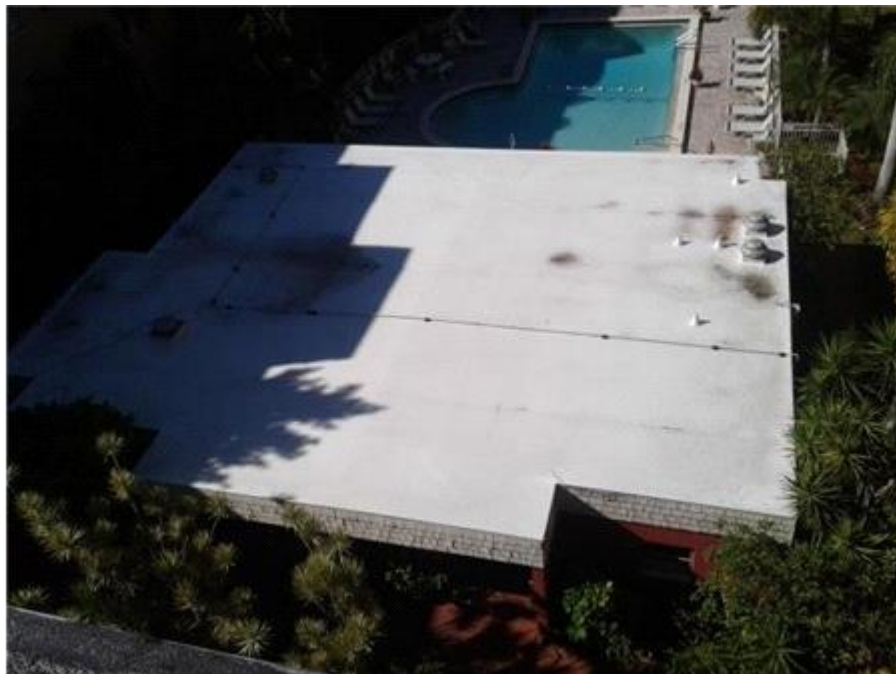
029- TPO Roof - Roof Overview

General roof overview.

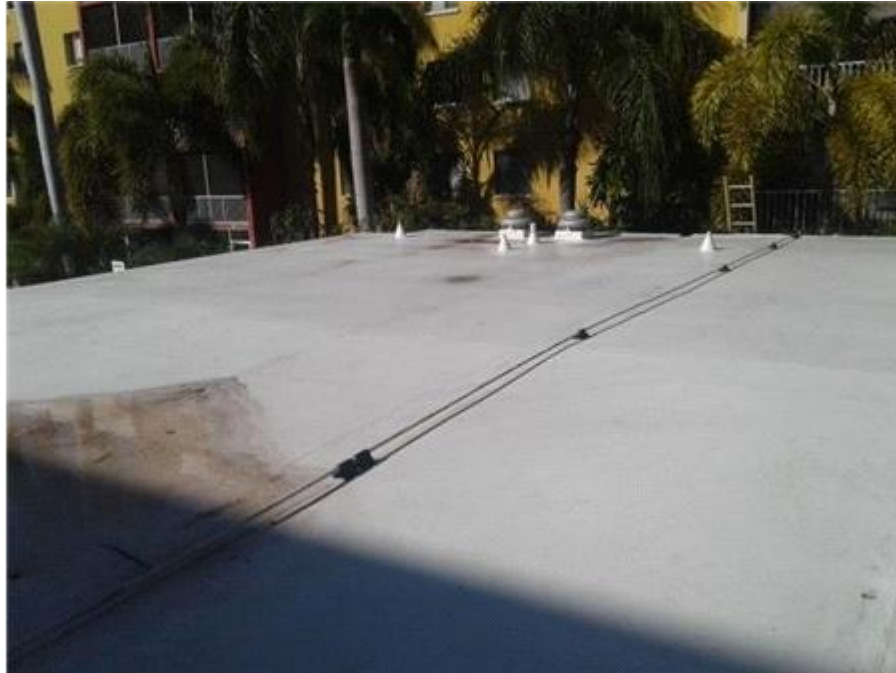
029- TPO Roof - Roof Overview

General roof overview.

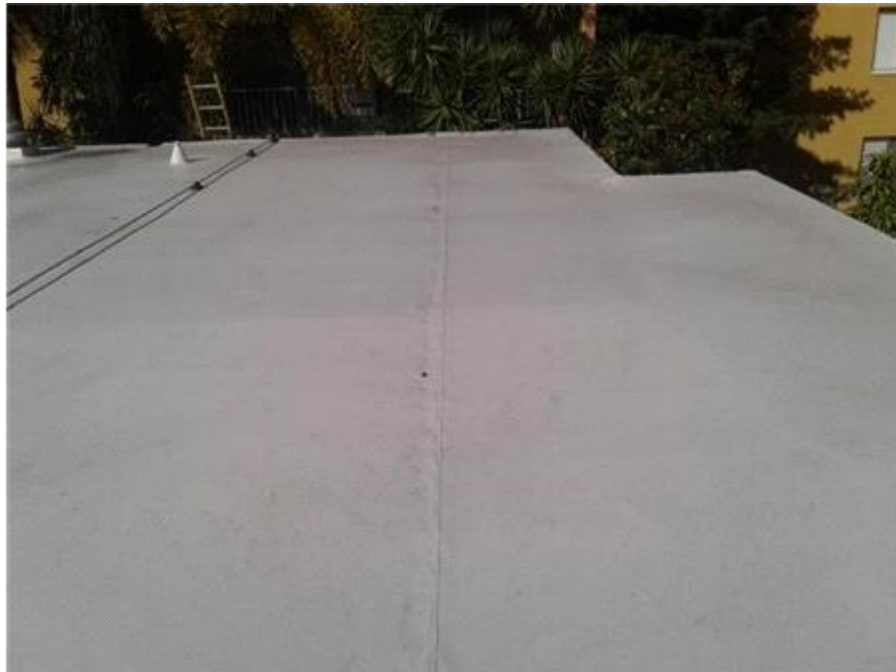
003G - TPO Roof - Membrane Overview

The membrane appears to be in good, maintainable condition at this time.

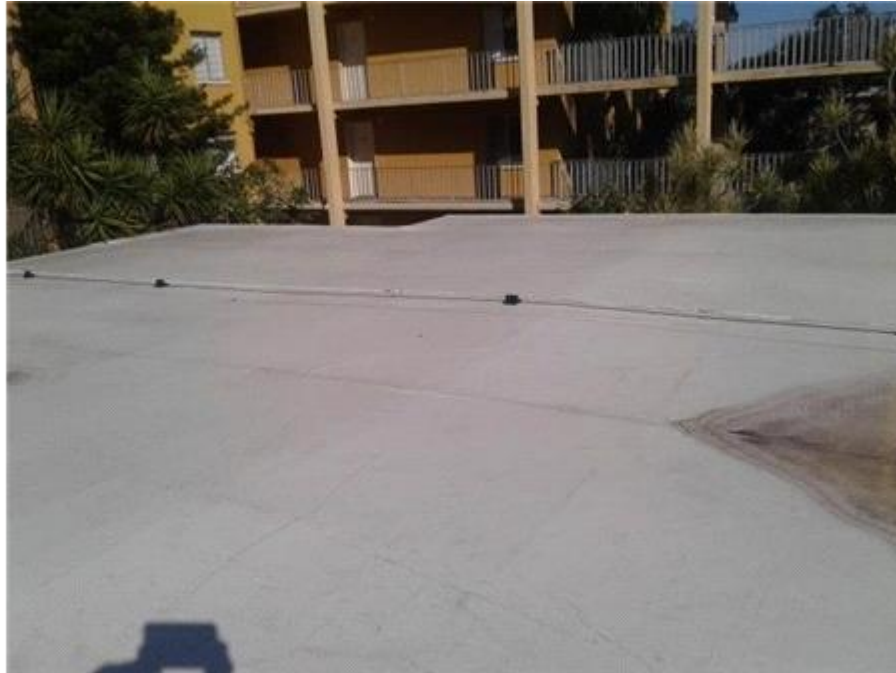
001G- TPO Roof - Surface Overview

The roof surface appears to be in good, maintainable condition at this time.

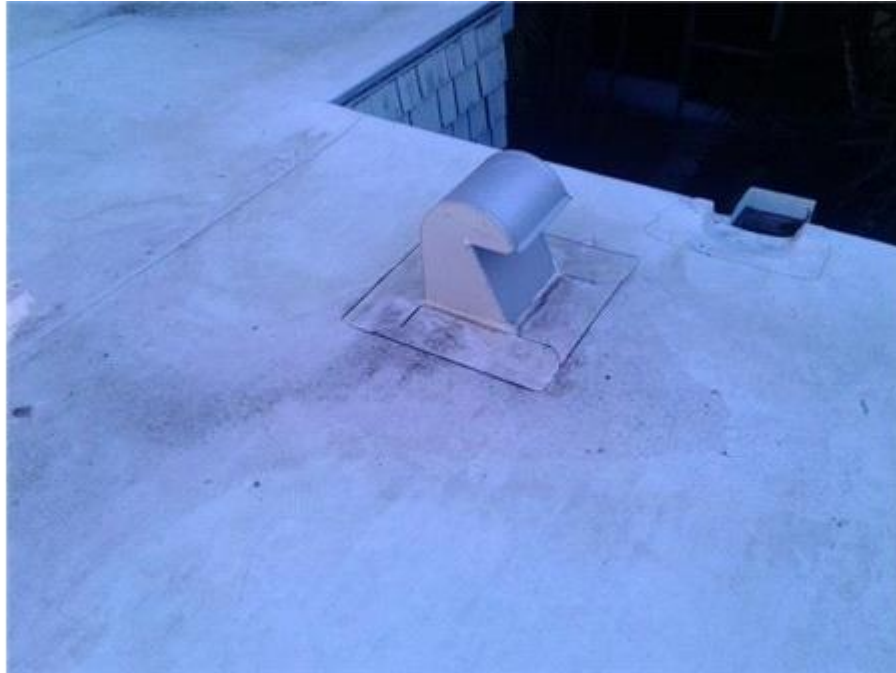
002G- TPO Roof - Roof Vents

Roof vents appear to be in good condition at this time.

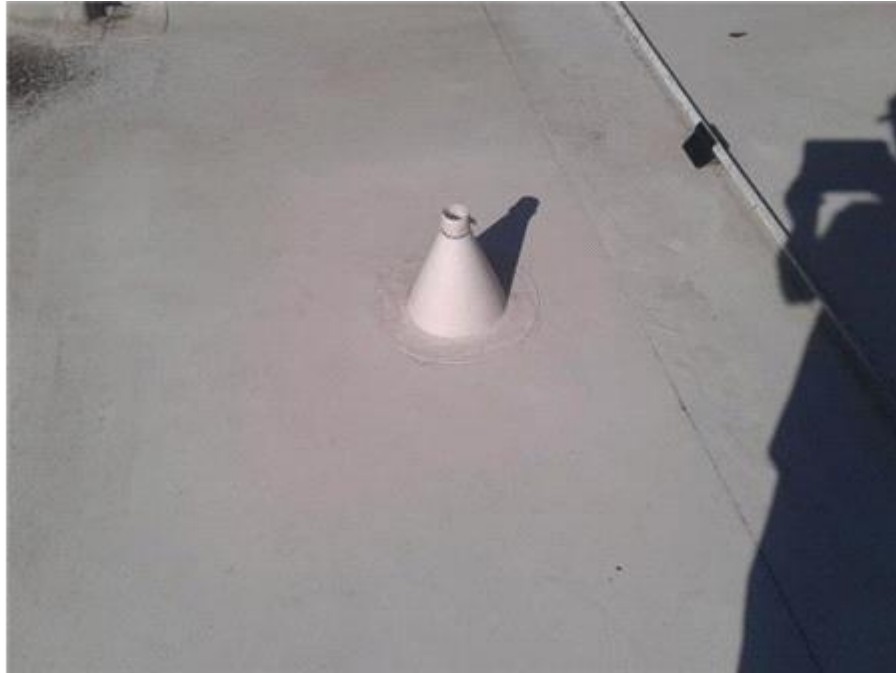
TPO Roof - Soil Stacks

Soil stack boots appear to be in good condition at this time.

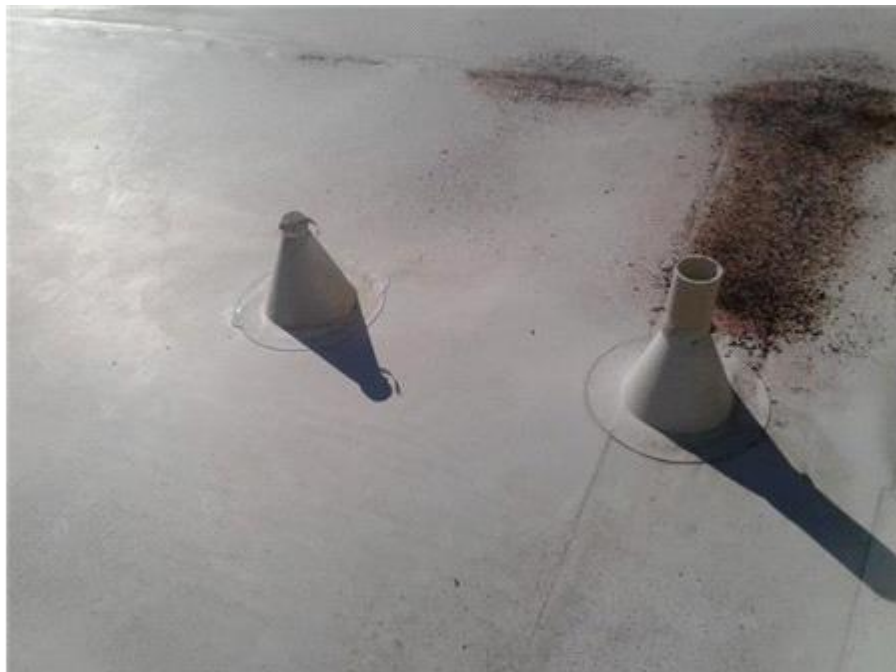
TPO Roof - Soil Stacks

Soil stack boots appear to be in good condition at this time.

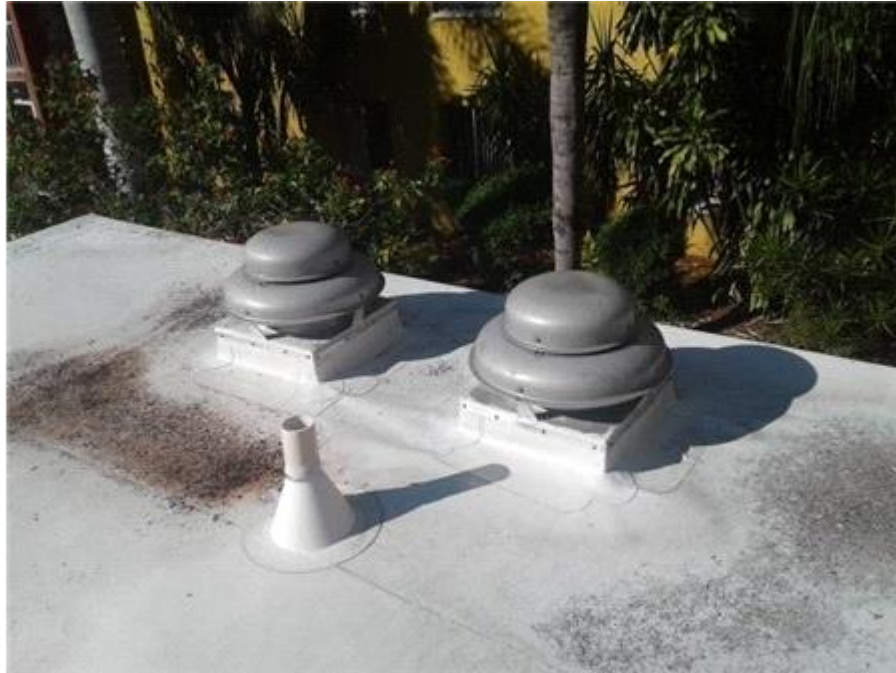
002G- TPO Roof - Roof Vents

Roof vents appear to be in good condition at this time.

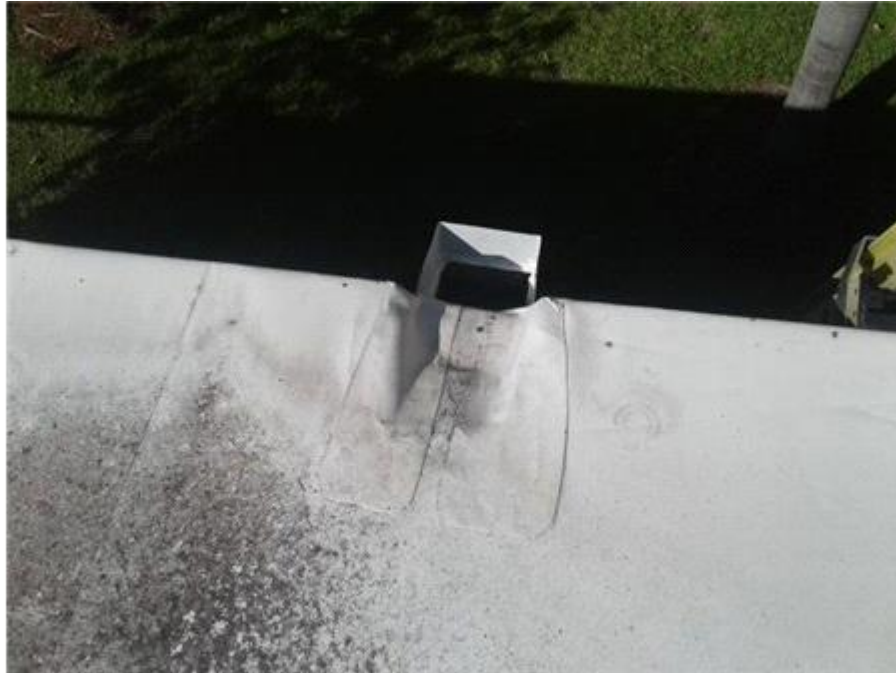
TPO Roof - Scuppers

Scuppers appear to be in good condition at this time.

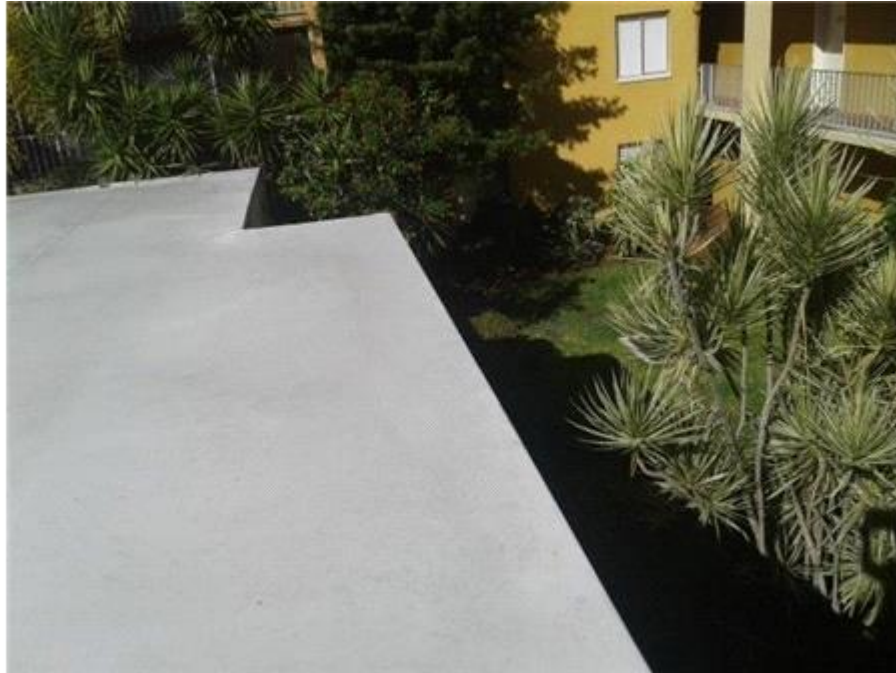
016G- TPO Roof - Roof Edge

Roof edge appears to be in good condition.
