# Inspection Report

**Facility:** Towers, The  
**Address:** 2366 East Mall Dr,  
Fort Myers, 33901

Work Order #: 5715

Re.: **Inspection Report (5 of 6) for The Towers**

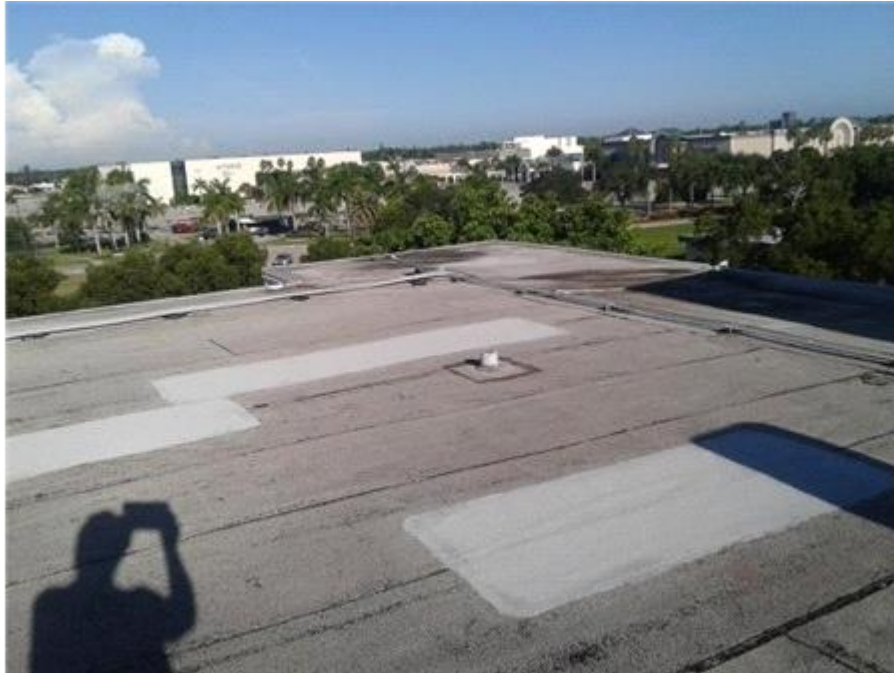
Appearance Overview

The appearance of the roof is in fair condition at this time.

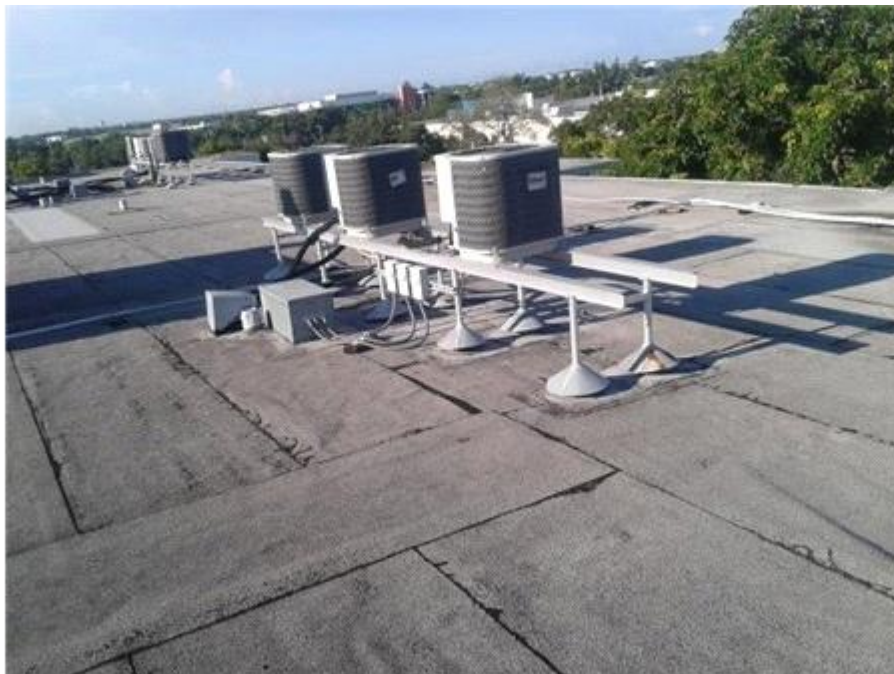
Appearance Overview

The appearance of the roof is in fair condition at this time.

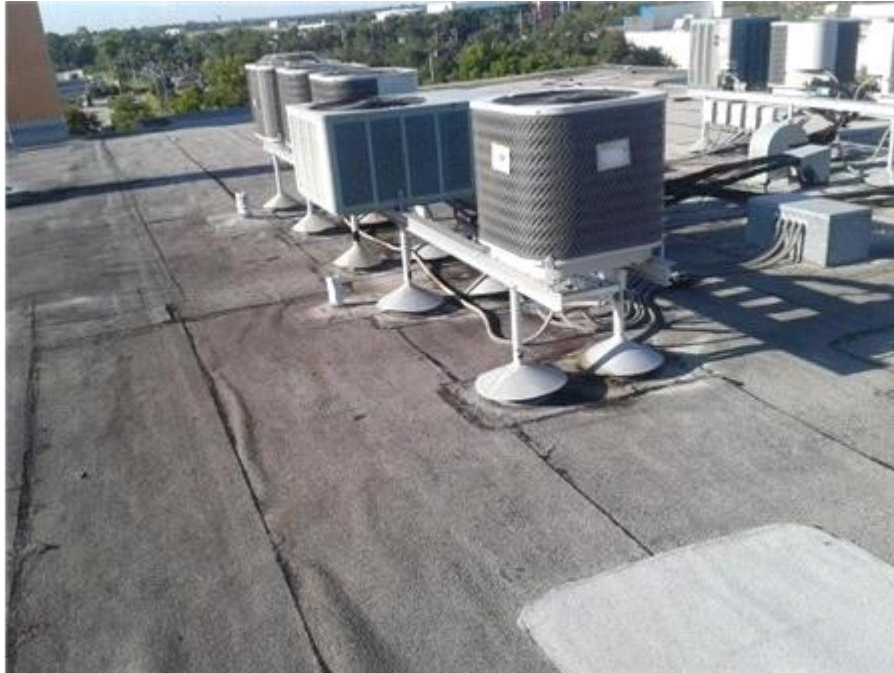
Appearance Overview

The appearance of the roof is in fair condition at this time.

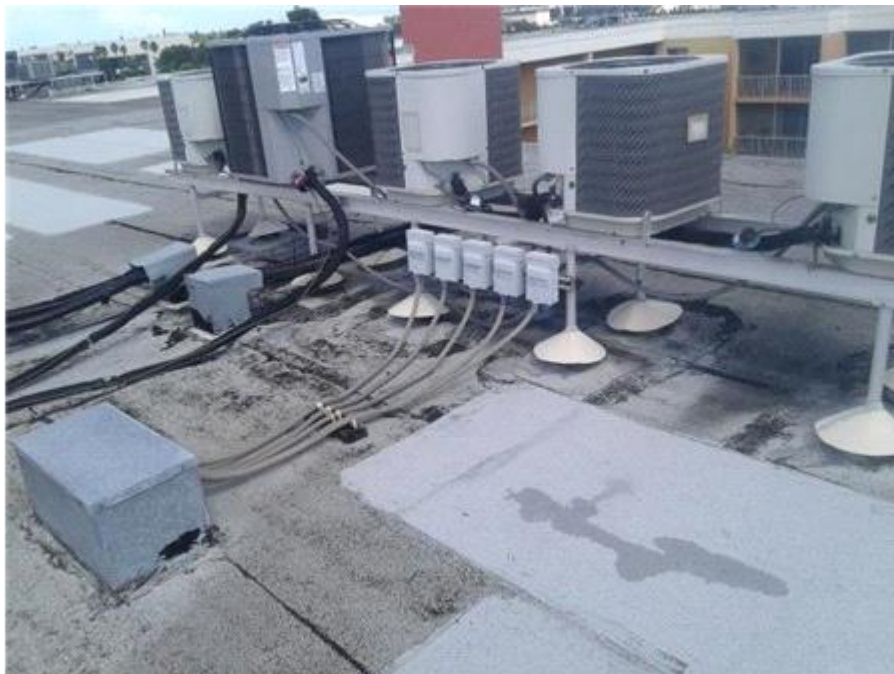
Appearance Overview

The appearance of the roof is in fair condition at this time.

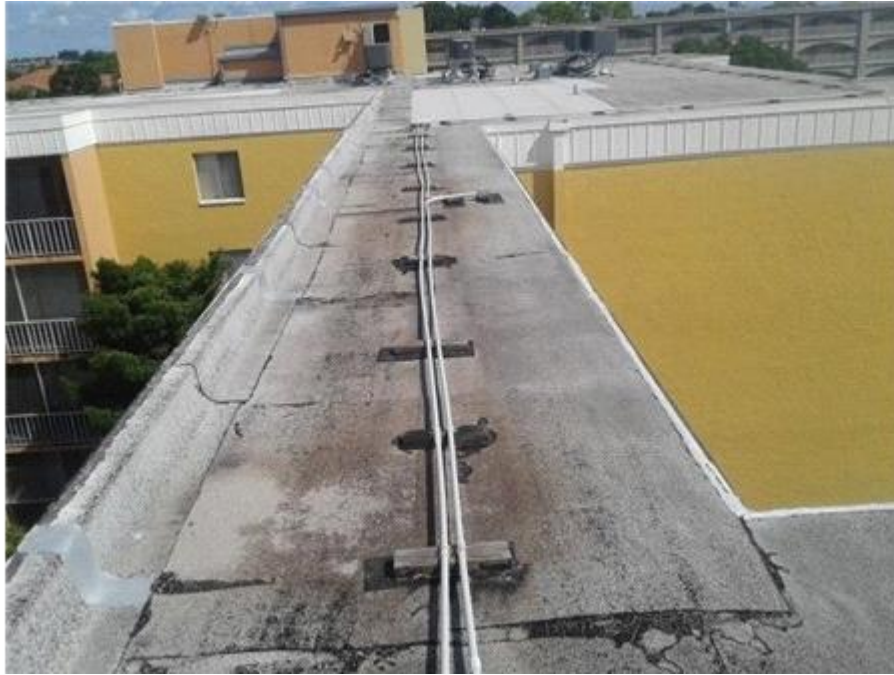
Appearance Overview

The appearance of the roof is in fair condition at this time.

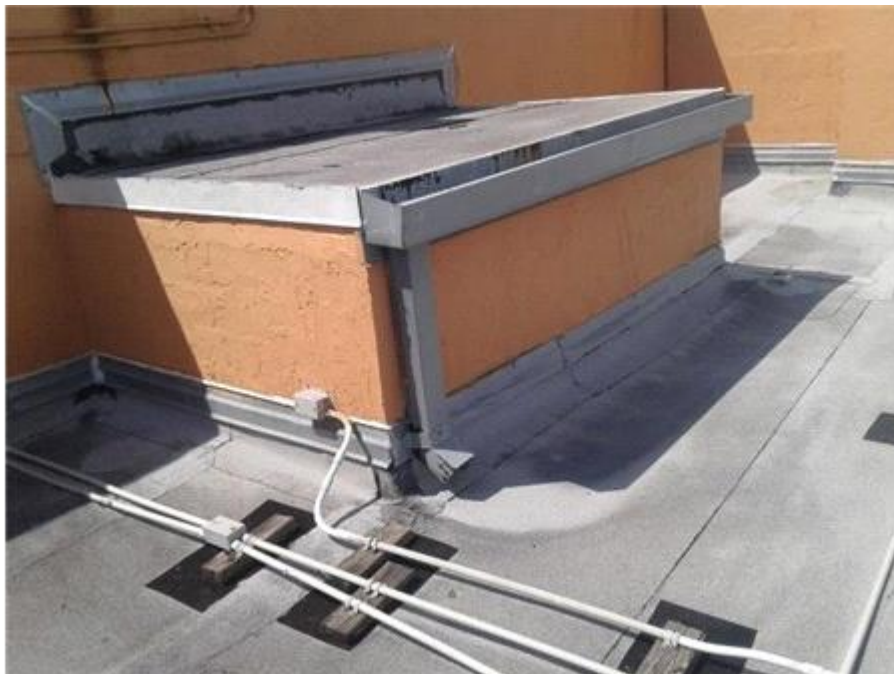
Appearance Overview

The appearance of the roof is in fair condition at this time.

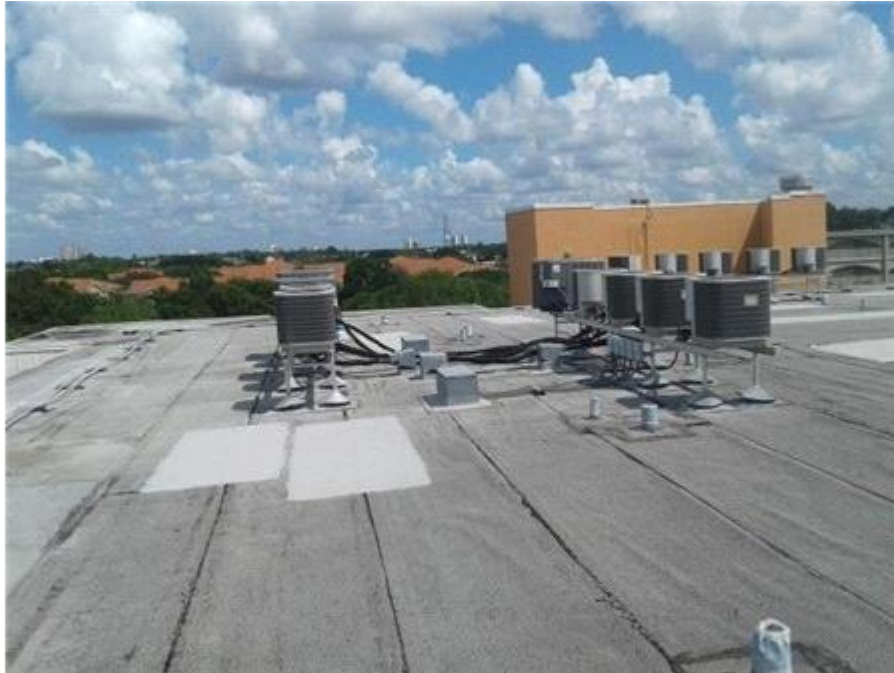
Appearance Overview

The appearance of the roof is in fair condition at this time.

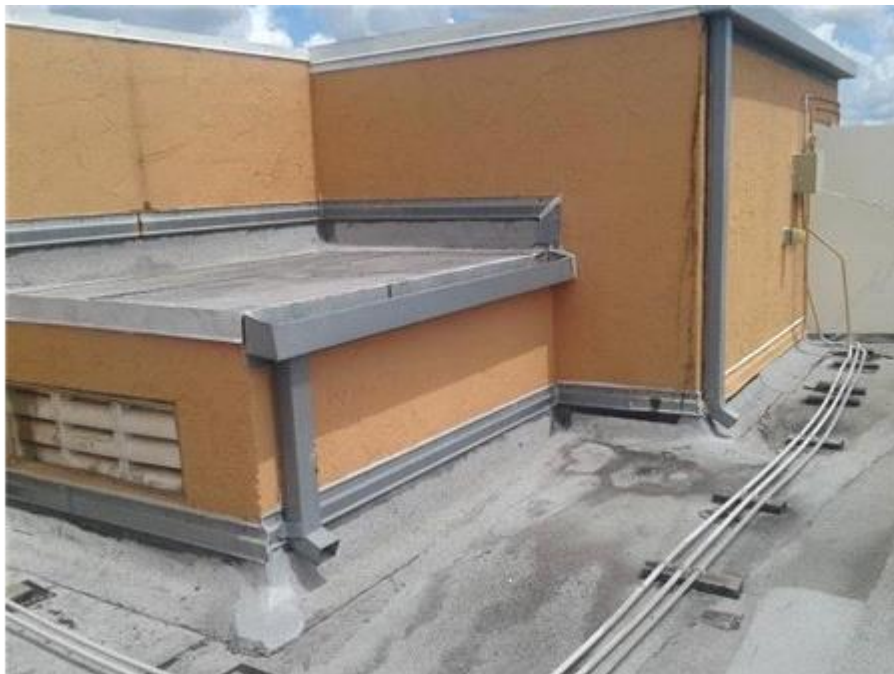
Appearance Overview

The appearance of the roof is in fair condition at this time.

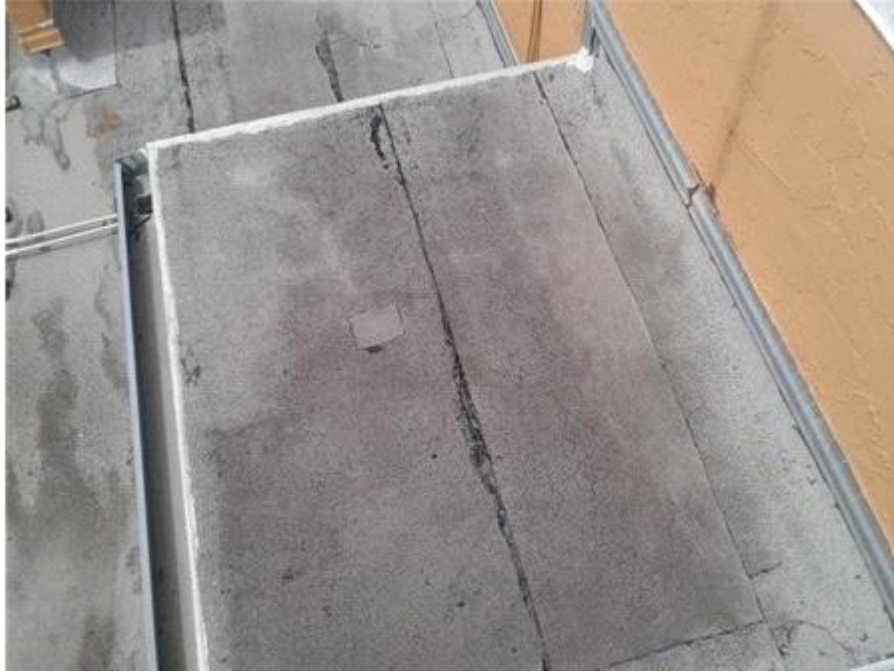
Appearance Overview

The appearance of the roof is in fair condition at this time.

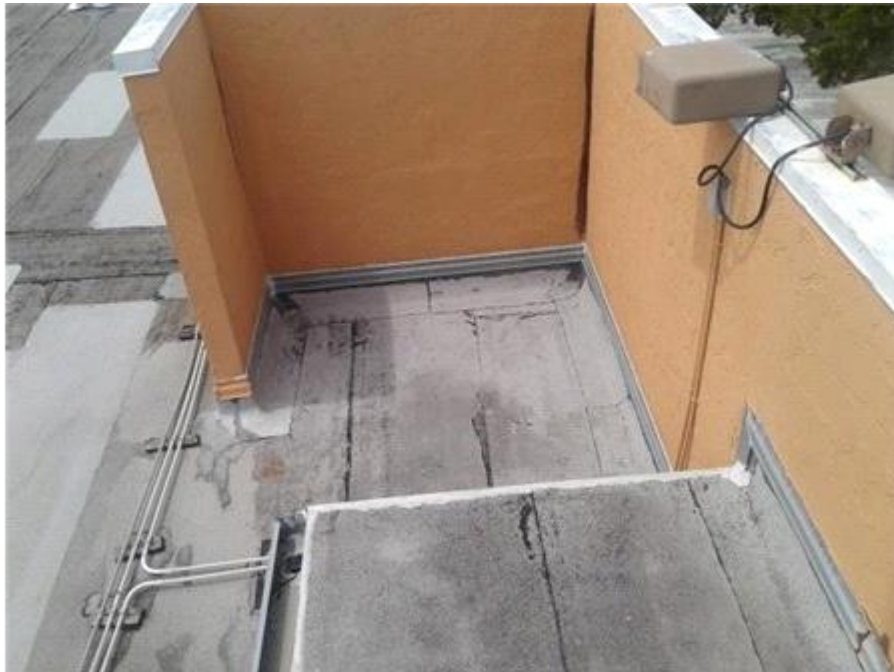
Appearance Overview

The appearance of the roof is in fair condition at this time.

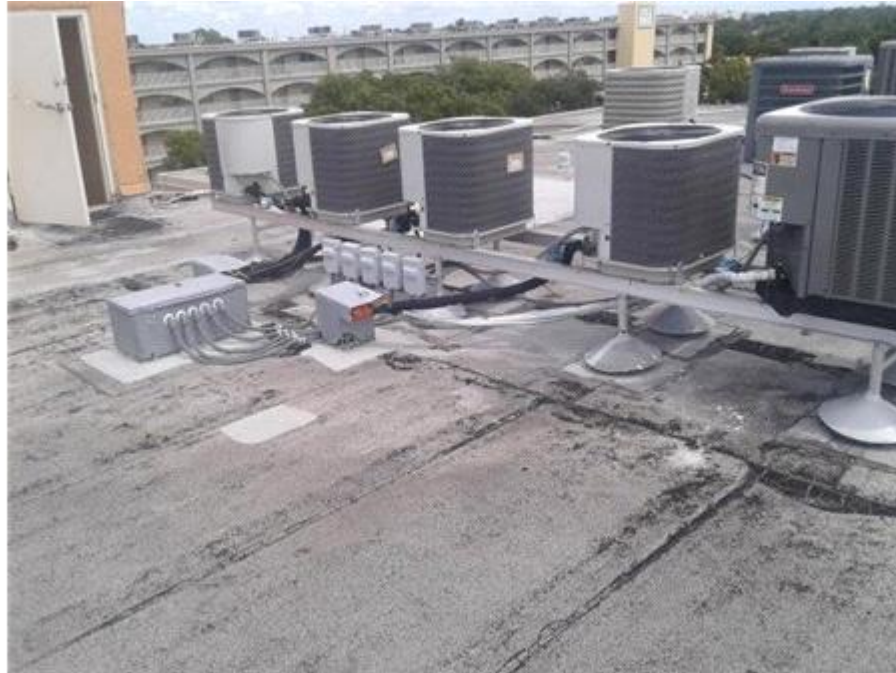
Appearance Overview

The appearance of the roof is in fair condition at this time.

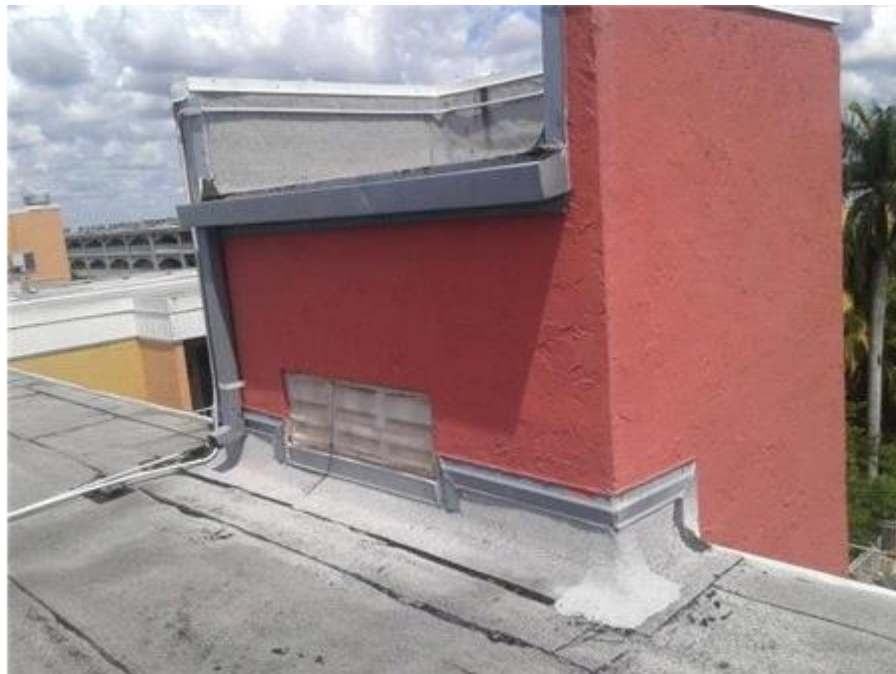
Appearance Overview

The appearance of the roof is in fair condition at this time.

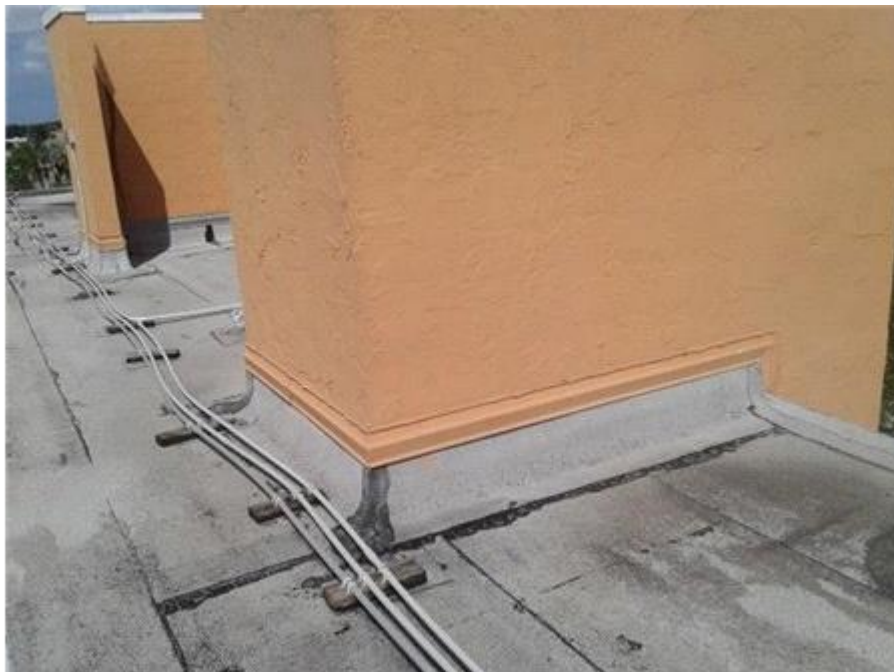
Counter Flashings

The counter flashing appears to be in good condition.

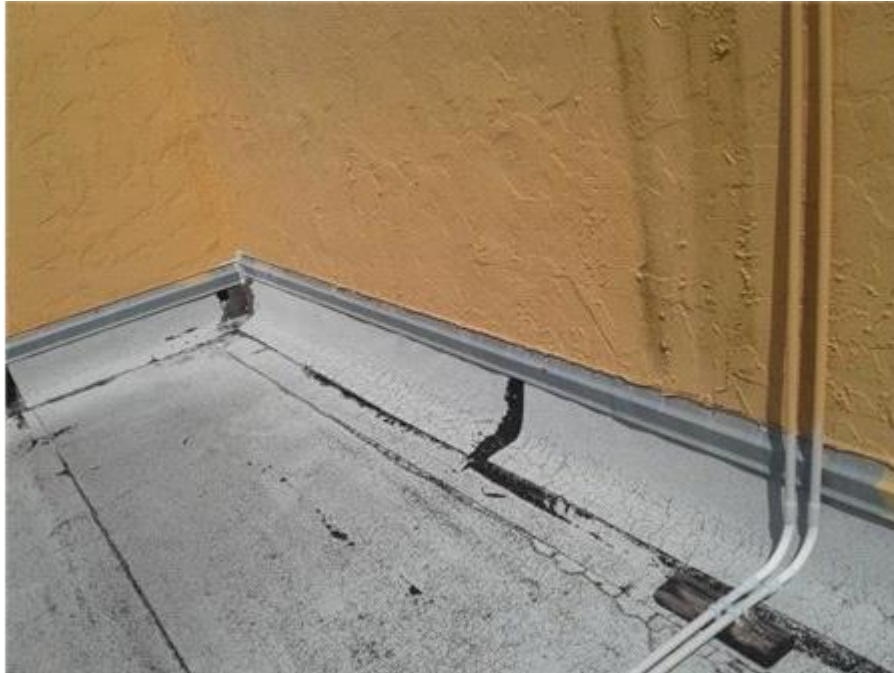
Counter Flashings

The counter flashing appears to be in good condition.

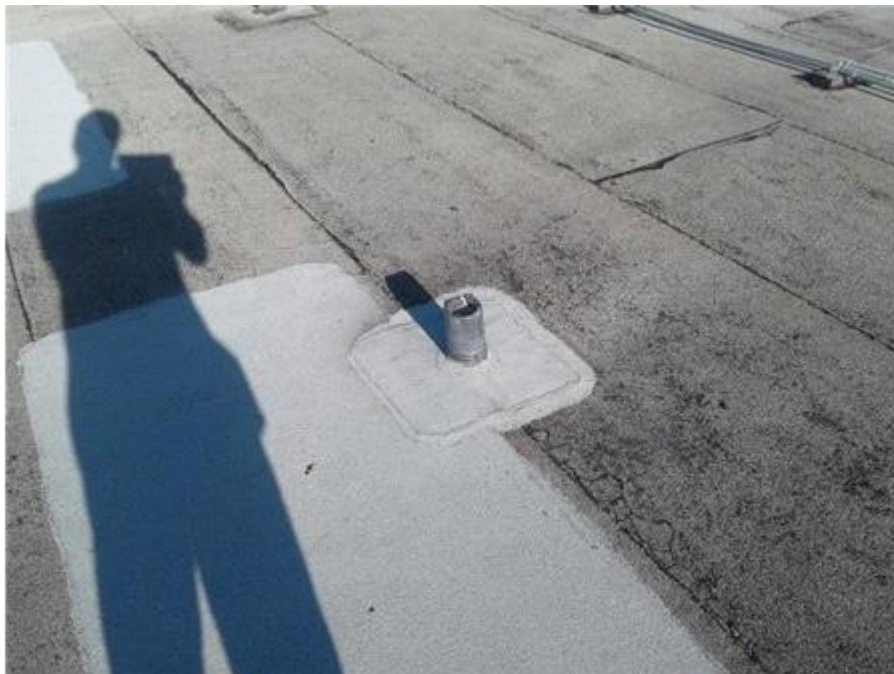
Lead Boots

Lead boots appear to be in good condition.

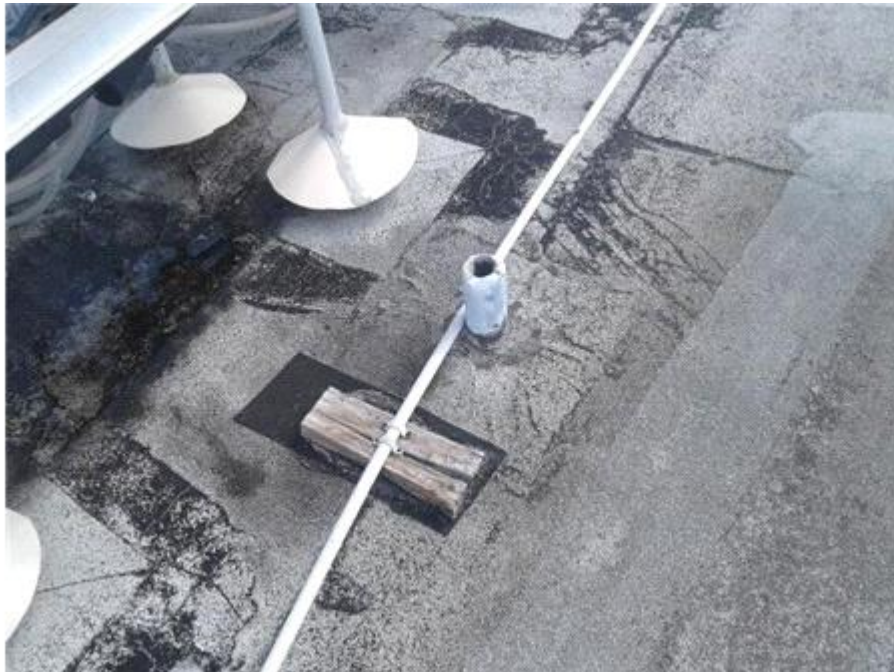
Lead Boots

Lead boots appear to be in fair condition.

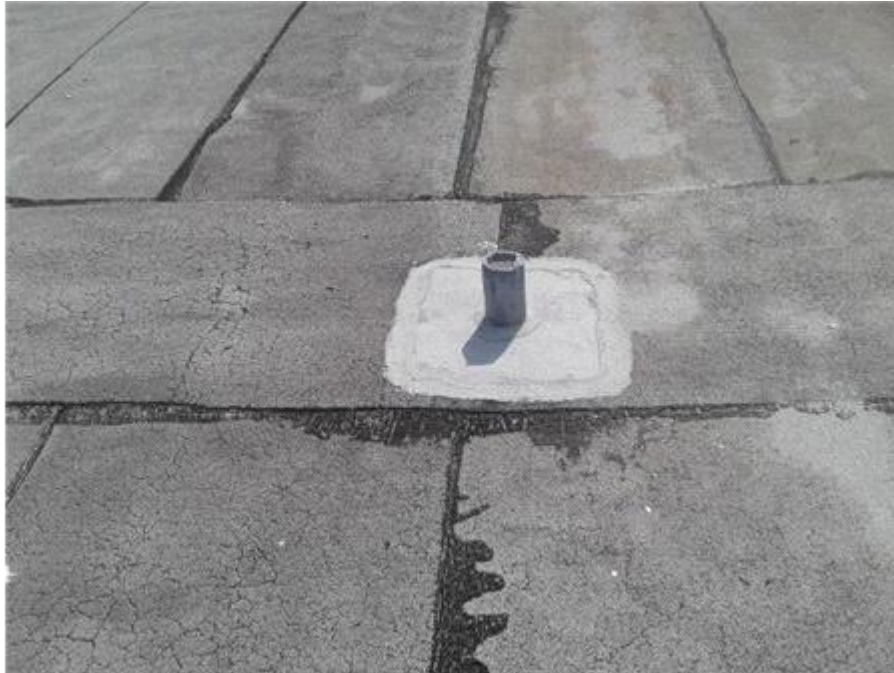
**Lead Boots**

Lead boots appear to be in fair condition.

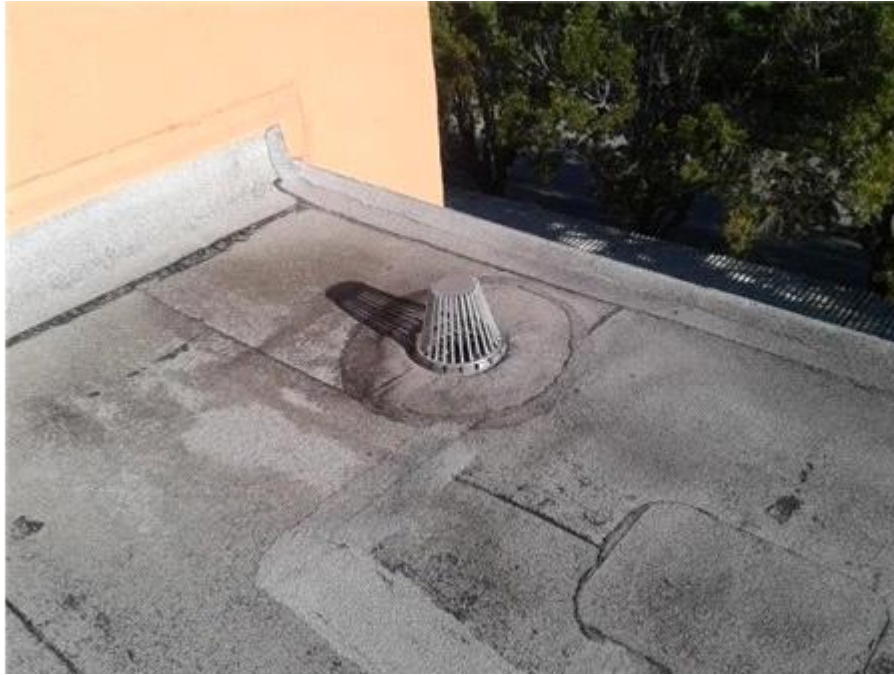
Roof Drains

Roof drains appear to be in good condition.

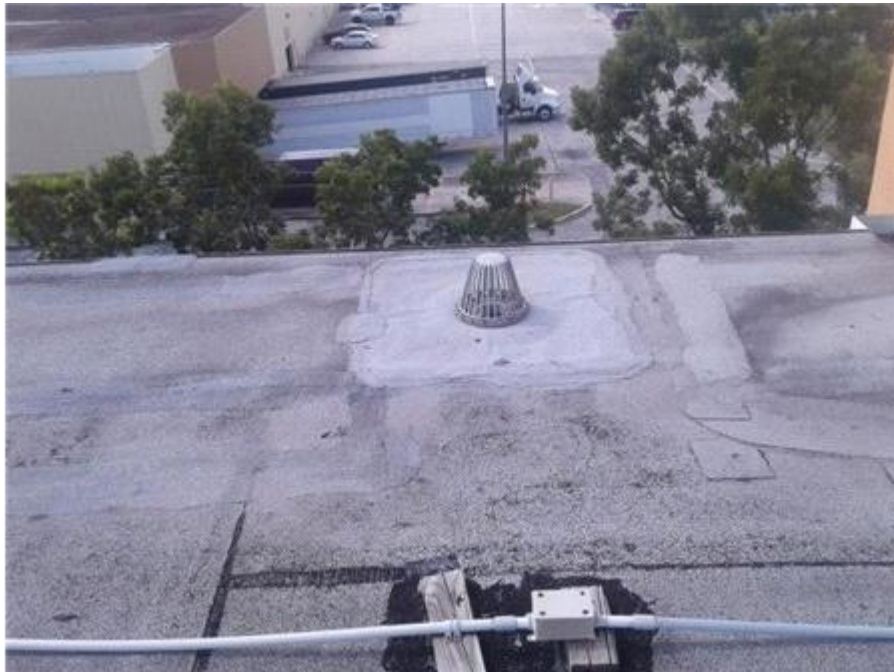
Roof Drains

Roof drains appear to be in good condition.

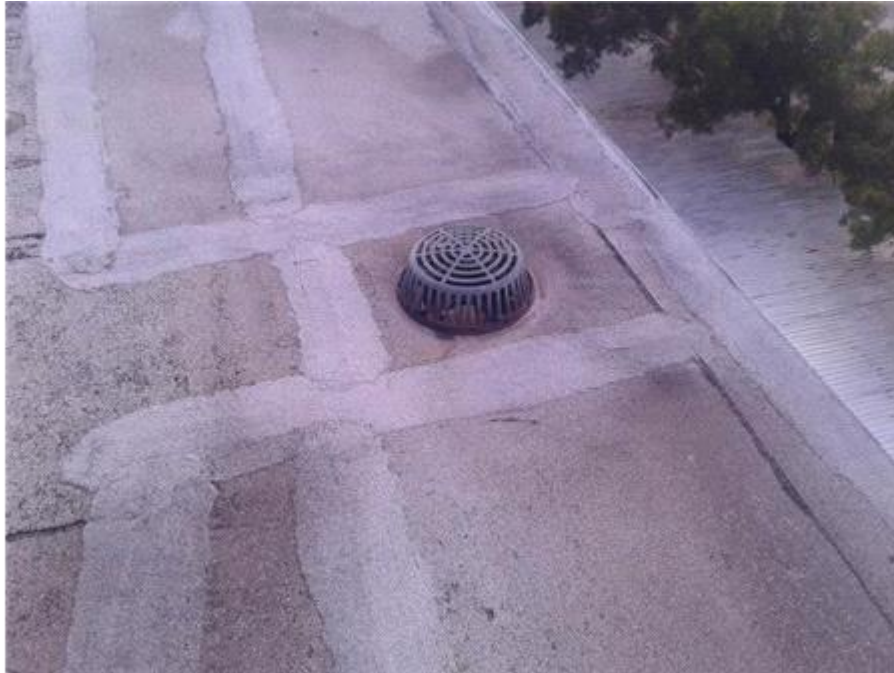
**Roof Drains**

Roof drains appear to be in fair condition.

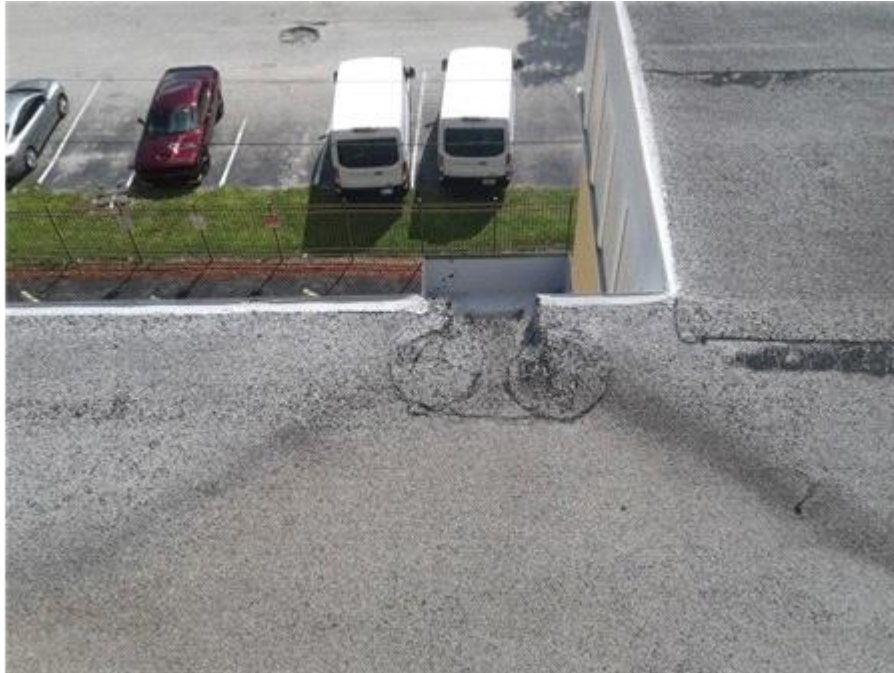
**Scuppers**

Scuppers appear to be in fair condition at this time.

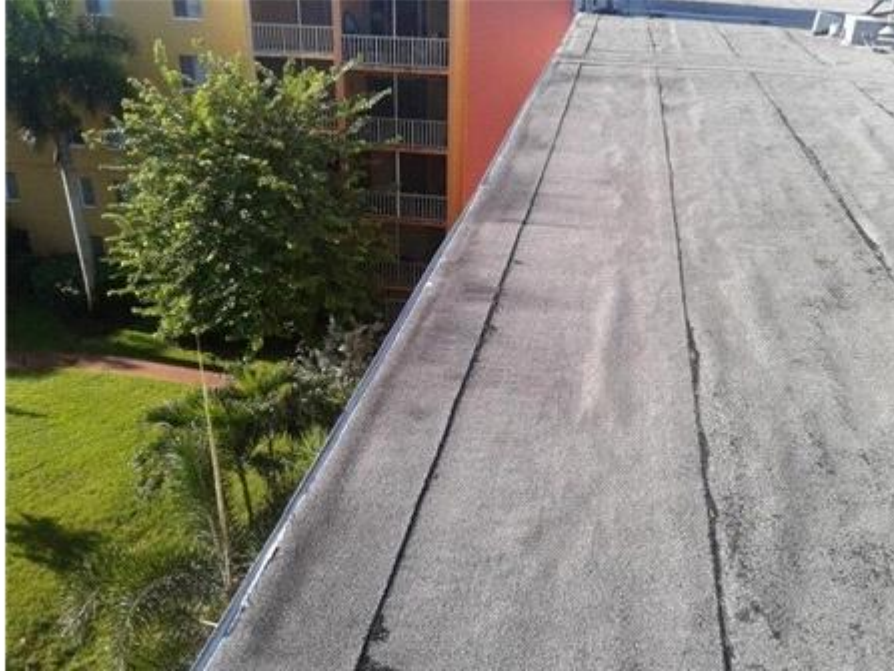
Roof Edge

Roof edge appears to be in fair condition.

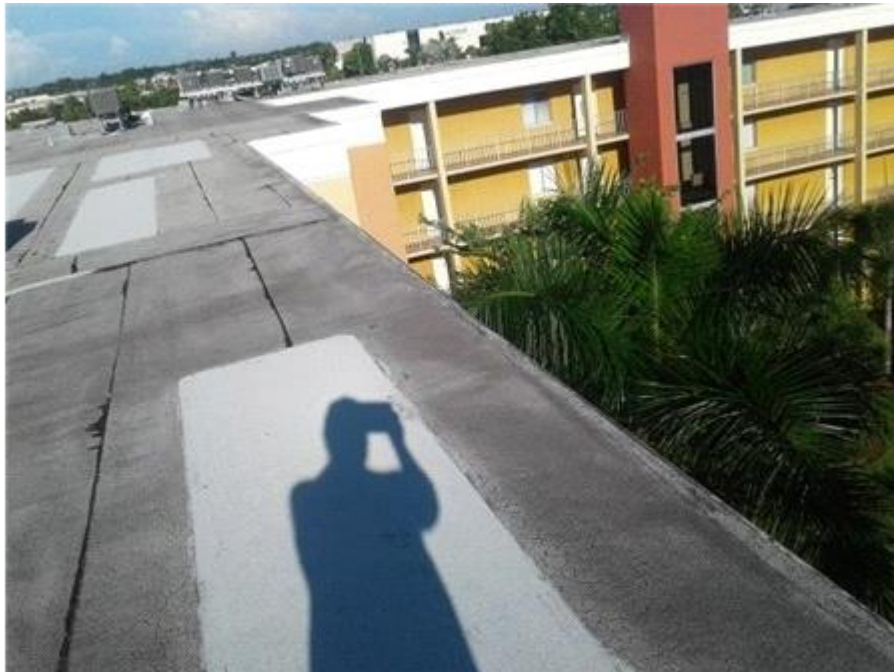
Roof Edge

Roof edge appears to be in fair condition.

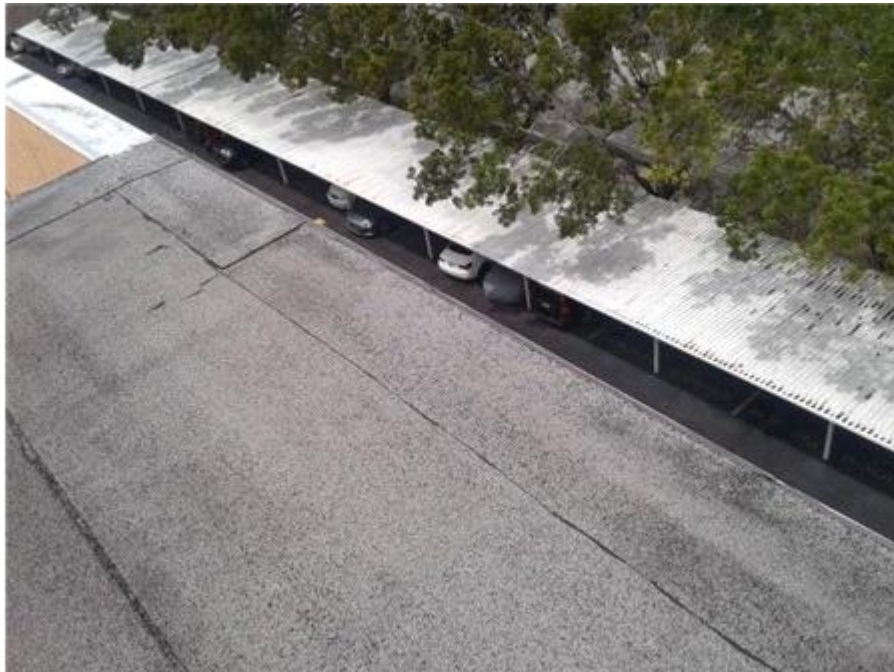
Roof Edge

Roof edge appears to be in fair condition.

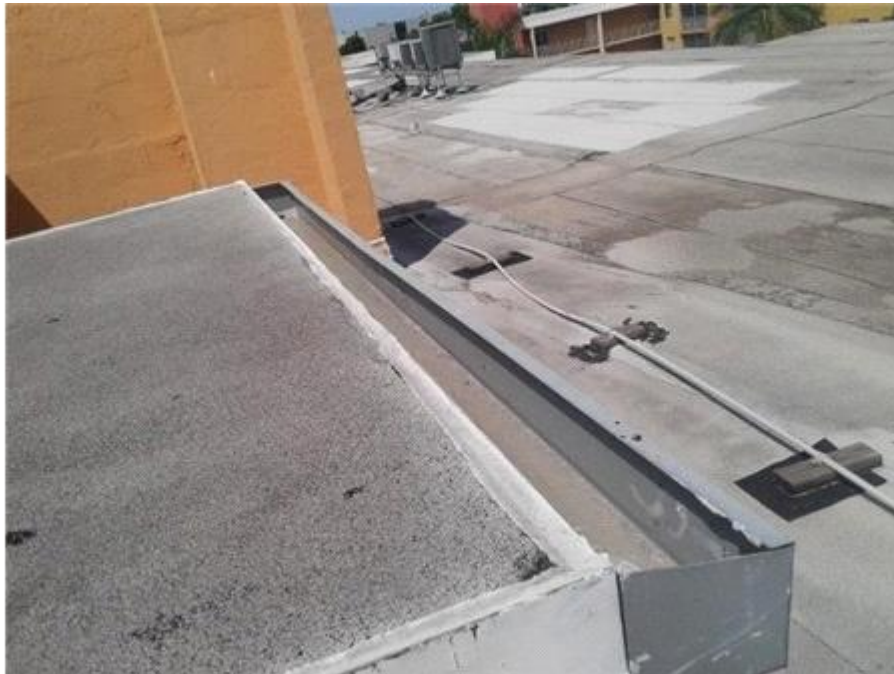
Gutters

The gutters appear to be in good condition.

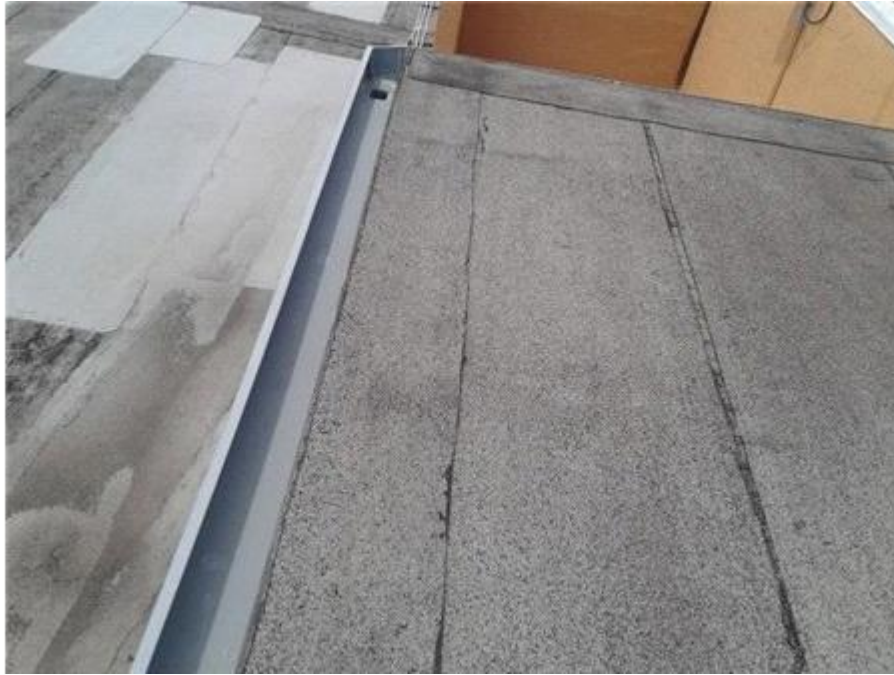
Gutters

The gutters appear to be in good condition.

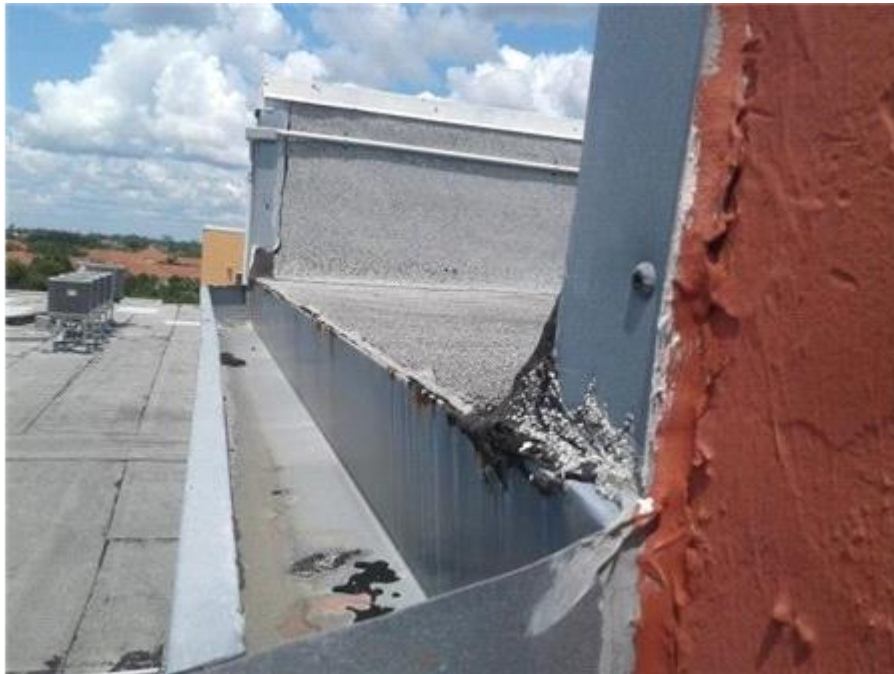
Gutters

The gutters appear to be in good condition.

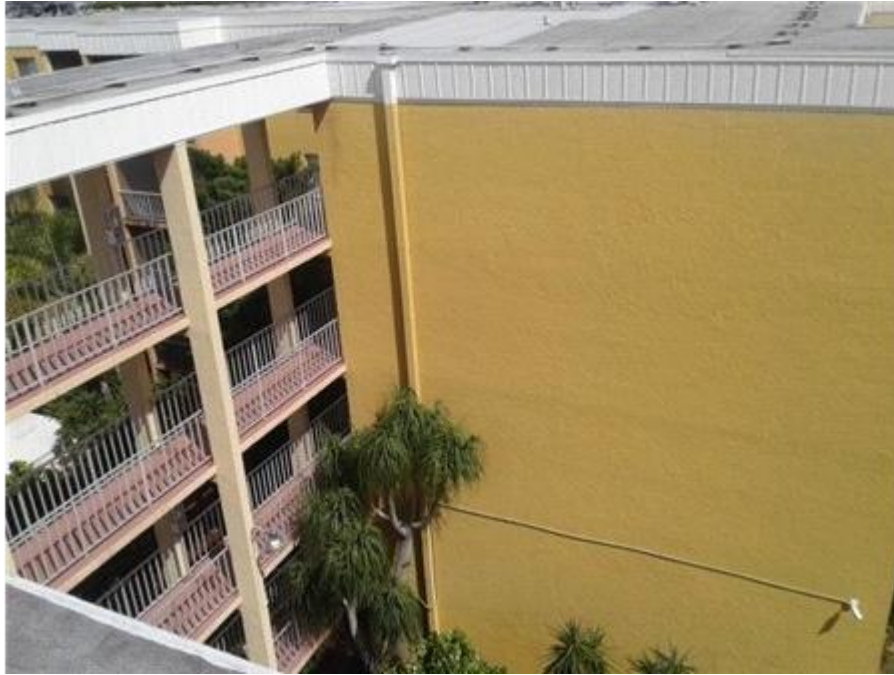
Downspouts

The downspouts appear to be in good condition.

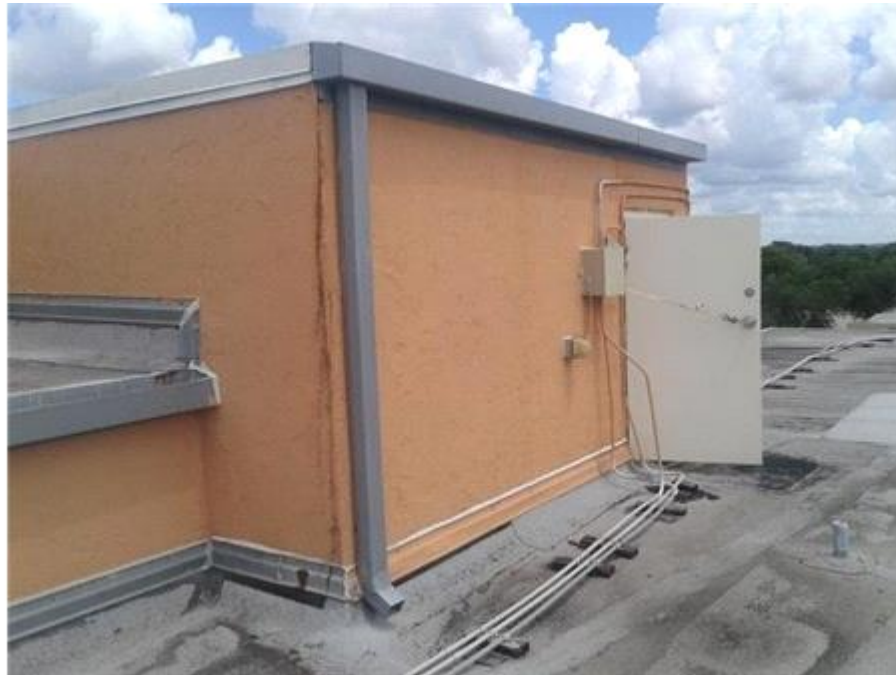
Downspouts

The downspouts appear to be in good condition.

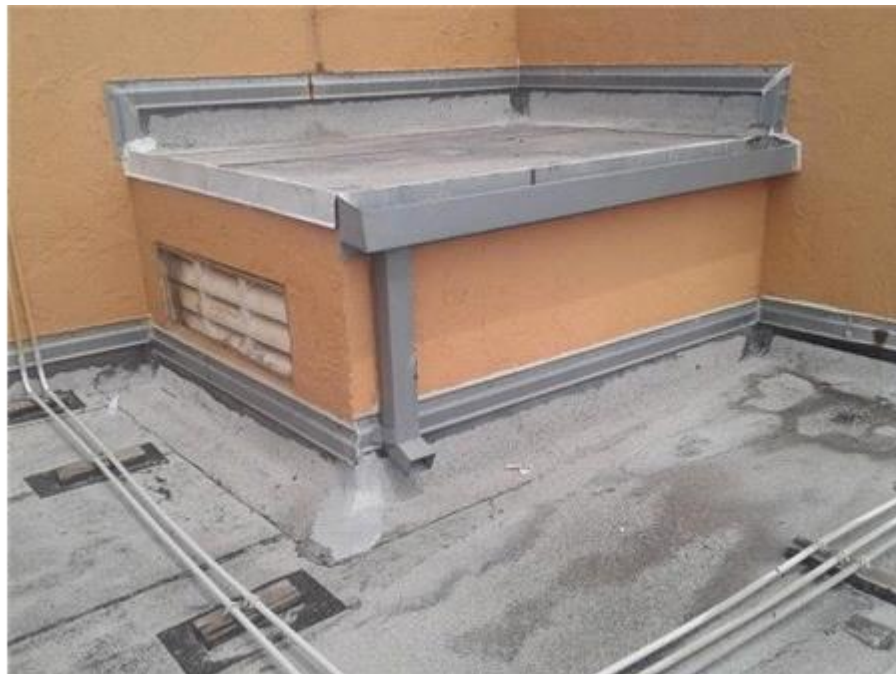
Downspouts

The downspouts appear to be in good condition.

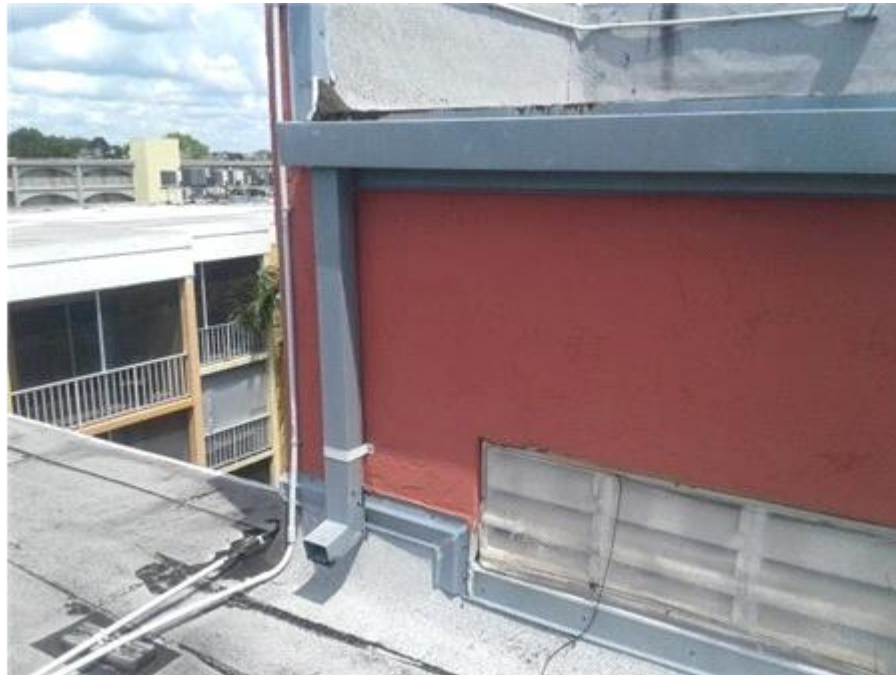
Downspouts

The downspouts appear to be in good condition.

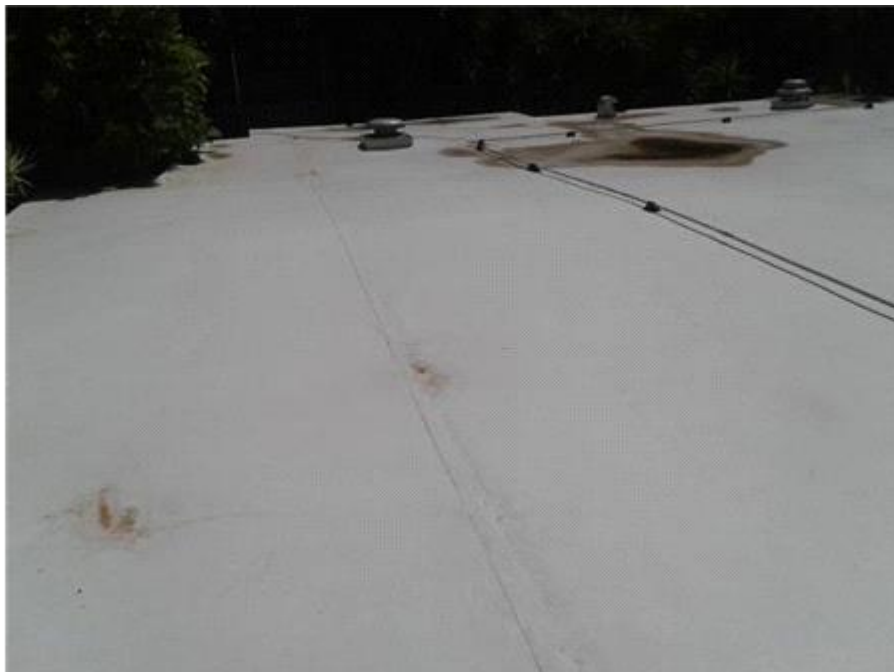
**Membrane Overview**

The membrane appears to be in good, maintainable condition at this time.

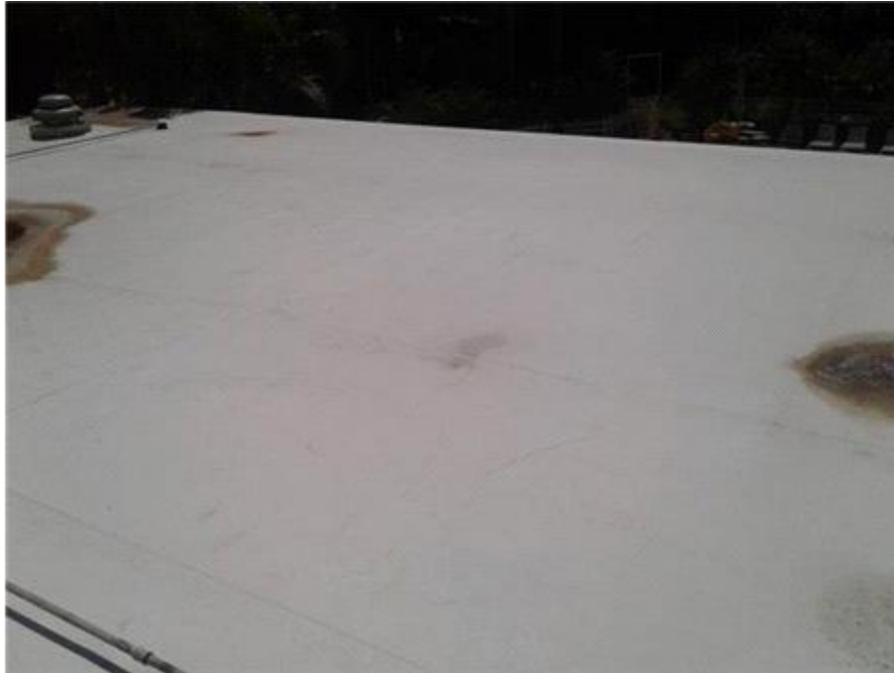
Surface Overview

The roof surface appears to be in good, maintainable condition at this time.

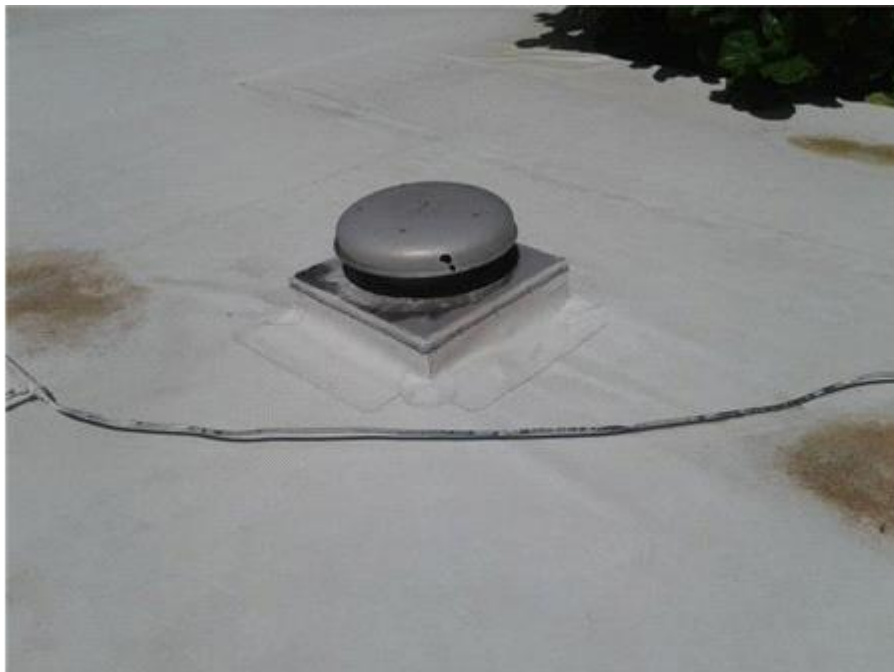
Base Flashings

The base flashings appear to be in good condition.

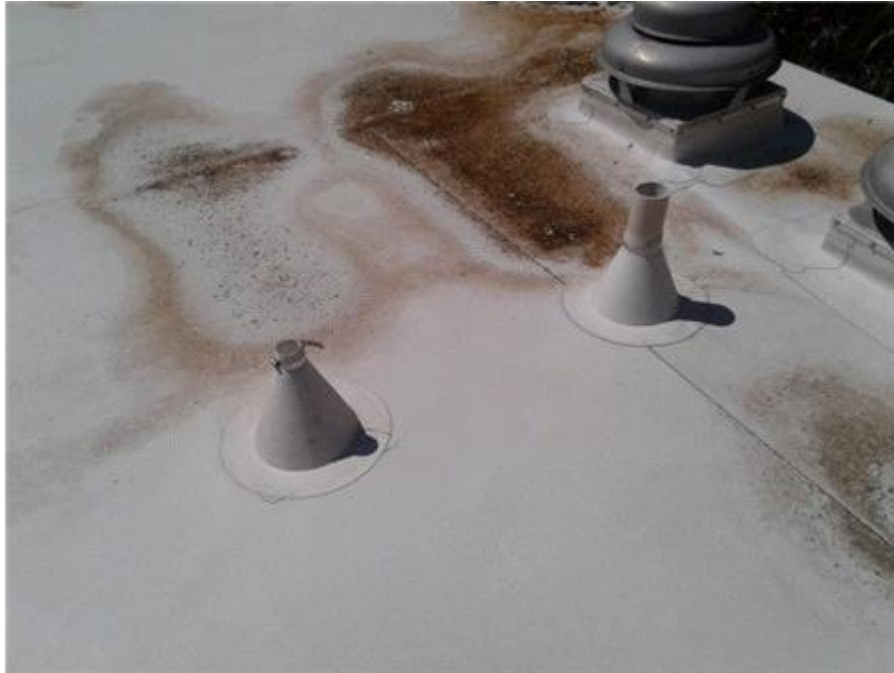
Soil Stacks

Soil stack boots appear to be in good condition at this time.

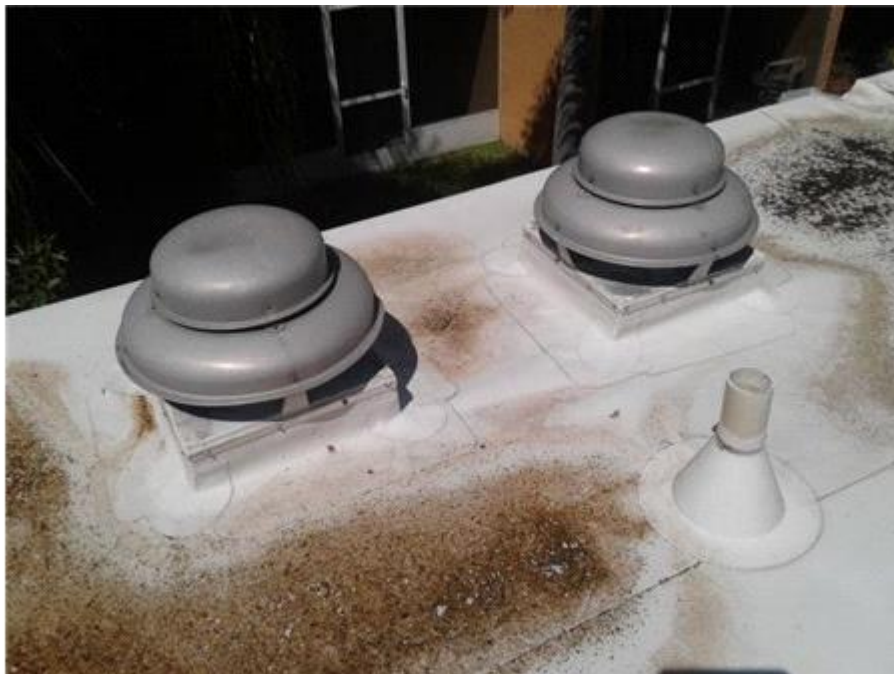
Roof Vents

Roof vents appear to be in good condition at this time.

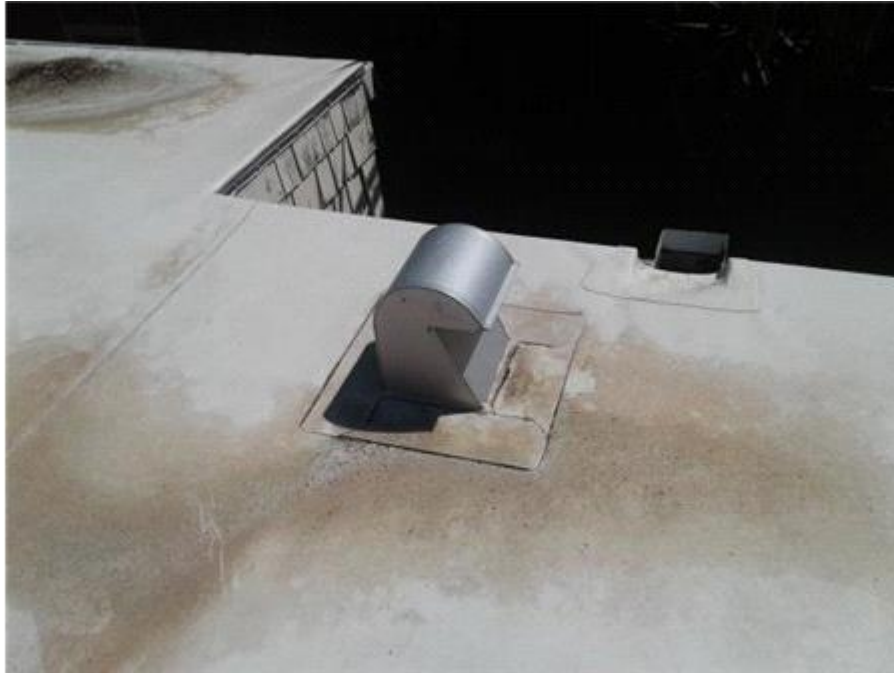
Roof Vents

Roof vents appear to be in good condition at this time.
