# Inspection Report

**Facility:** Towers, The  
**Address:** 2366 East Mall Dr,  
Fort Myers, 33901

Work Order #: 5715

Re.: **Inspection Report (5 of 6) for The Towers**

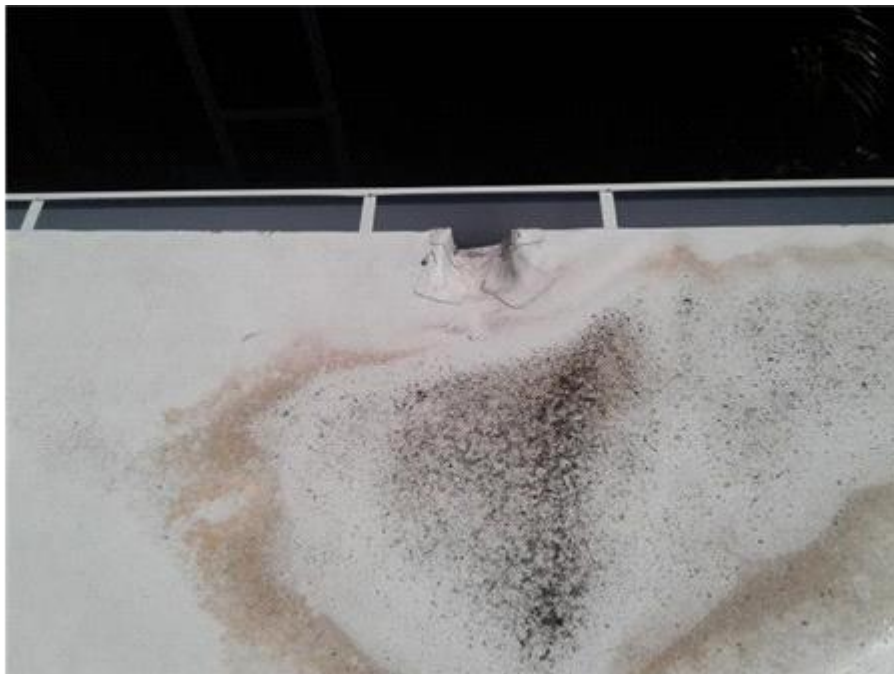
Scuppers appear to be in good condition at this time.

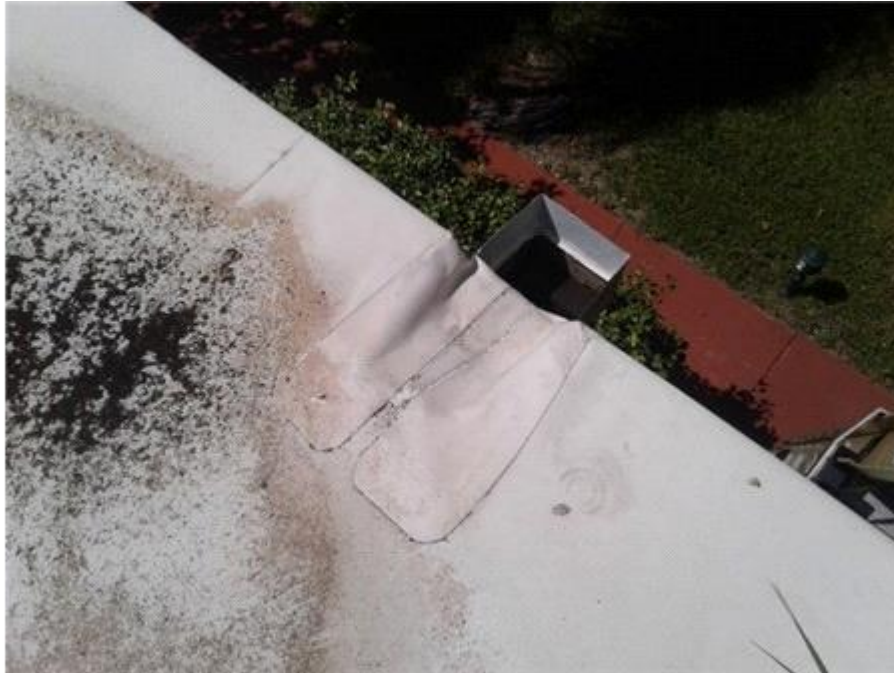
**Scuppers**

Scuppers appear to be in good condition at this time.

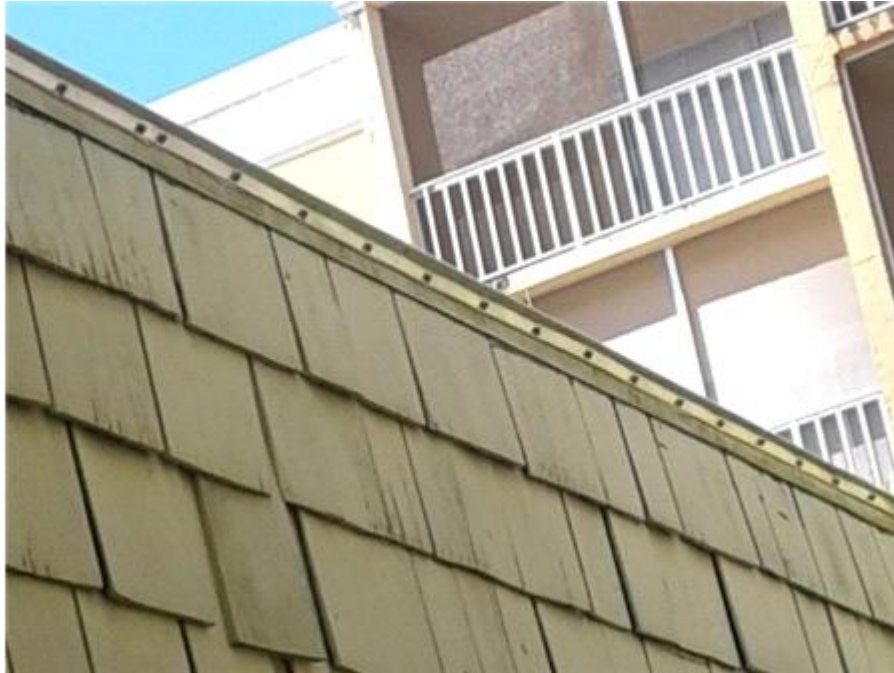
T-Bar appears to be in good condition at this time.

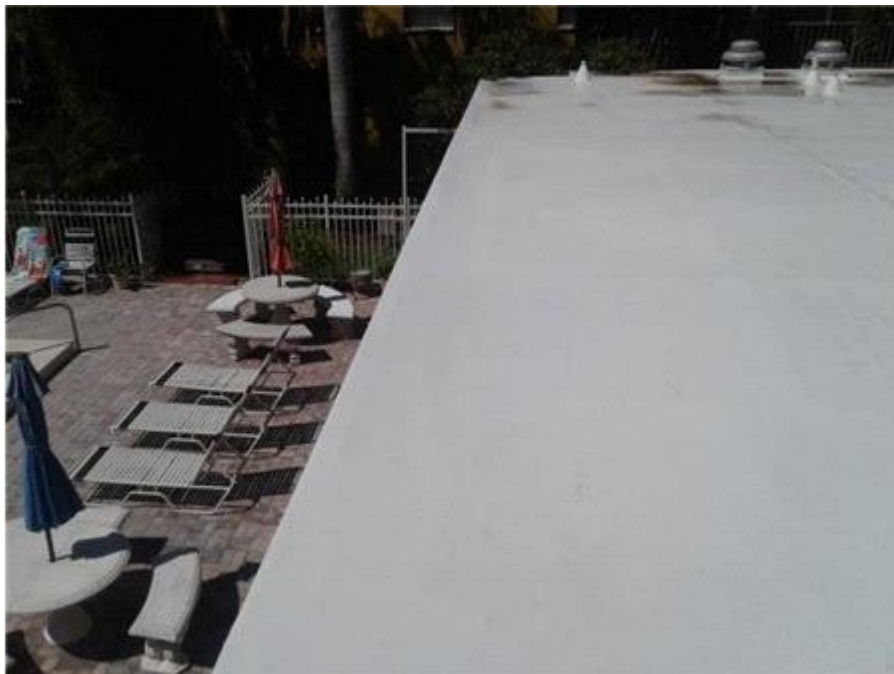
Roof Edge

Roof edge appears to be in good condition.

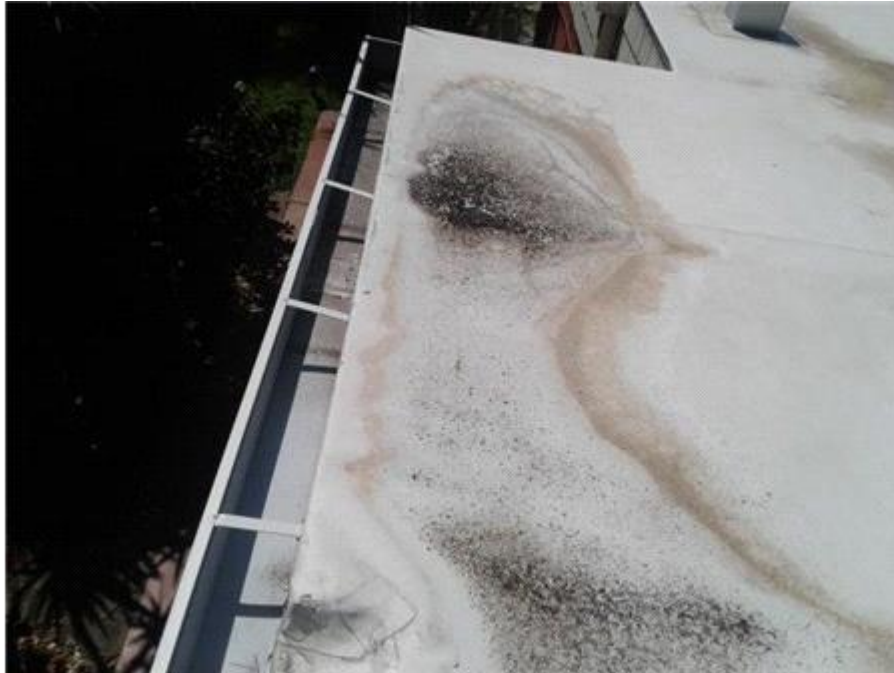
Gutters

The gutters appear to be in good condition.

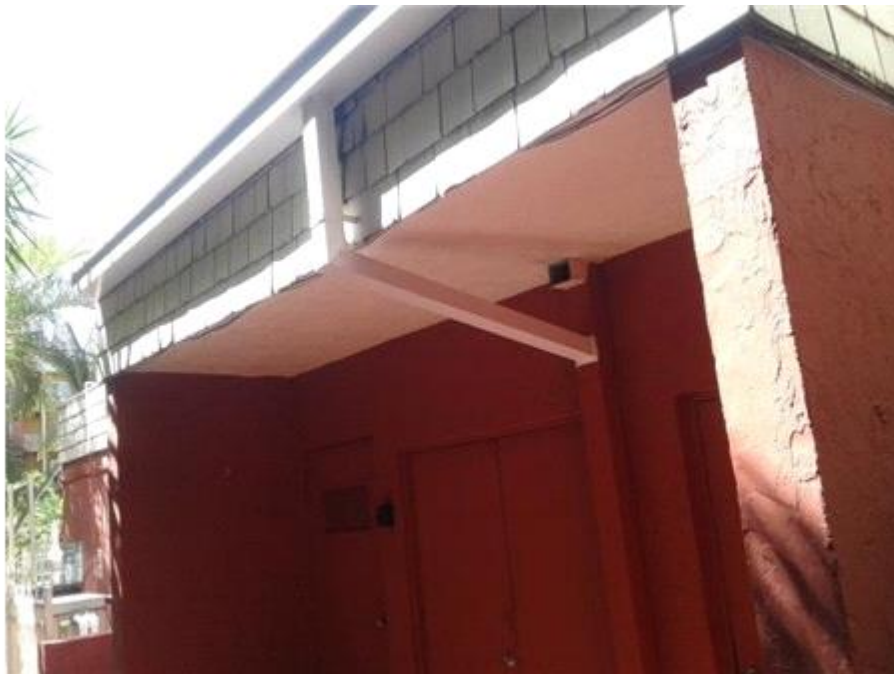
Downspouts

The downspouts appear to be in good condition.
