Inspection Report

Facility: Towers, The
Address: 2366 East Mall Dr,
Fort Myers, 33912

Work Order #: 3086

Re.: **Inspection Report (6 of 6) for The Towers**

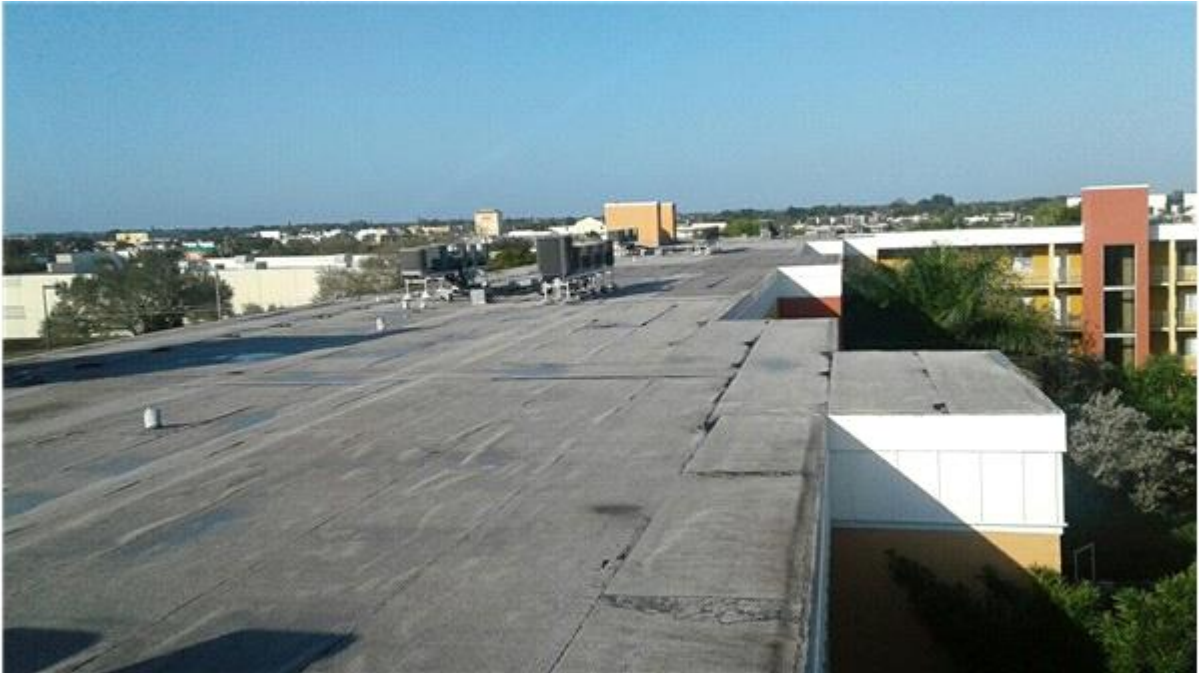
029- Roof overview

General roof overview

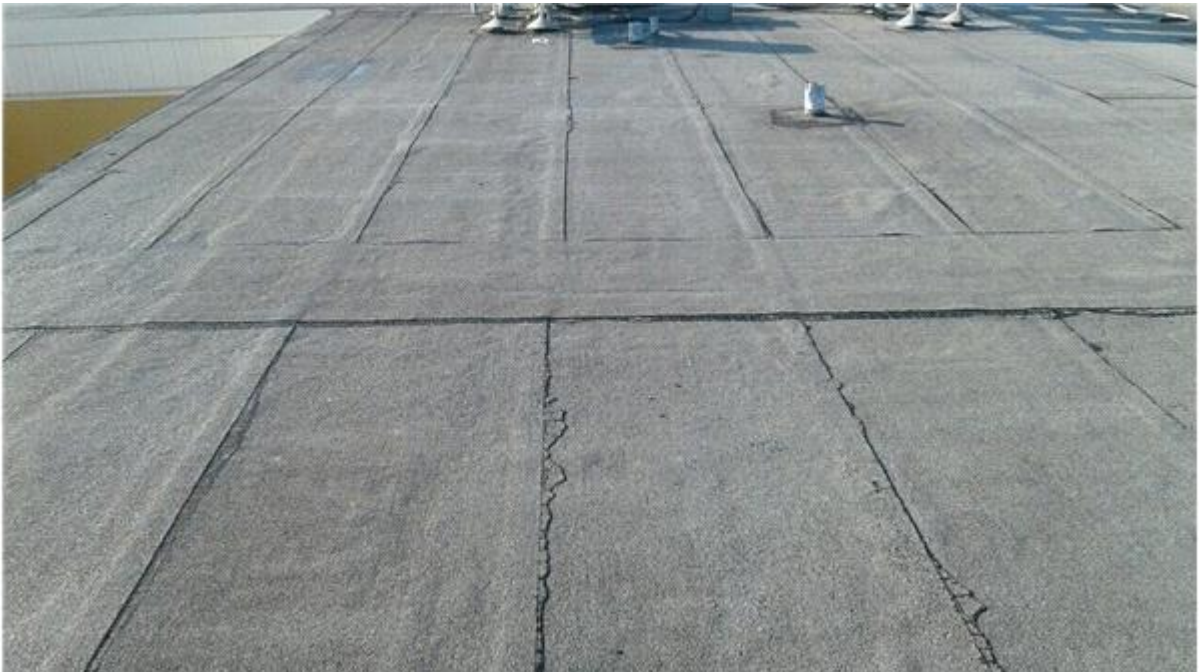
003F -Membrane Overview

The roof membrane appears to be in fair condition at this time.

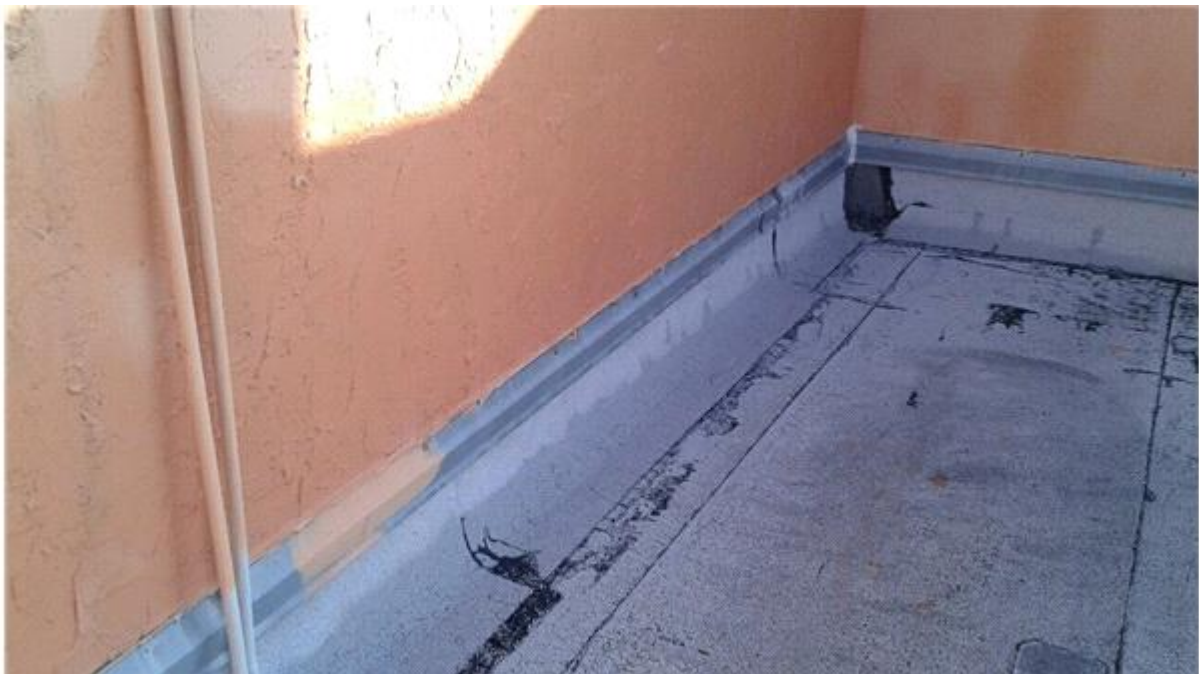
005G- Counter Flashings

The counter flashing appears to be in good condition.

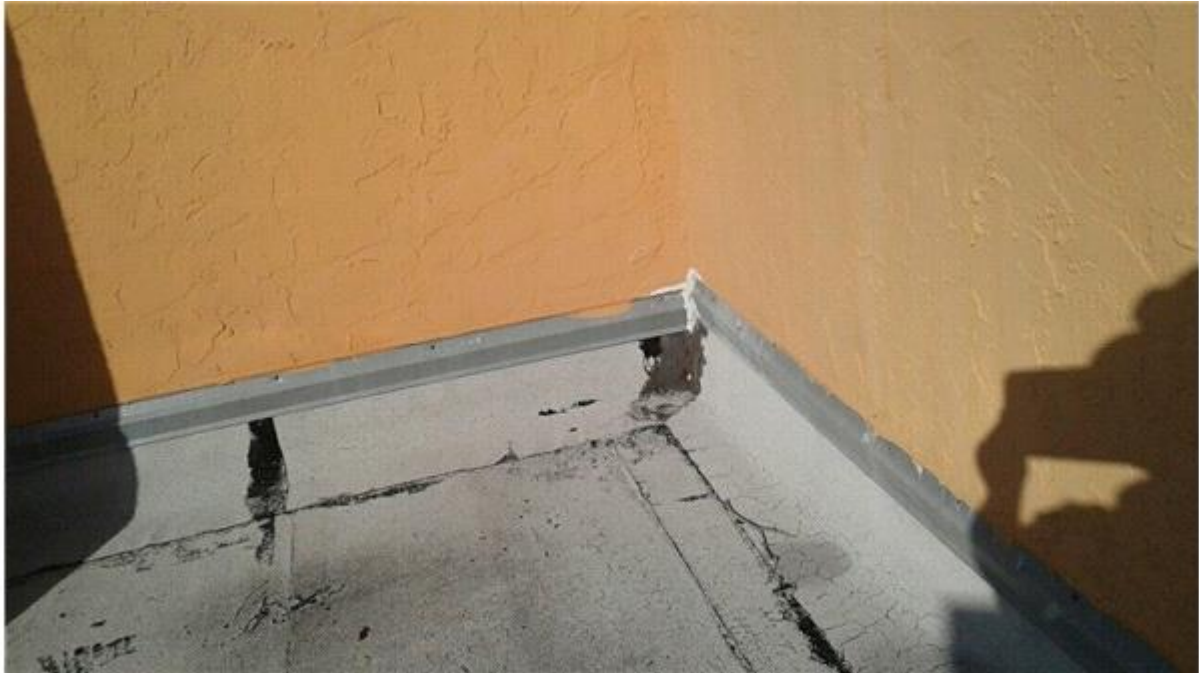
005G- Counter Flashings

The counter flashing appears to be in good condition.

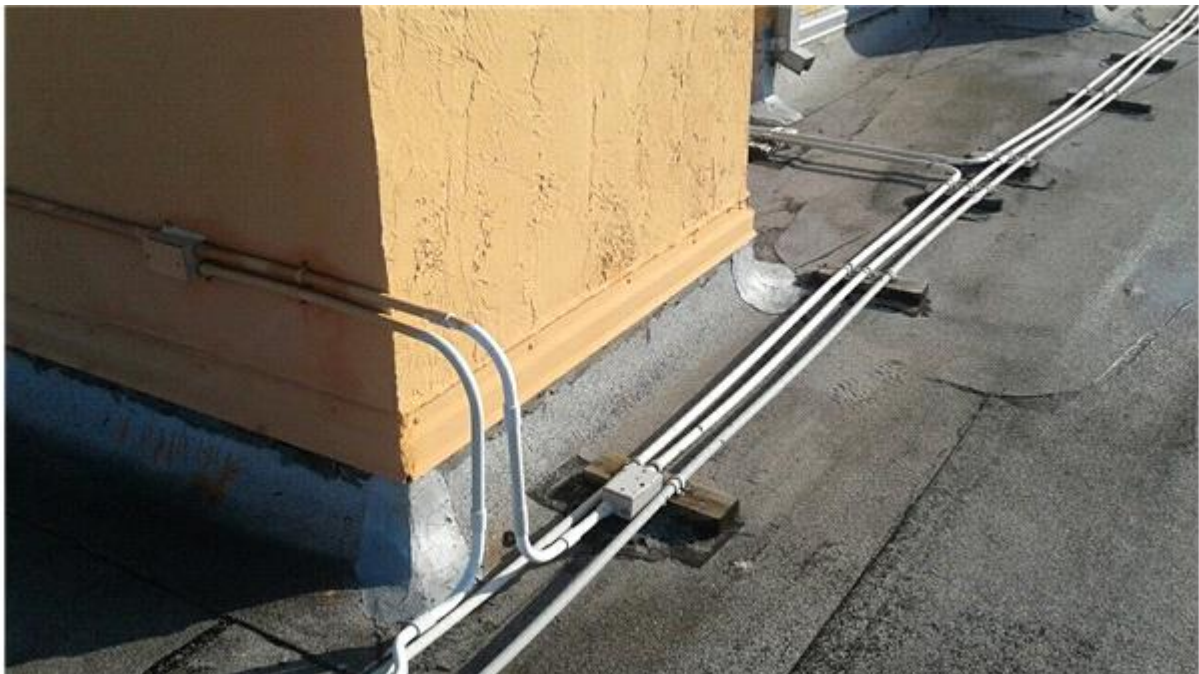
005G- Counter Flashings

The counter flashing appears to be in good condition.

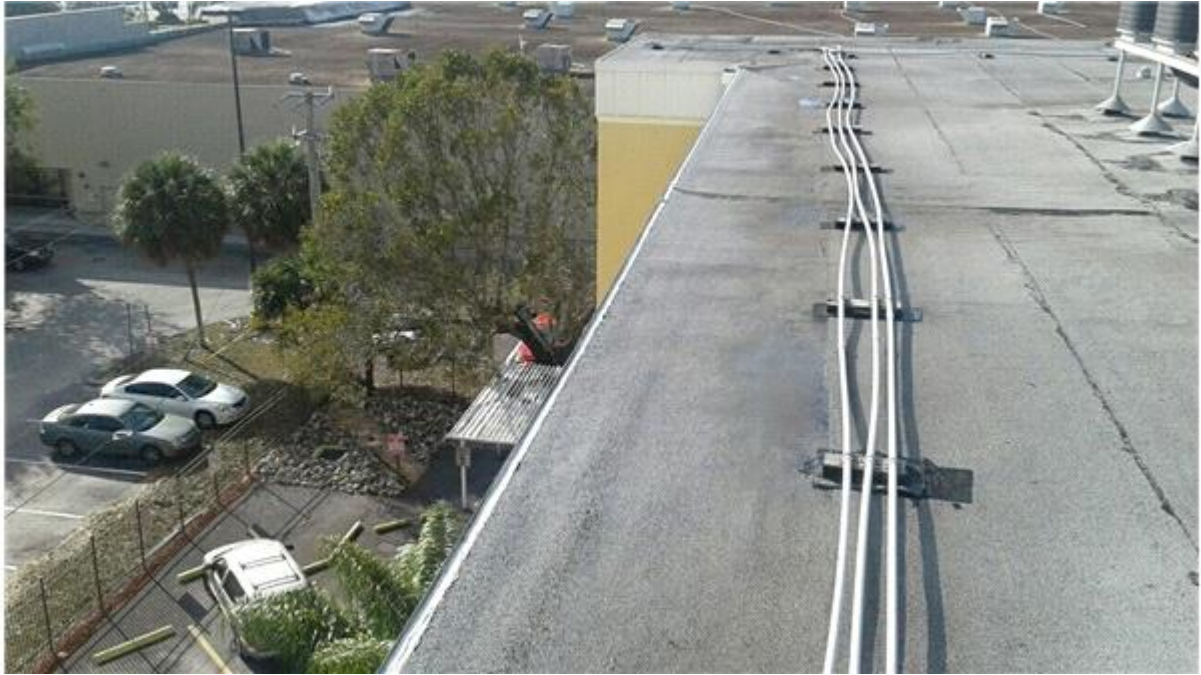
016F-Roof Edge

Roof edge appears to be in fair condition

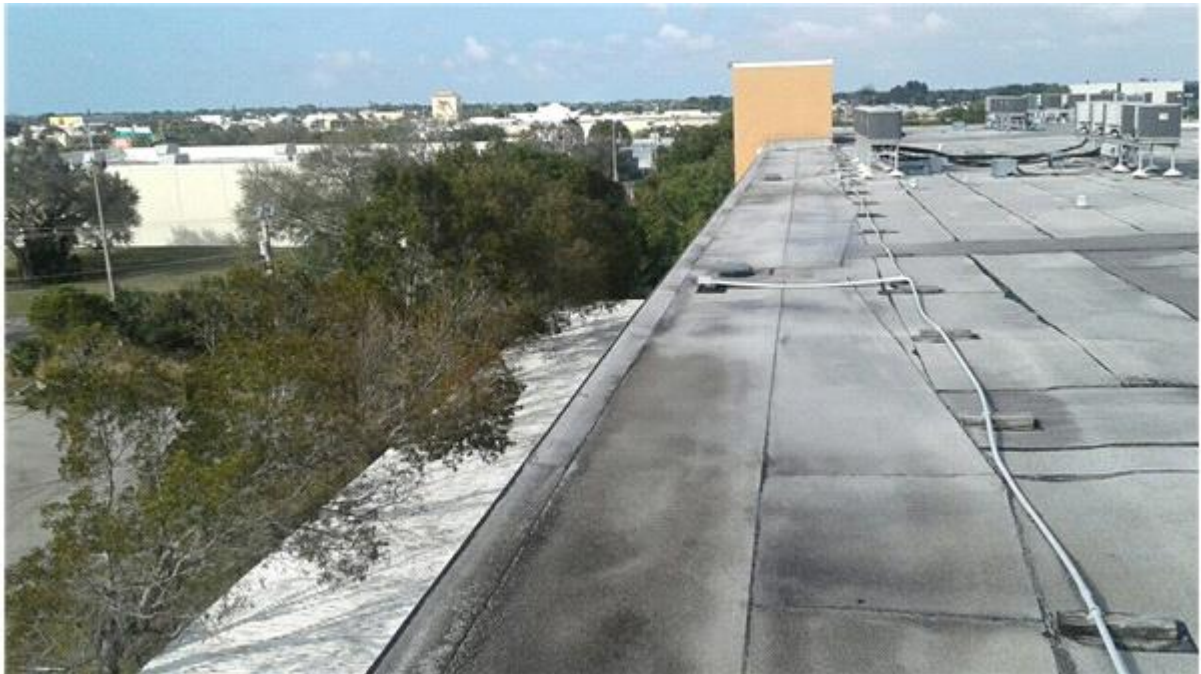
016F-Roof Edge

Roof edge appears to be in fair condition

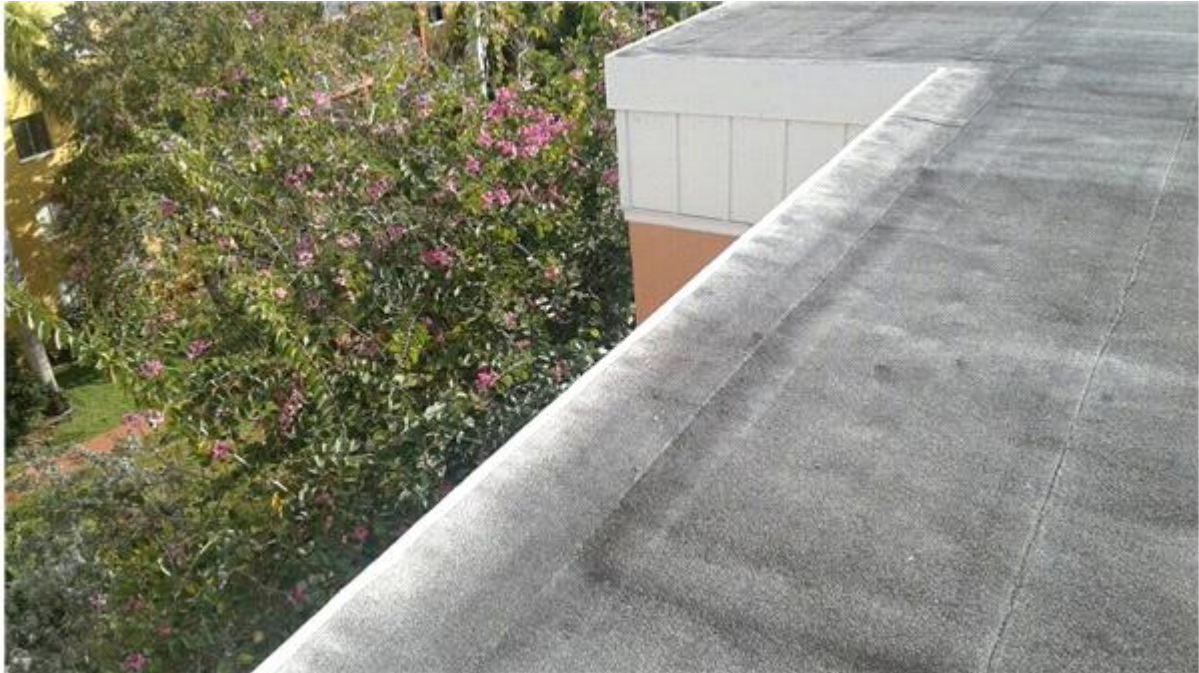
016F-Roof Edge

Roof edge appears to be in fair condition

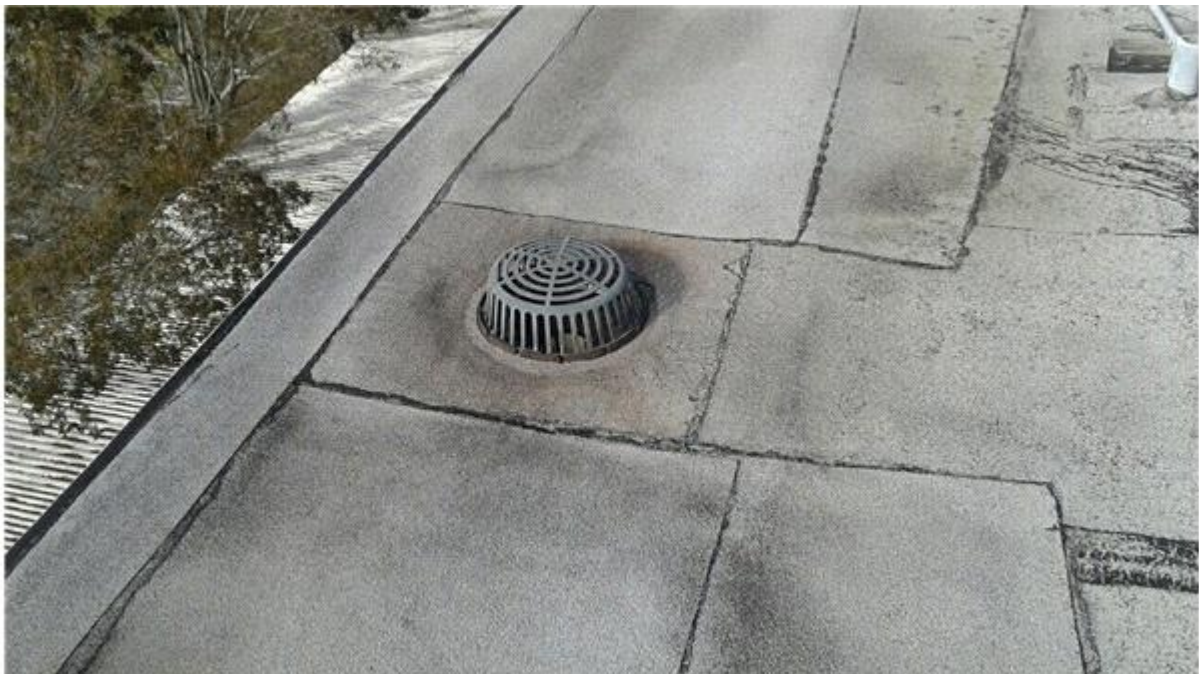
020F-Roof Drains

Roof drains appear to be in fair condition

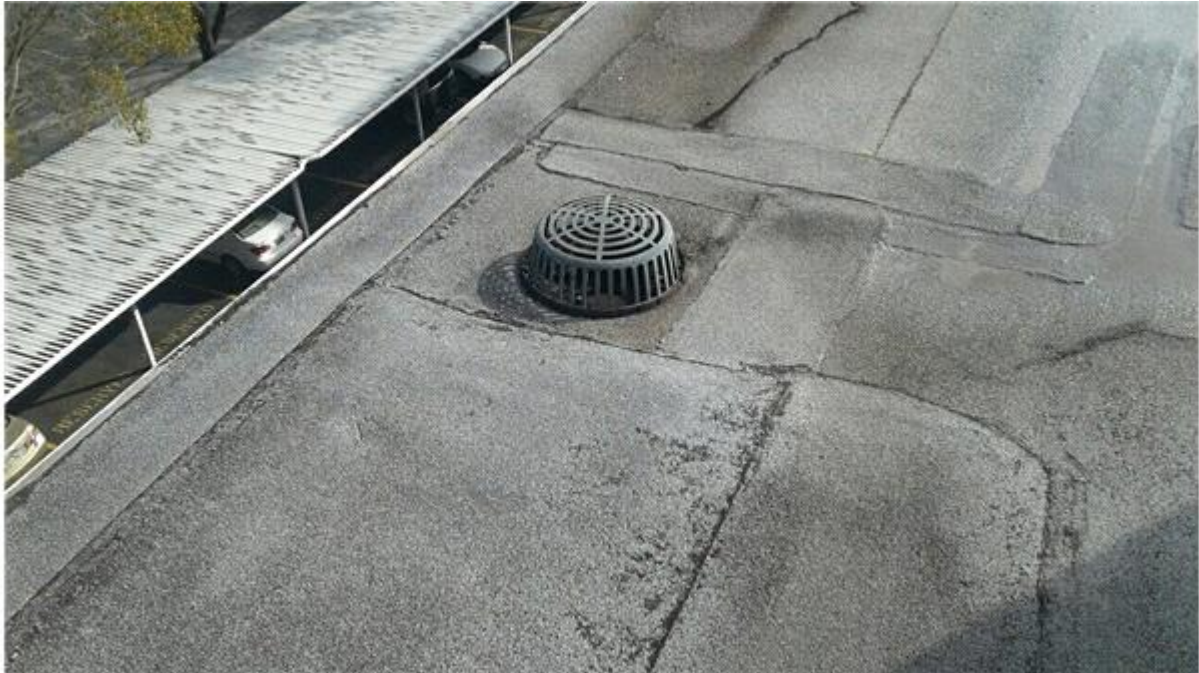
020F-Roof Drains

Roof drains appear to be in fair condition

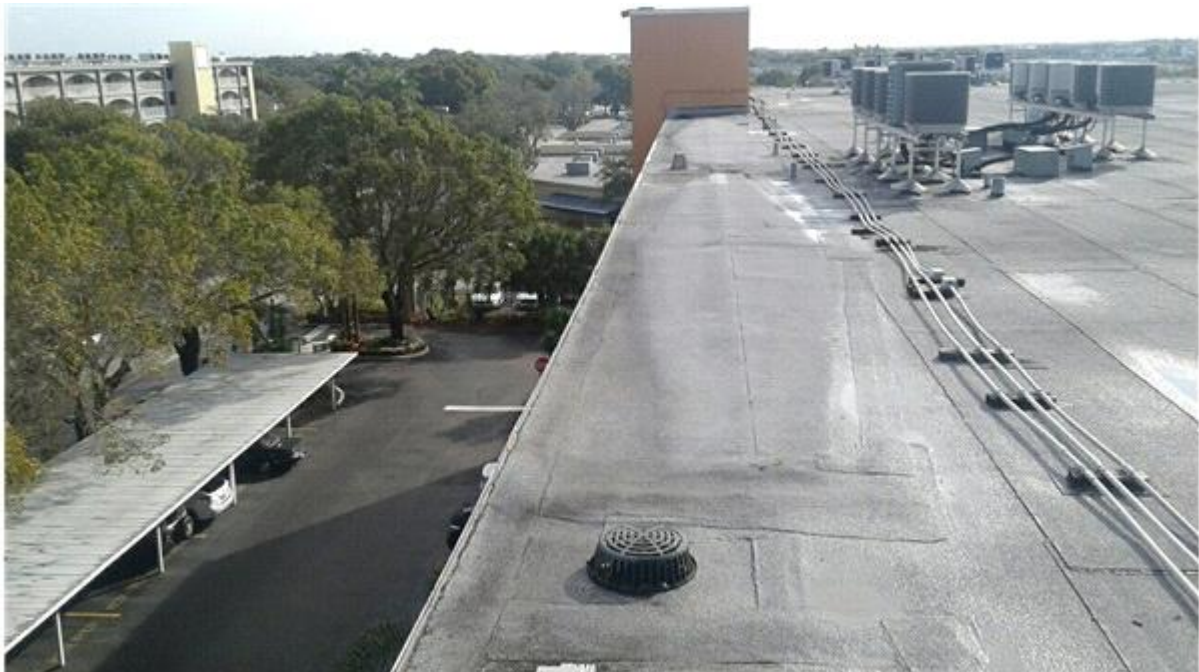
002F - Appearance Overview

The appearance of the roof in fair condition at this time.

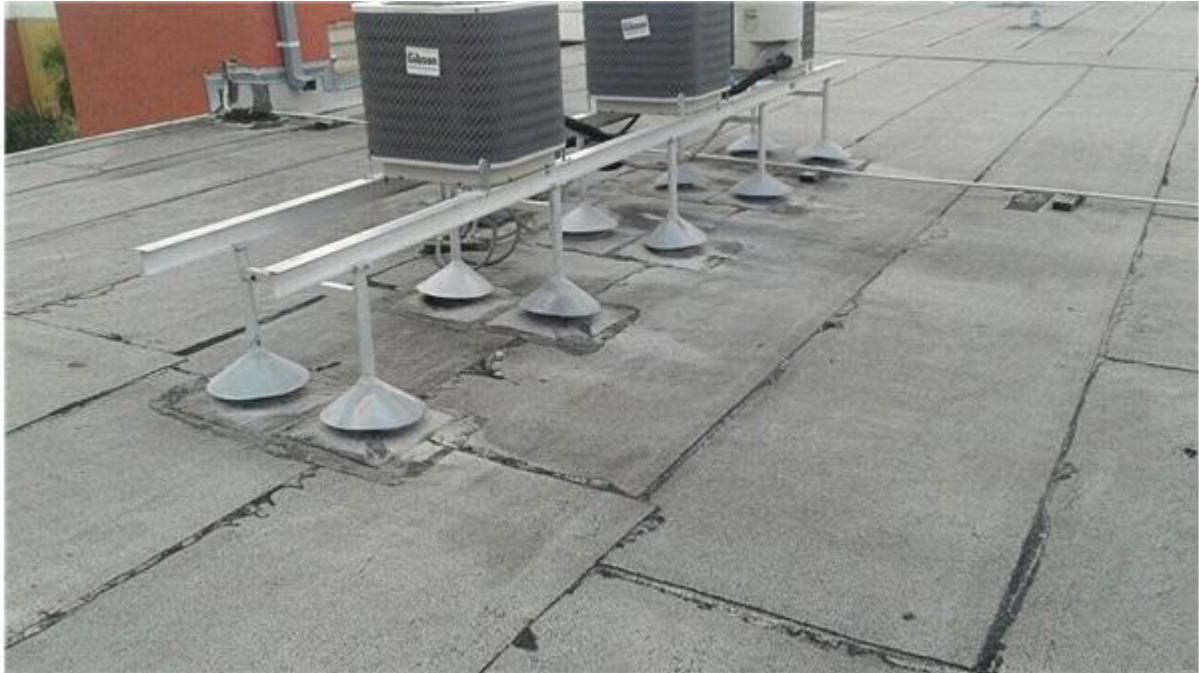
002F - Appearance Overview

The appearance of the roof in fair condition at this time.

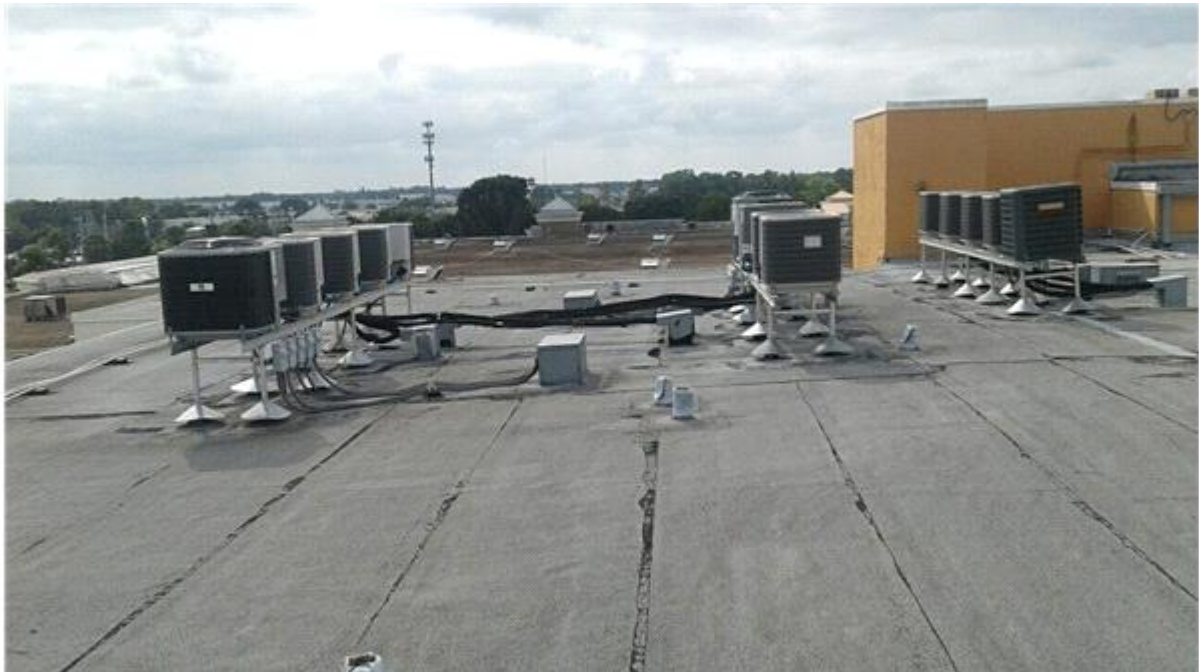
002F - Appearance Overview

The appearance of the roof in fair condition at this time.

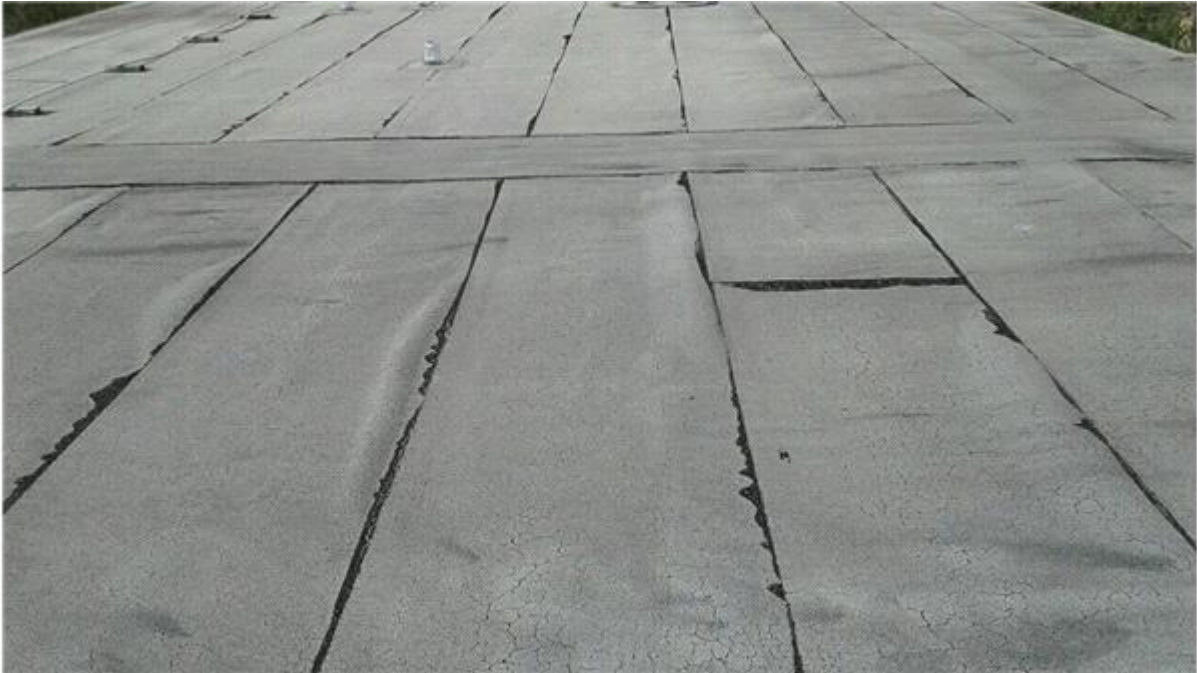
F-200 Field Membrane

Blisters are caused by gas trapped in the system and may be ruptured with foot traffic. Crowther Roofing will monitor.

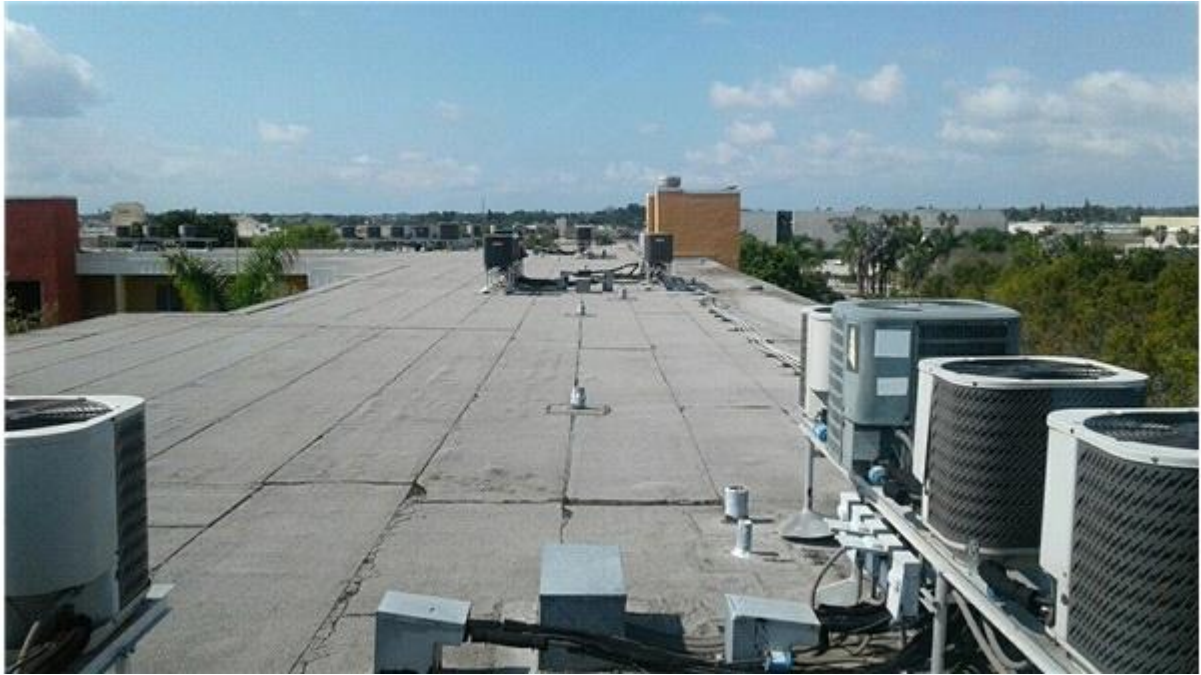
002F - Appearance Overview

The appearance of the roof in fair condition at this time.

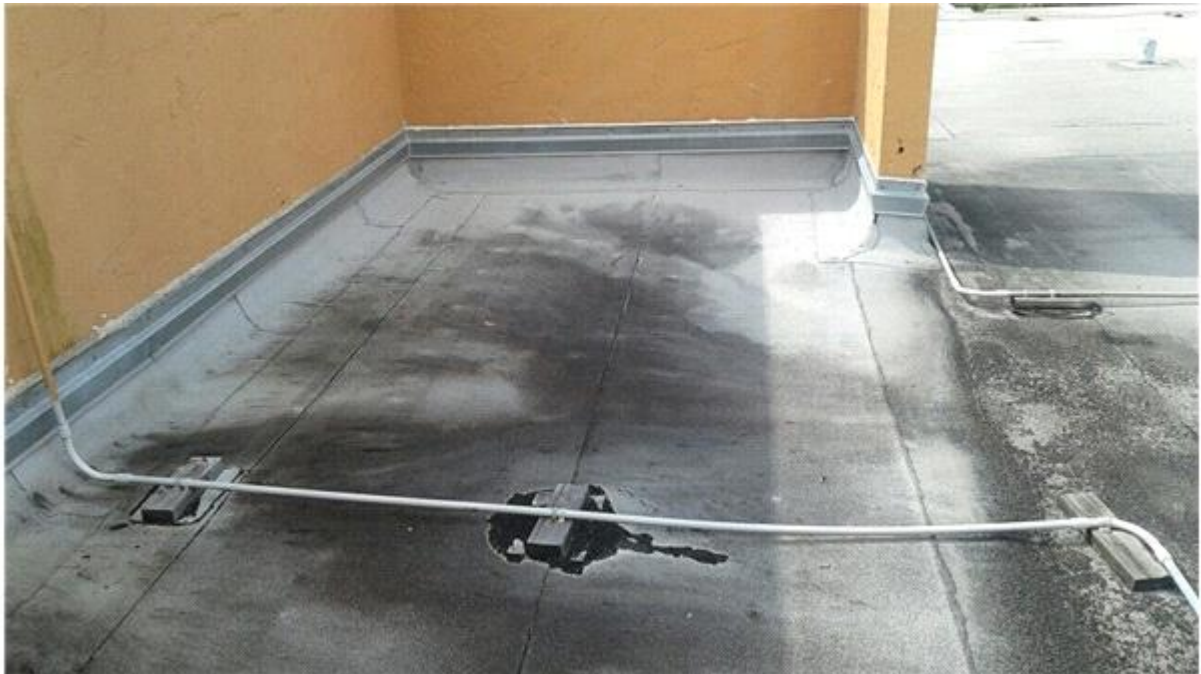
002F - Appearance Overview

The appearance of the roof in fair condition at this time.

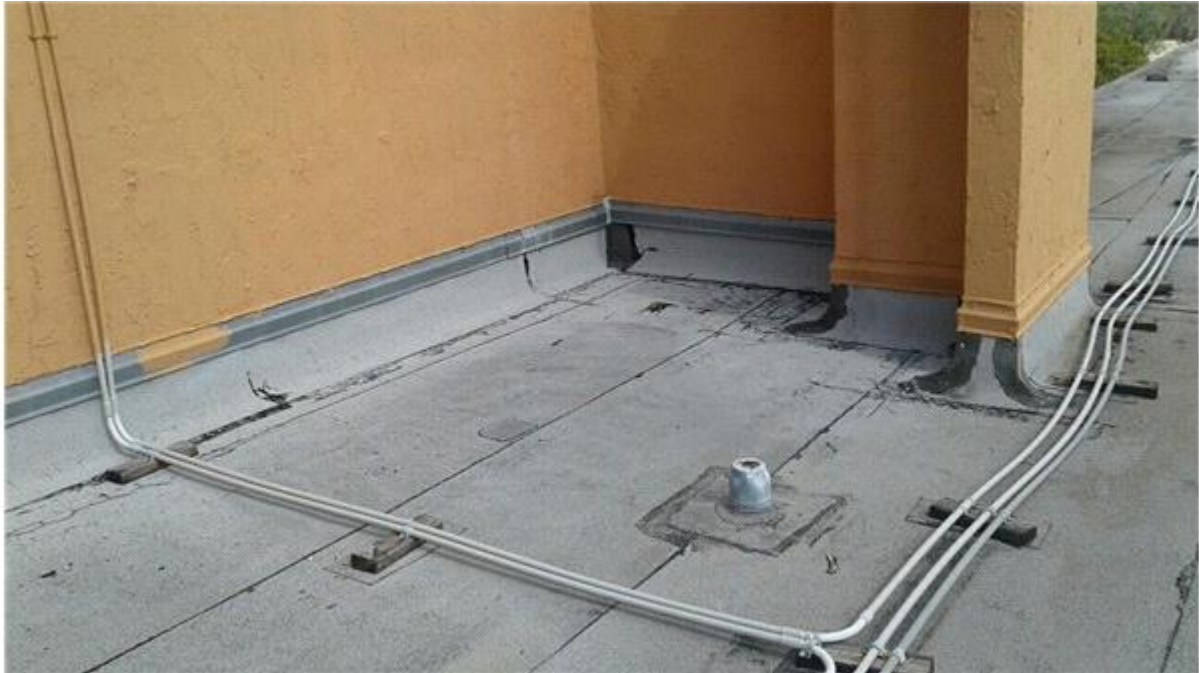
002F - Appearance Overview

The appearance of the roof in fair condition at this time.

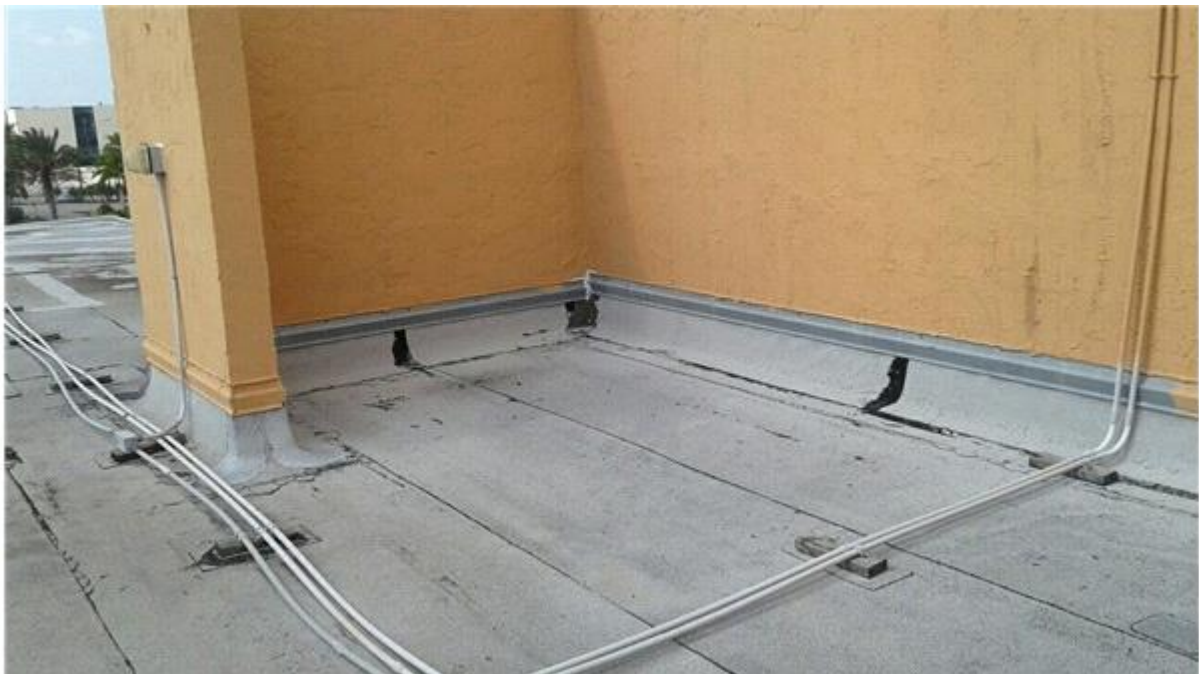
002F - Appearance Overview

The appearance of the roof in fair condition at this time.

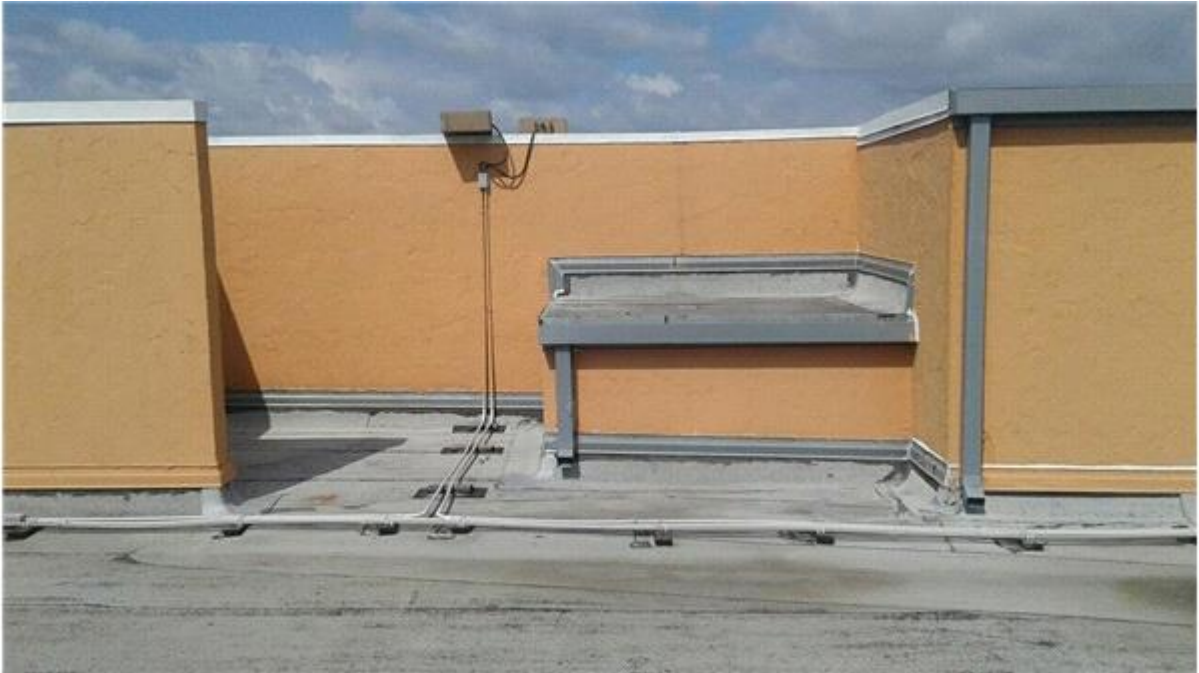
002F - Appearance Overview

The appearance of the roof is in fair condition at this time.

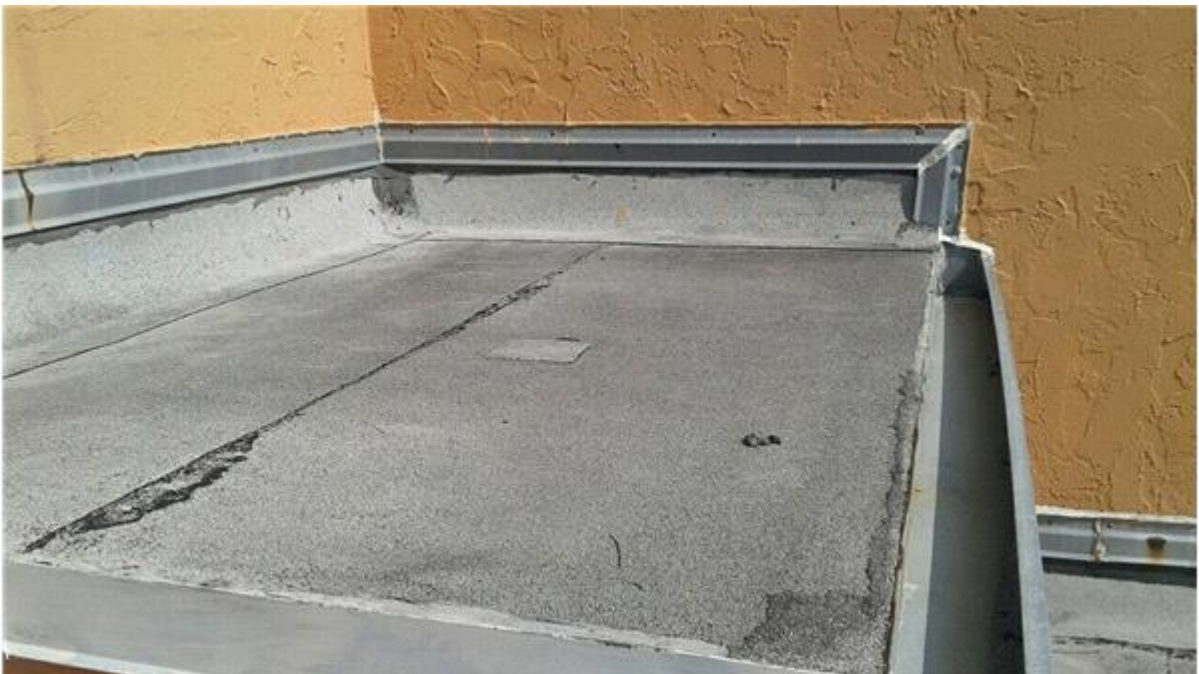
003F -Membrane Overview

The roof membrane appears to be in fair condition at this time.

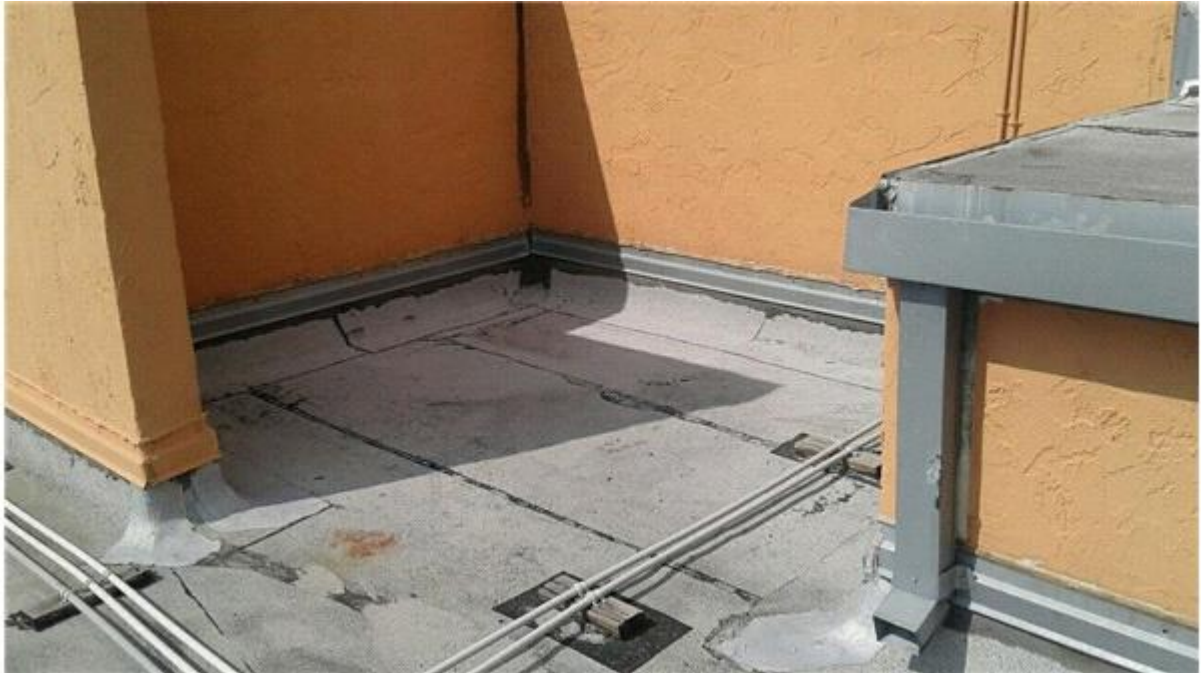
002F - Appearance Overview

The appearance of the roof is in fair condition at this time.

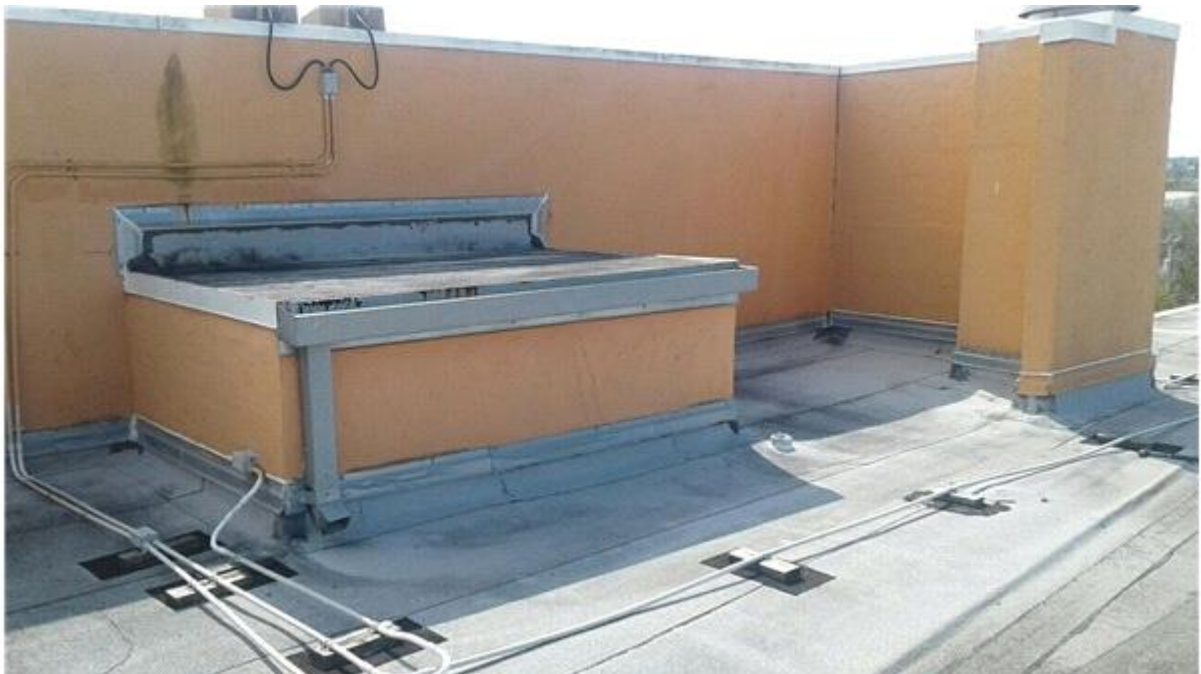
029- Roof overview

General roof overview

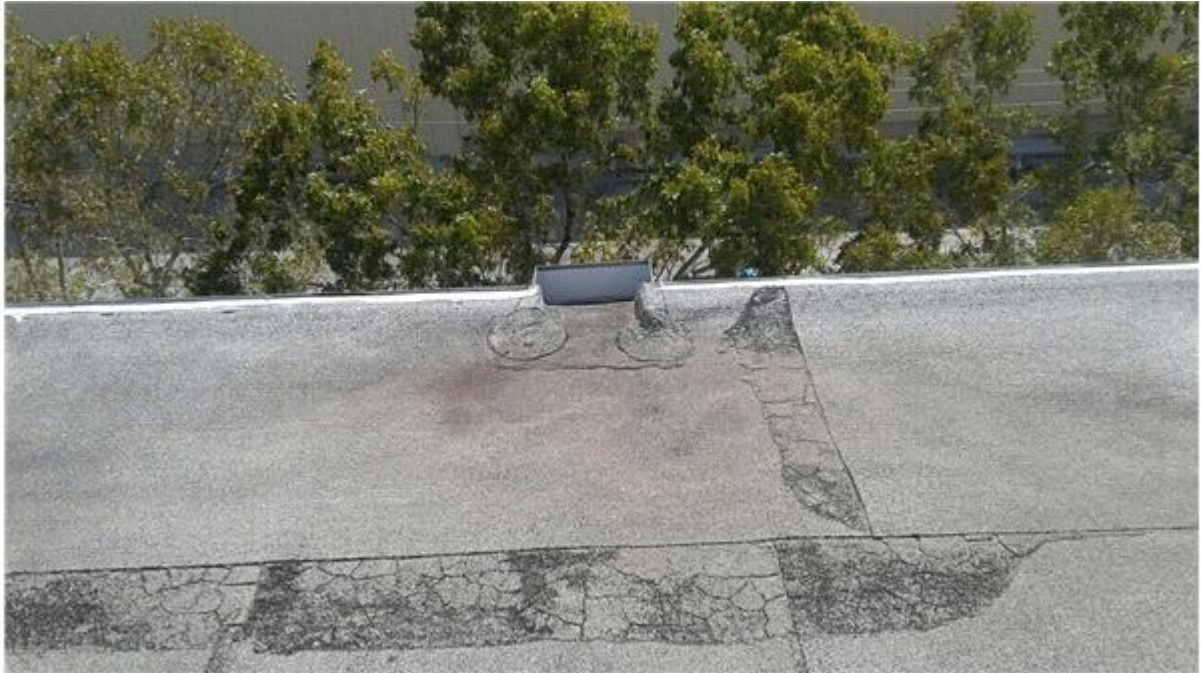
Overflows appear to be in fair condition at this time.

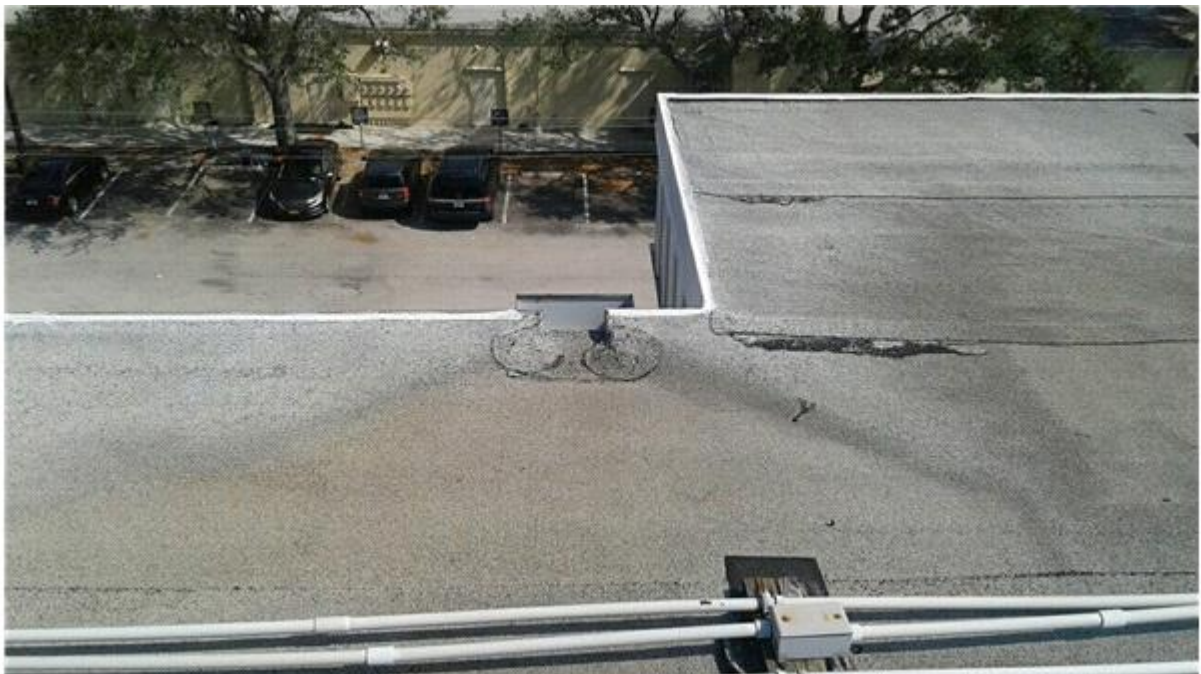
Overflows appear to be in fair condition at this time.

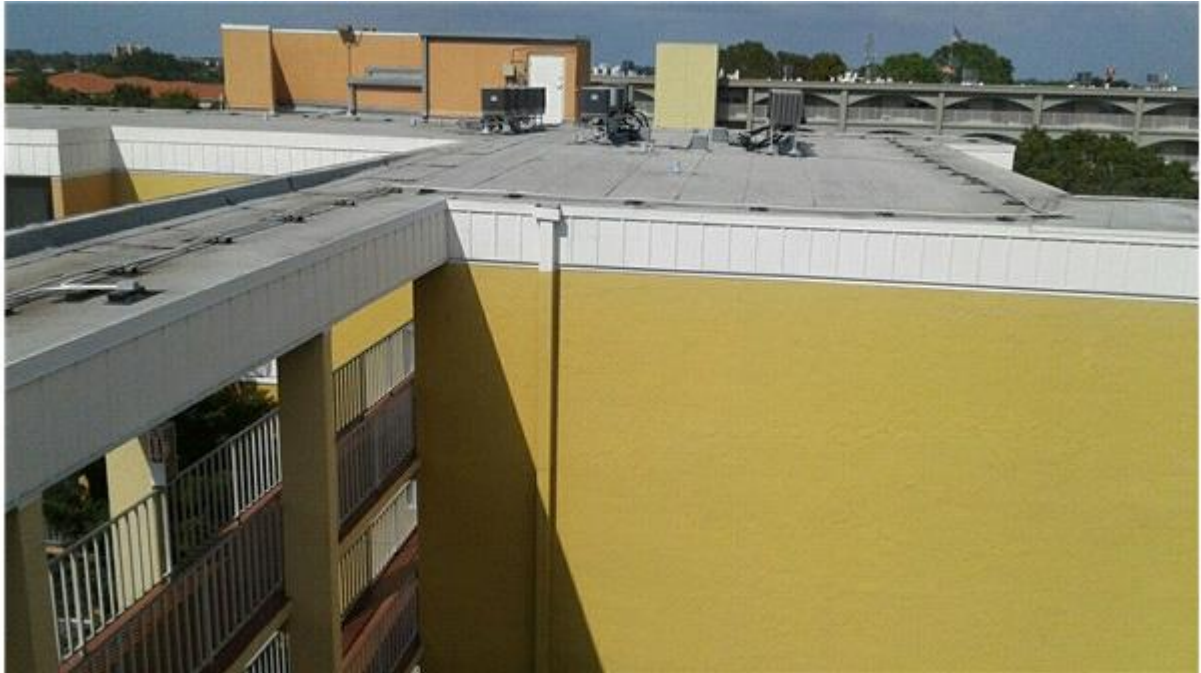
009G- Downspouts

The downspouts appear to be in good condition.

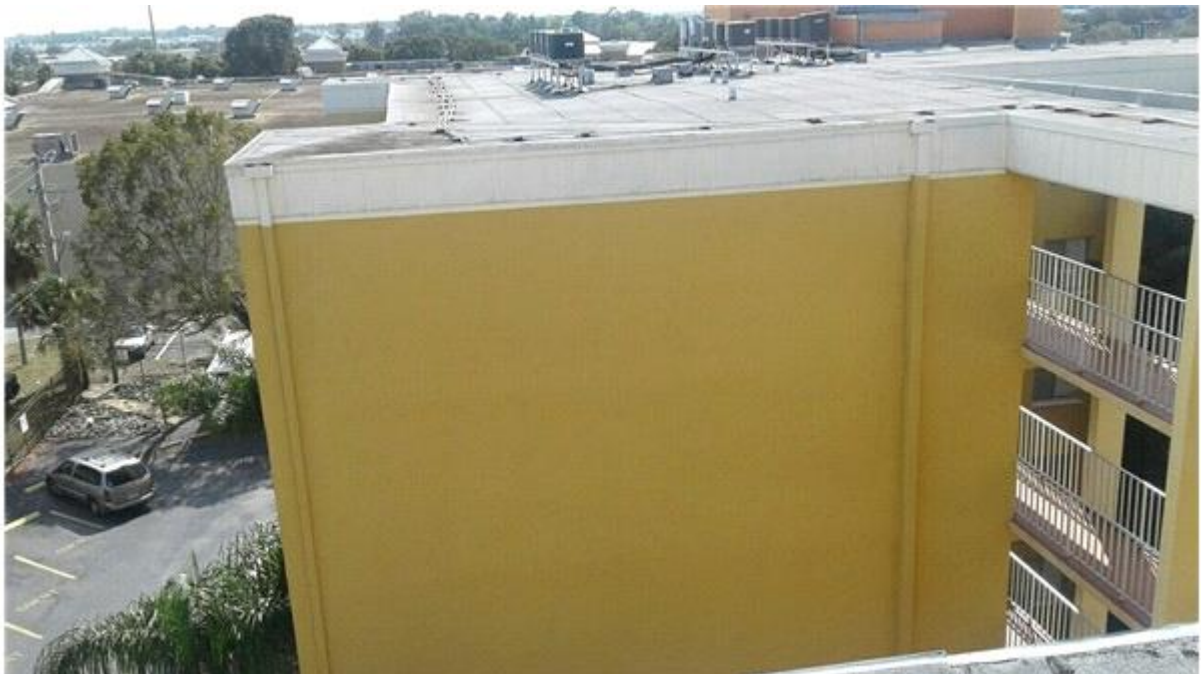
009G- Downspouts

The downspouts appear to be in good condition.

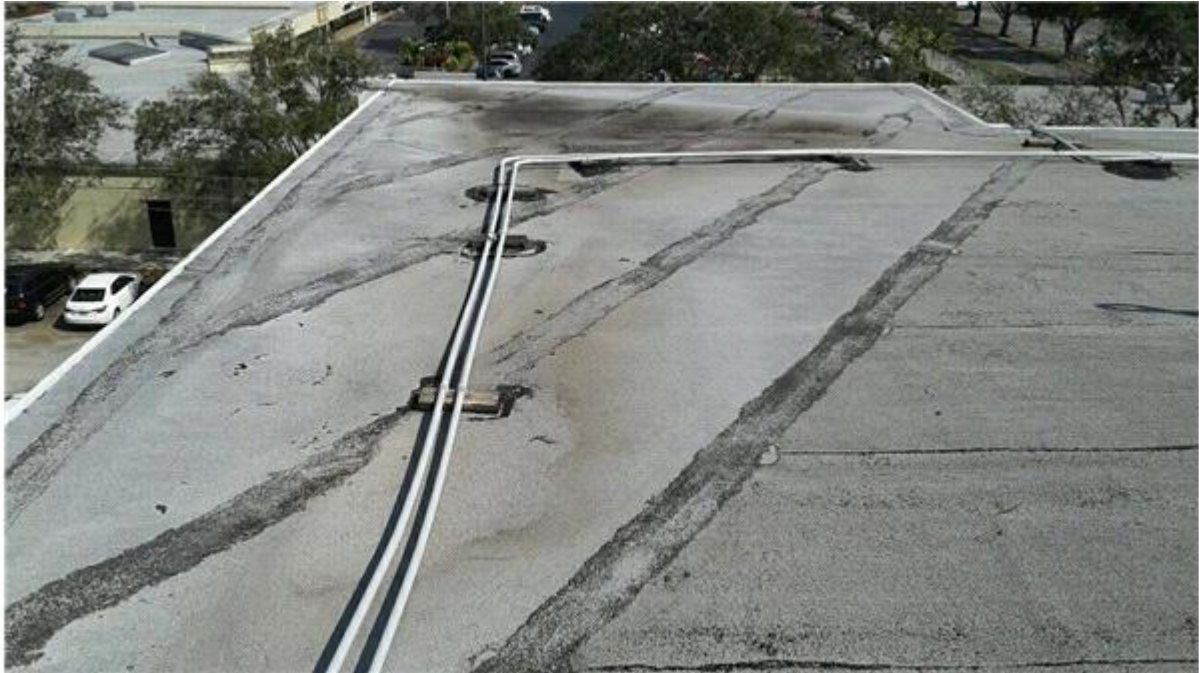
Field Membrane

Membrane is in fair condition at this time

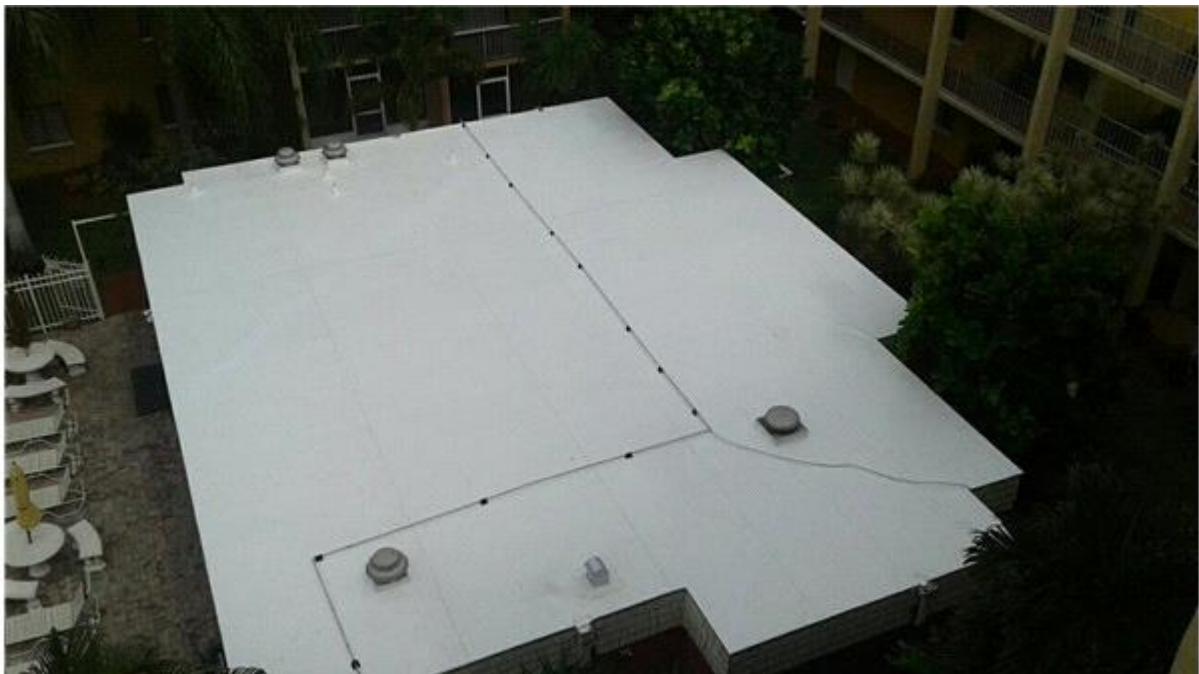
029- Roof overview of Clubhouse

General roof overview
