Inspection Report

Facility: Towers, The
Address: 2366 East Mall Dr,
Fort Myers, 33912

Work Order #: 3086

Re.: **Inspection Report (6 of 6) for The Towers**

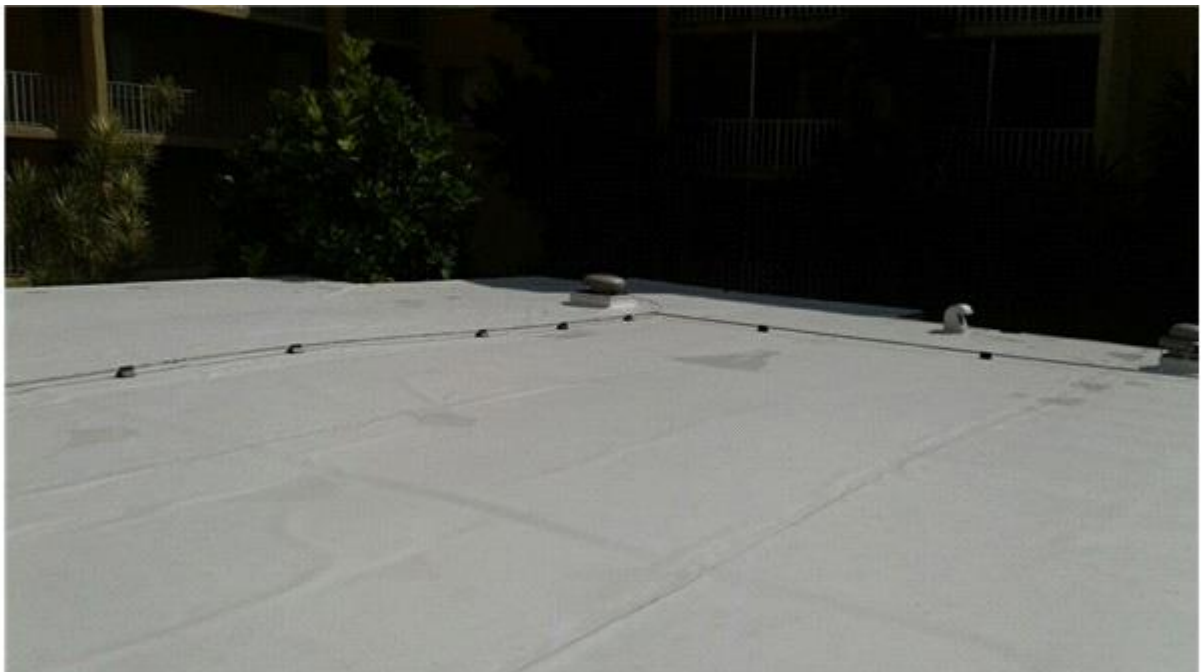
003G - Membrane Overview

The membrane appears to be in good, maintainable condition at this time.

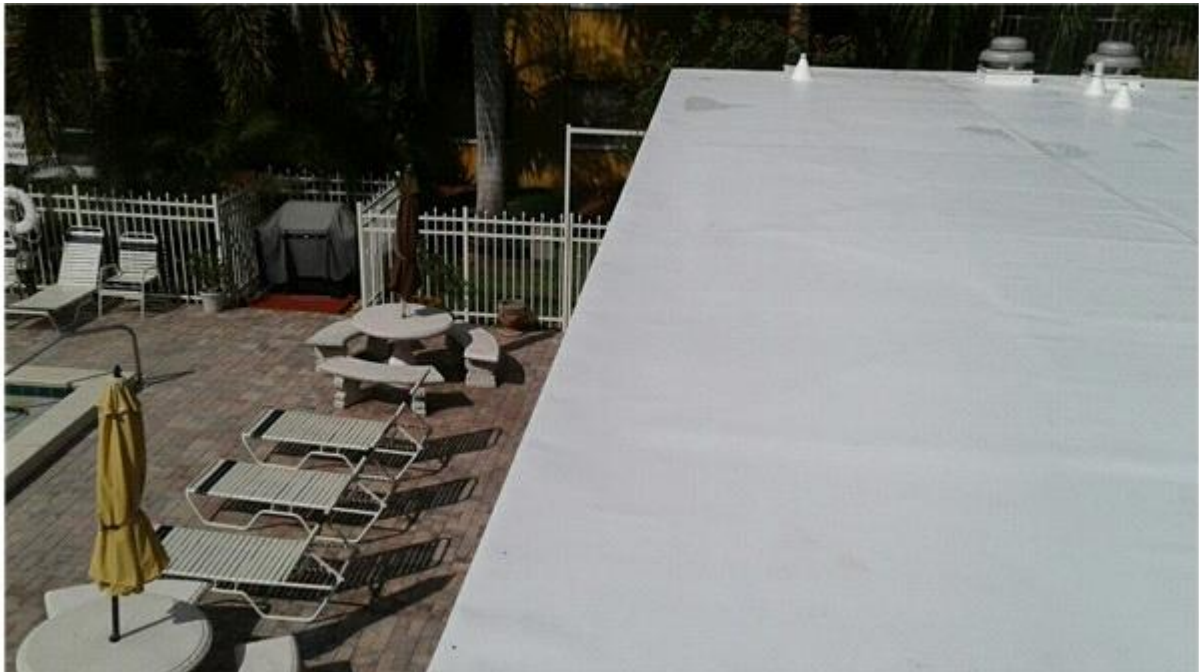
002G-Roof Vents

Roof vents appear to be in good condition at this time

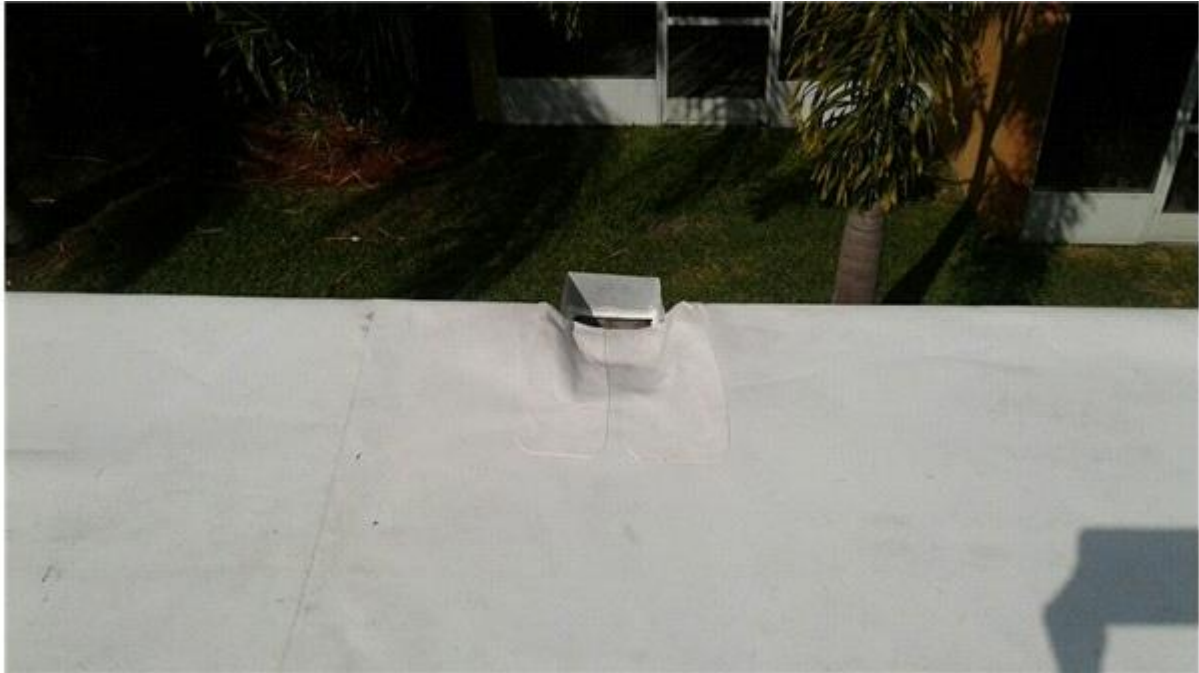
016G-Roof Edge

Roof edge appears to be in good condition

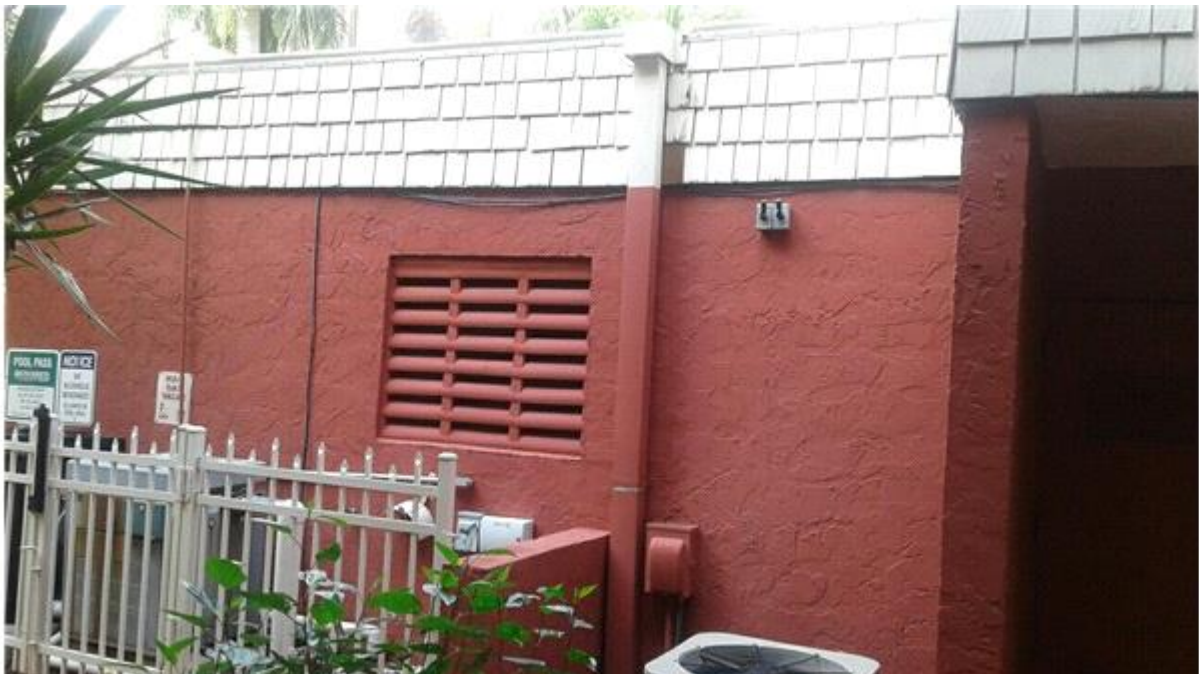
002G- Appearance Overview

The roof appearance is in good, maintainable condition at this time.

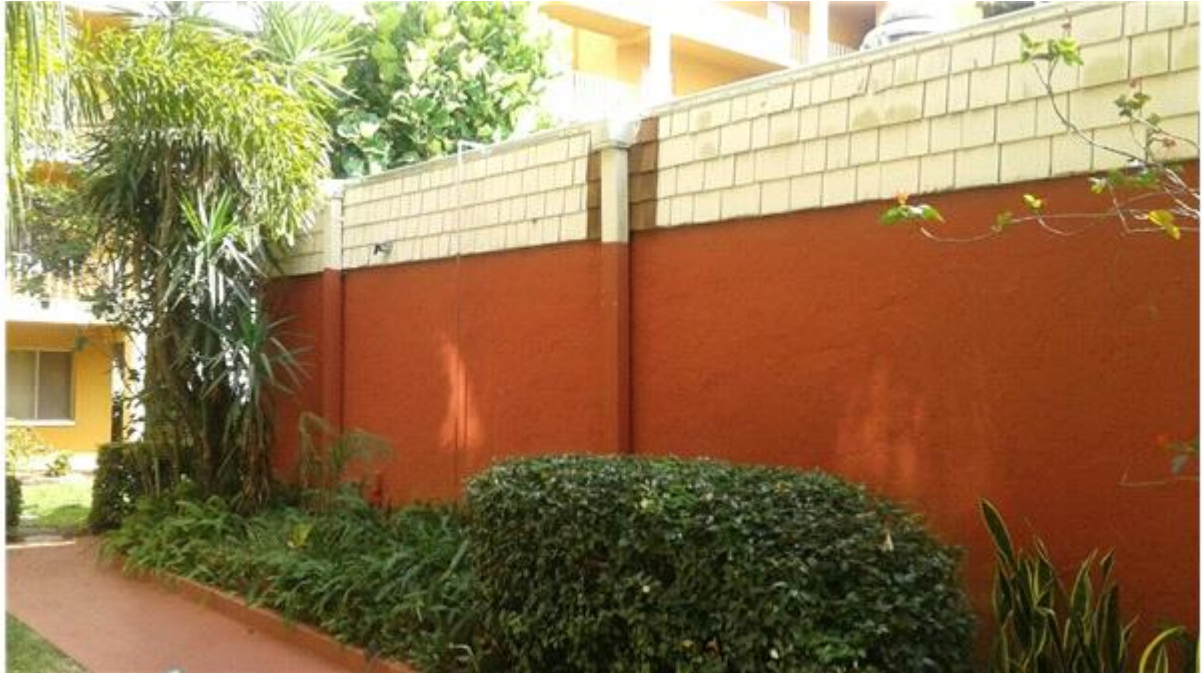
009G- Downspouts

The downspouts appear to be in good condition.

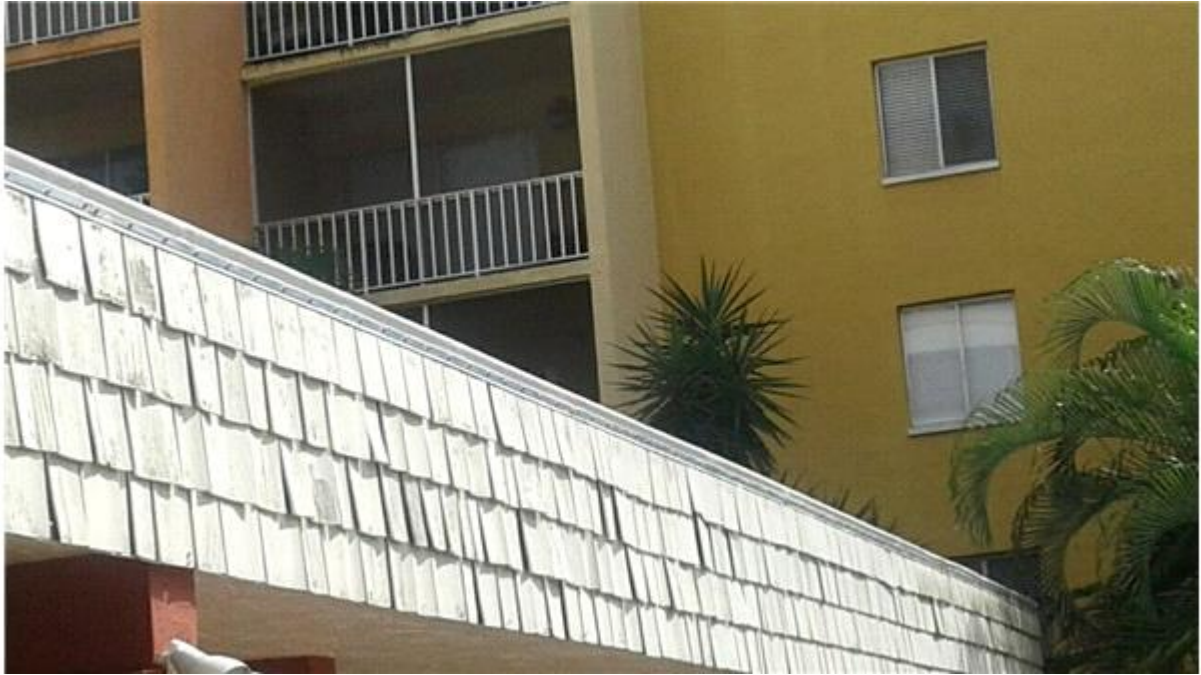
016G-Roof Edge

Roof edge appears to be in good condition

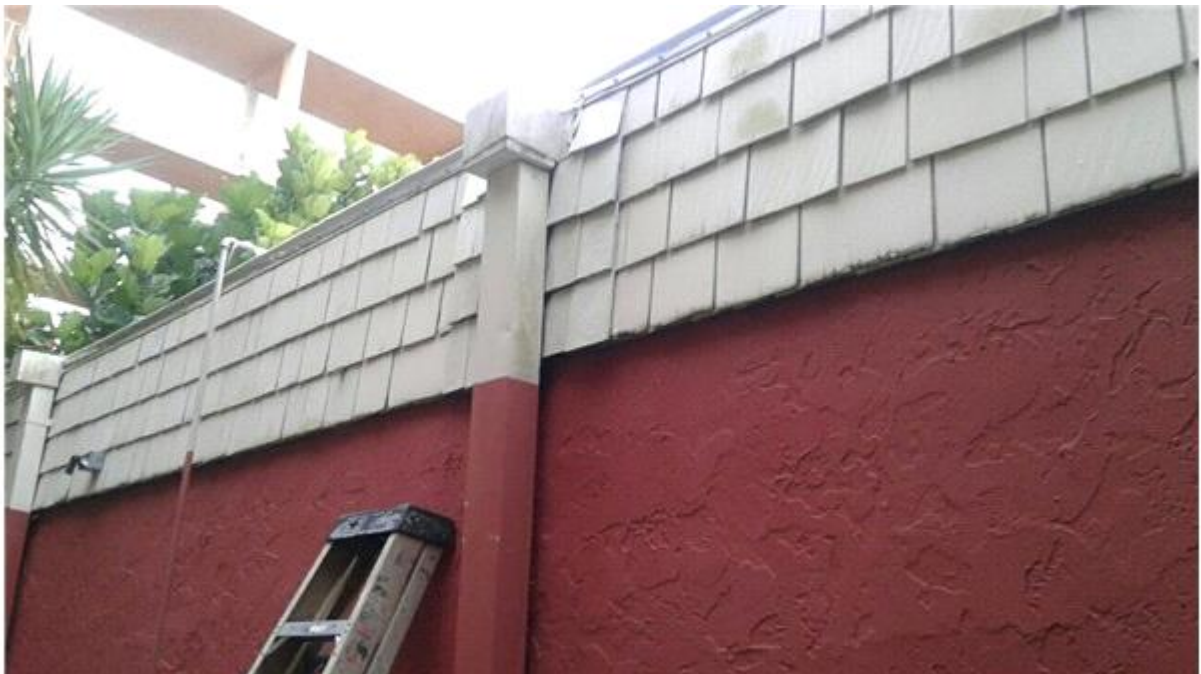
016G-Roof Edge

Roof edge appears to be in good condition

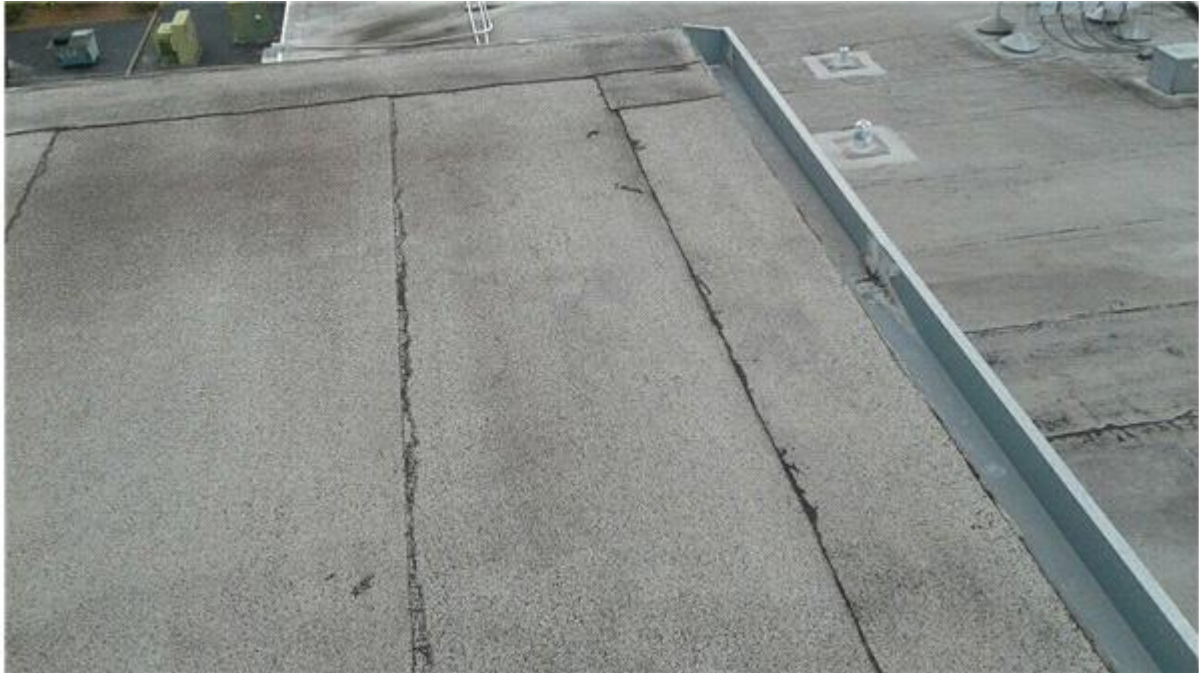
003F -Membrane Overview
The roof membrane appears to be in fair condition at this time.

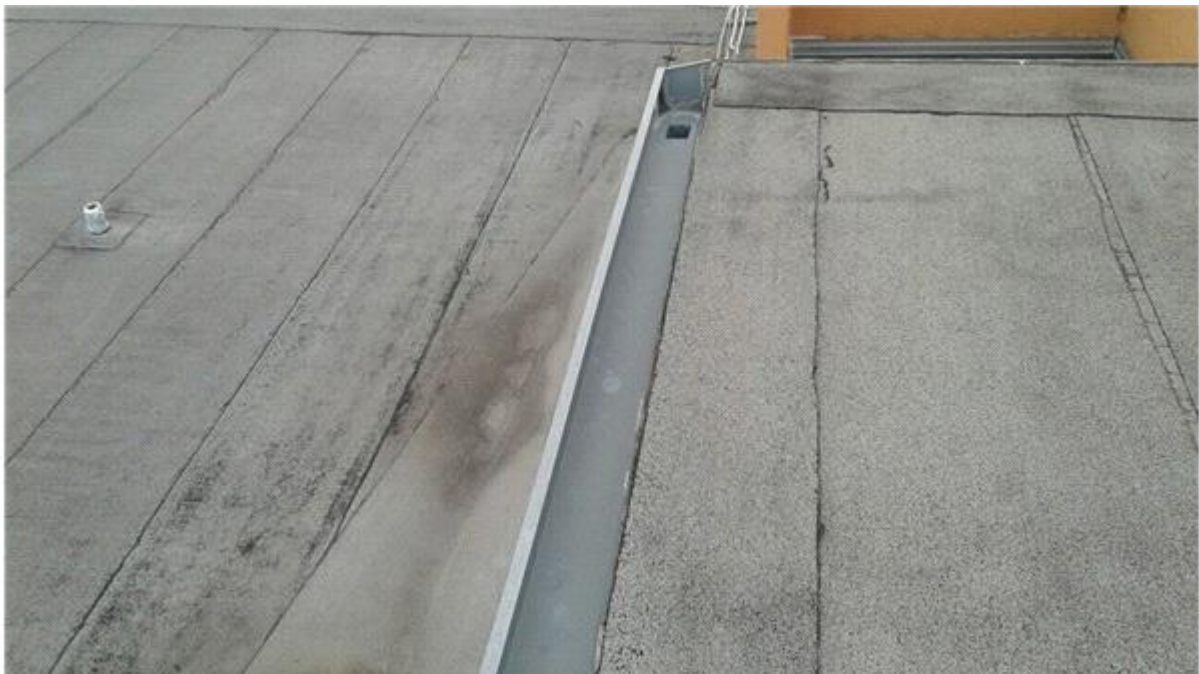
016F-Roof Edge

Roof edge appears to be in fair condition

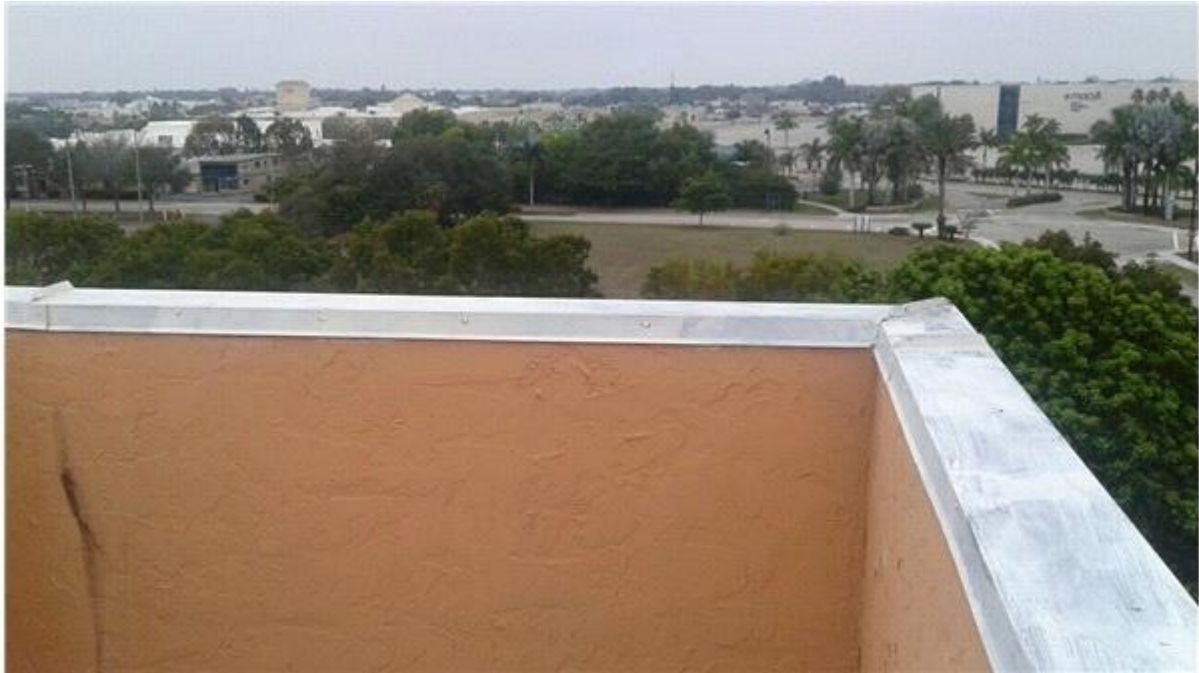
006G- Coping

The coping appears to be in good condition.

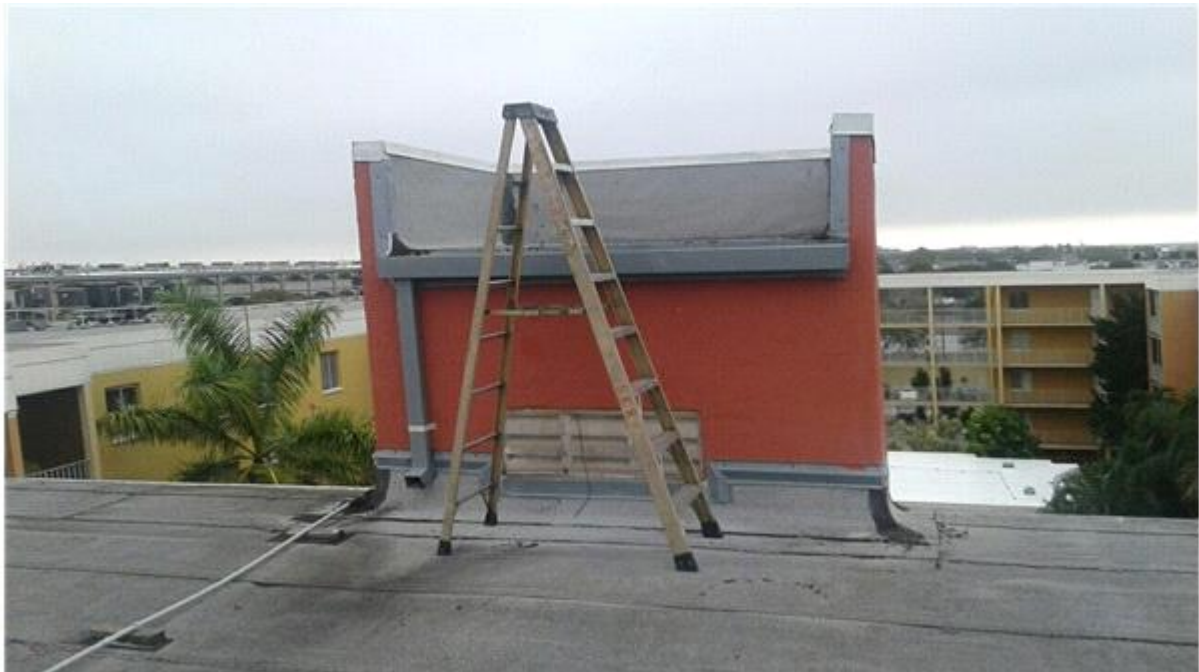
006G- Coping

The coping appears to be in good condition.

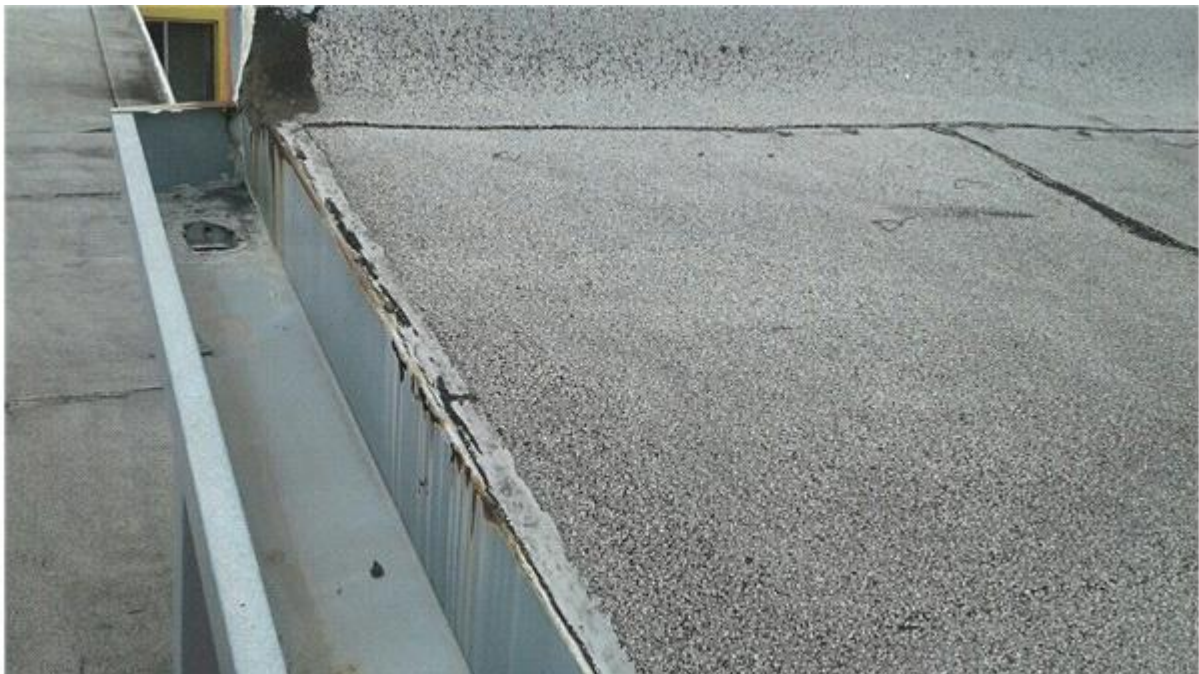
002F - Appearance Overview

The appearance of the roof in fair condition at this time.

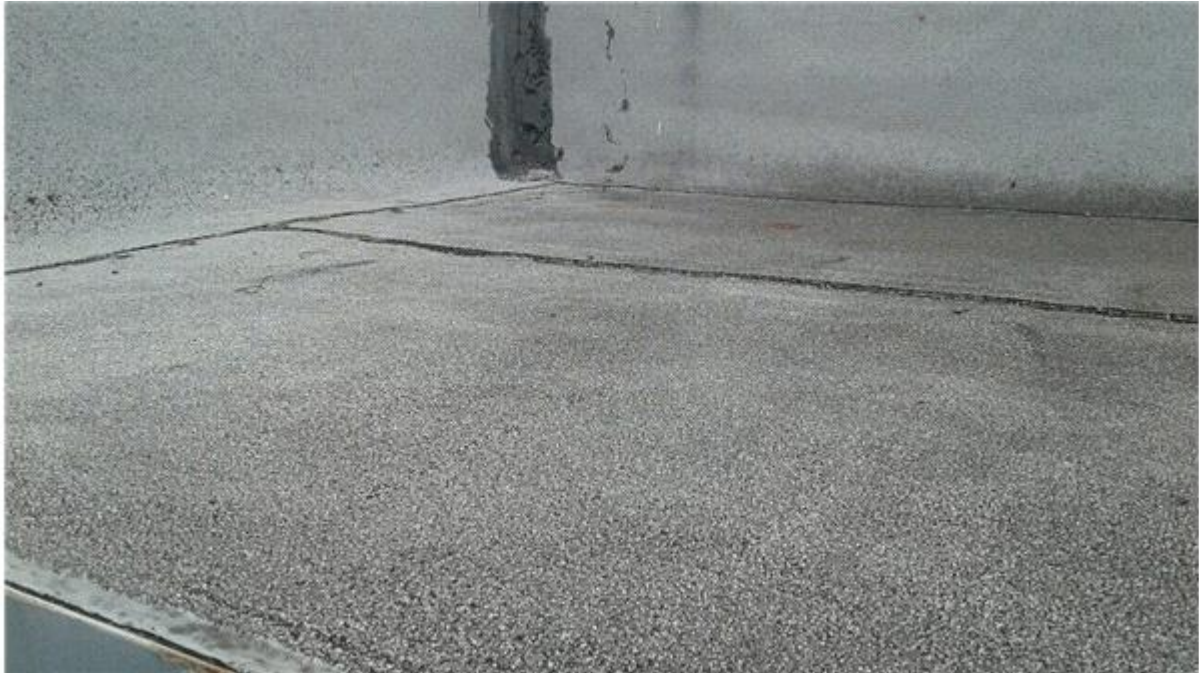
016F-Roof Edge

Roof edge appears to be in fair condition

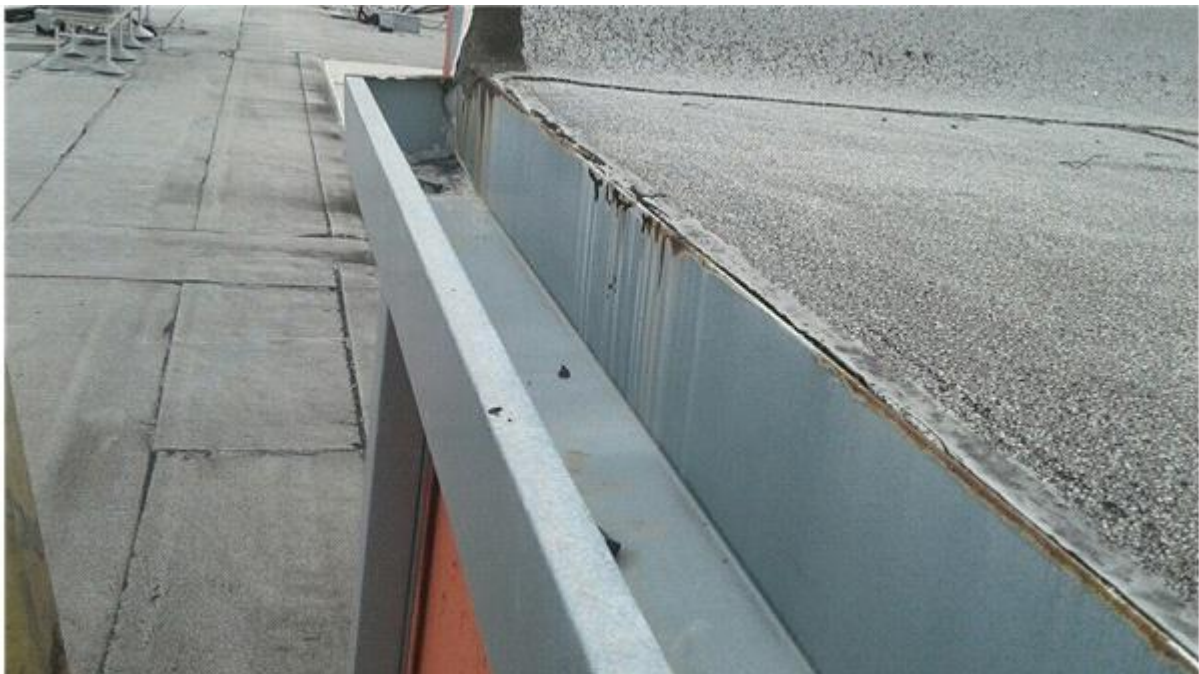
003F -Membrane Overview

The roof membrane appears to be in fair condition at this time.

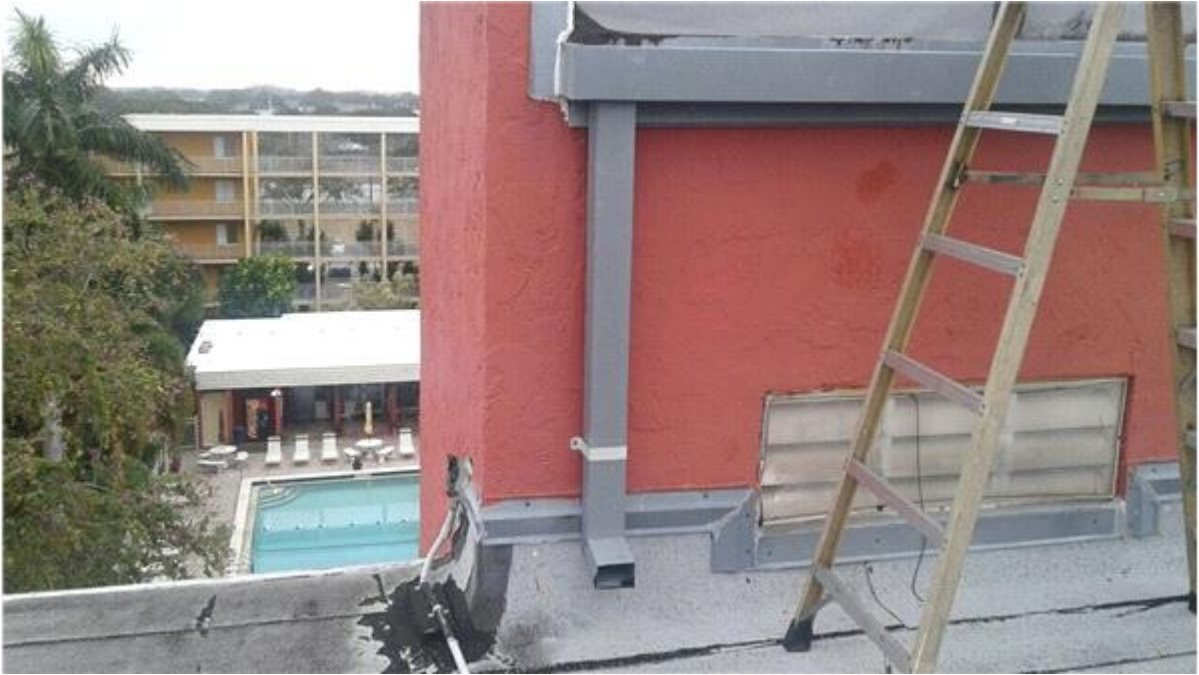
008G- Gutters

The gutters appear to be in good condition.
